Baseline Assessment – Stream Attributes

Reach S-B67 (Timber Mat Crossing)

Spread B Stream S-B67 (Timber Mat Crossing) Lewis County

Client: PROFILE AND CROSS-SECTIONS
BASELINE SURVEY
CROSSING S-B67 - LEFT FORK FREEMANS CREEK (MP 45.85)
LEWIS COUNTY, WV

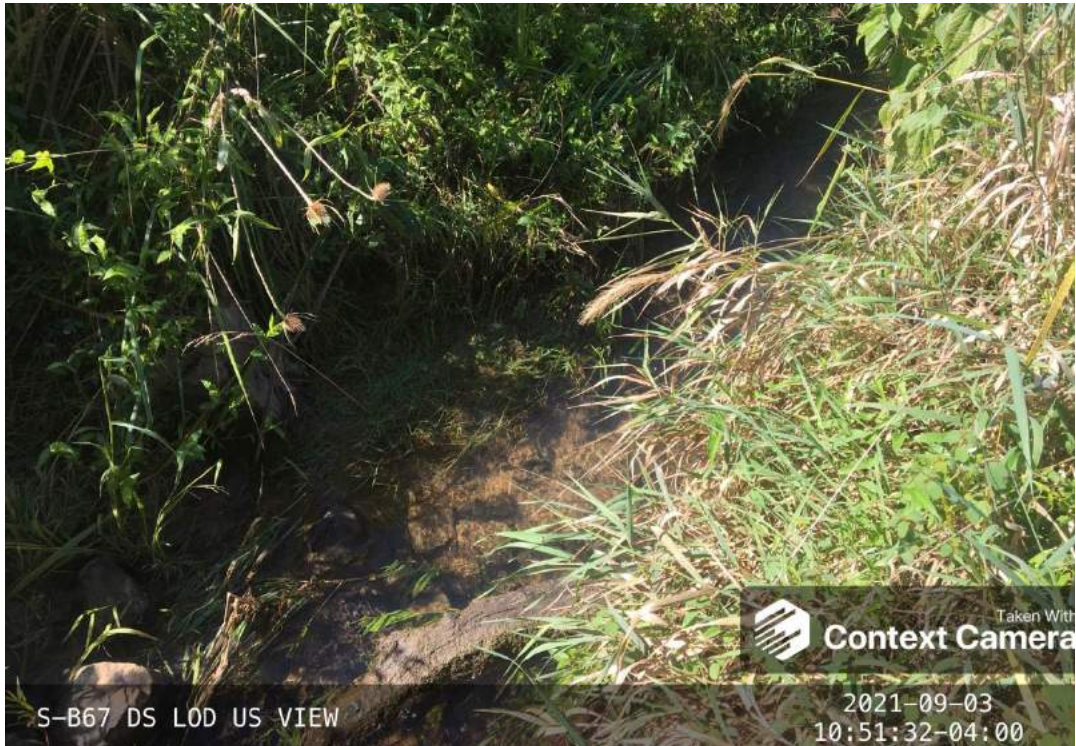
Photo Type: DS, US View

Location, Orientation, Photographer Initials: Downstream Edge of ROW, Upstream View, DP/HK/VM
Lat: 39.079556 Long: -80.581346

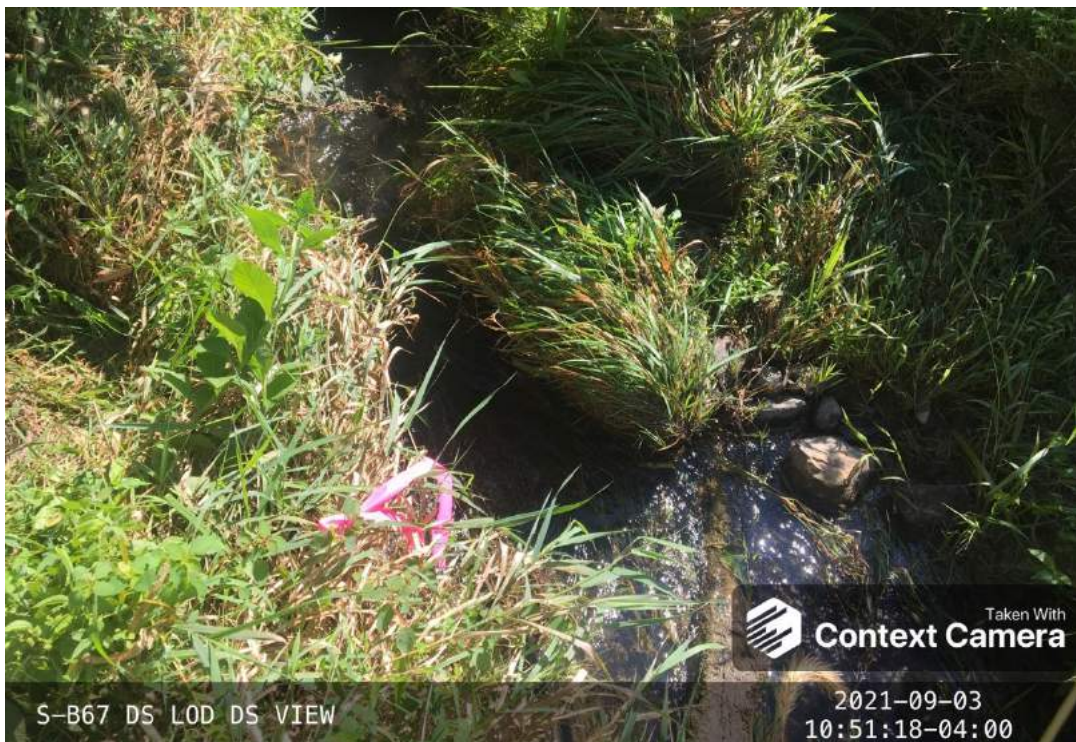
Photo Type: DS, DS View

Location, Orientation, Photographer Initials: Downstream Edge of ROW, Upstream View, DP/HK/VM
Lat: 39.079556 Long: -80.581346

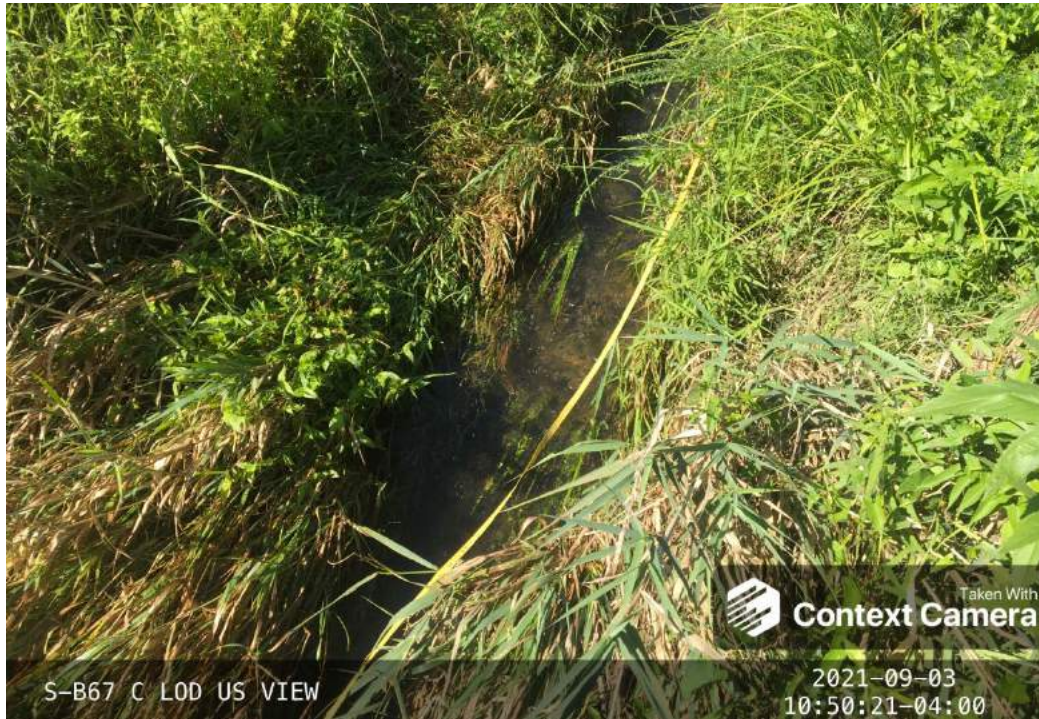
Photo Type: US View at Center
Location, Orientation, Photographer Initials: Downstream Edge of ROW, Upstream View, DP/HK/VM
Lat: 39.079556 Long: -80.581346

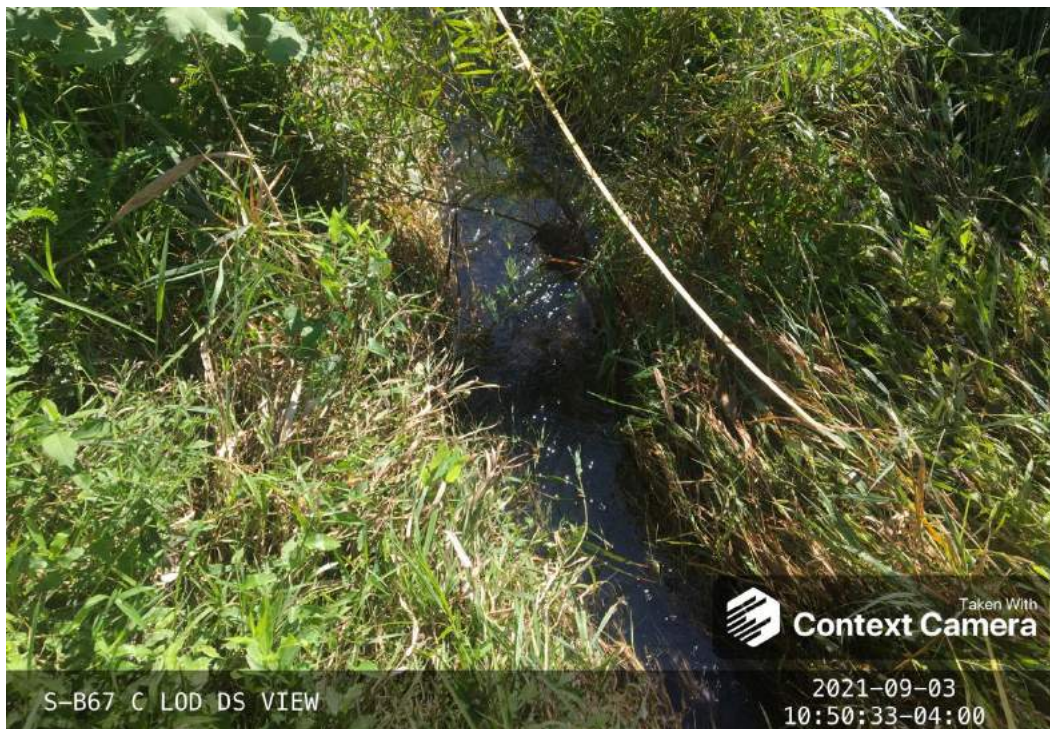
Photo Type: DS View at Center
Location, Orientation, Photographer Initials: Downstream Edge of ROW, Upstream View, DP/HK/VM
Lat: 39.079556 Long: -80.581346

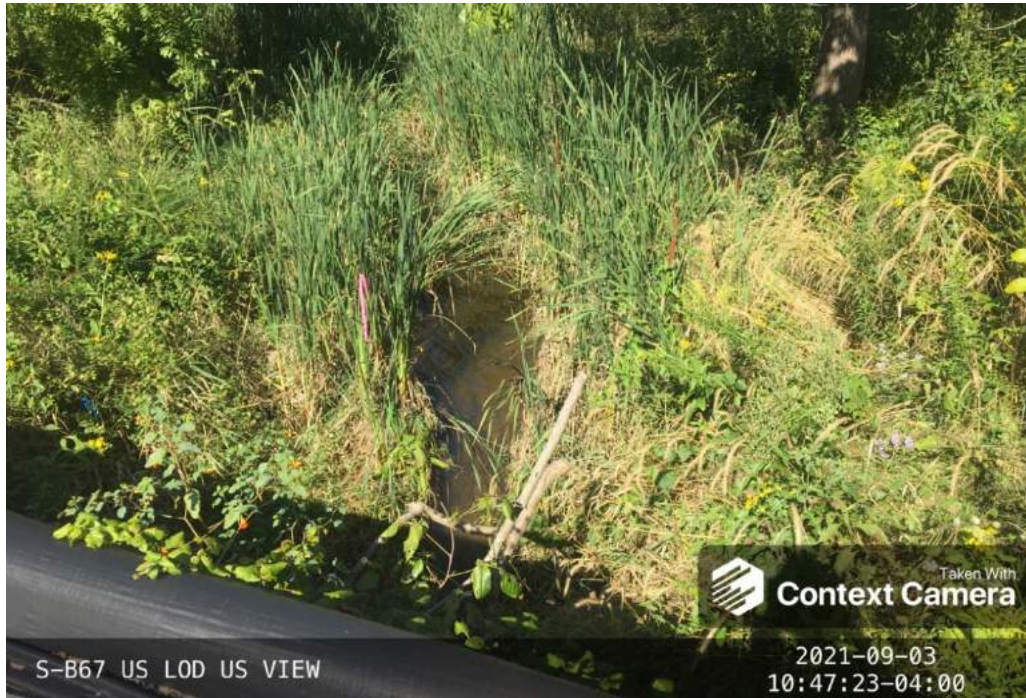
Photo Type: US, US View
Location, Orientation, Photographer Initials: Downstream Edge of ROW, Upstream View, DP/HK/VM
Lat: 39.079556 Long: -80.581346

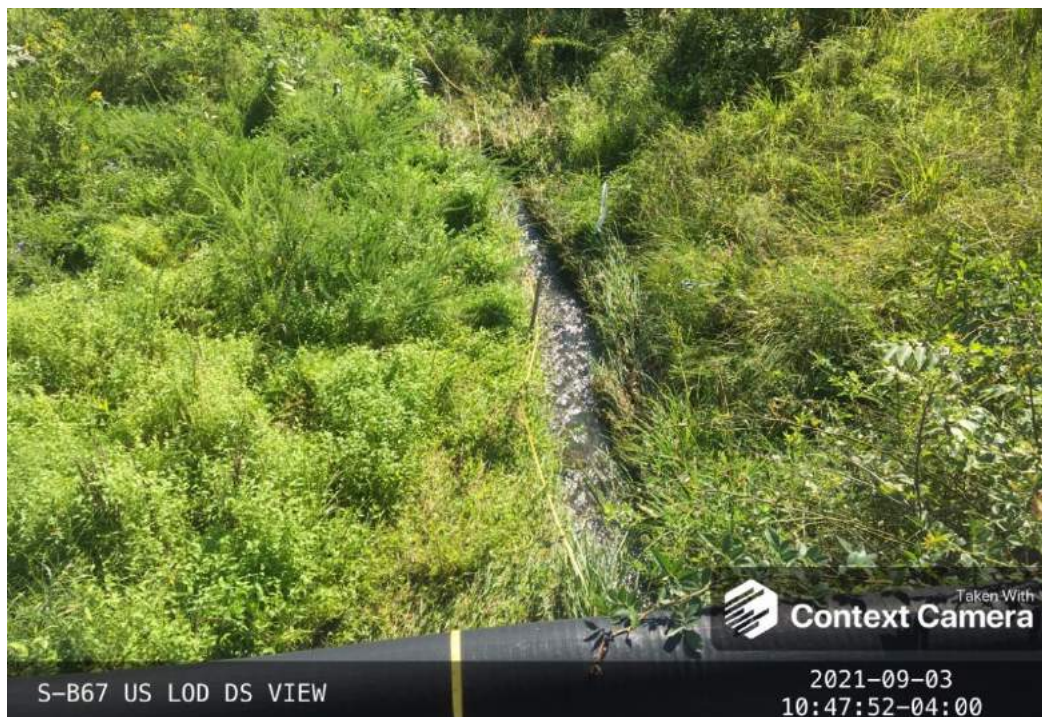
Photo Type: US, DS View
Location, Orientation, Photographer Initials: Downstream Edge of ROW, Upstream View, DP/HK/VM
Lat: 39.079556 Long: -80.581346

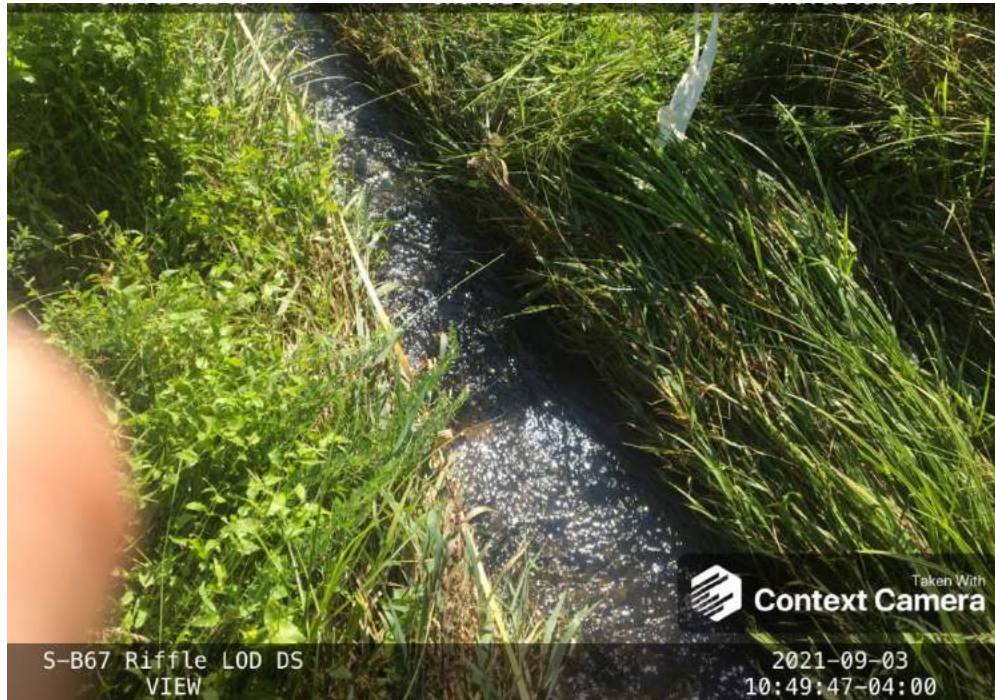
Photo Type: Riffle, DS View
Location, Orientation, Photographer Initials: Upstream of Riffle, Downstream View, DP/HK/VM
Lat: 39.079556 Long: -80.581346

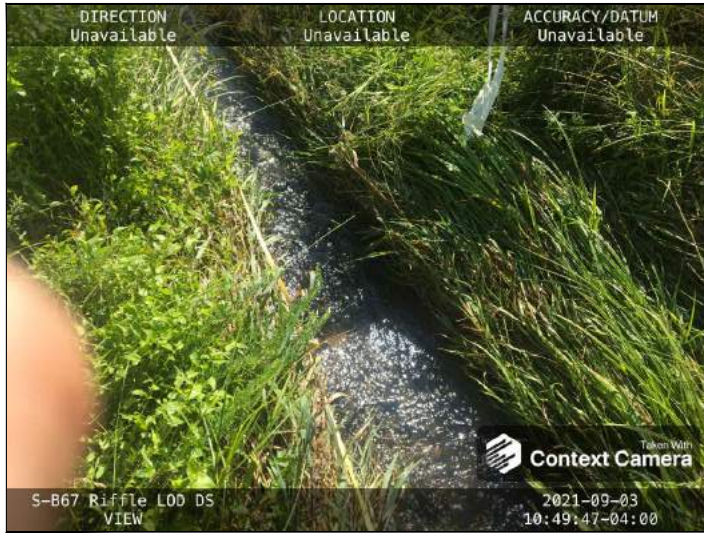
PHOTO TAKEN LOOKING DOWNSTREAM FROM UPSTREAM IMPACT LIMITS

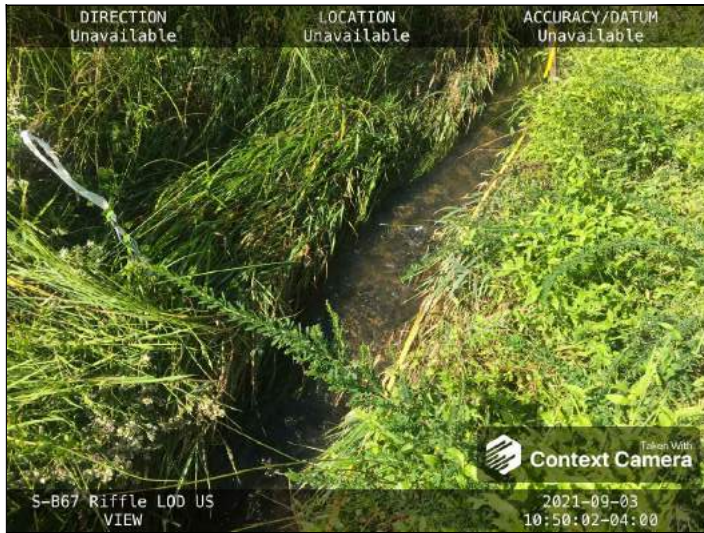
PHOTO TAKEN LOOKING UPSTREAM FROM DOWNSTREAM IMPACT LIMITS
