## Baseline Assessment – Stream Attributes

### Reach S-CD16 (Timber Mat Crossing) Intermittent Spread B Lewis County, West Virginia

Profile and Cross-Sections  
Baseline Survey  
Crossing S-CD16 - Unnamed Trib. to  
Second Big Run (MP 61.21)  
Lewis County, WV

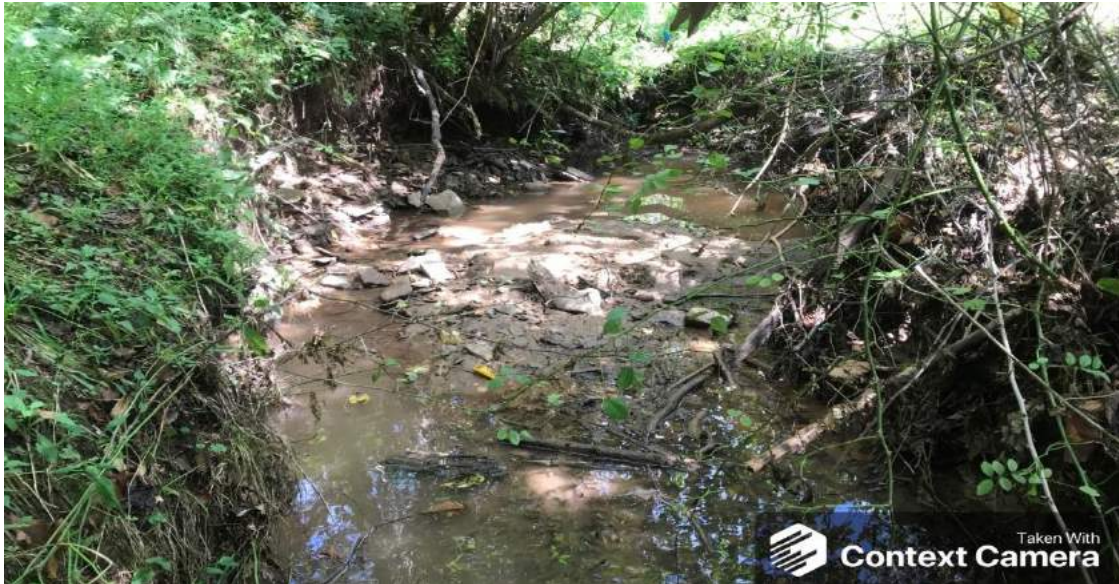
Photo Type: DS, US View

Location, Orientation, Photographer Initials: Downstream Edge of ROW, Upstream View, AJE/PEL

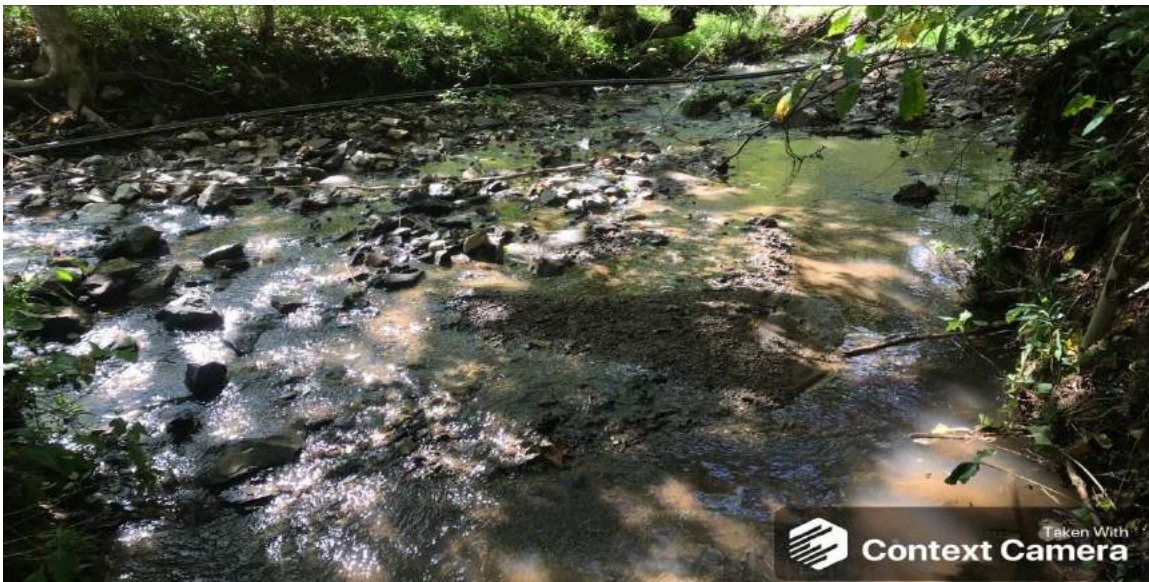
Photo Type: DS, DS View

Location, Orientation, Photographer Initials: Downstream Edge of ROW, Downstream View, AJE/PEL

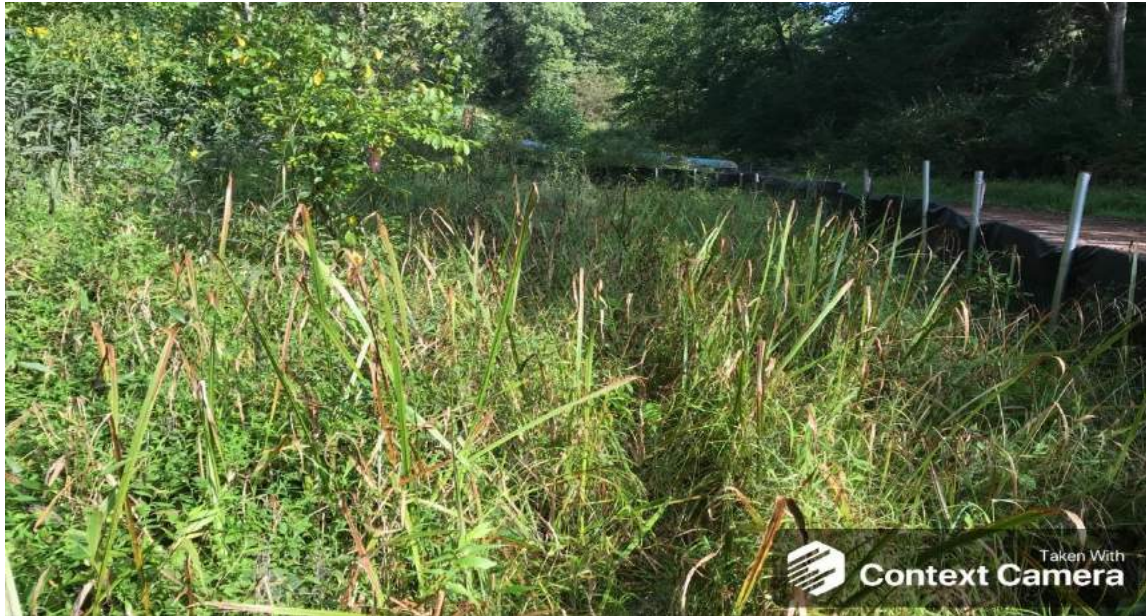
Photo Type: US View at Center  
Location, Orientation, Photographer Initials: Center ROW, Upstream View, AJE/PEL  
Lat: 38.904135 Long: -80.563719

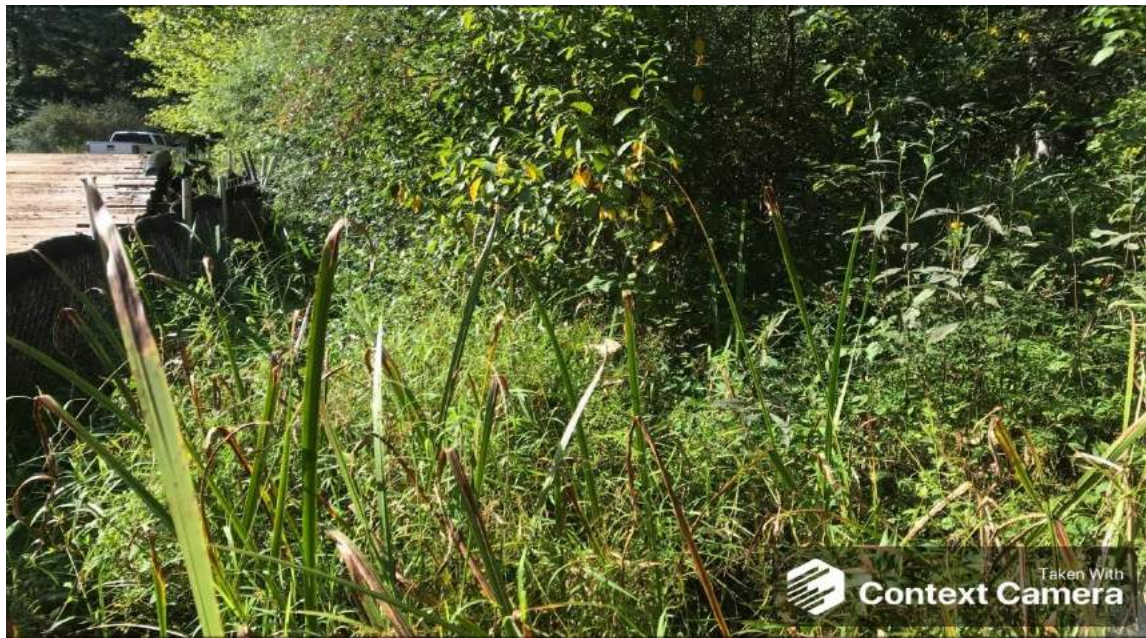
Photo Type: DS View at Center  
Location, Orientation, Photographer Initials: ROW Center, Downstream View, AJE/PEL  
Lat: 38.904135 Long: -80.563719

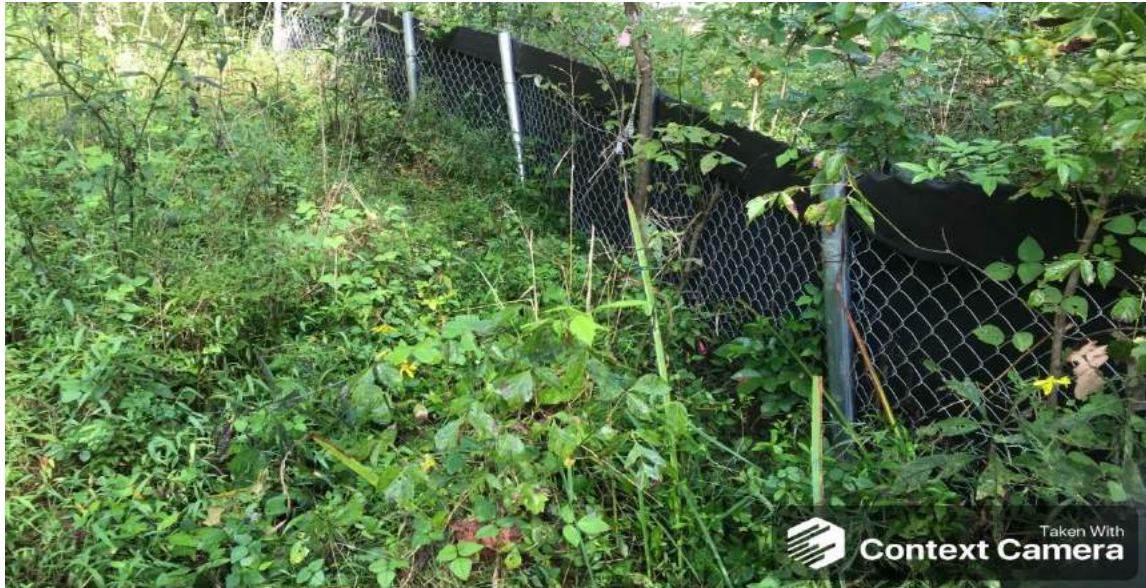
Photo Type: US, US View

Location, Orientation, Photographer Initials: Upstream Edge of ROW, Upstream View, AJE/PEL

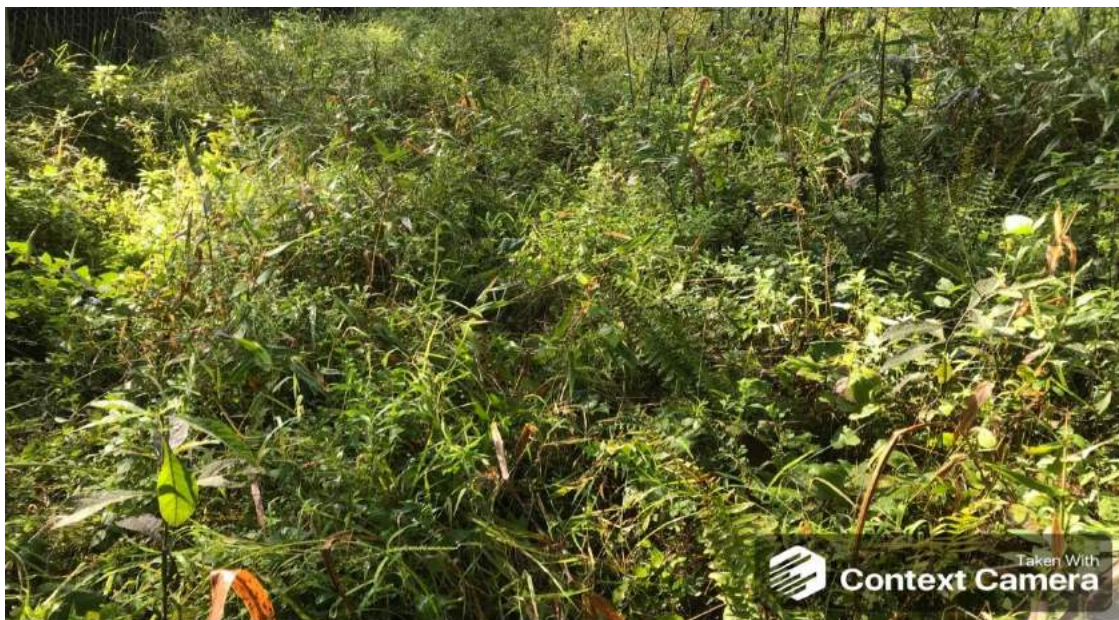
Photo Type: US, DS View

Location, Orientation, Photographer Initials: Upstream Edge of ROW, Downstream View, AJE/PEL

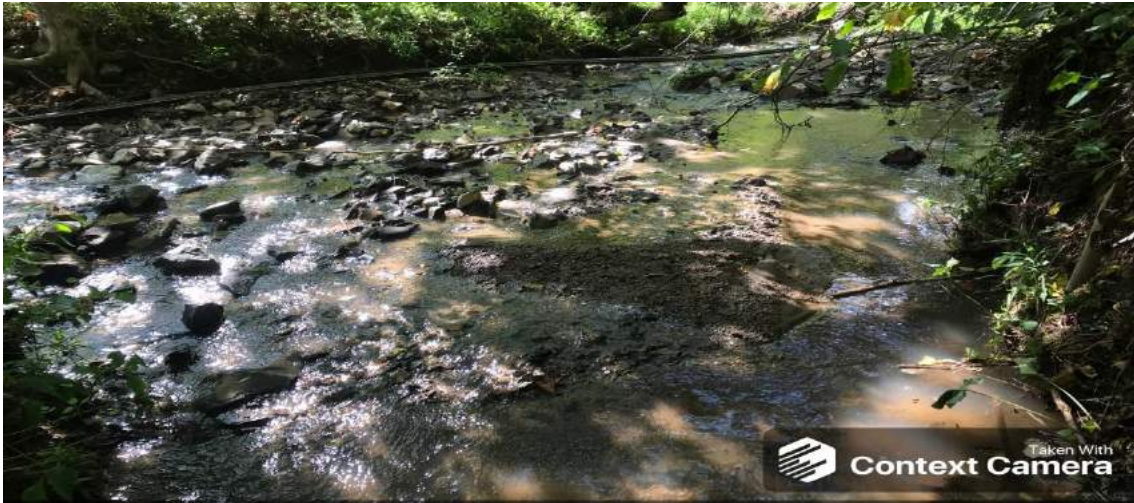
Photo Type: Riffle, DS View  
Location, Orientation, Photographer Initials: Upstream of Riffle, Downstream View, AJE/PEL  
Lat: 38.904135 Long: -80.563719

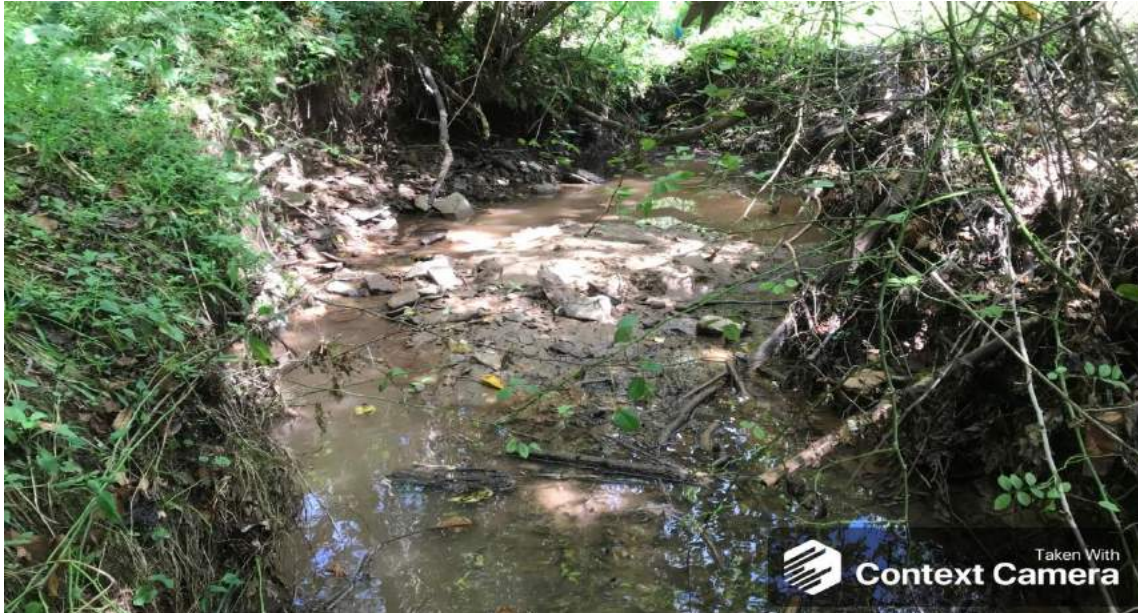
Photo Type: Riffle, US View  
Location, Orientation, Photographer Initials: Downstream of Riffle, Upstream View, AJE/PEL  
Lat: 38.904135 Long: -80.563719

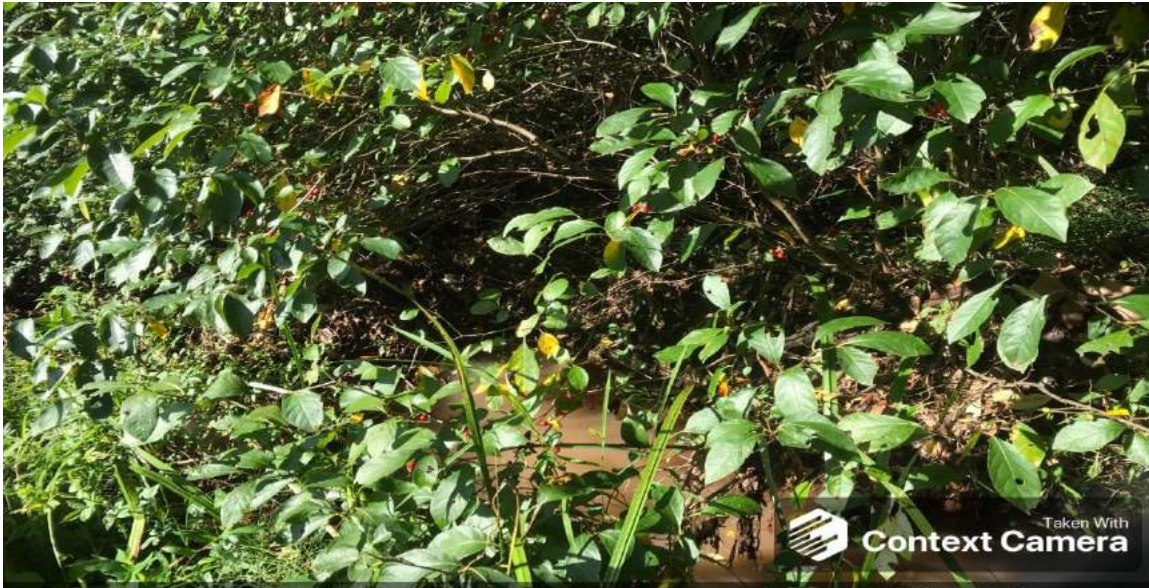
Photo Type: Pool, DS View  
Location, Orientation, Photographer Initials: Upstream of Pool, Downstream View, AJE/PEL  
Lat: 38.904135 Long: -80.563719

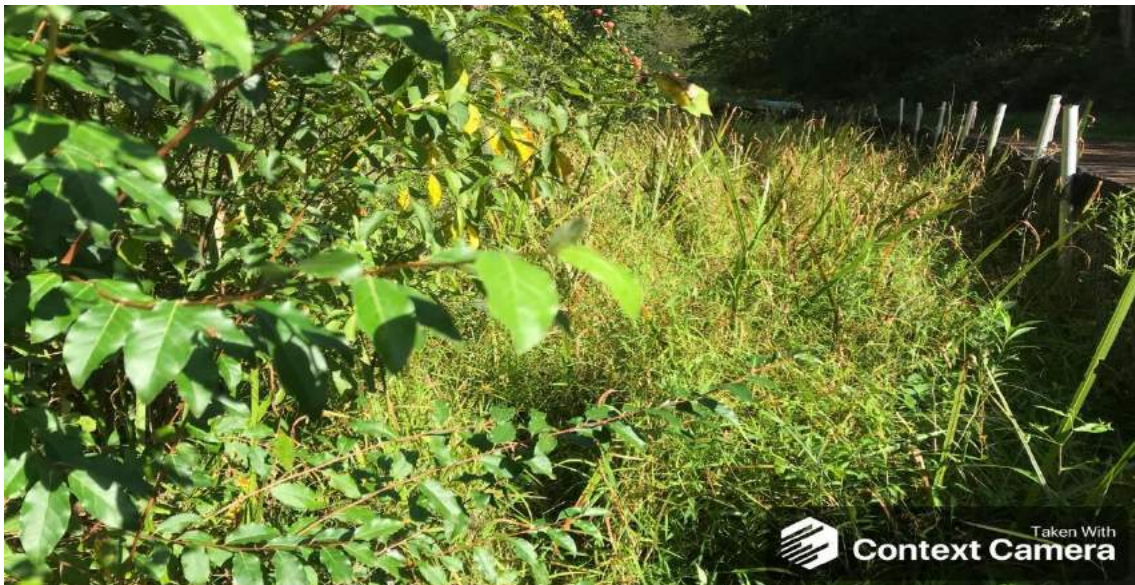
Photo Type: Pool, US View  
Location, Orientation, Photographer Initials: Downstream of Pool, Upstream View, AJE/PEL  
Lat: 38.904135 Long: -80.563719

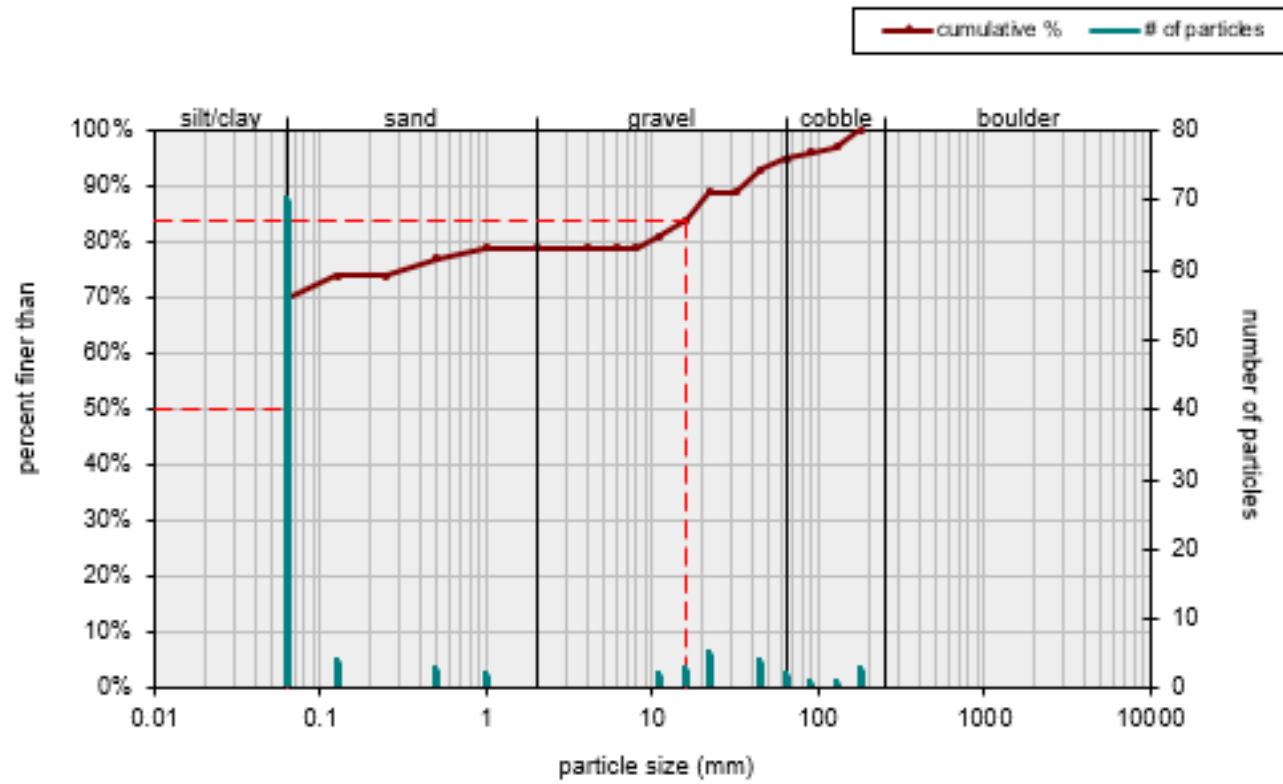
Bankfull Channel Pebble Count, S-CD16

Size (mm)		Size Distribution		Type	
D16	0.062	mean	1.0	silt/clay	70%
D35	0.062	dispersion	129.5	sand	9%
D50	0.062	skewness	0.78	gravel	16%
D65	0.062			cobble	5%
D84	16			boulder	0%
D95	64

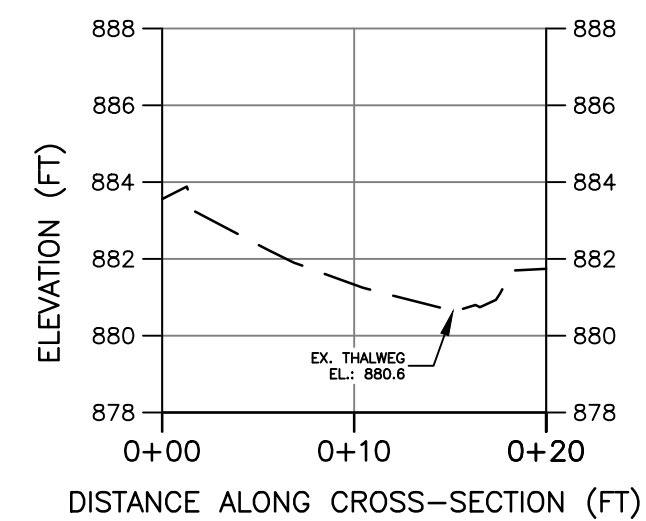
TYPICAL 5-POINT CROSS-SECTION  
(FACING DOWNSTREAM)

The cross-section profile shows the elevation of the road surface relative to the centerline. The Y-axis represents Elevation (FT) from 876 to 886. The X-axis represents Distance Along Cross-Section (FT) from 0+00 to 0+20. The profile starts at approximately 883.0 FT at 0+00, drops to a minimum of 879.1 FT at 0+10 (labeled 'EX. THALWEG EL.: 879.1'), and then rises to approximately 883.0 FT at 0+20.

Distance Along Cross-Section (FT)	Elevation (FT)
0+00	883.0
0+05	879.5
0+10	879.1
0+15	883.0
0+20	883.0

AS-BUILT TABLE: 5-CD16 CROSS SECTION B					
PRE-CROSSING			AS-BUILT		
PT. LOC.	NORTHING	EASTING	ELEV	VERT. DIFF.	HORZ. DIFF.
TS-L	14127704.94	1764510.35	883.00		
BS-L	14127705.15	1764509.80	879.58		
THW	14127706.34	1764506.68	879.14		
BS-R	14127707.25	1764504.31	879.57		
TS-R	14127707.92	1764502.56	881.09

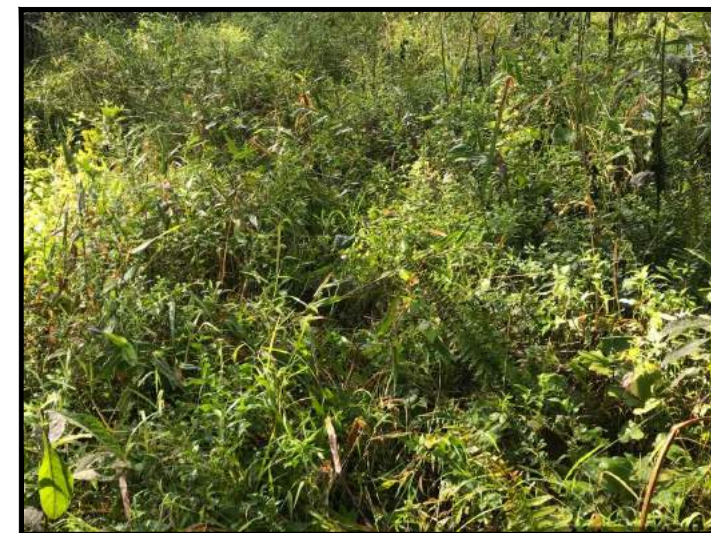
PHOTO TAKEN LOOKING DOWNSTREAM  
FROM UPSTREAM IMPACT LIMITS

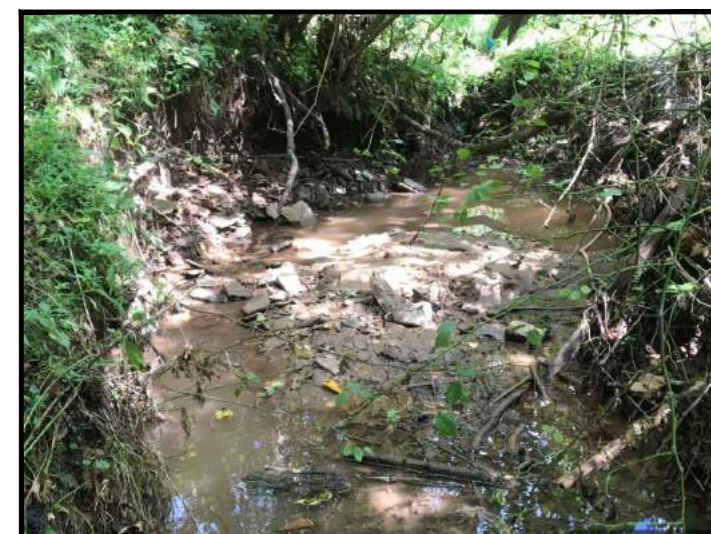
PHOTO TAKEN LOOKING UPSTREAM FROM  
DOWNSTREAM IMPACT LIMITS
