# **Baseline Assessment – Stream Attributes**

# Reach S-E50 (1) (Pipeline ROW) Perennial Spread D Webster County, West Virginia

# Spread D Stream S-E50 (1) (Pipeline ROW) Webster County

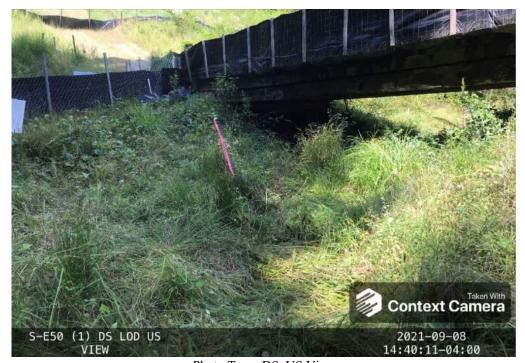
Photo Type: DS, US View Location, Orientation, Photographer Initials: Downstream Edge of ROW, Upstream View, MW/SM Lat: 38.370597 Long: -80.611921

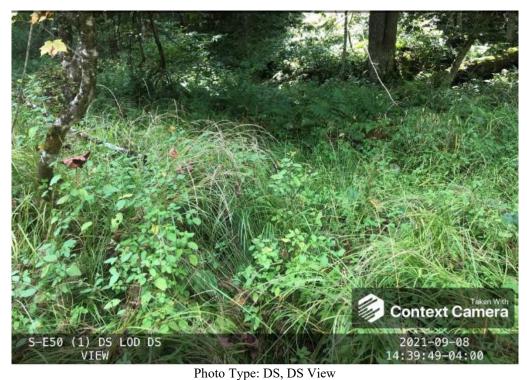
Location, Orientation, Photographer Initials: Downstream Edge of ROW, Downstream View, MW/SM Lat: 38.370597 Long: -80.611921

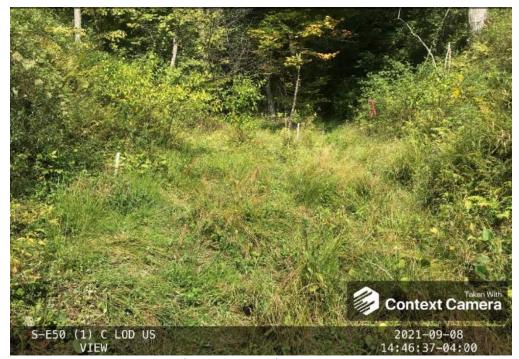
Photo Type: US View at Center Location, Orientation, Photographer Initials: Center ROW, Upstream View, MW/SM Lat: 38.370597 Long: -80.611921

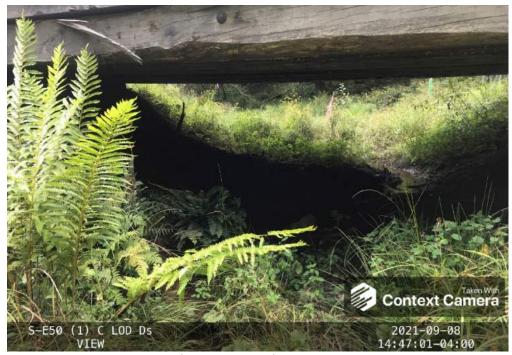
Photo Type: DS View at Center Location, Orientation, Photographer Initials: Center ROW, Downstream View, MW/SM Lat: 38.370597 Long: -80.611921

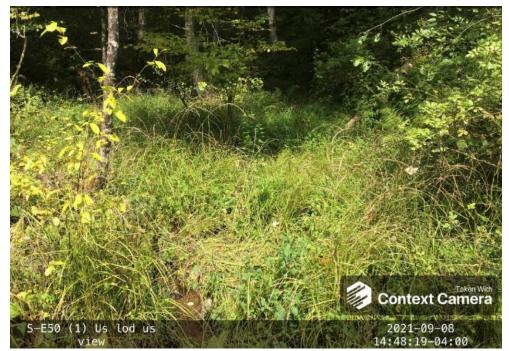
Photo Type: US, US View
Location, Orientation, Photographer Initials: Upstream Edge of ROW, Upstream View, MW/SM
Lat: 38.370597 Long: -80.611921

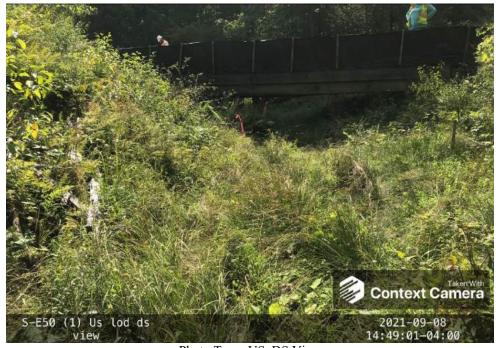
Photo Type: US, DS View
Location, Orientation, Photographer Initials: Upstream Edge of ROW, Downstream View, MW/SM
Lat: 38.370597 Long: -80.611921

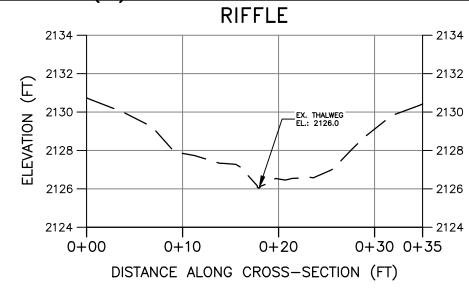
# S-E50 (1) BASELINE CROSS-SECTION A

NOTE: ALL SECTIONS VIEWS SHOWN LEFT TO RIGHT FACING DOWNSTREAM.

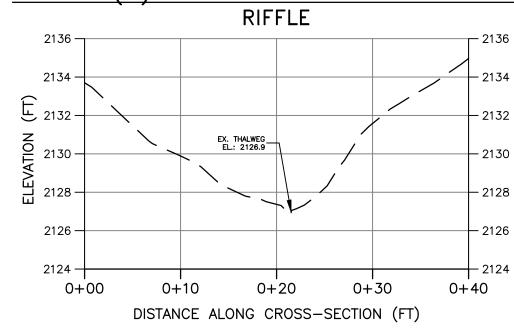
S-E50 (1) BASELINE CROSS-SECTION B

AS-BUILT TABLE: S-E50 (1) CROSS SECTION B							
	Pi	AŞ-BUILT					
PT. LOC.	NORTHING	EASTING	ELEV	VERT. DIFF.	HORZ. DIFF.		
TS-L	13933721.3500	1751640.9070	2127.499'				
BS-L	13933720.8100	1751641.54801	2126.989'				
THW	13933720.5800	1751642.0560	2127.064'				
BS-R	13933720.5800	1751642.0040	2126.947'				
TS-R	13933720,2000	1751642.78301	2127.271'

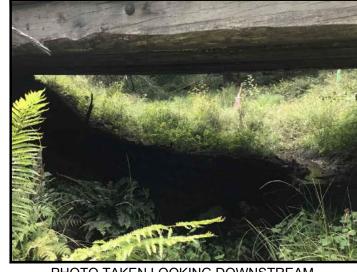
PHOTO TAKEN LOOKING DOWNSTREAM FROM UPSTREAM IMPACT LIMITS

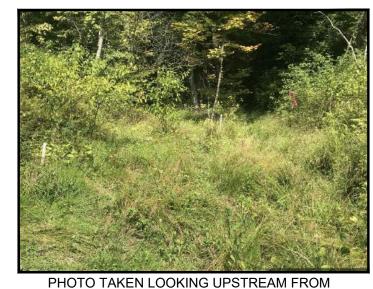
DOWNSTREAM IMPACT LIMITS
