Baseline Assessment – Stream Attributes

Reach S-E50 (2) (Pipeline ROW) Perennial Spread D Webster County, West Virginia

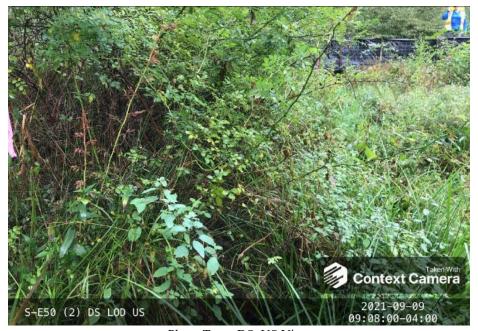
Photo Type: DS, US View Location, Orientation, Photographer Initials: Downstream Edge of ROW, Upstream View, SM/MW Lat: 38.36728 Long: -80.612317

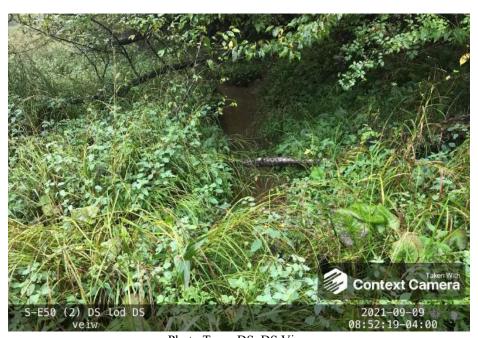
Photo Type: DS, DS View
Location, Orientation, Photographer Initials: Downstream Edge of ROW, Downstream View, SM/MW
Lat: 38.36728 Long: -80.612317

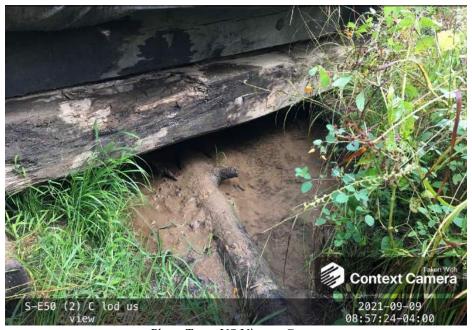
Photo Type: US View at Center Location, Orientation, Photographer Initials: Center ROW, Upstream View, SM/MW Lat: 38.36728 Long: -80.612317

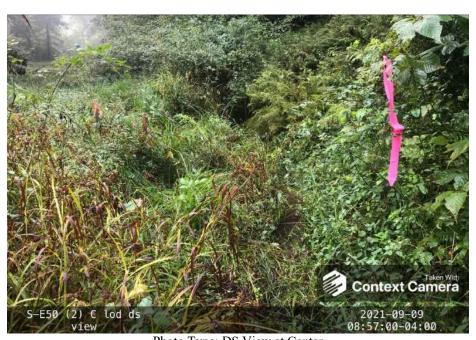
Photo Type: DS View at Center Location, Orientation, Photographer Initials: ROW Center, Downstream View, SM/MW Lat: 38.36728 Long: -80.612317

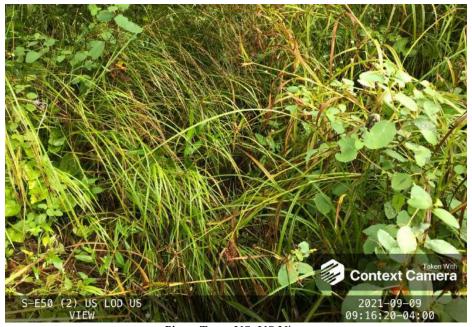
Photo Type: US, US View
Location, Orientation, Photographer Initials: Upstream Edge of ROW, Upstream View, SM/MW
Lat: 38.36728 Long: -80.612317

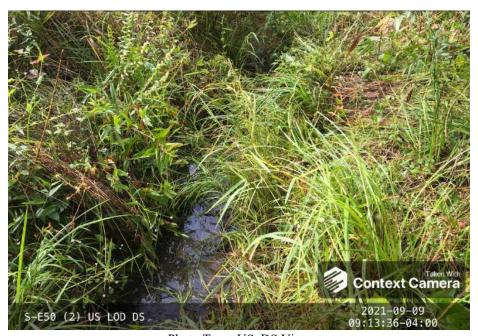
Photo Type: US, DS View Location, Orientation, Photographer Initials: Upstream Edge of ROW, Downstream View, SM/MW Lat: 38.36728 Long: -80.612317

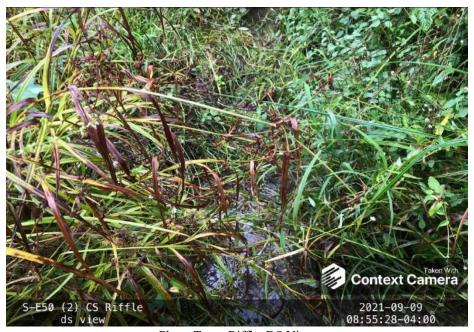
Photo Type: Riffle, DS View Location, Orientation, Photographer Initials: Upstream of Riffle, Downstream View, SM/MW Lat: 38.36728 Long: -80.612317

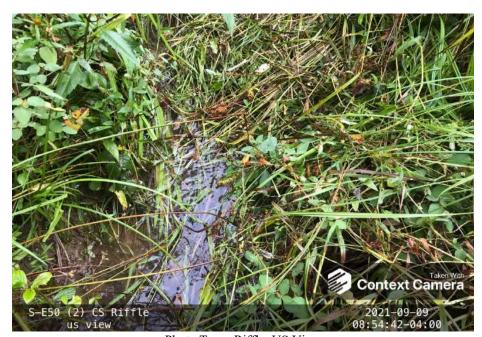
Photo Type: Riffle, US View Location, Orientation, Photographer Initials: Downstream of Riffle, Upstream View, SM/MW Lat: 38.36728 Long: -80.612317

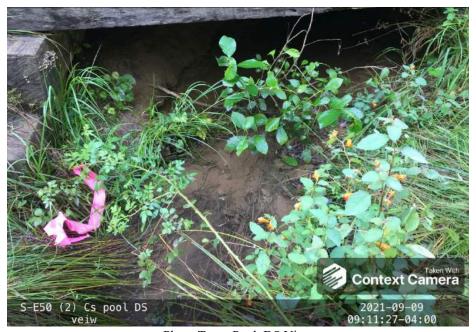
Photo Type: Pool, DS View Location, Orientation, Photographer Initials: Upstream of Pool, Downstream View, SM/MW Lat: 38.36728 Long: -80.612317

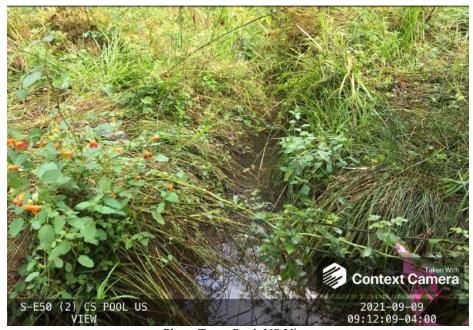
Photo Type: Pool, US View Location, Orientation, Photographer Initials: Downstream of Pool, Upstream View, SM/MW Lat: 38.36728 Long: -80.612317

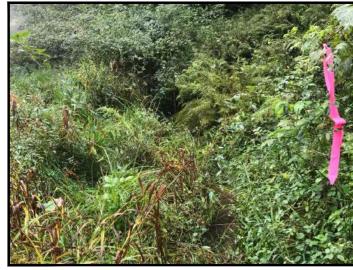
PHOTO TAKEN LOOKING DOWNSTREAM FROM UPSTREAM IMPACT LIMITS

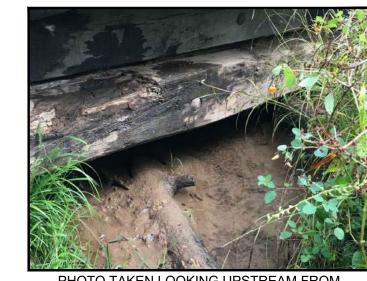
PHOTO TAKEN LOOKING UPSTREAM FROM DOWNSTREAM IMPACT LIMITS
