Baseline Assessment – Stream Attributes

Reach S-E76 (Timber Mat Crossing) Ephemeral Spread C Webster County, West Virginia

Title
PROFILE AND CROSS-SECTIONS
BASELINE SURVEY
CROSSING S-E76 - UNNAMED TRIB. TO LEFT
FORK HOLLY RIVER (MP 81.72)
WEBSTER COUNTY, WV

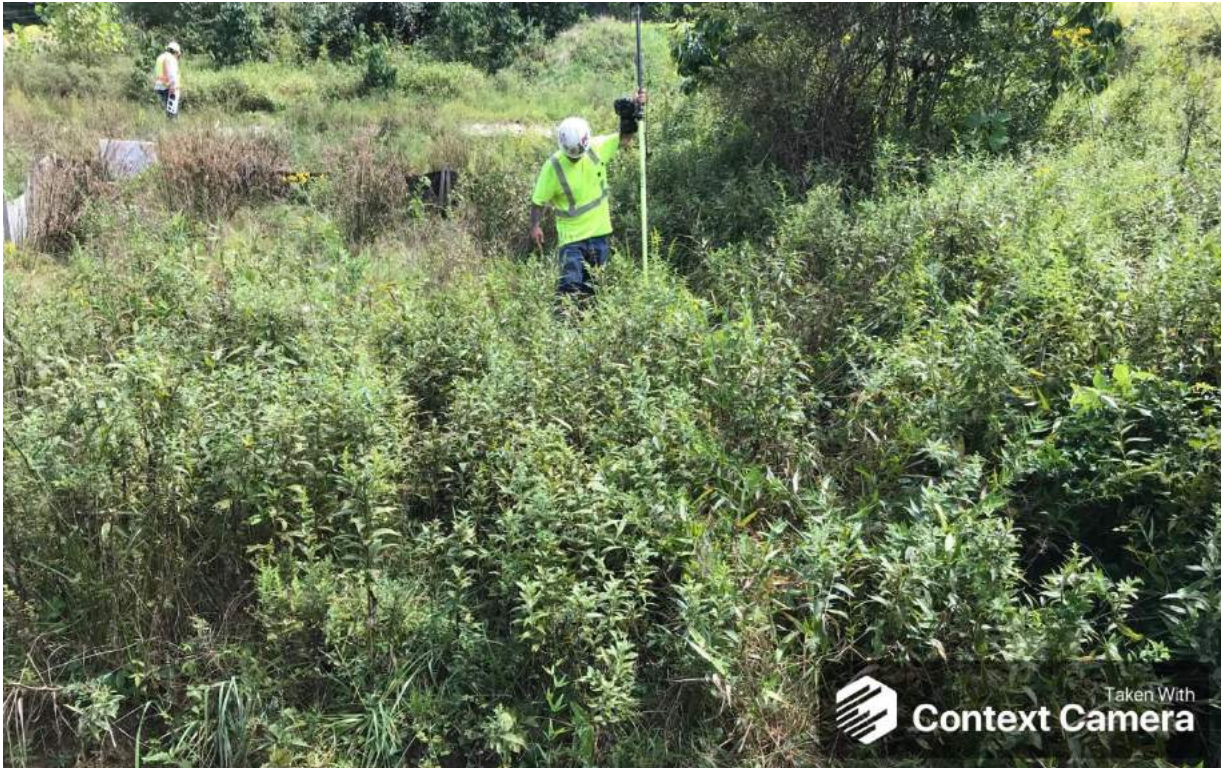
Photo Type: DS, US View
Location, Orientation, Photographer Initials: Downstream Edge of ROW, Upstream View, DD/LC
Lat: 38.674988 Long: -80.47736

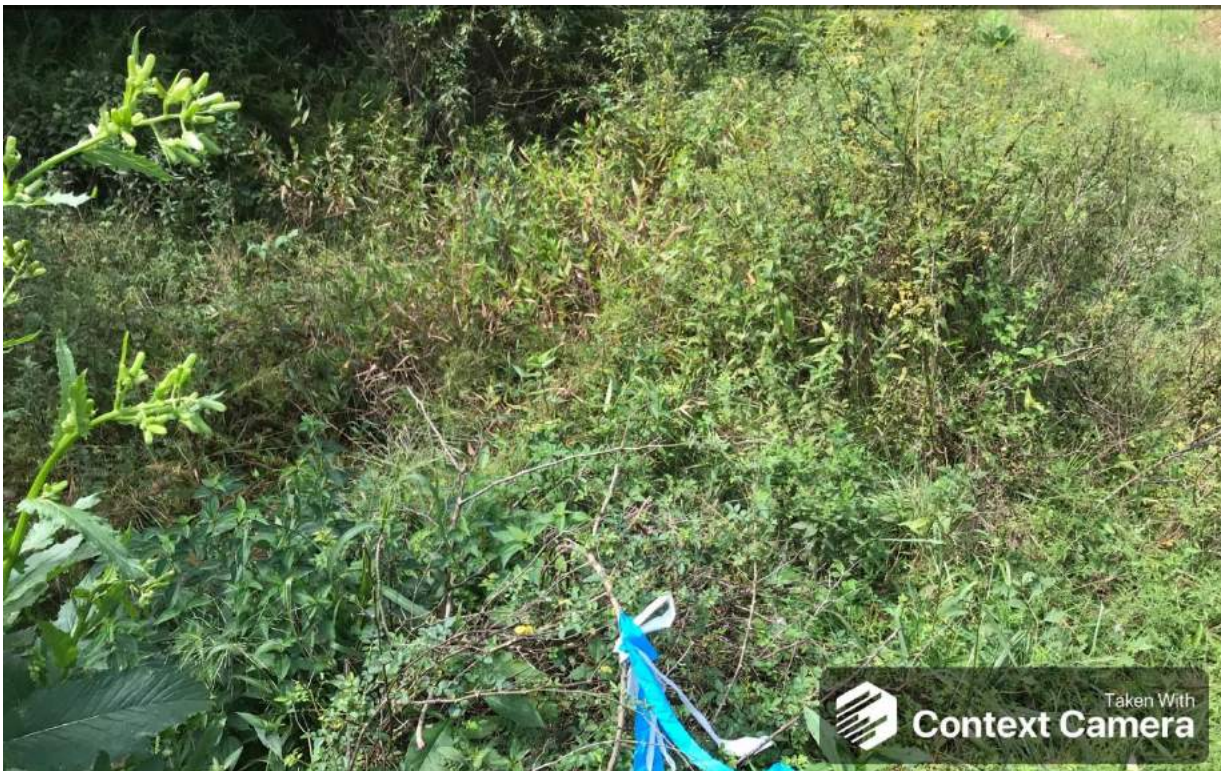
Photo Type: DS, DS View
Location, Orientation, Photographer Initials: Downstream Edge of ROW, Downstream View, DD/LC
Lat: 38.674988 Long: -80.47736

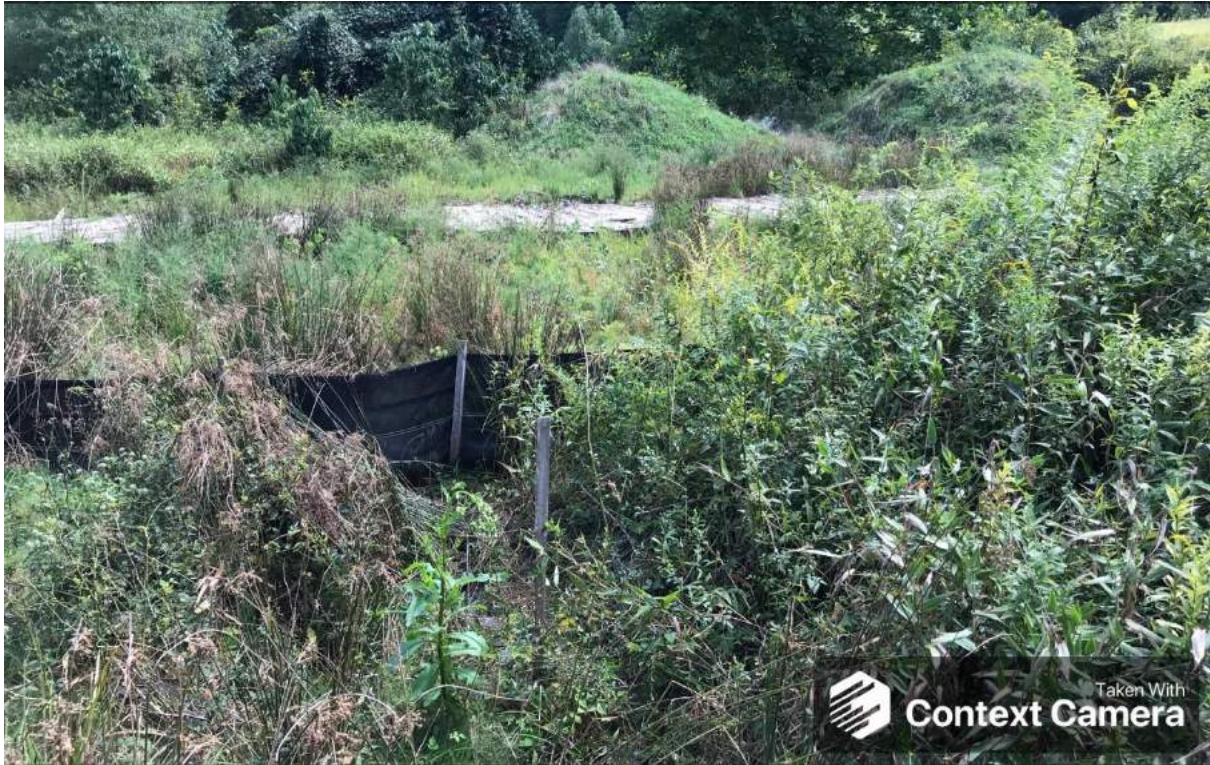
Photo Type: US View at Center
Location, Orientation, Photographer Initials: Center ROW, Upstream View, DD/LC
Lat: 38.674988 Long: -80.47736

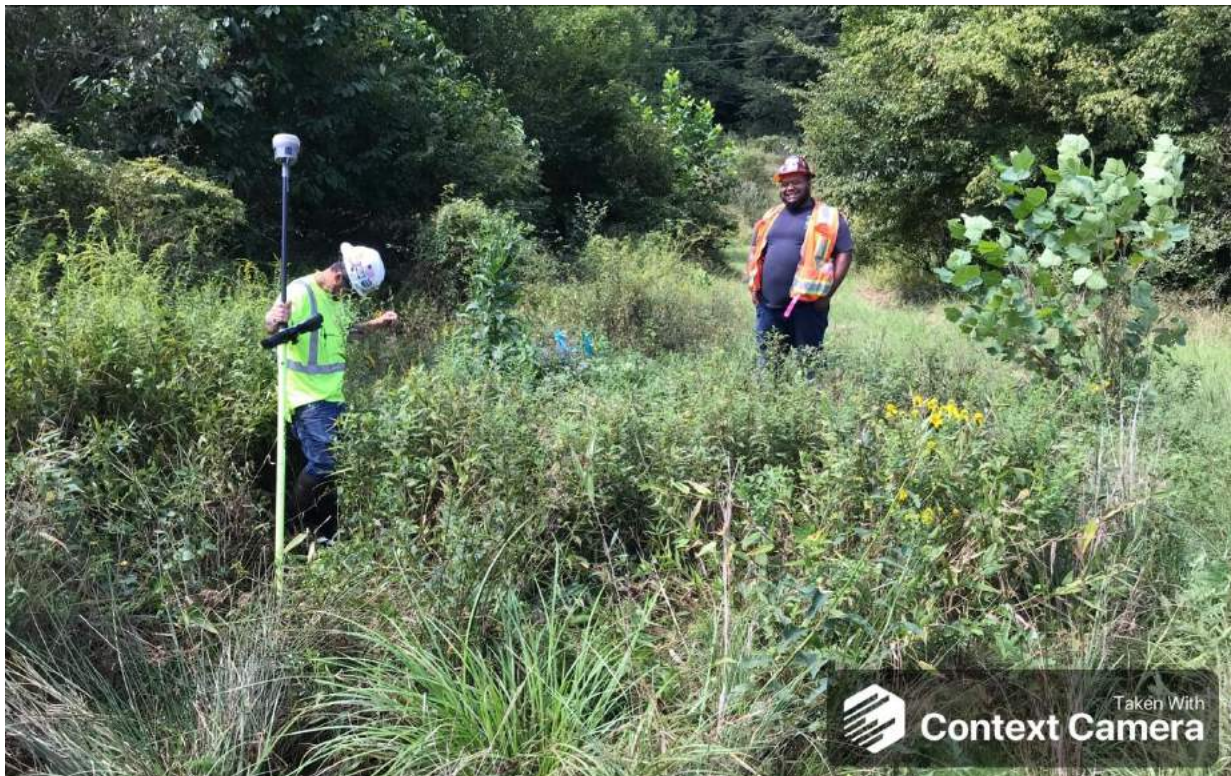
Photo Type: DS View at Center
Location, Orientation, Photographer Initials: ROW Center, Downstream View, DD/LC
Lat: 38.674988 Long: -80.47736

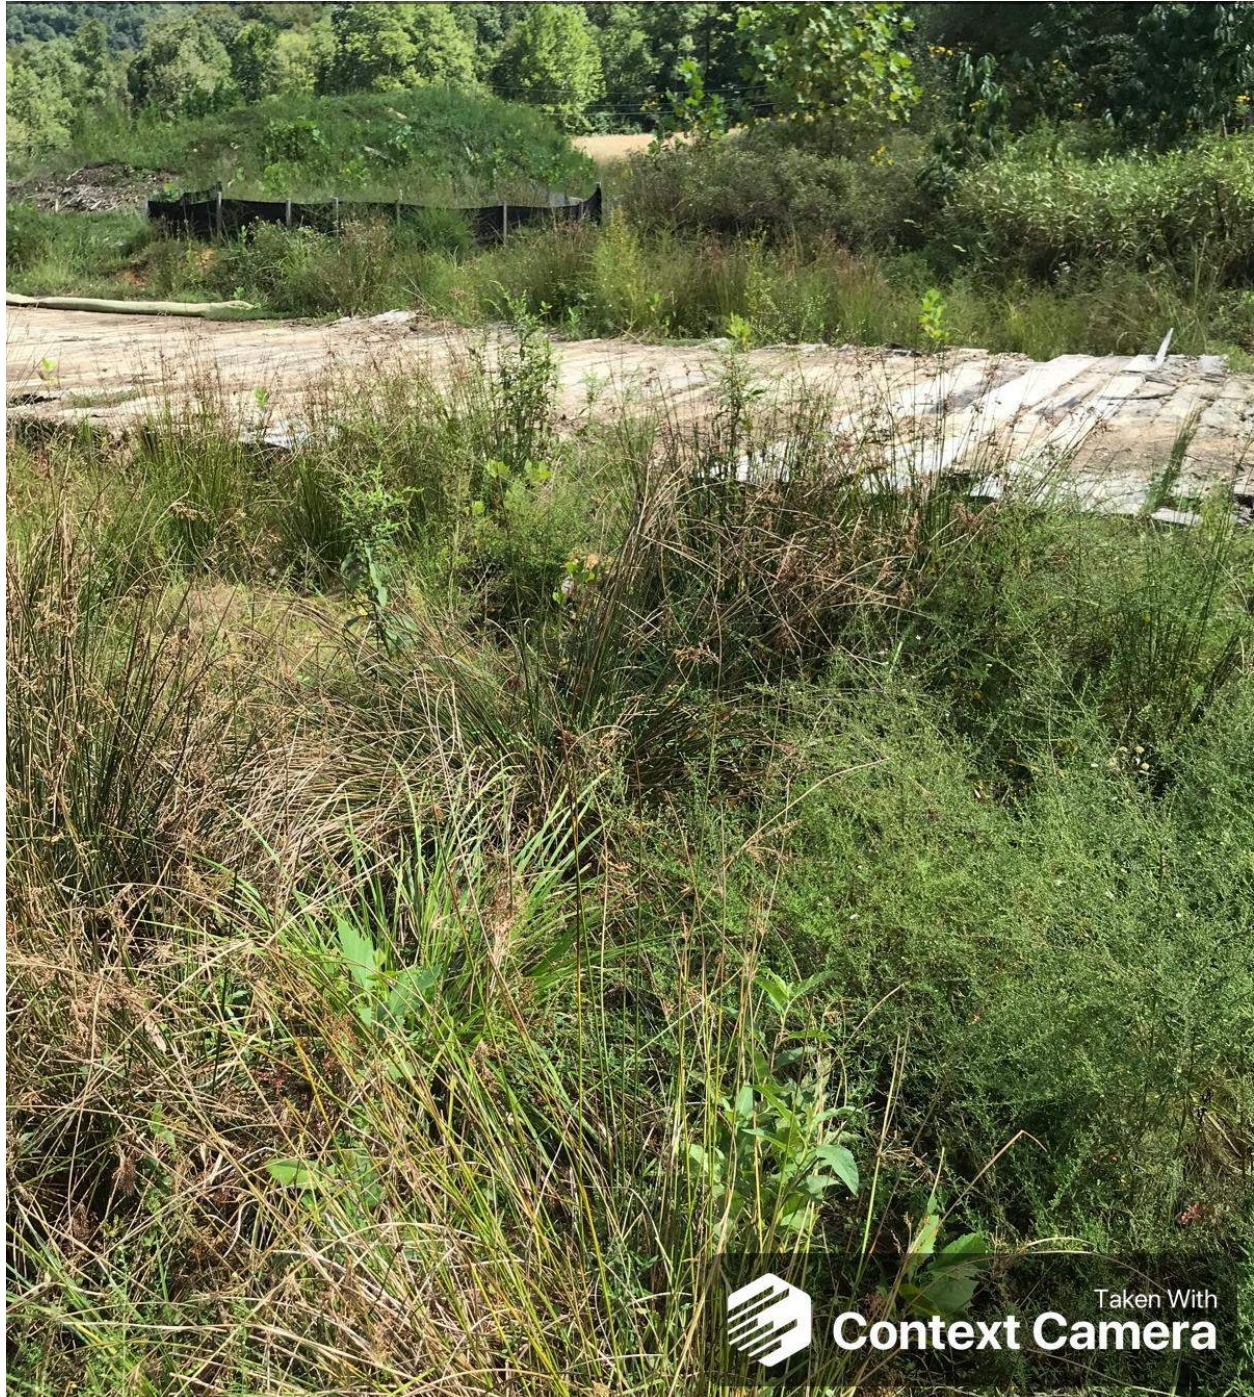
Photo Type: US, US View
Location, Orientation, Photographer Initials: Upstream Edge of ROW, Upstream View, DD/LC
Lat: 38.674988 Long: -80.47736

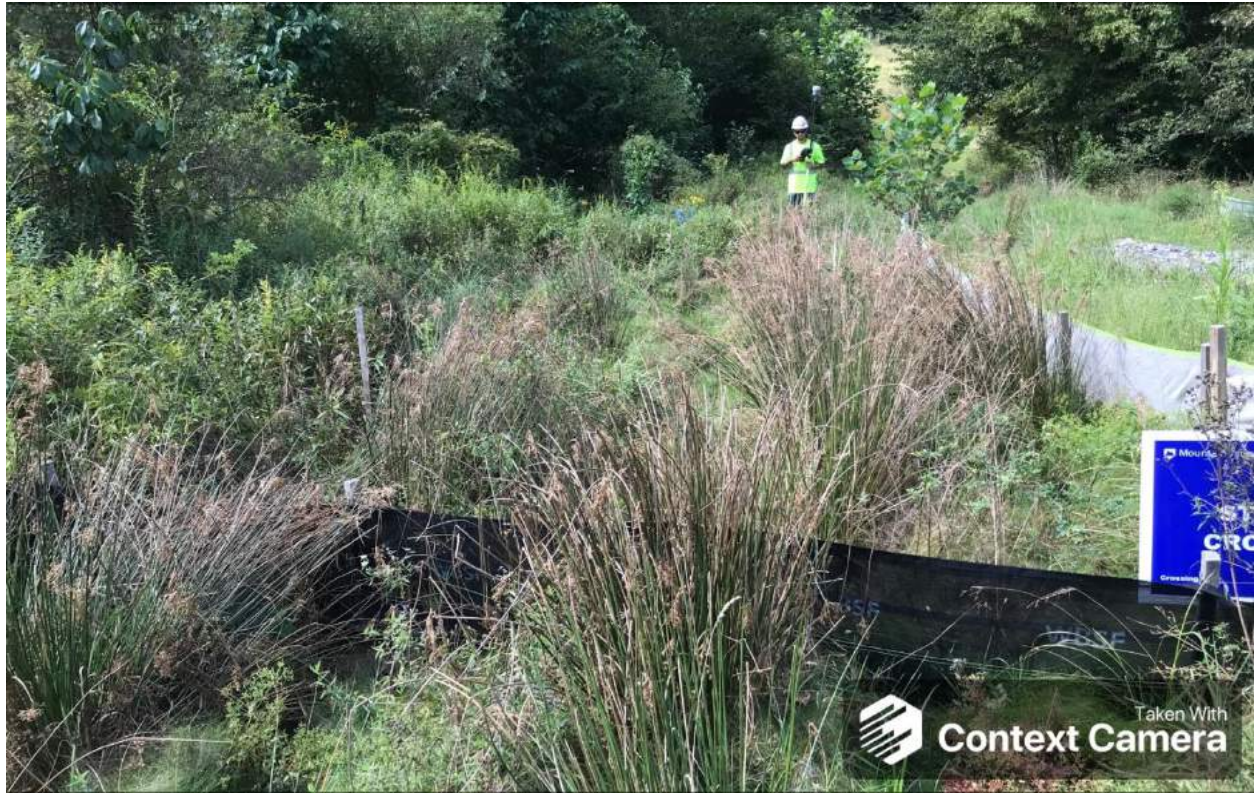
Photo Type: US, DS View
Location, Orientation, Photographer Initials: Upstream Edge of ROW, Downstream View, DD/LC
Lat: 38.674988 Long: -80.47736
