## Baseline Assessment – Stream Attributes

### Reach S-F21 (Timber Mat Crossing) Perennial Spread D Nicholas County, West Virginia

## Spread D Stream S-F21 (Timber Mat Crossing) Nicholas County

Client  
MOUNTAIN VALLEY PIPELINE, LLC  
2200 ENERGY DRIVE, 2ND FLOOR  
CANONSBURG, PA 15317  
Title  
PROFILE AND CROSS-SECTIONS  
BASELINE SURVEY  
CROSSING S-F21 - BARN RUN (MP 111.27)  
NICHOLAS COUNTY, WV

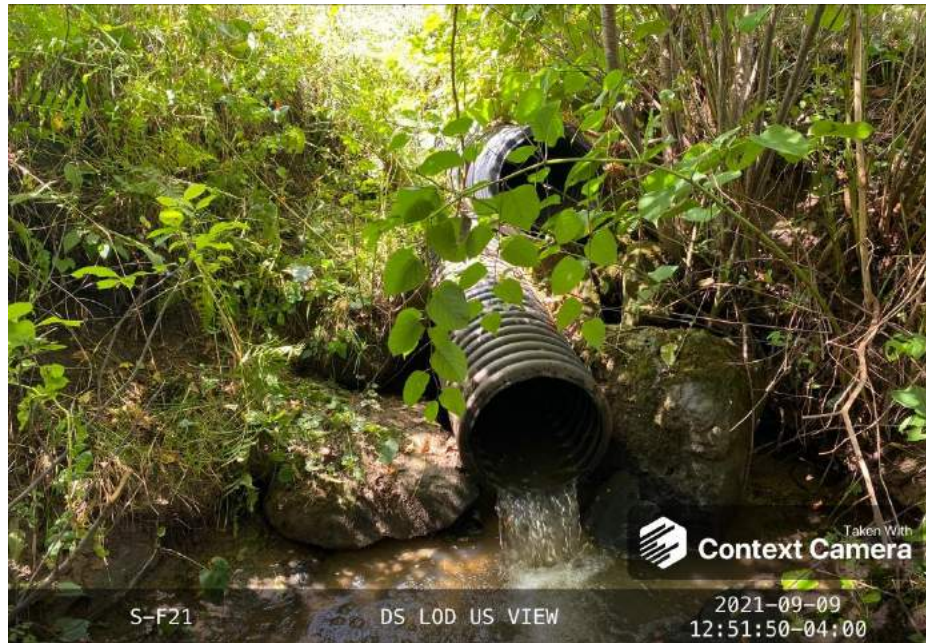
Photo Type: DS, US View

Location, Orientation, Photographer Initials: Downstream Edge of ROW, Upstream View, RC/CC  
Lat: 38.355859 Long: -80.633328

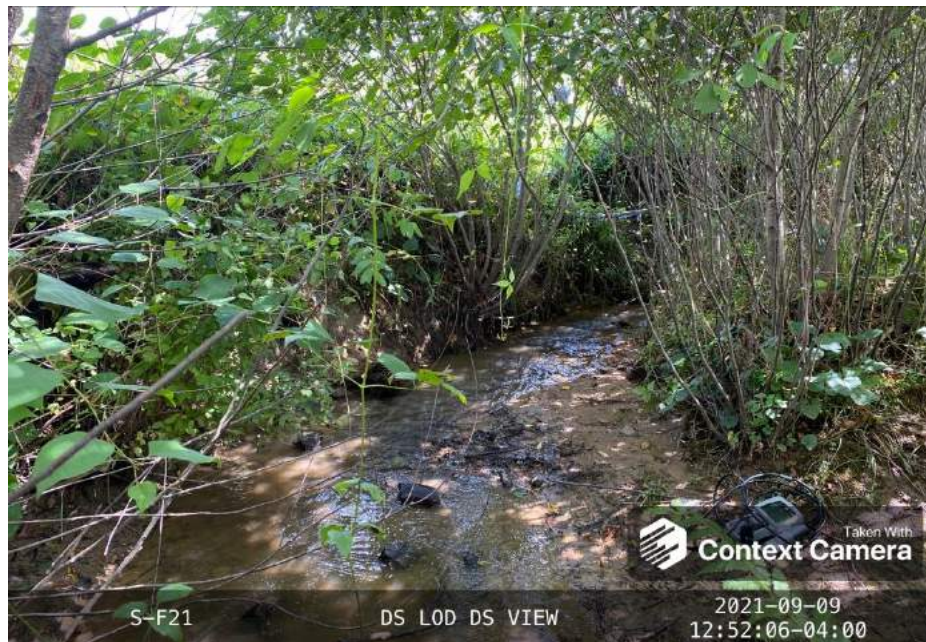
Photo Type: DS, DS View

Location, Orientation, Photographer Initials: Downstream Edge of ROW, Downstream View, RC/CC  
Lat: 38.355859 Long: -80.633328

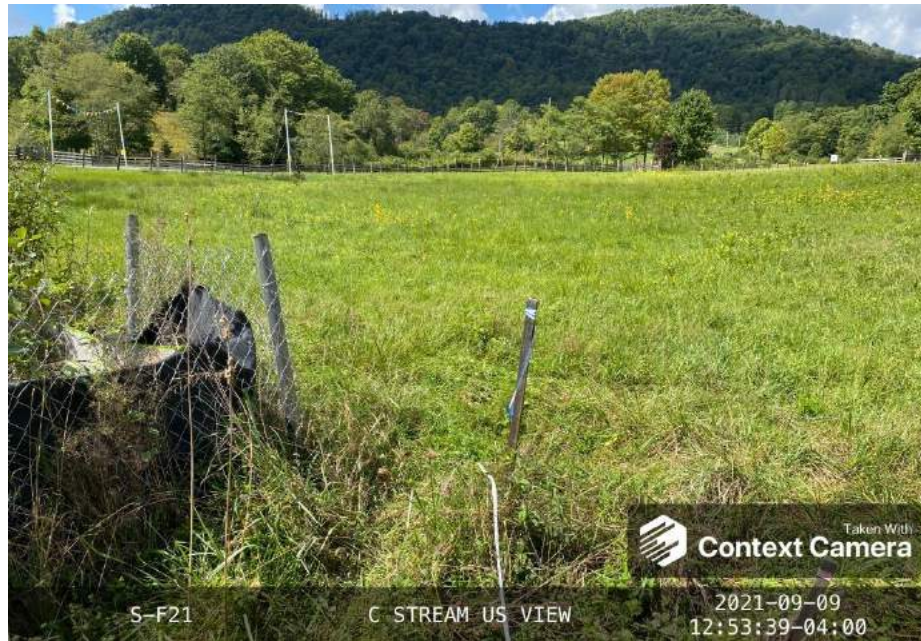
Photo Type: US View at Center  
Location, Orientation, Photographer Initials: Center ROW, Upstream View, RC/CC  
Lat: 38.355859 Long: -80.633328

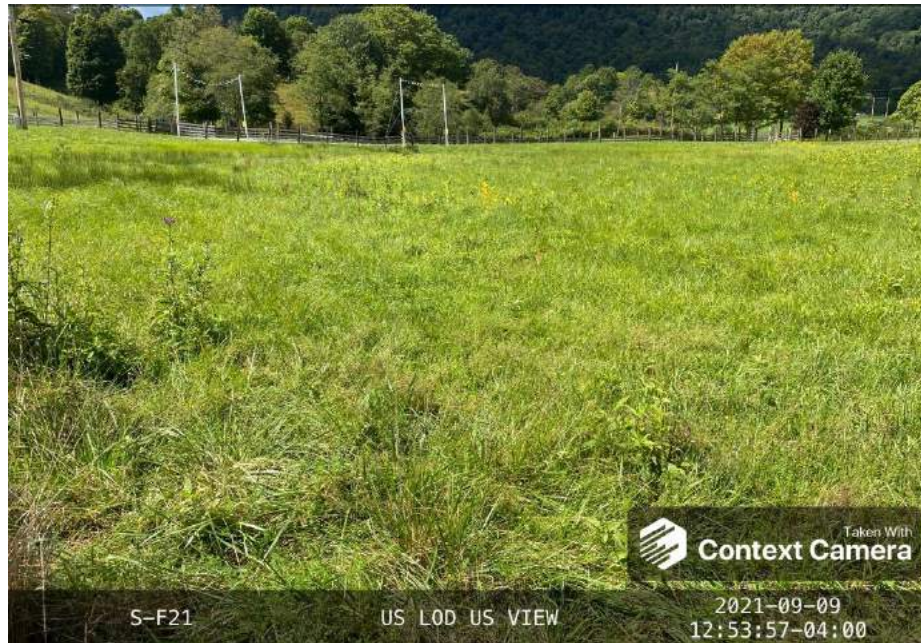
Photo Type: US, US View

Location, Orientation, Photographer Initials: Upstream Edge of ROW, Upstream View, RC/CC

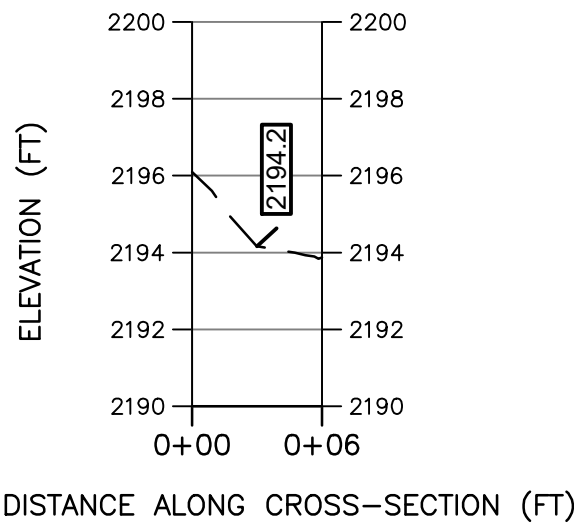
S-F21 BASELINE THALWEG PROFILE

PROFILE  
SCALE: H: 1"=10'  
V: 1"=5'

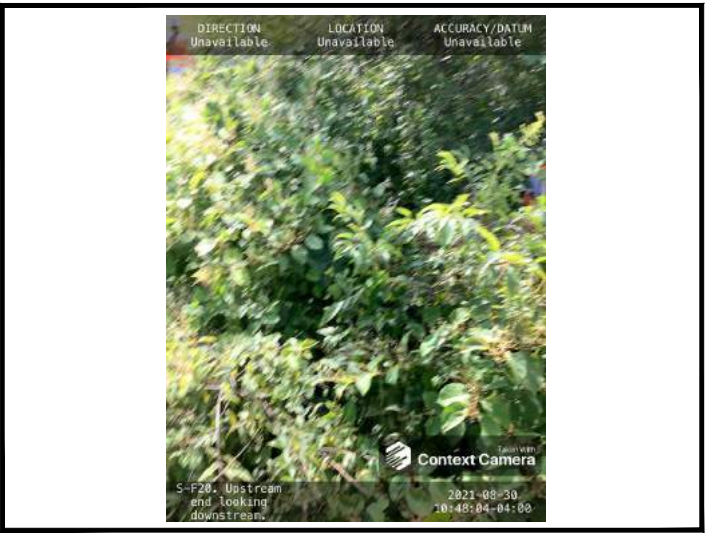
PHOTO TAKEN LOOKING DOWNSTREAM FROM UPSTREAM IMPACT LIMITS
