## Baseline Assessment – Stream Attributes

**Reach S-F34 (Timber Mat Crossing)**

**Webster County, West Virginia**

Client	MC 222
File	PROFILE AND CROSS-SECTIONS BASELINE SURVEY CROSSING S-F34 - UNNAMED TRIB. TO BIRCH RIVER (MP 104.30) WEBSTER COUNTY, WV

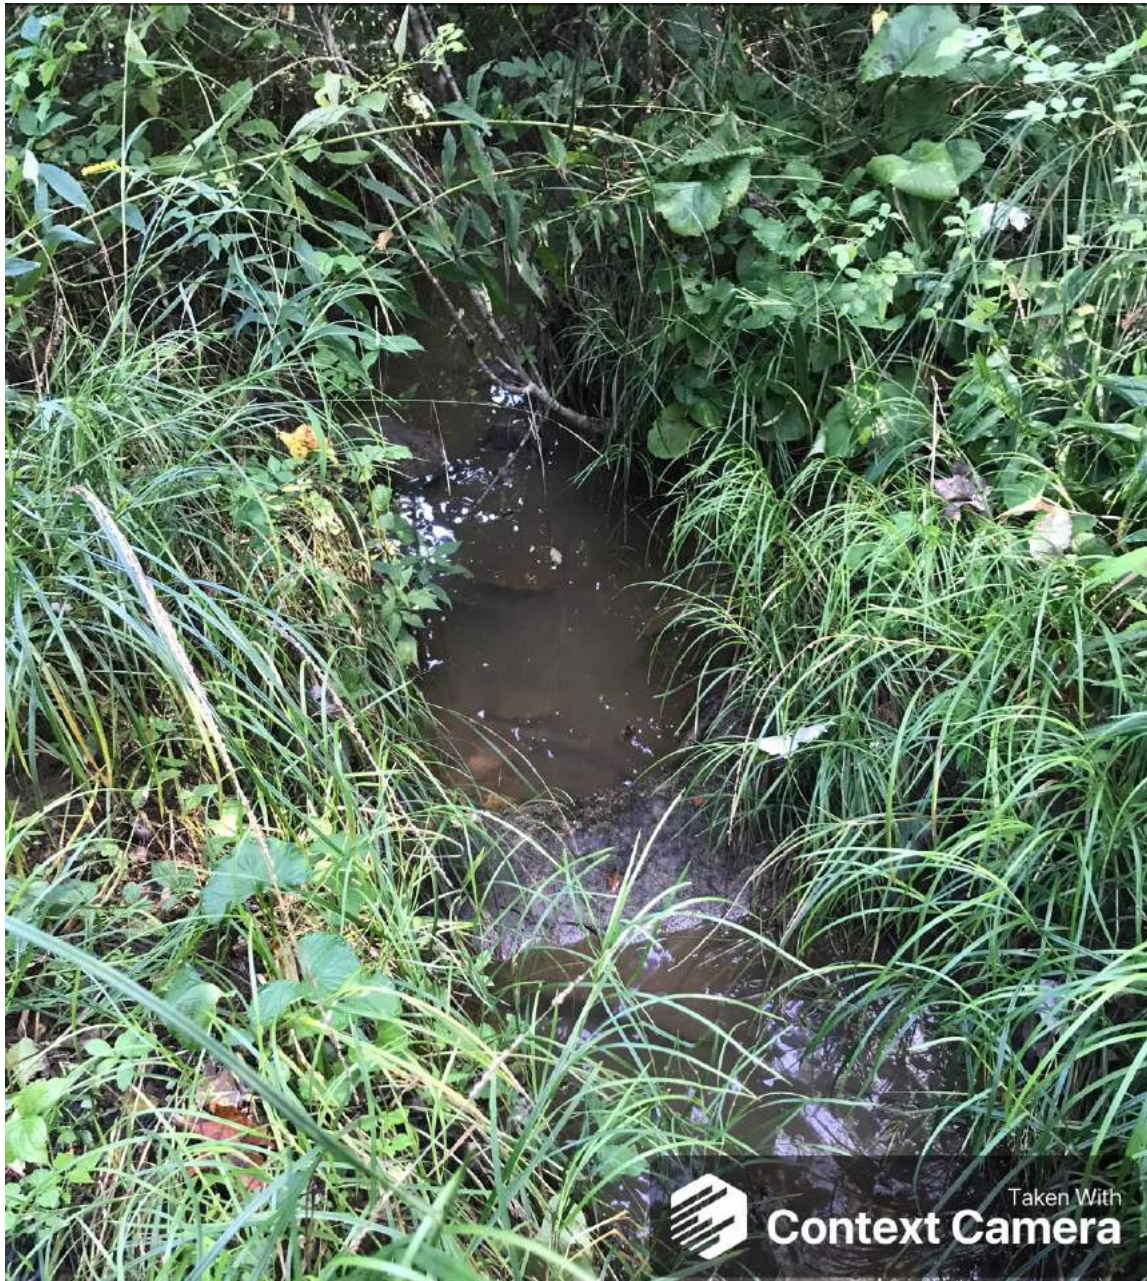
Photo Type: DS, US View

Location, Orientation, Photographer Initials: Downstream Edge of ROW, Upstream View, DD/LC/KP

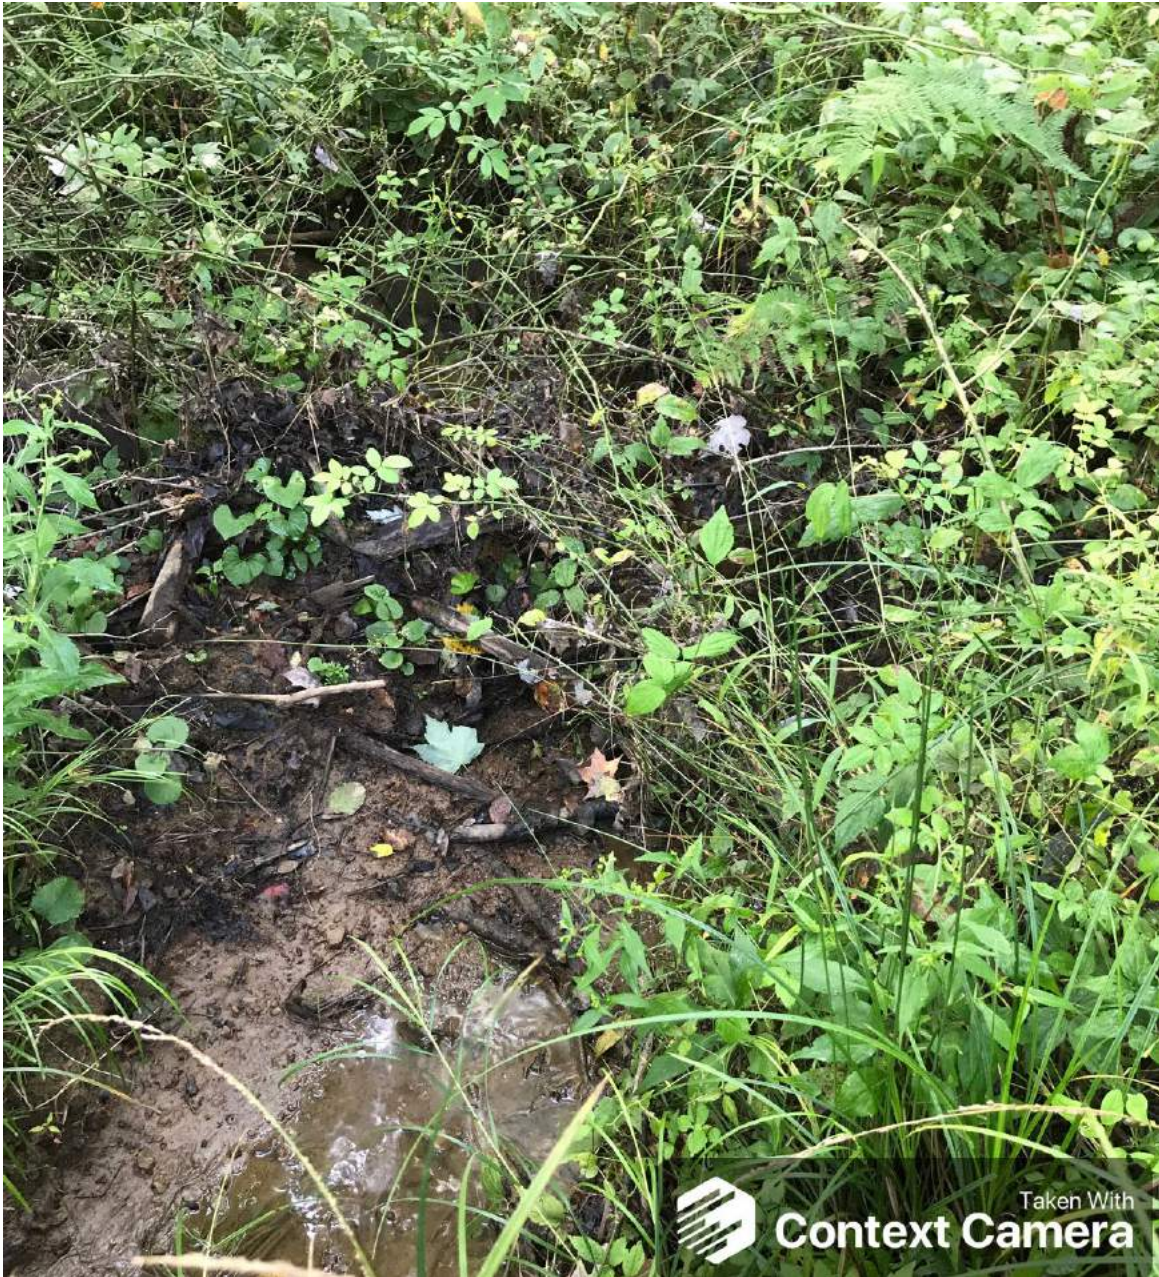
Photo Type: DS, DS View

Location, Orientation, Photographer Initials: Downstream Edge of ROW, Downstream View, DD/LC/KP

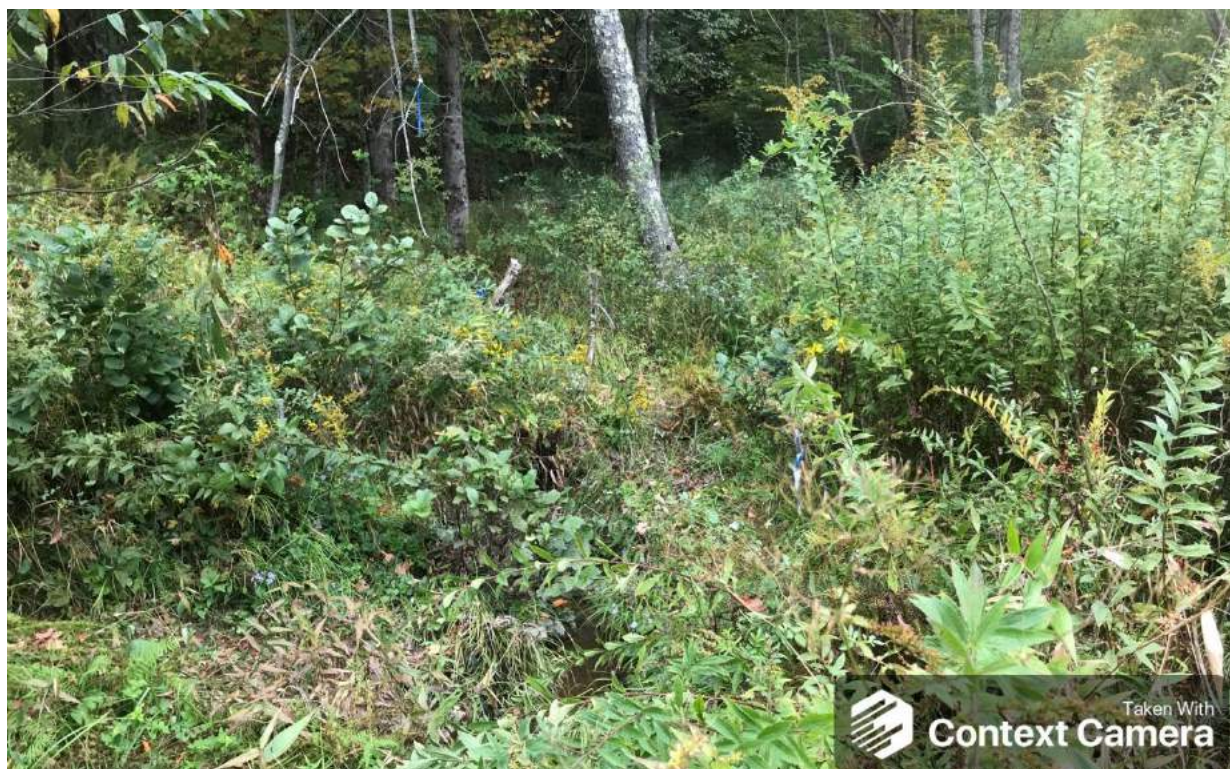
Photo Type: US View at Center  
Location, Orientation, Photographer Initials: ROW Center, Downstream View, DD/LC/KP  
Lat: 38.423988 Long: -80.57068

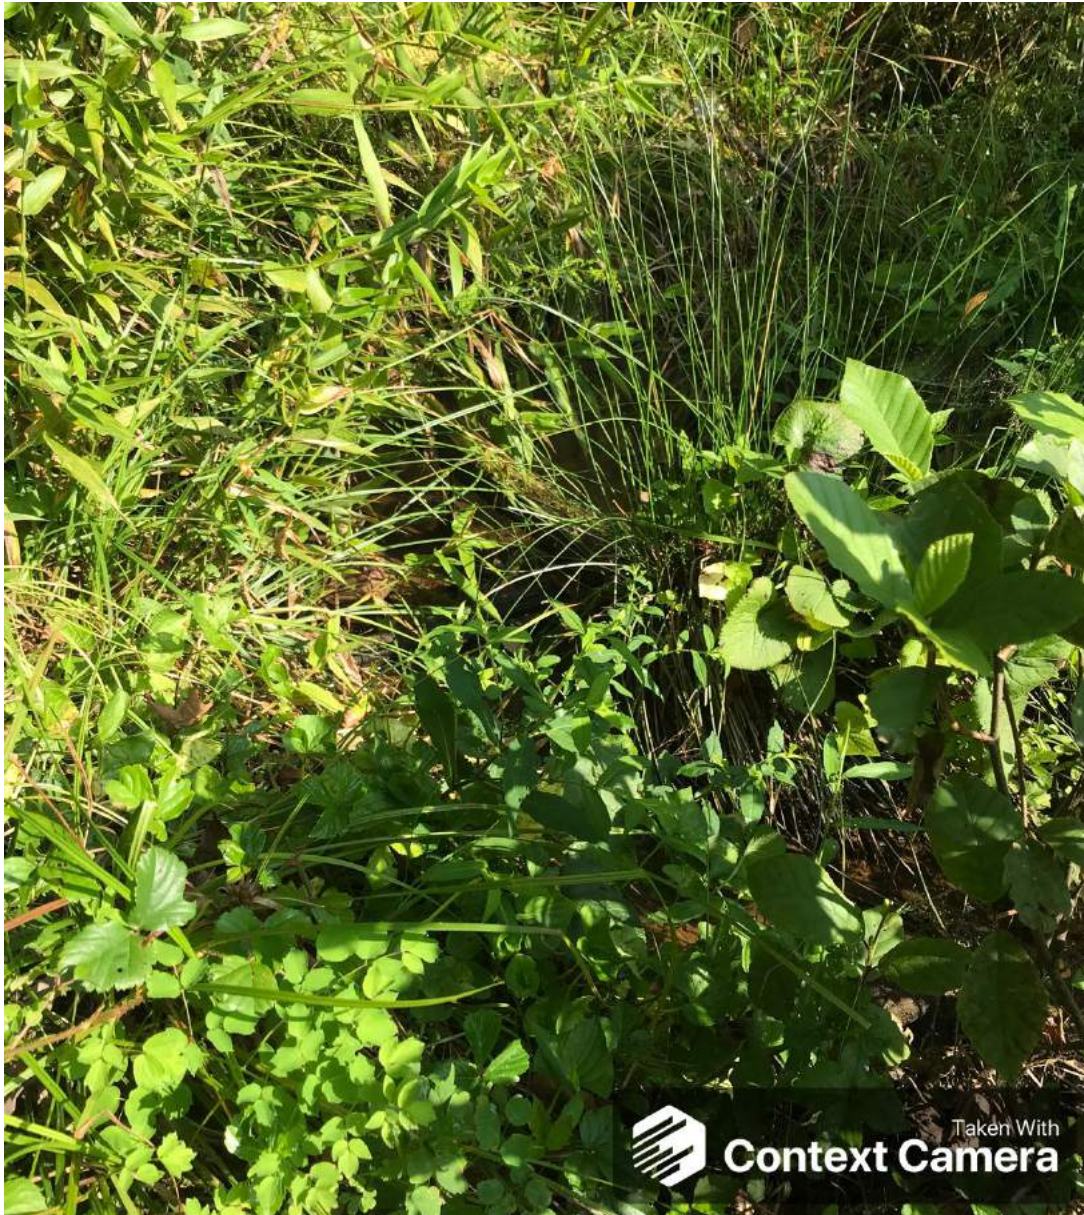
Photo Type: US, US View

Location, Orientation, Photographer Initials: Upstream Edge of ROW, Upstream View, DD/LC/KP

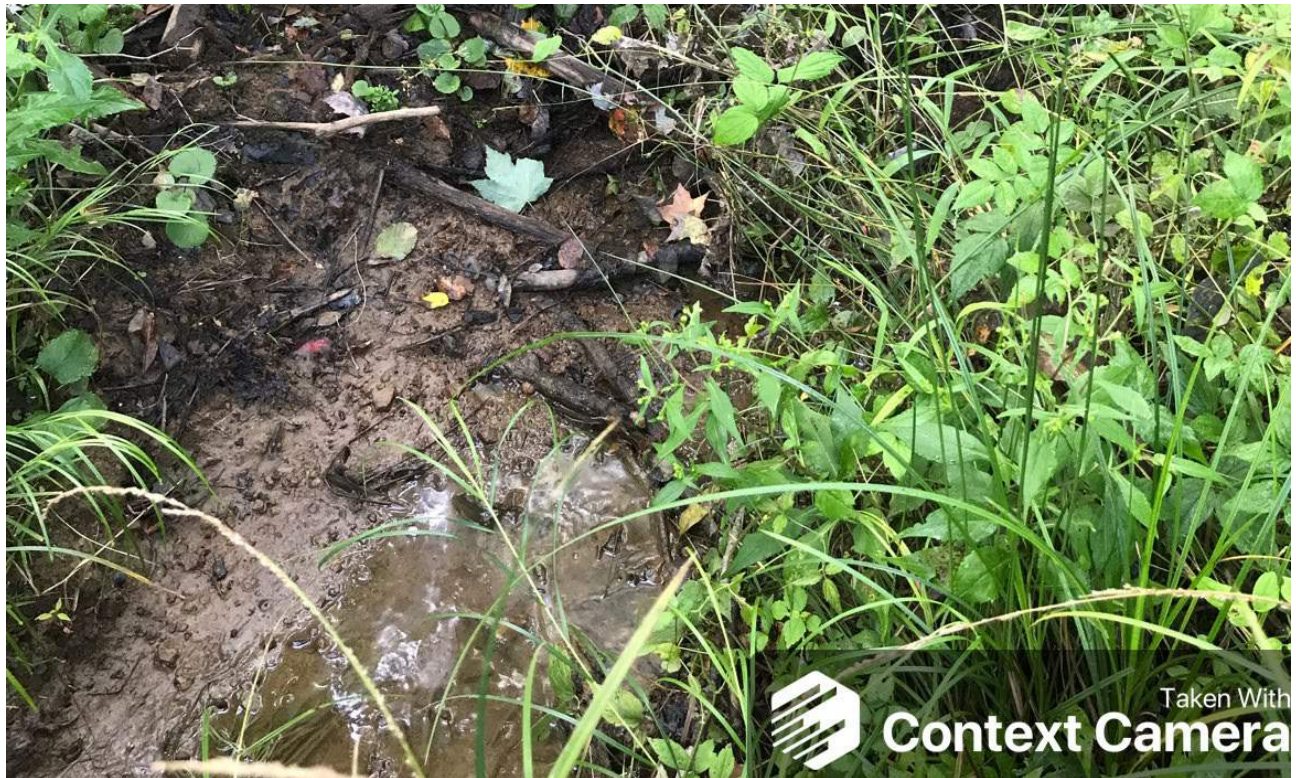
Photo Type: Pool, US View

Location, Orientation, Photographer Initials: Downstream of Pool, Upstream View, DD/LC/KP

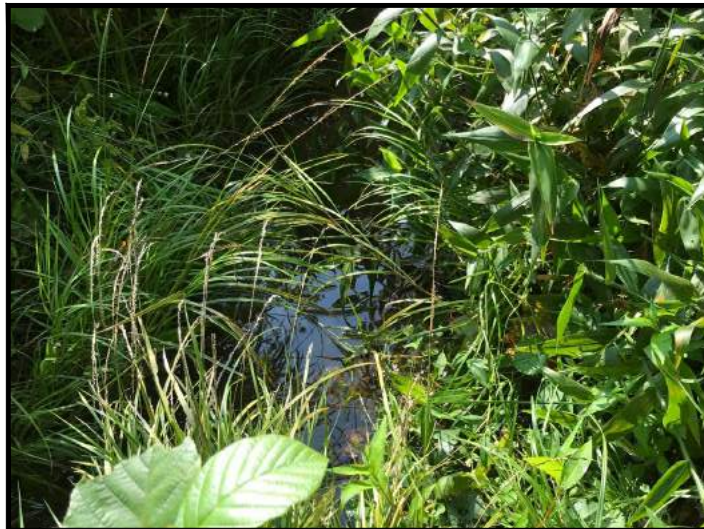
PHOTO TAKEN LOOKING DOWNSTREAM  
FROM UPSTREAM IMPACT LIMITS

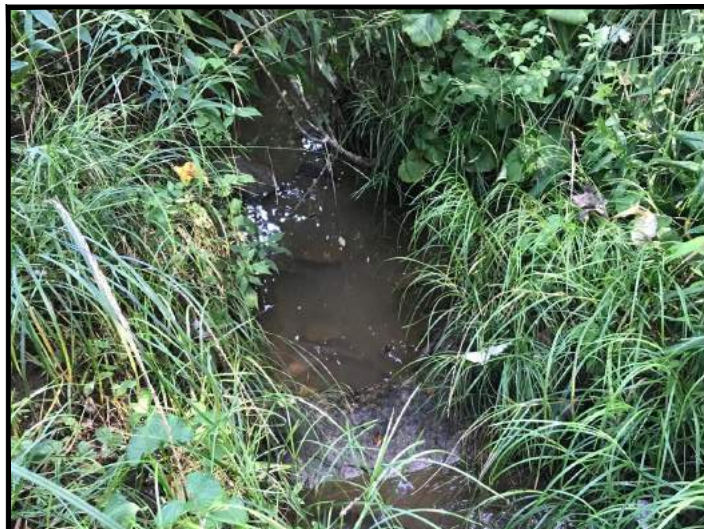
PHOTO TAKEN LOOKING UPSTREAM FROM  
DOWNSTREAM IMPACT LIMITS
