Baseline Assessment – Stream Attributes

Reach S-F35 (Timber Mat Crossing)

Spread D

Webster County, West Virginia

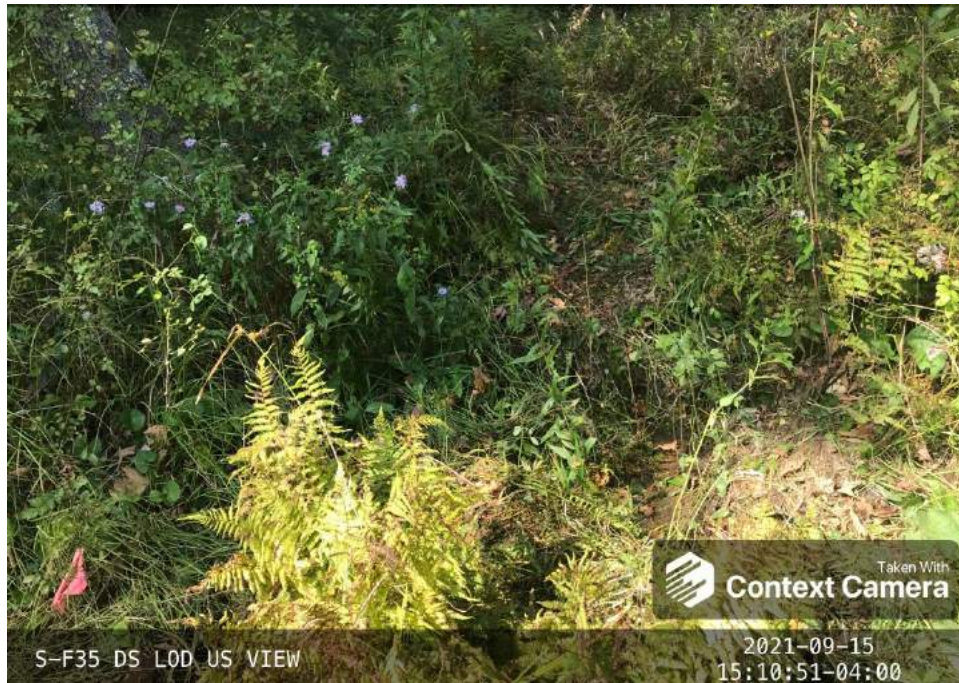
Photo Type: DS, US View
Location, Orientation, Photographer Initials: Downstream Edge of ROW, Upstream View, RH/PF
Lat: 38.424082 Long: -80.57071

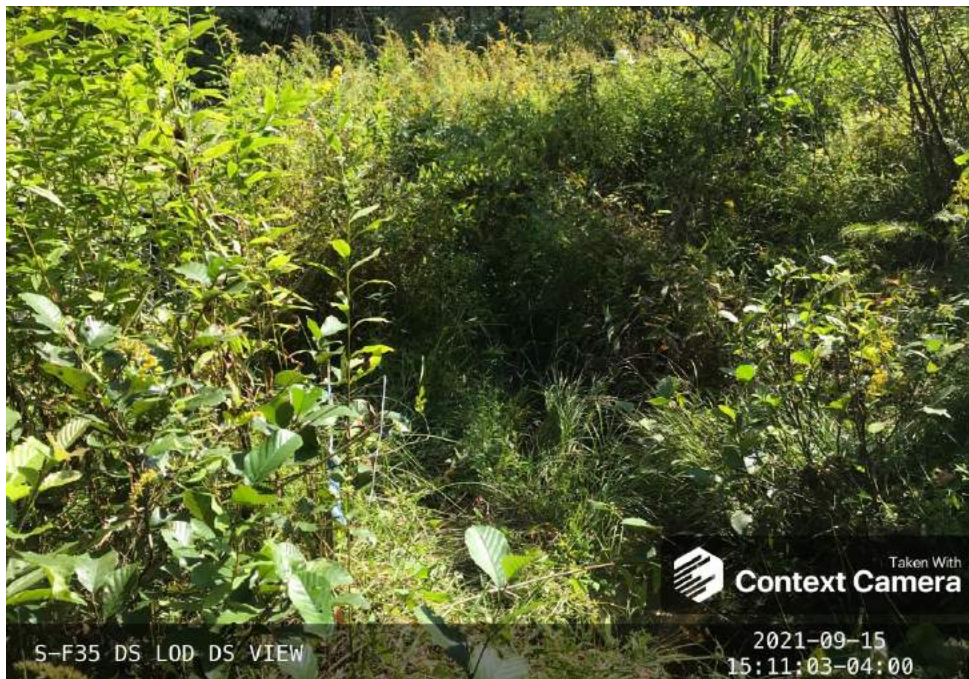
Photo Type: DS, DS View
Location, Orientation, Photographer Initials: Downstream Edge of ROW, Downstream View, RH/PF
Lat: 38.424082 Long: -80.57071

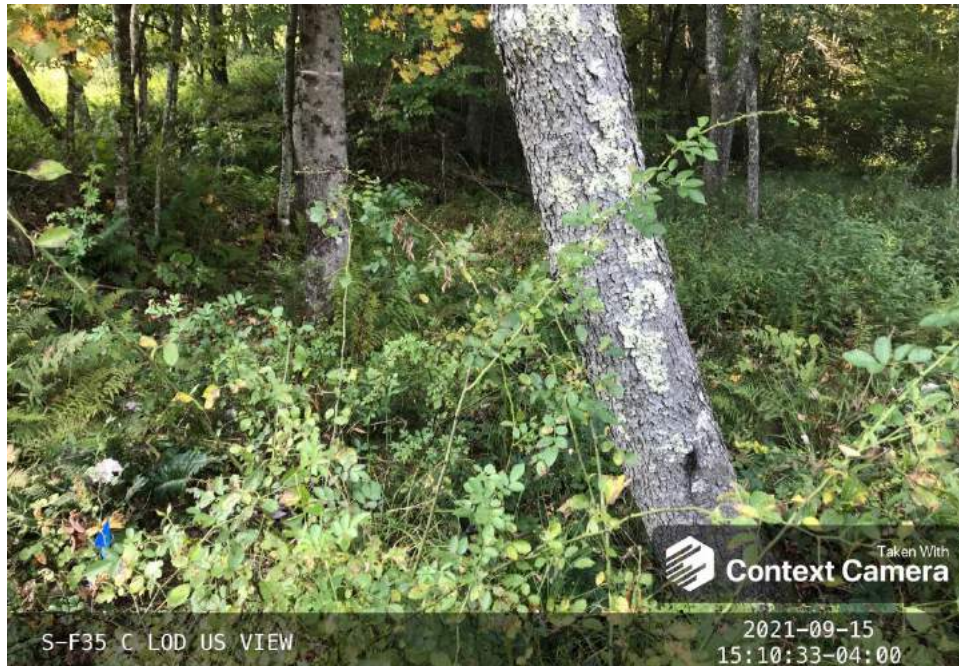
Photo Type: US View at Center
Location, Orientation, Photographer Initials: Center ROW, Upstream View, RH/PF
Lat: 38.424082 Long: -80.57071

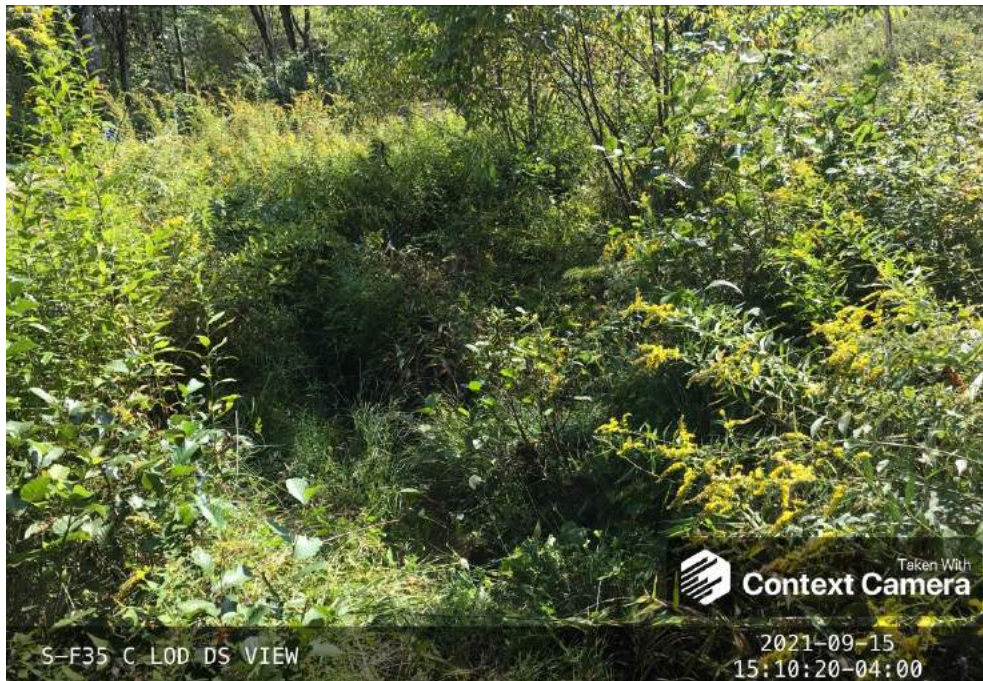
Photo Type: DS View at Center
Location, Orientation, Photographer Initials: ROW Center, Downstream View, RH/PF
Lat: 38.424082 Long: -80.57071

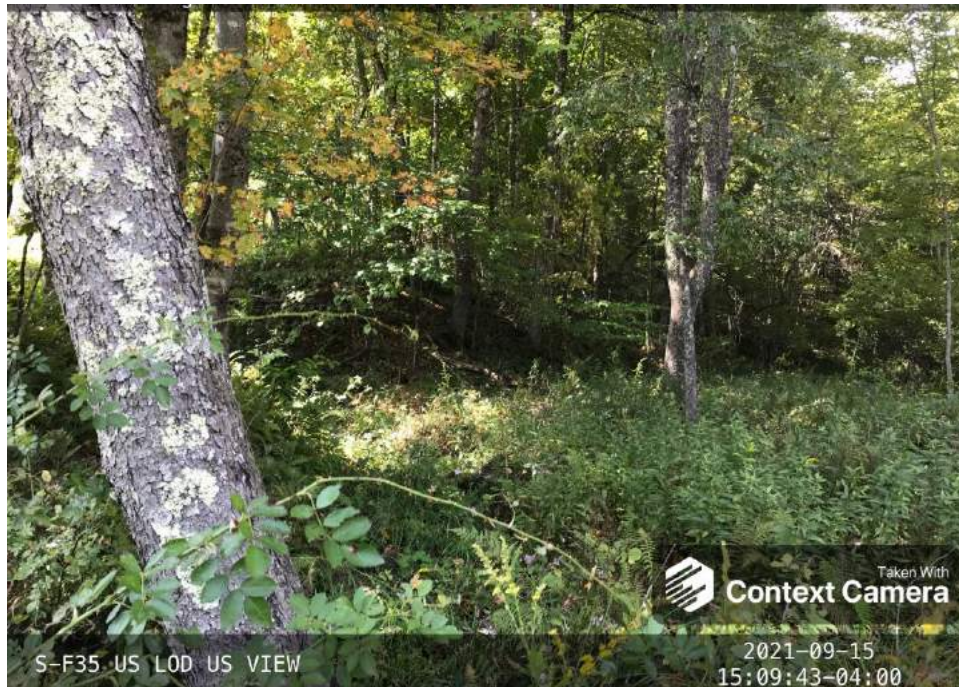
Photo Type: US, US View

Location, Orientation, Photographer Initials: Upstream Edge of ROW, Upstream View, RH/PF
Lat: 38.424082 Long: -80.57071

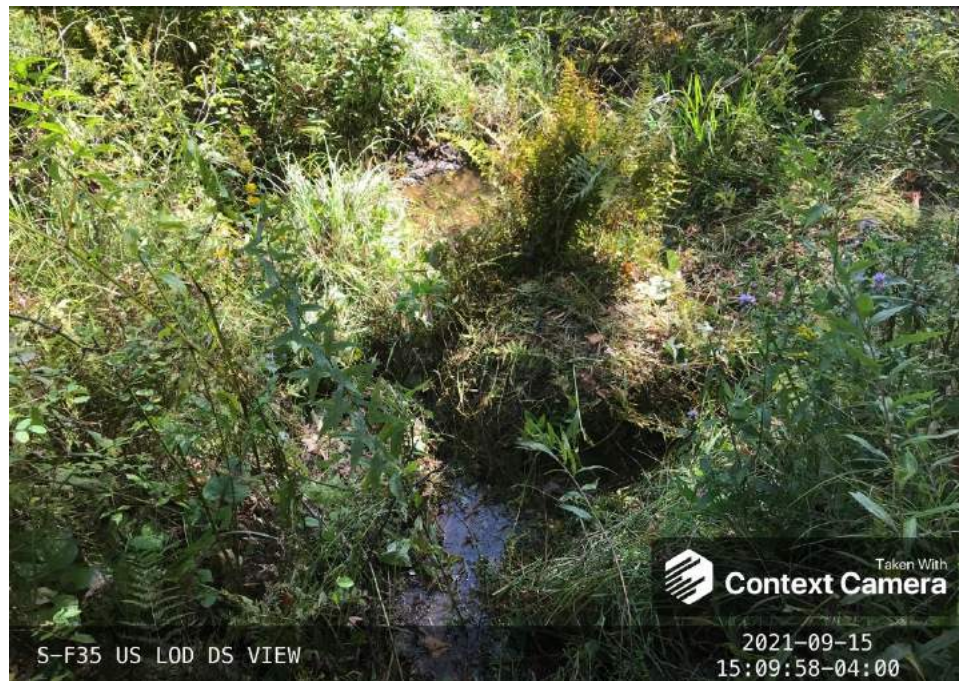
Photo Type: US, DS View

Location, Orientation, Photographer Initials: Upstream Edge of ROW, Downstream View, RH/PF
Lat: 38.424082 Long: -80.57071

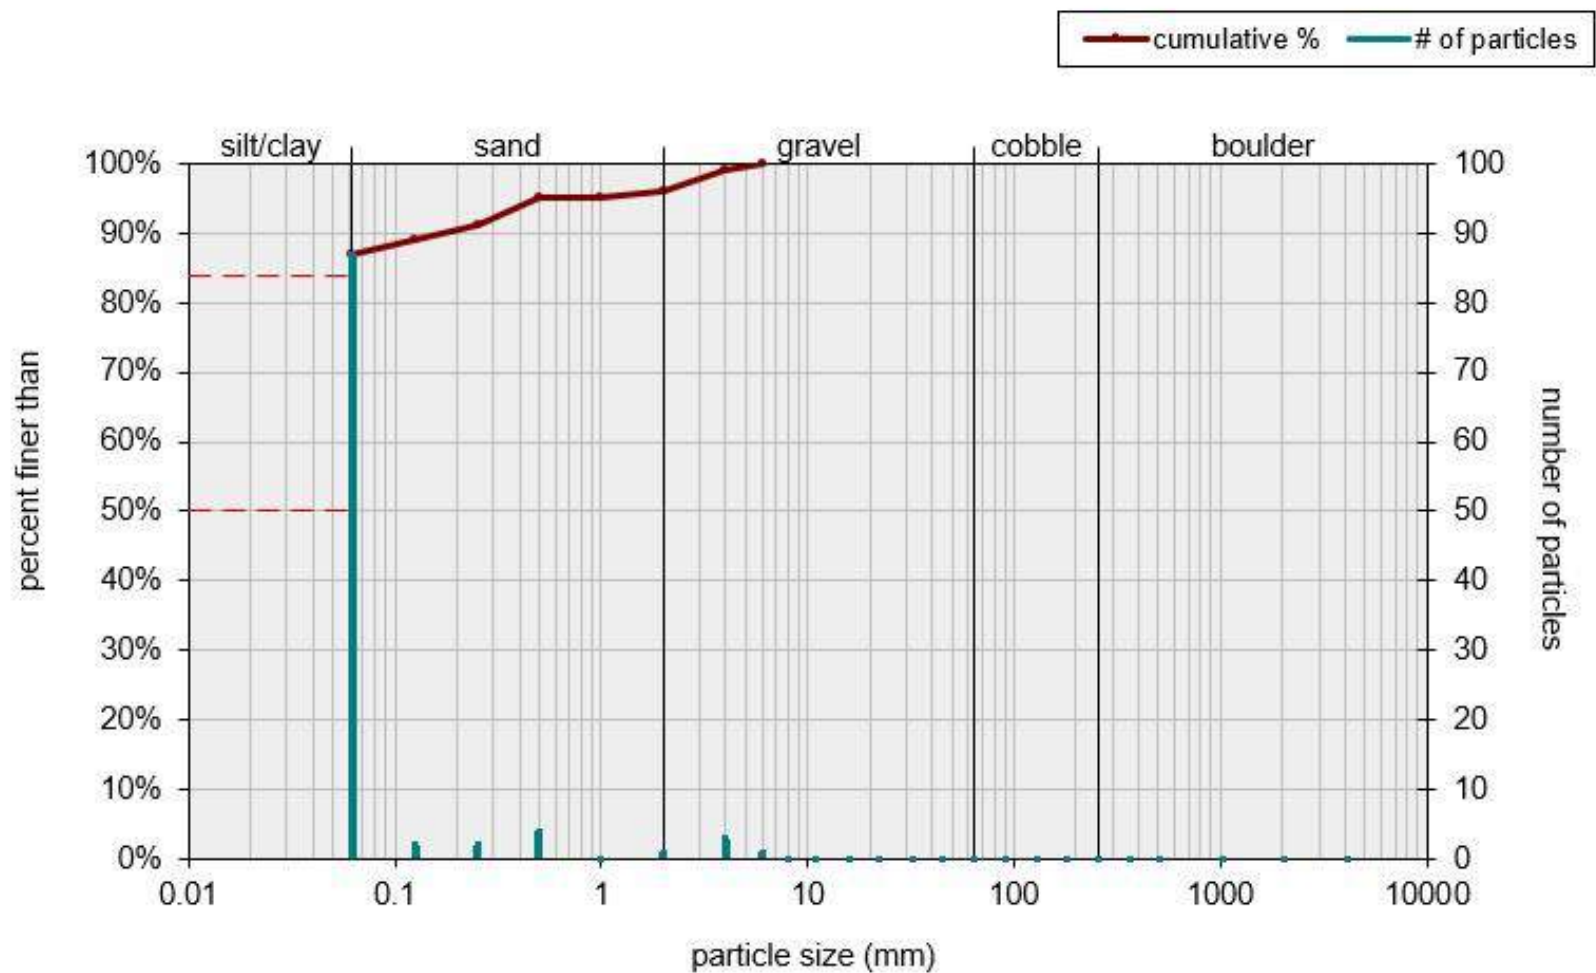
Bankfull Channel Pebble Count, S-F35, UNT to Birch River

Size (mm)		Size Distribution		Type	
D16	0.062	mean	0.1	silt/clay	87%
D35	0.062	dispersion	1.0	sand	9%
D50	0.062	skewness	---	gravel	4%
D65	0.062			cobble	0%
D84	0.062			boulder	0%
D95	1

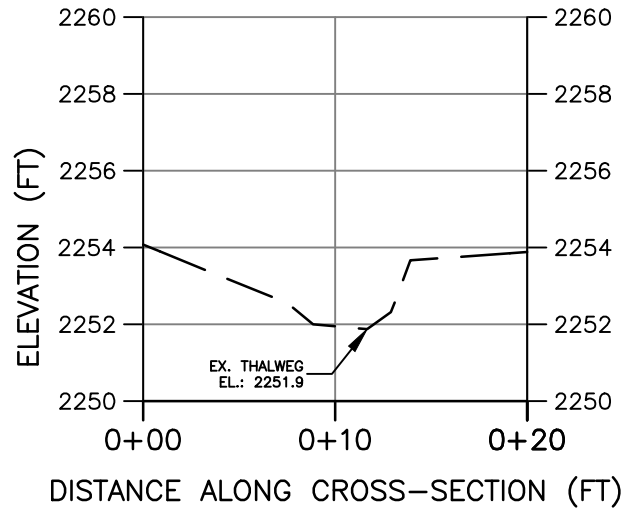
S-F34 BASELINE CROSS-SECTION B
DOWNSTREAM OF TIMBER MAT

AS-BUILT TABLE: S-F34 CROSS SECTION B					
PRE-CROSSING				AS-BUILT	
PT. LOC.	NORTHING	EASTING	ELEV.	VERT. DIFF.	HORZ. DIFF.
TS-L	13953170.31	1763378.89	2252.55		
BS-L	13953169.51	1763377.86	2252.01		
THW	13953167.76	1763375.65	2251.88		
BS-R	13953167.00	1763374.68	2252.32		
TS-R	13953166.37	1763373.88	2253.67		
AS-BUILT TABLE: S-F35 CROSS SECTION C					
THW	13953244.25	1763359.08	2253.25

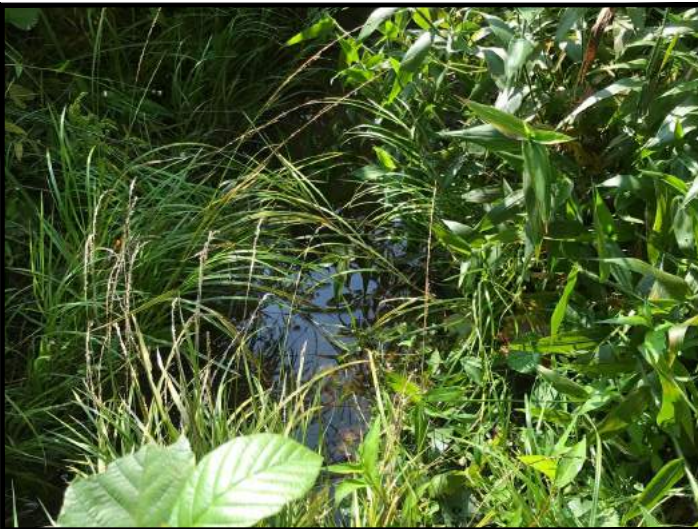
PHOTO TAKEN LOOKING DOWNSTREAM FROM UPSTREAM IMPACT LIMITS S-F34

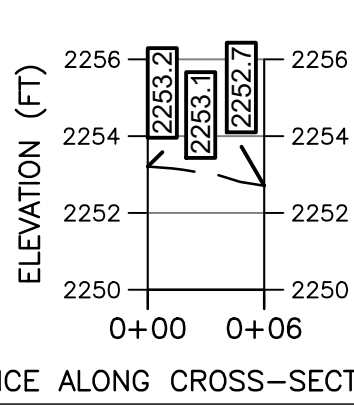
S-F35 BASELINE THALWEG

EXISTING STREAM PROFILE
INVERT ALONG THALWEG

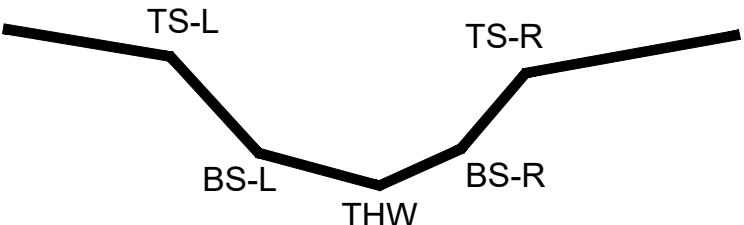
TYPICAL 5-POINT CROSS-SECTION
(FACING DOWNSTREAM)

TS: TOP OF SLOPE
BS: BOTTOM OF SLOPE
THW: THALWEG (INVERT)
