Baseline Assessment – Stream Attributes

Reach S-F36a (1) (Temporary Access Road) Perennial Spread D Webster County, West Virginia

Bankfull Channel Pebble Count, S-F36a (1), UNT to Birch River (1)

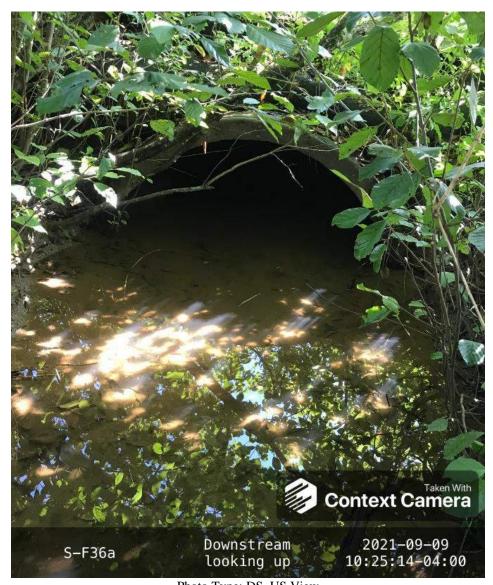
Photo Type: DS, US View
Location, Orientation, Photographer Initials: Downstream Edge of ROW, Upstream View, EG
Lat: 38.422056 Long: -80.569457

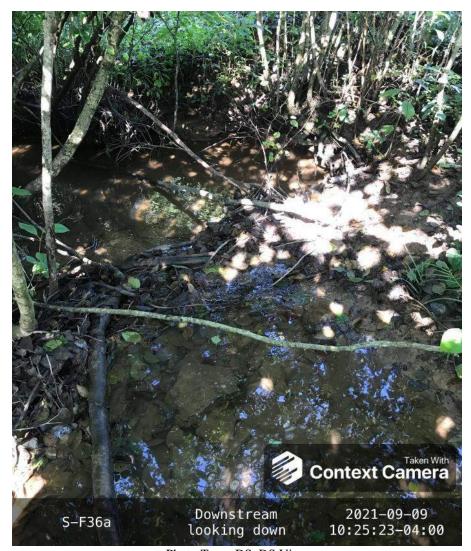
Photo Type: DS, DS View Location, Orientation, Photographer Initials: Downstream Edge of ROW, Downstream View, EG Lat: 38.422056 Long: -80.569457

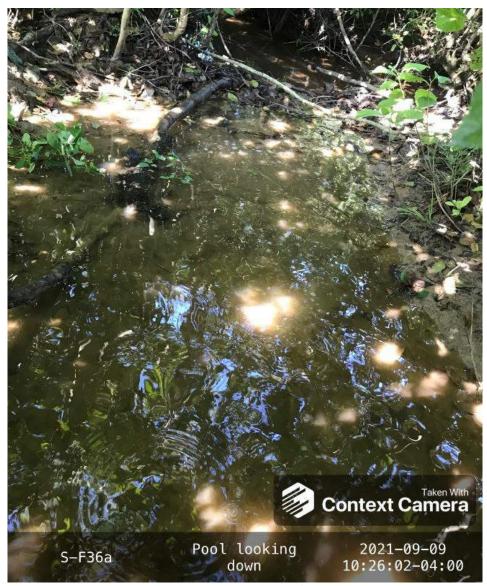
Photo Type: Pool, DS View Location, Orientation, Photographer Initials: Upstream of Pool, Downstream View, EG Lat: 38.422056 Long: -80.569457

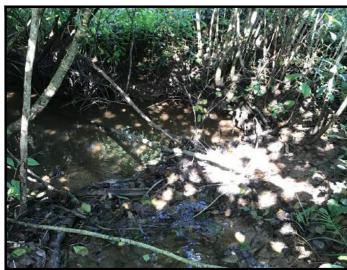
PHOTO TAKEN LOOKING DOWNSTREAM FROM UPSTREAM IMPACT LIMITS

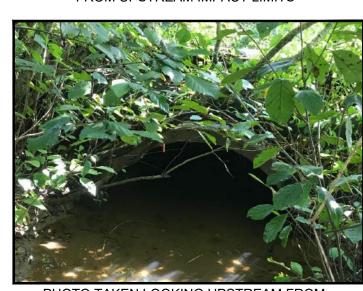
PHOTO TAKEN LOOKING UPSTREAM FROM DOWNSTREAM IMPACT LIMITS
