## Baseline Assessment – Stream Attributes

### Reach S-F36a (2) (Temporary Access Road) Perennial Spread D Webster County, West Virginia

## Spread D Stream S-F36a (2) (Temporary Access Road) Webster County

**Title** PROFILE AND CROSS-SECTIONS  
BASELINE SURVEY  
CROSSING S-F36A (2) - UNNAMED  
TRIBUTARY TO BIRCH RIVER (MP 104.89)  
WESTER COUNTY, WV

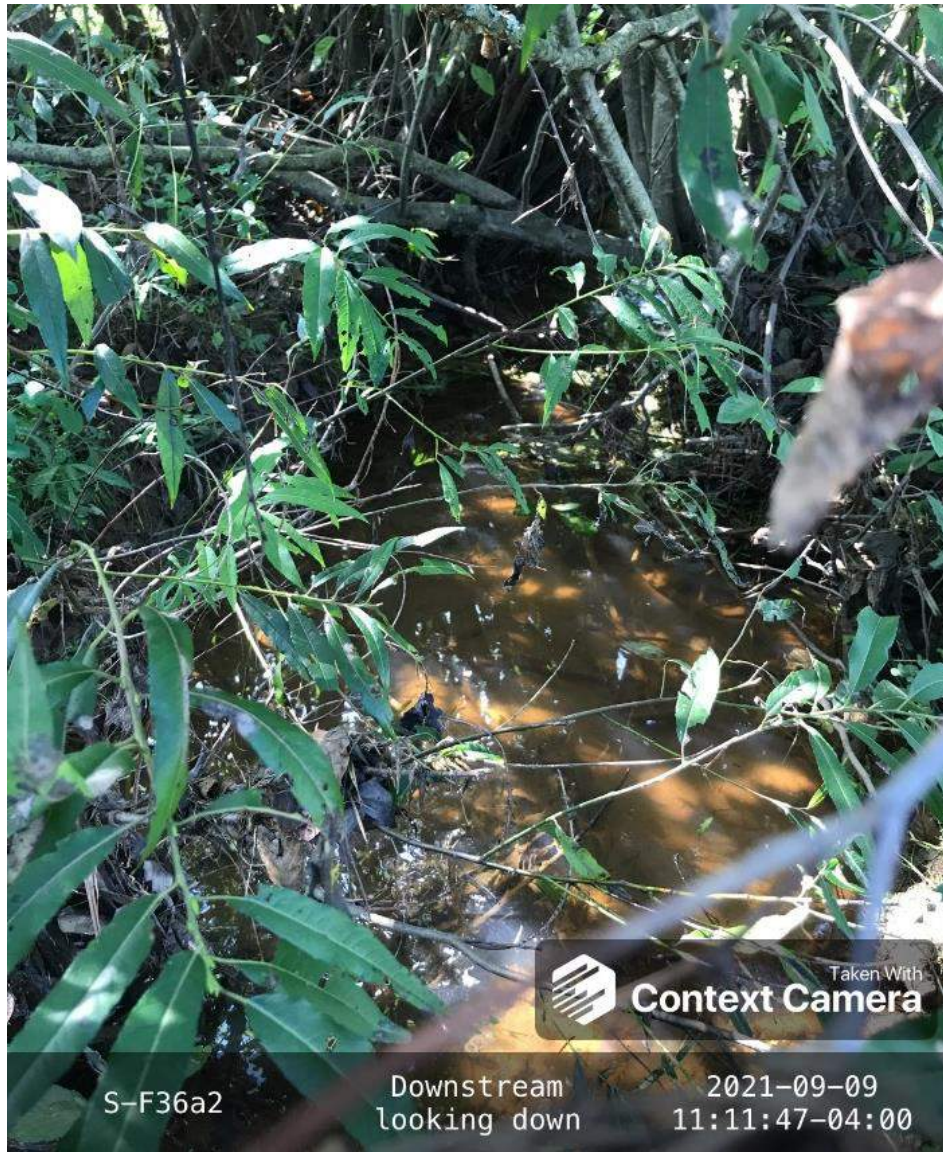
Photo Type: DS, DS View

Location, Orientation, Photographer Initials: Downstream Edge of ROW, Downstream View, EG

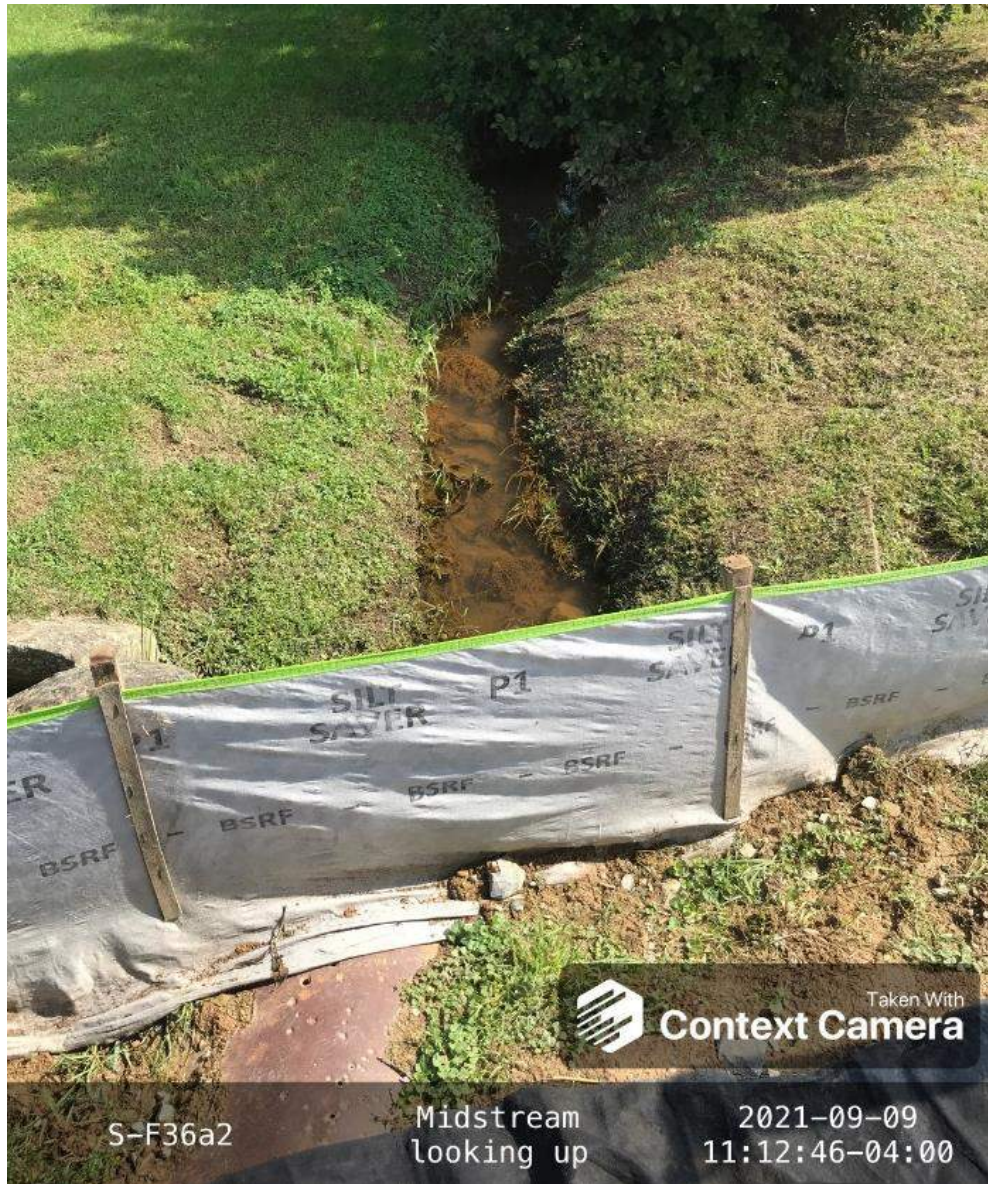
Photo Type: US View at Center  
Location, Orientation, Photographer Initials: Center ROW, Upstream View, EG  
Lat: 38.421474 Long: -80.570012

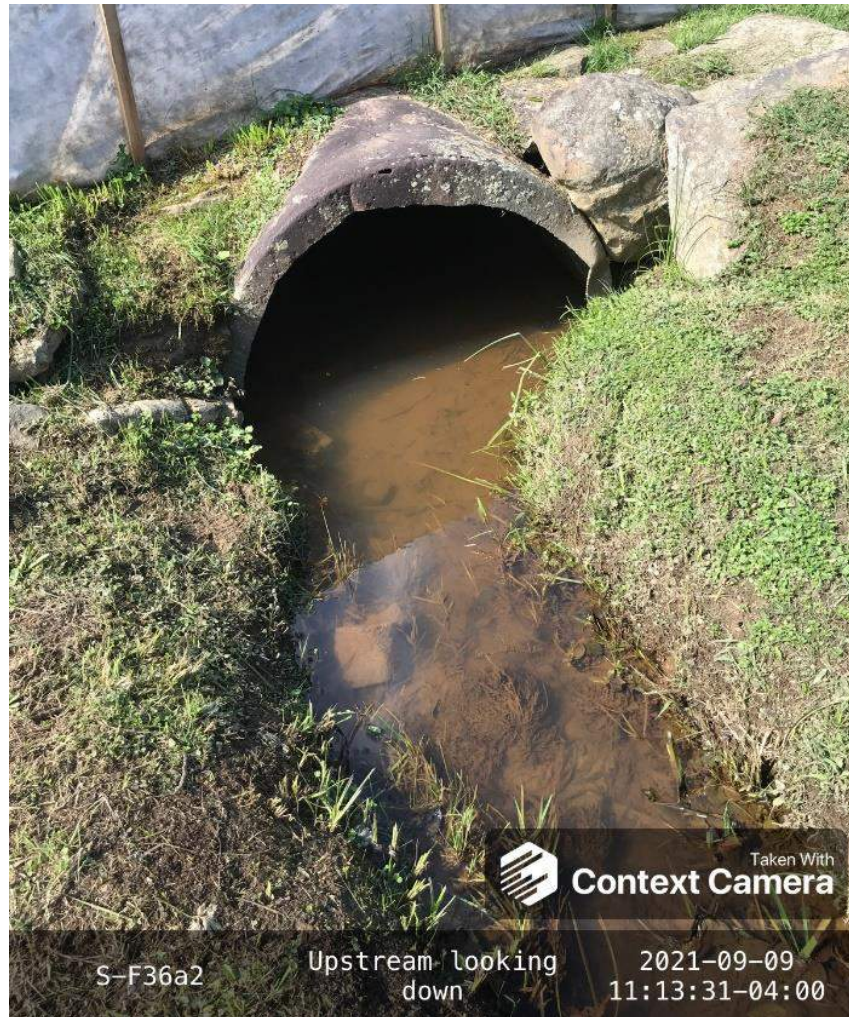
Photo Type: US, DS View  
Location, Orientation, Photographer Initials: Upstream Edge of ROW, Downstream View, EG  
Lat: 38.421474 Long: -80.570012

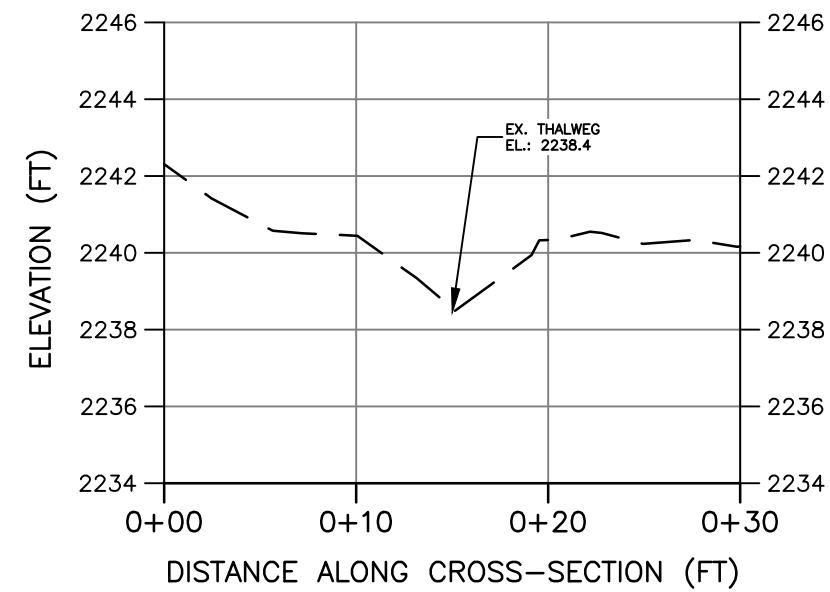
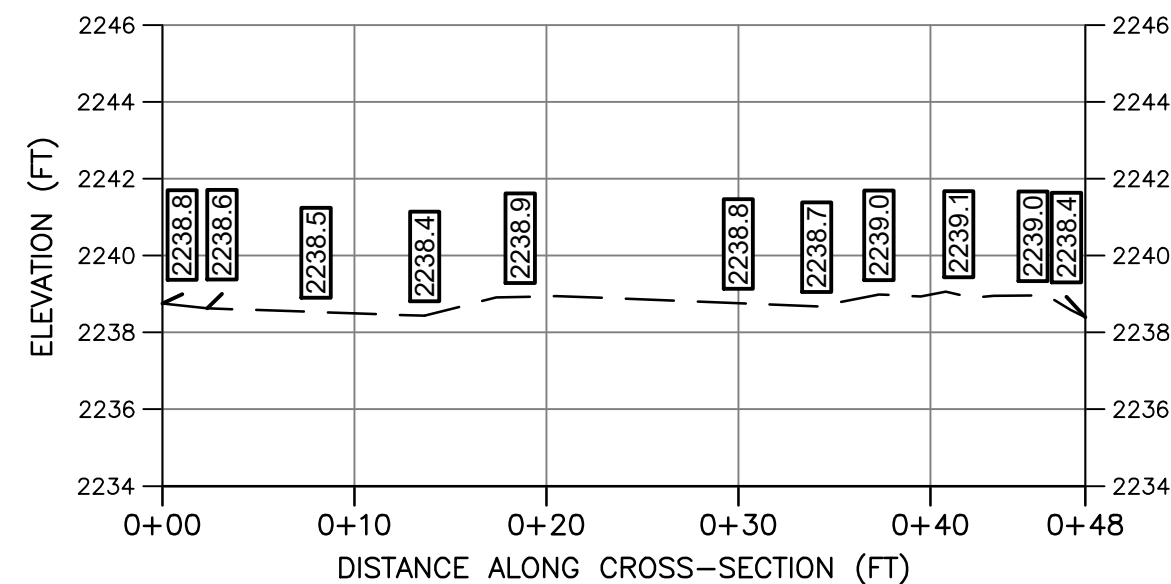
EXISTING STREAM PROFILE  
INVERT ALONG THALWEG

AS-BUILT TABLE: 5-F36A (2) CROSS SECTION B					
PRE-CROSSING				AS-BUILT	
PT. LOC.	NORTHING	EASTING	ELEV	VERT. DIFF.	HORZ. DIFF.
TS- L	13952308.0100	1763584.5740	2739.592'		
BS- L	13952307.6400	1763584.7010	2738.487'		
THW	13952306.6500	1763585.4750	2738.394'		
BS- R	13952305.7300	1763585.8170	2738.470'		
TS- R	13952305.4300	1763586.0350	2739.570'

NOTE: ALL SECTIONS VIEWS SHOWN LEFT TO RIGHT FACING DOWNSTREAM.

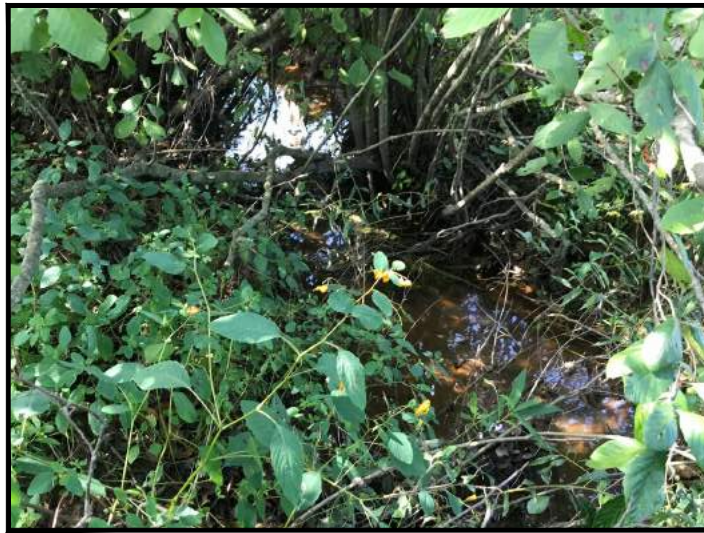
PHOTO TAKEN LOOKING DOWNSTREAM  
FROM UPSTREAM IMPACT LIMITS

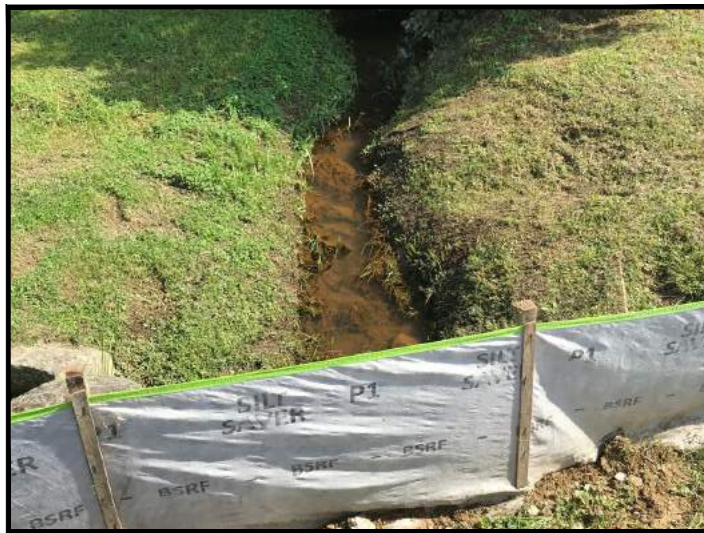
PHOTO TAKEN LOOKING UPSTREAM FROM  
DOWNSTREAM IMPACT LIMITS
