Baseline Assessment – Stream Attributes

Reach S-F36a (4) (Temporary Access Road) Perennial Spread D Webster County, West Virginia

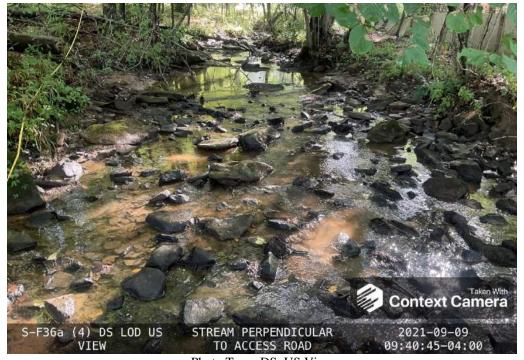
Photo Type: DS, US View Location, Orientation, Photographer Initials: Downstream Edge of ROW, Upstream View, CNJ Lat: 38.418122 Long: -80.574566

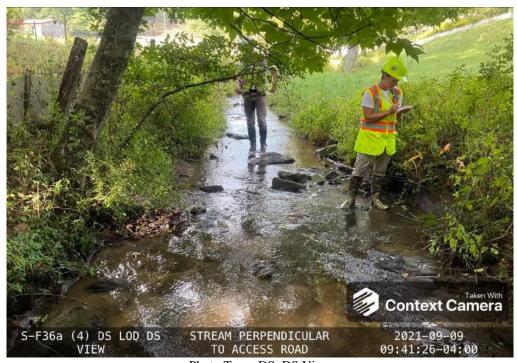
Photo Type: DS, DS View Location, Orientation, Photographer Initials: Downstream Edge of ROW, Downstream View, CNJ Lat: 38.418122 Long: -80.574566

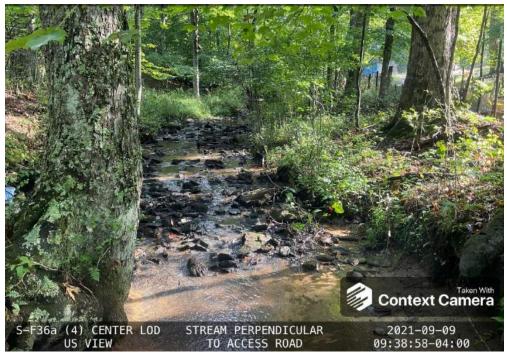
Photo Type: US View at Center Location, Orientation, Photographer Initials: Center ROW, Upstream View, CNJ Lat: 38.418122 Long: -80.574566

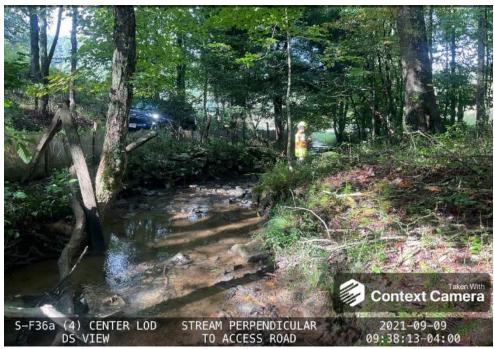
Photo Type: DS View at Center Location, Orientation, Photographer Initials: Center ROW, Downstream View, CNJ Lat: 38.418122 Long: -80.574566

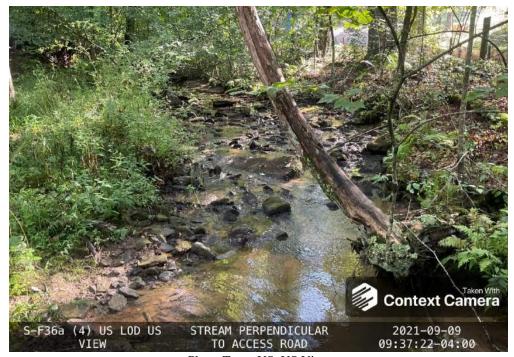
Photo Type: US, US View Location, Orientation, Photographer Initials: Upstream Edge of ROW, Upstream View, CNJ Lat: 38.418122 Long: -80.574566

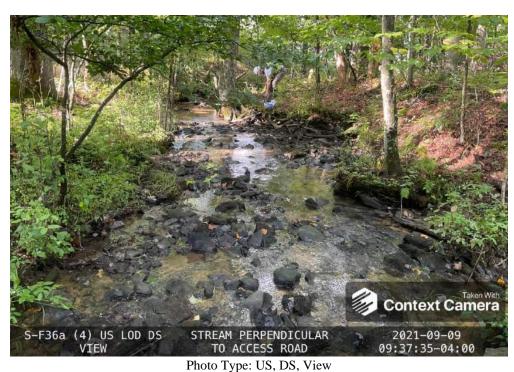
Location, Orientation, Photographer Initials: Upstream Edge of ROW, Downstream View, CNJ
Lat: 38.418122 Long: -80.574566

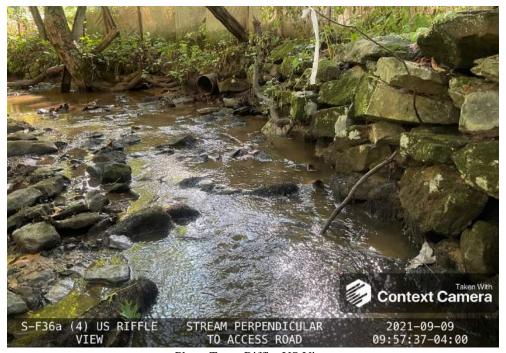
Photo Type: Riffle, US View Location, Orientation, Photographer Initials: Downstream of Riffle, Upstream View, CNJ Lat: 38.418122 Long: -80.574566

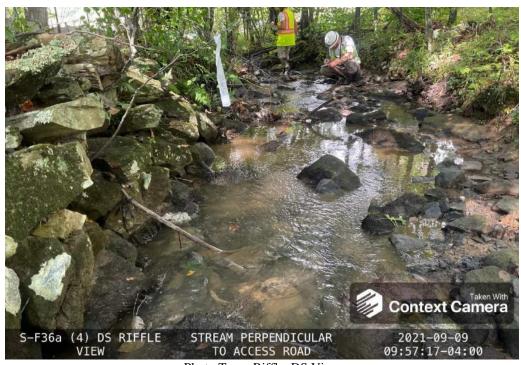
Photo Type: Riffle, DS View
Location, Orientation, Photographer Initials: Upstream of Riffle, Downstream View, CNJ
Lat: 38.418122 Long: -80.574566

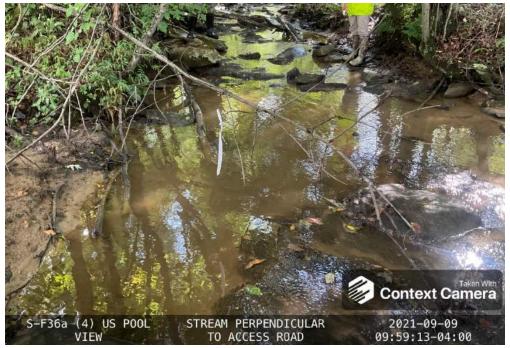
Photo Type: Pool, US View Location, Orientation, Photographer Initials: Downstream of Pool, Upstream View, CNJ Lat: 38.418122 Long: -80.574566

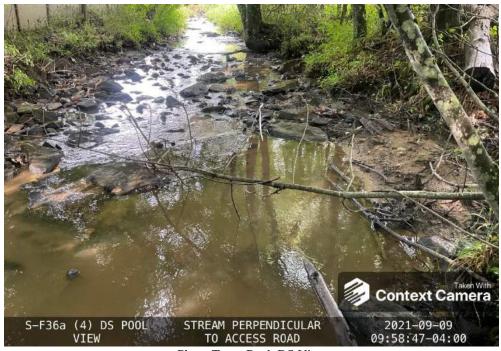
Photo Type: Pool, DS View Location, Orientation, Photographer Initials: Upstream of Pool, Downstream View, CNJ Lat: 38.418122 Long: -80.574566

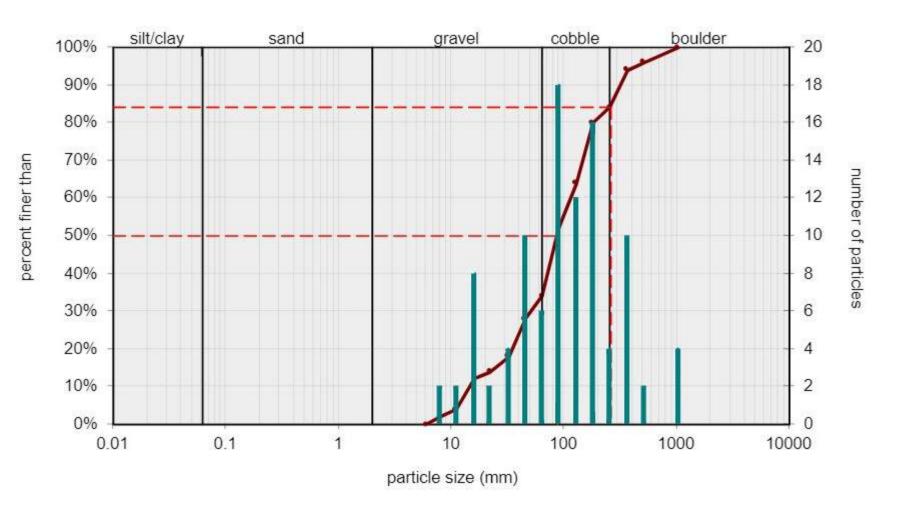
Size (r	nm)		
775	D16	27	=32	
	D35	65		
	D50	87		
	D65	130		
	D84	260		
	D95	430

Size Distribution				
mean	83.8			
dispersion	3.1			
skewness	-0.02

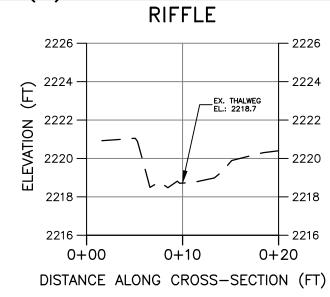
S-F36A (4) BASELINE CROSS-SECTION A

H: 1"=10'
V: 1"=5'

NOTE: ALL SECTIONS VIEWS SHOWN LEFT TO RIGHT FACING DOWNSTREAM.

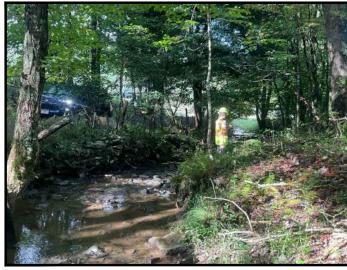
PHOTO TAKEN LOOKING DOWNSTREAM FROM UPSTREAM IMPACT LIMITS

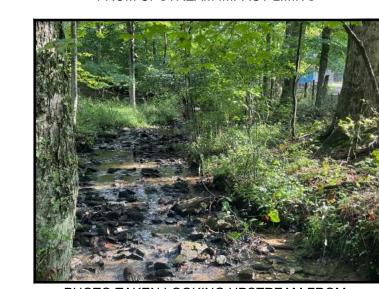
PHOTO TAKEN LOOKING UPSTREAM FROM DOWNSTREAM IMPACT LIMITS
