Baseline Assessment – Stream Attributes

Reach S-H107 (Pipeline ROW) Intermittent Spread C Webster County, West Virginia

Project Name: MVP-stream assessment **Location:** Webster County, Spread C

Sampling Date: 9/8/2021 Project Site Before Project

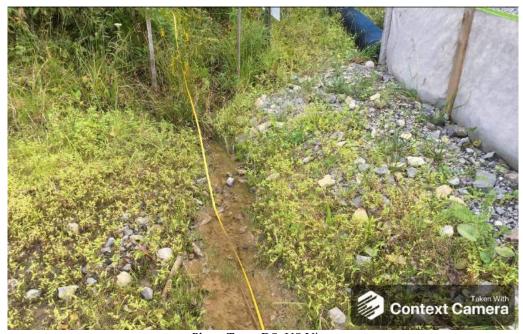
Photo Type: DS, US View Location, Orientation, Photographer Initials: Downstream Edge of ROW, Upstream View, HC/SK/JB Lat: 38.548467 Long: -80.540073

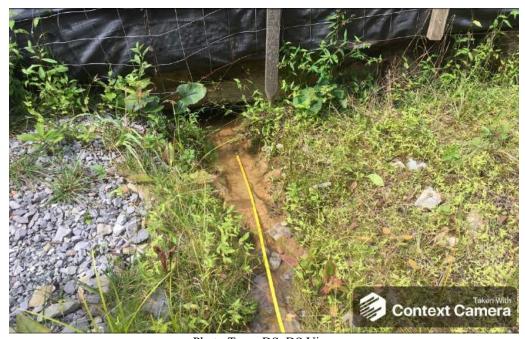
Photo Type: DS, DS View Location, Orientation, Photographer Initials: Downstream Edge of ROW, Downstream View, HC/SK/JB Lat: 38.548467 Long: -80.540073

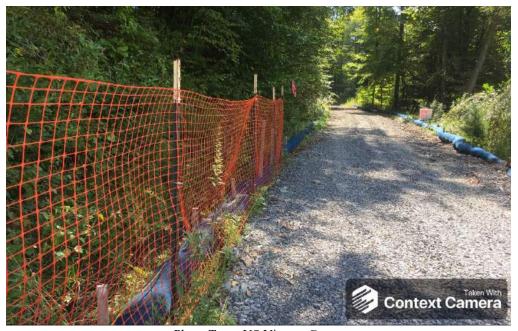
Photo Type: US View at Center Location, Orientation, Photographer Initials: Center ROW, Upstream View, HC/SK/JB Lat: 38.548467 Long: -80.540073

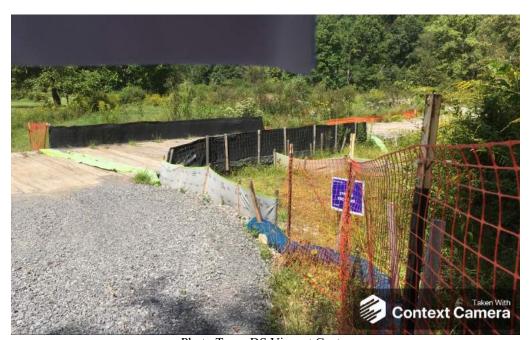
Photo Type: DS View at Center Location, Orientation, Photographer Initials: Center ROW, Downstream View, HC/SK/JB Lat: 38.548467 Long: -80.540073

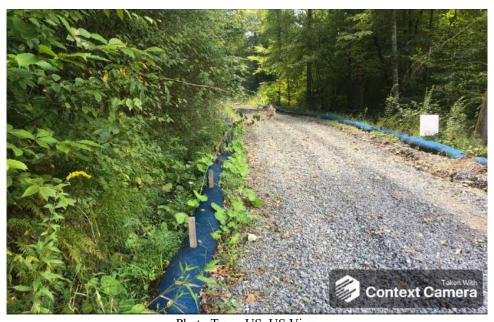
Photo Type: US, US View Location, Orientation, Photographer Initials: Upstream Edge of ROW, Upstream View, HC/SK/JB Lat: 38.548467 Long: -80.540073

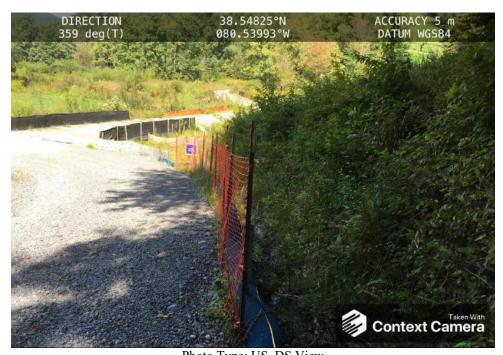
Photo Type: US, DS View Location, Orientation, Photographer Initials: Upstream Edge of ROW, Downstream View, HC/SK/JB Lat: 38.548467 Long: -80.540073

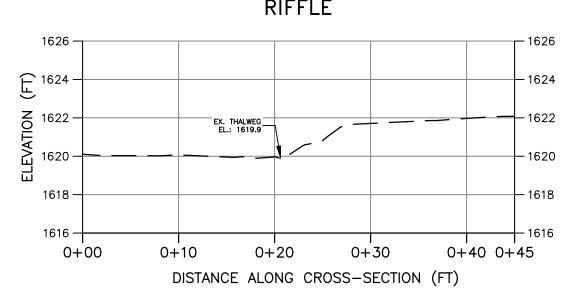
S-H107 BASELINE CROSS-SECTION B

AS-BUILT TABLE: S-H107 CROSS SECTION B									
	PI	PRE-CROSSING							
PT. LOC.	NORTHING	EASTING	ELEV	VERT. DIFF.	HORZ. DIFF.				
TS-L	13998550.9800	1771931.1640	1620.121'						
BS-L	13998550.7800	1771930.80901	1619.964'						
THW	13998550.9700	1771929.7000	1619.845'						
BS-R	13998550.1200	1771930.3900	1619.899'	·					
TS-R	13998548.8500	1771929.1870	1620.548'

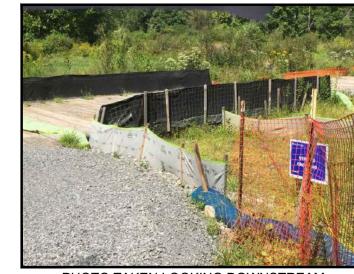
PHOTO TAKEN LOOKING DOWNSTREAM FROM UPSTREAM IMPACT LIMITS

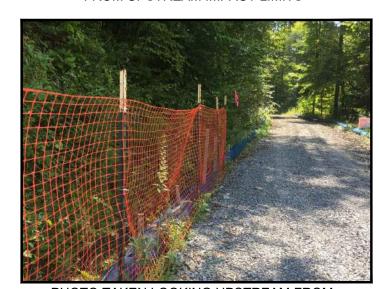
PHOTO TAKEN LOOKING UPSTREAM FROM DOWNSTREAM IMPACT LIMITS
