Baseline Assessment – Stream Attributes

Reach S-H123 (1) (Pipeline ROW) Perennial Spread C Braxton County, West Virginia

Spread C Stream S-H123 (1) (Pipeline ROW) Braxton County

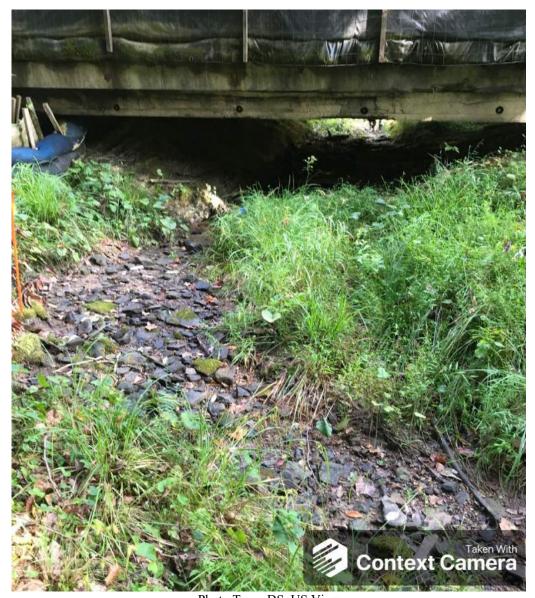
Photo Type: DS, US View
Location, Orientation, Photographer Initials: Downstream Edge of ROW, Upstream View, LC, DD
Lat: 38.761197 Long: -80.514887

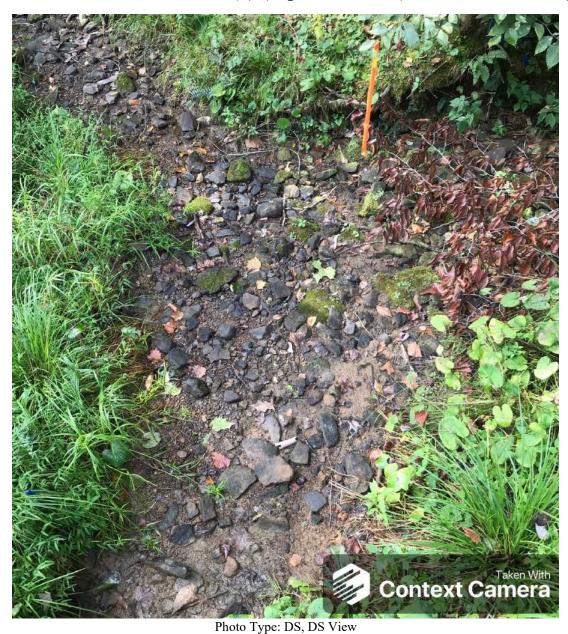
Location, Orientation, Photographer Initials: Downstream Edge of ROW, Downstream View, LC, DD

Lat: 38.761197 Long: -80.514887

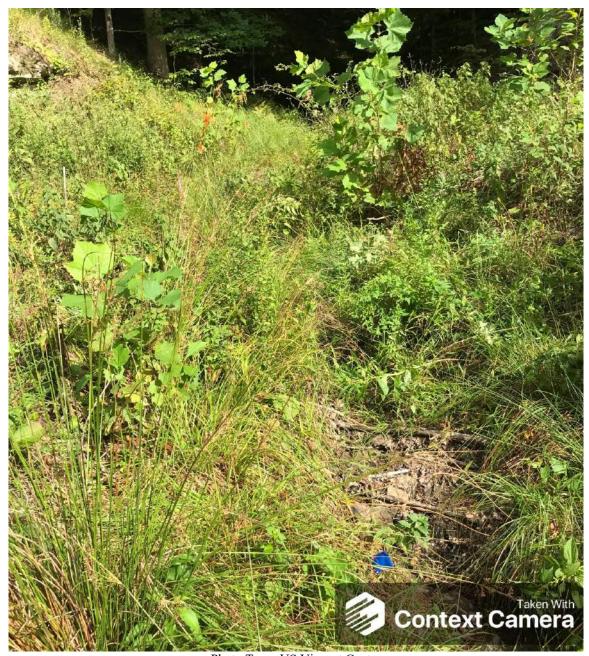
Photo Type: US View at Center Location, Orientation, Photographer Initials: Center ROW, Upstream View, LC, DD Lat: 38.761197 Long: -80.514887

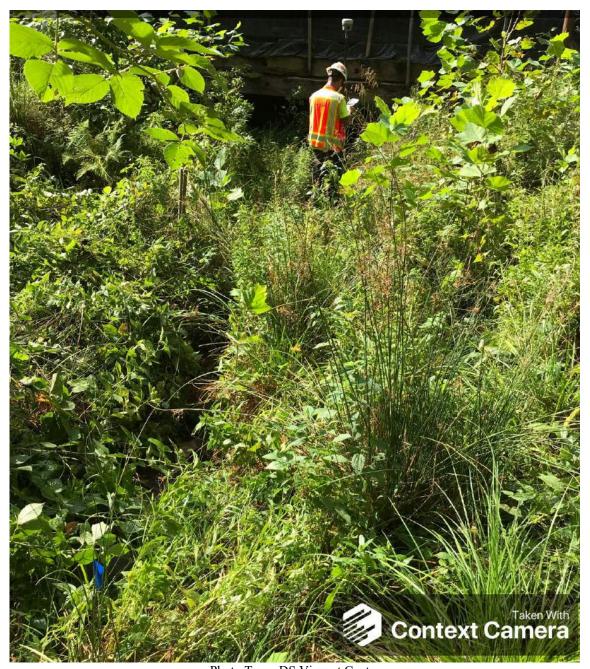
Photo Type: DS View at Center Location, Orientation, Photographer Initials: ROW Center, Downstream View, LC, DD Lat: 38.761197 Long: -80.514887

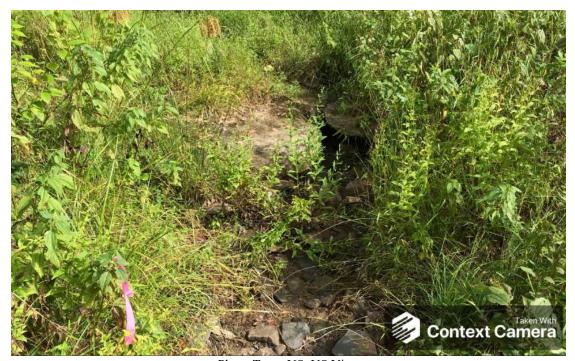
Photo Type: US, US View Location, Orientation, Photographer Initials: Upstream Edge of ROW, Upstream View, LC, DD Lat: 38.761197 Long: -80.514887

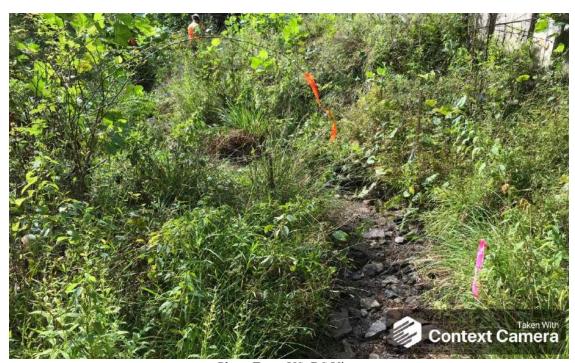
Photo Type: US, DS View
Location, Orientation, Photographer Initials: Upstream Edge of ROW, Downstream View, LC, DD
Lat: 38.761197 Long: -80.514887

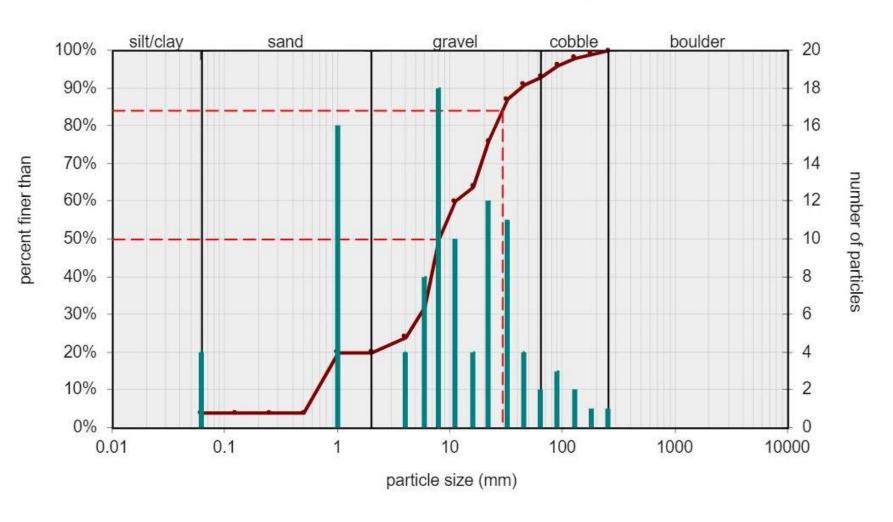
Size (r	nm)	1
D16	0.84	
D35	6.3	
D50	8	
D65	16	
D84	29	
D95	80

ribution
4.9
6.6
-0.17

silt/clay	4%
sand	16%
gravel	73%
cobble	7%
ooulder	0%

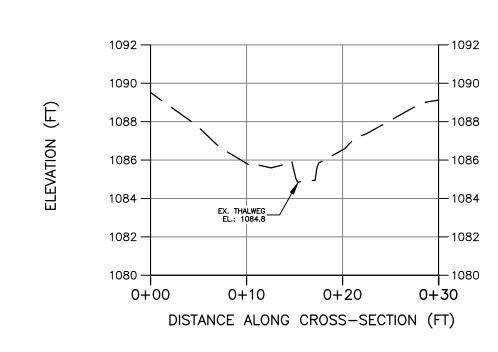
S-H123 (1) BASELINE CROSS-SECTION A

H: 1"=10'
V: 1"=5'

NOTE: ALL SECTIONS VIEWS SHOWN LEFT TO RIGHT FACING DOWNSTREAM.

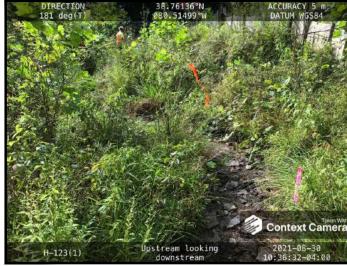
PHOTO TAKEN LOOKING DOWNSTREAM FROM UPSTREAM IMPACT LIMITS

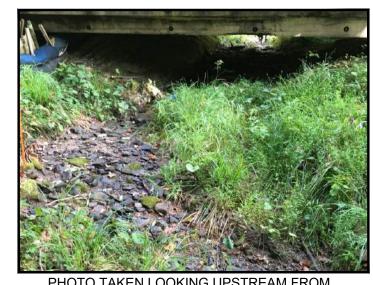
PHOTO TAKEN LOOKING UPSTREAM FROM DOWNSTREAM IMPACT LIMITS
