Baseline Assessment – Stream Attributes

Reach S-H123 (2) (Pipeline ROW)

Braxton County, West Virginia

PROFILE AND CROSS-SECTIONS
BASELINE SURVEY
CROSSING S-H123 (2) - UNNAMED
TRIB. TO ELLIOT RUN (MP 74.05)
PRAYTON COUNTY, WY

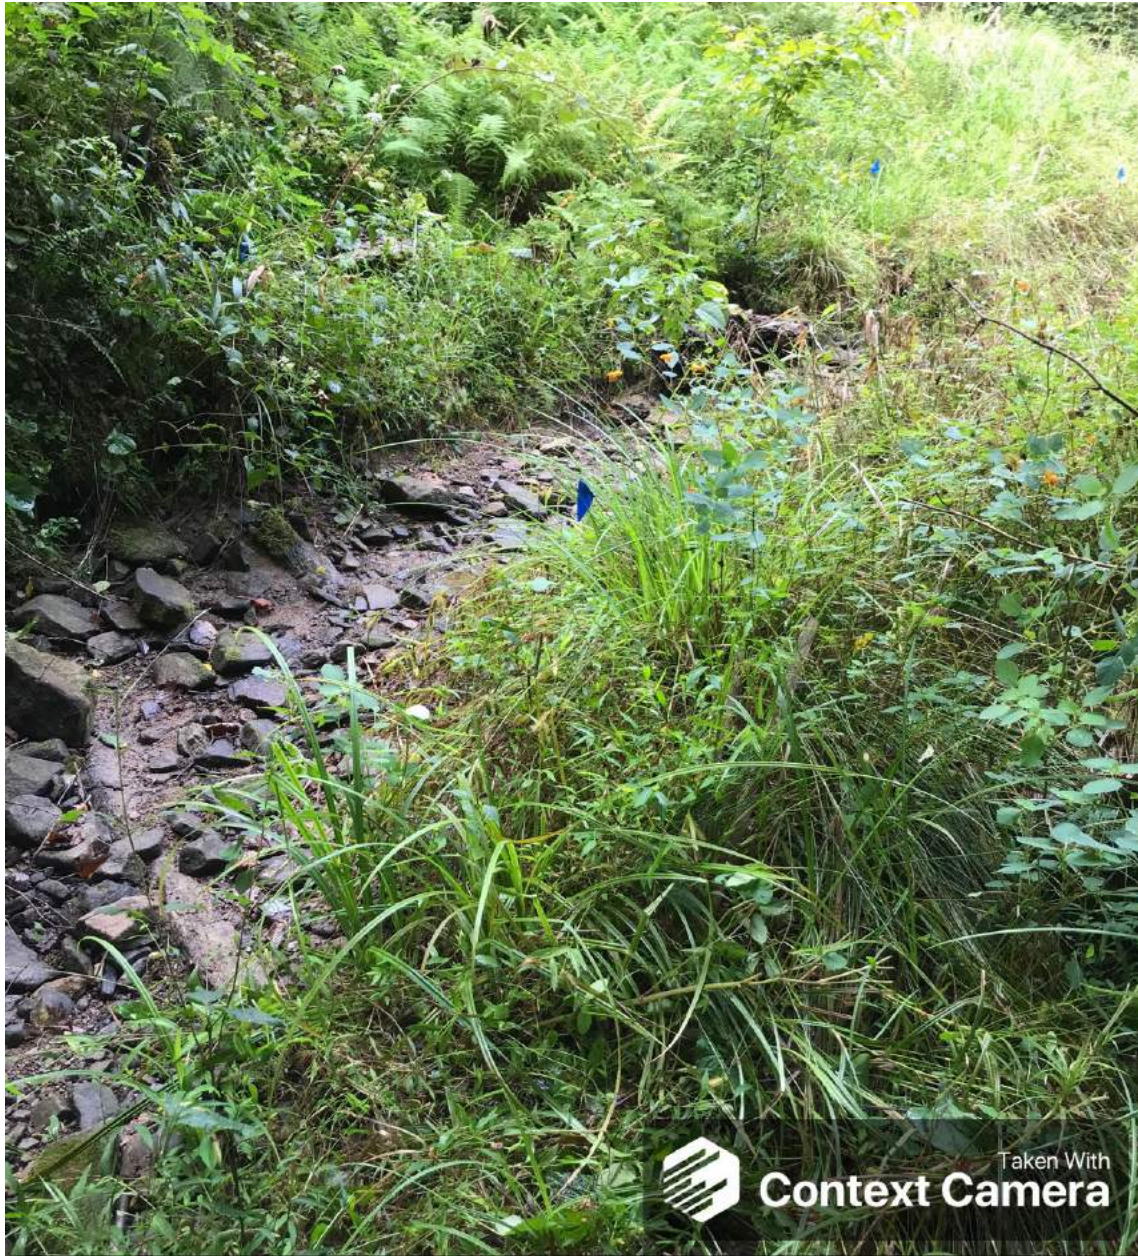
Photo Type: DS, US View
Location, Orientation, Photographer Initials: Downstream Edge of ROW, Upstream View, LC, DD
Lat: 38.760426 Long: -80.513624

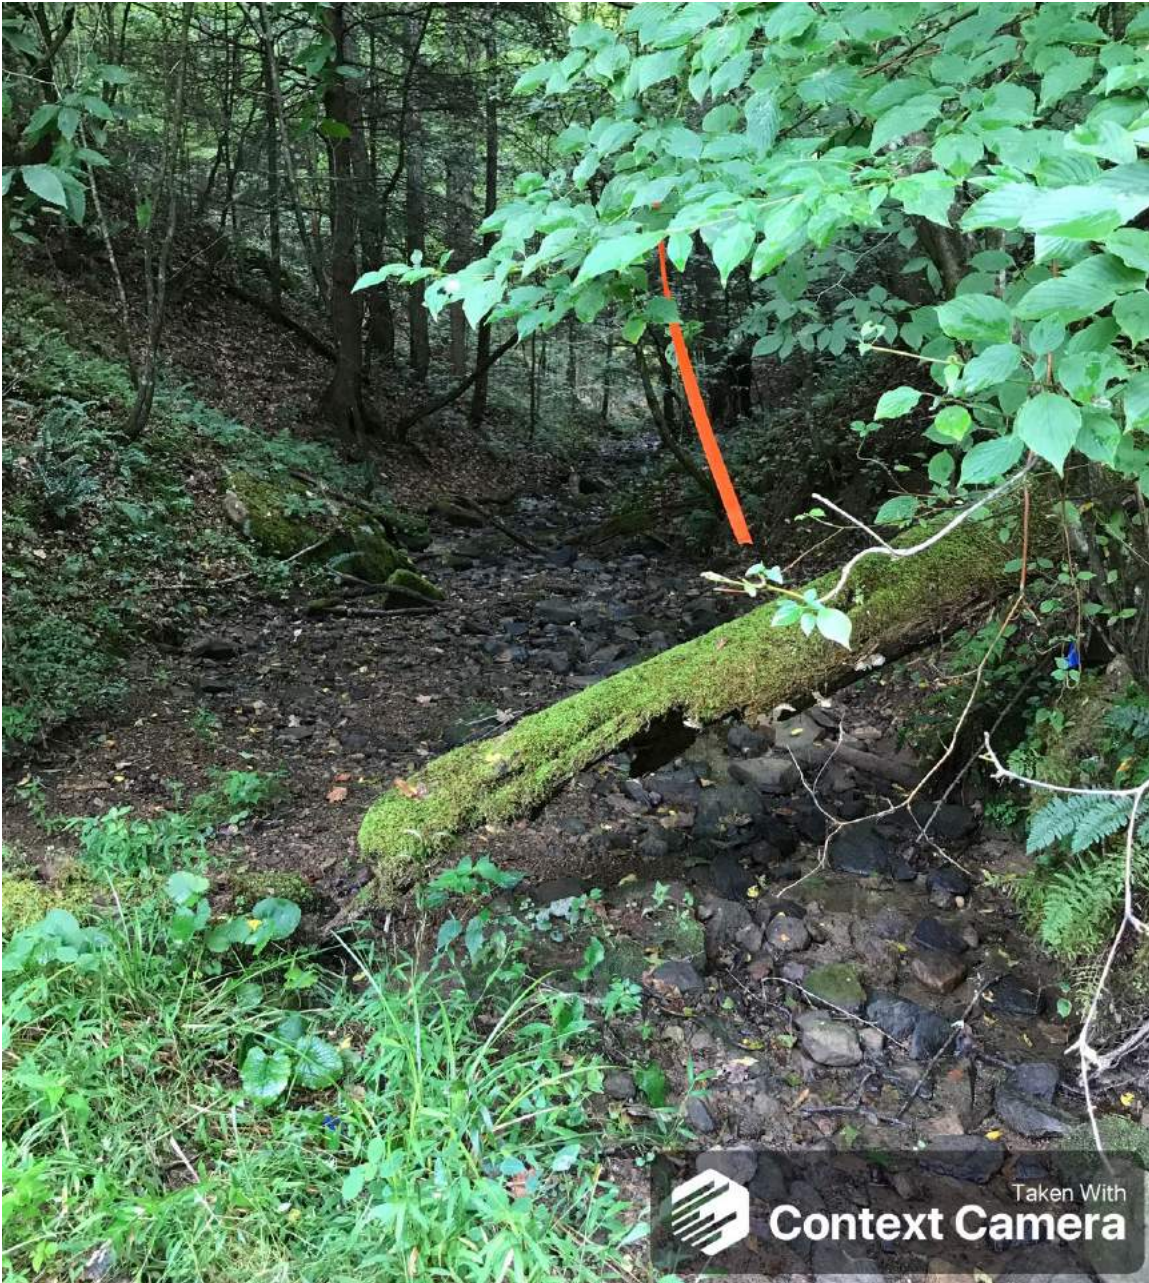
Photo Type: DS, DS View
Location, Orientation, Photographer Initials: Downstream Edge of ROW, Downstream View, LC, DD
Lat: 38.760426 Long: -80.513624

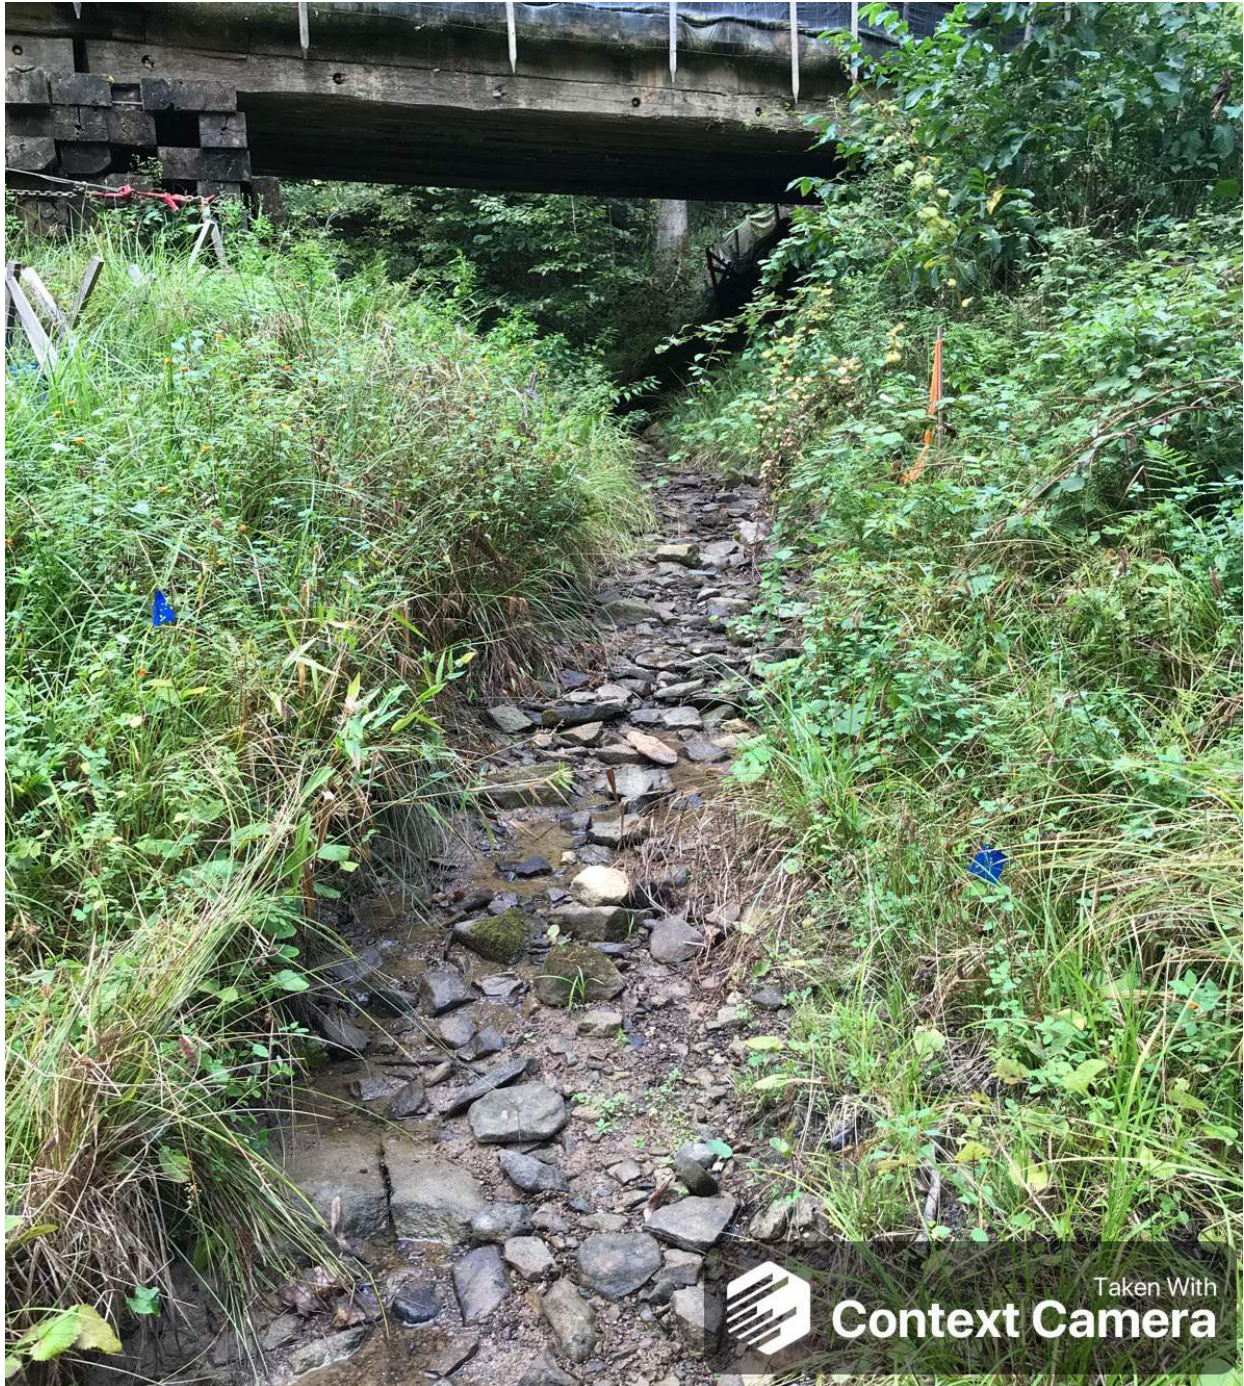
Photo Type: US View at Center
Location, Orientation, Photographer Initials: Center ROW, Upstream View, LC, DD
Lat: 38.760426 Long: -80.513624

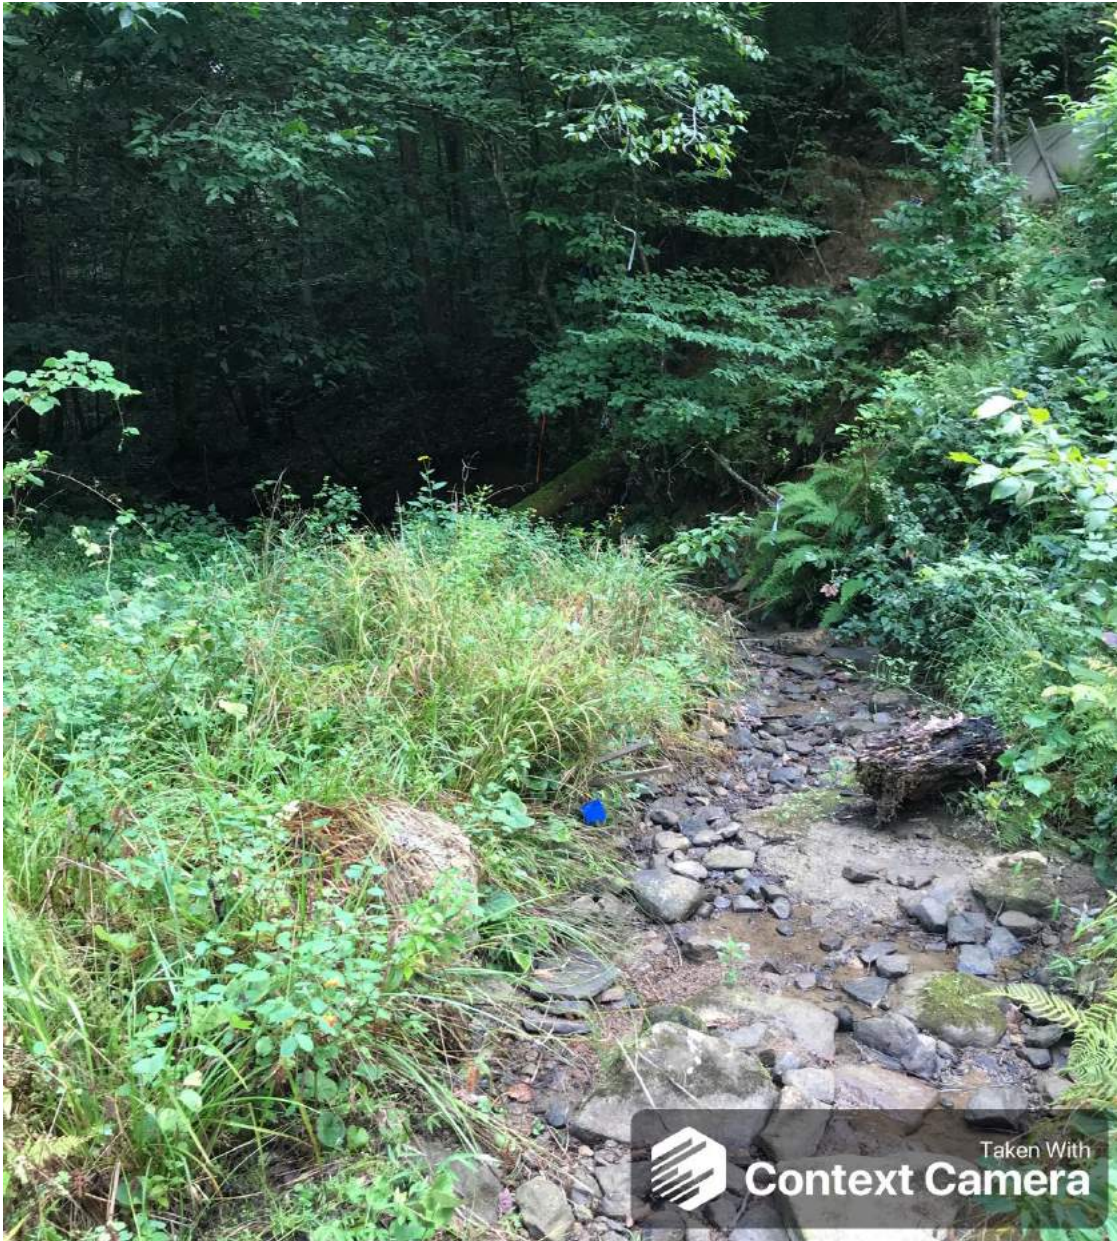
Photo Type: DS View at Center
Location, Orientation, Photographer Initials: ROW Center, Downstream View, LC, DD
Lat: 38.760426 Long: -80.513624

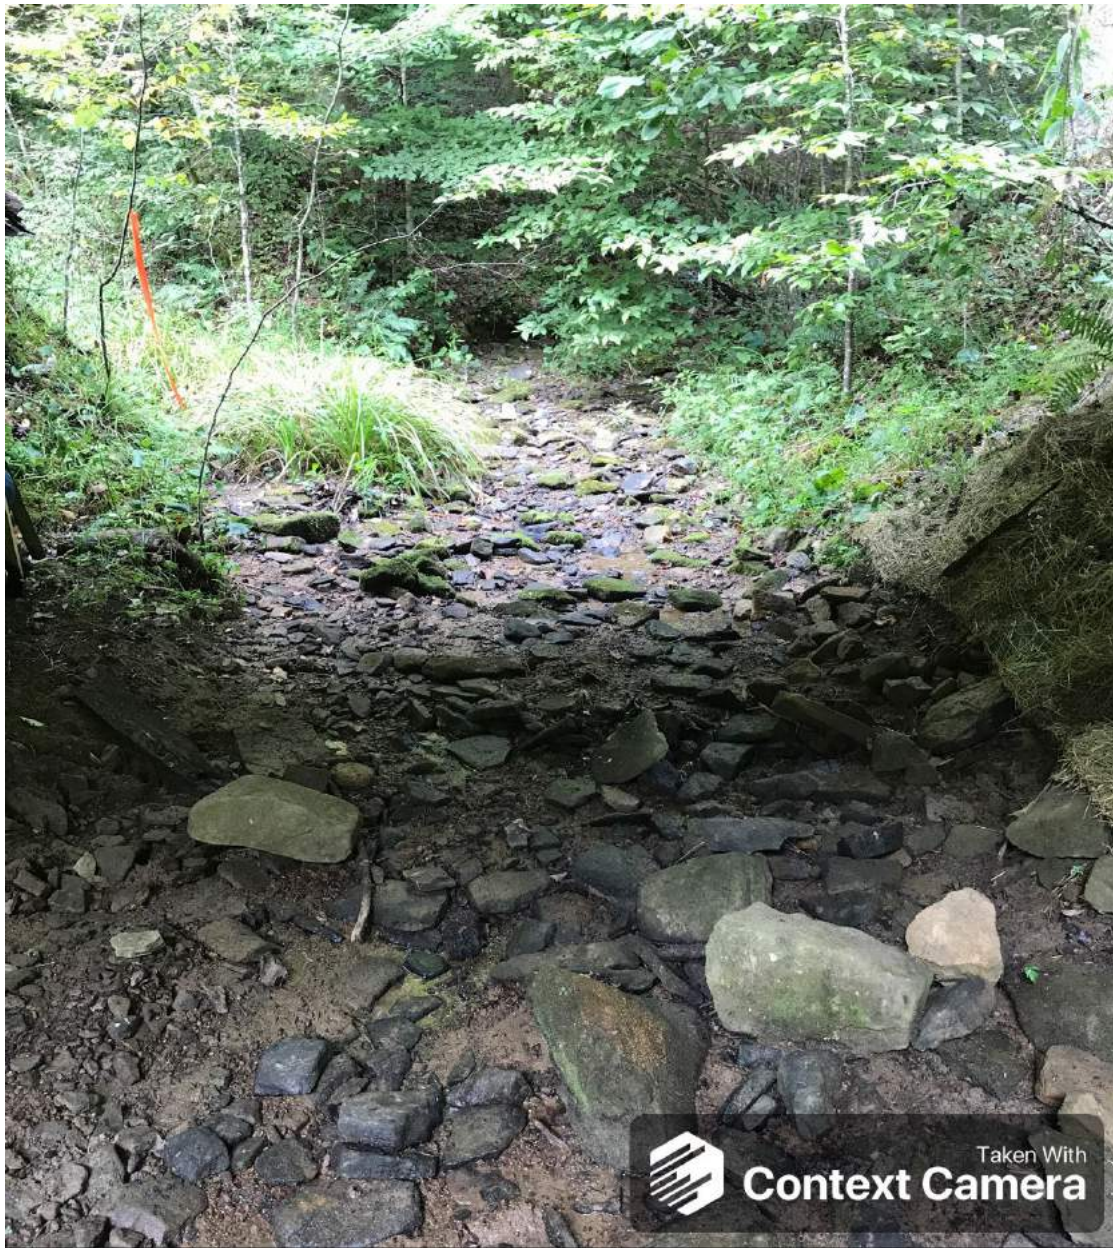
Photo Type: US, US View
Location, Orientation, Photographer Initials: Upstream Edge of ROW, Upstream View, LC, DD
Lat: 38.760426 Long: -80.513624

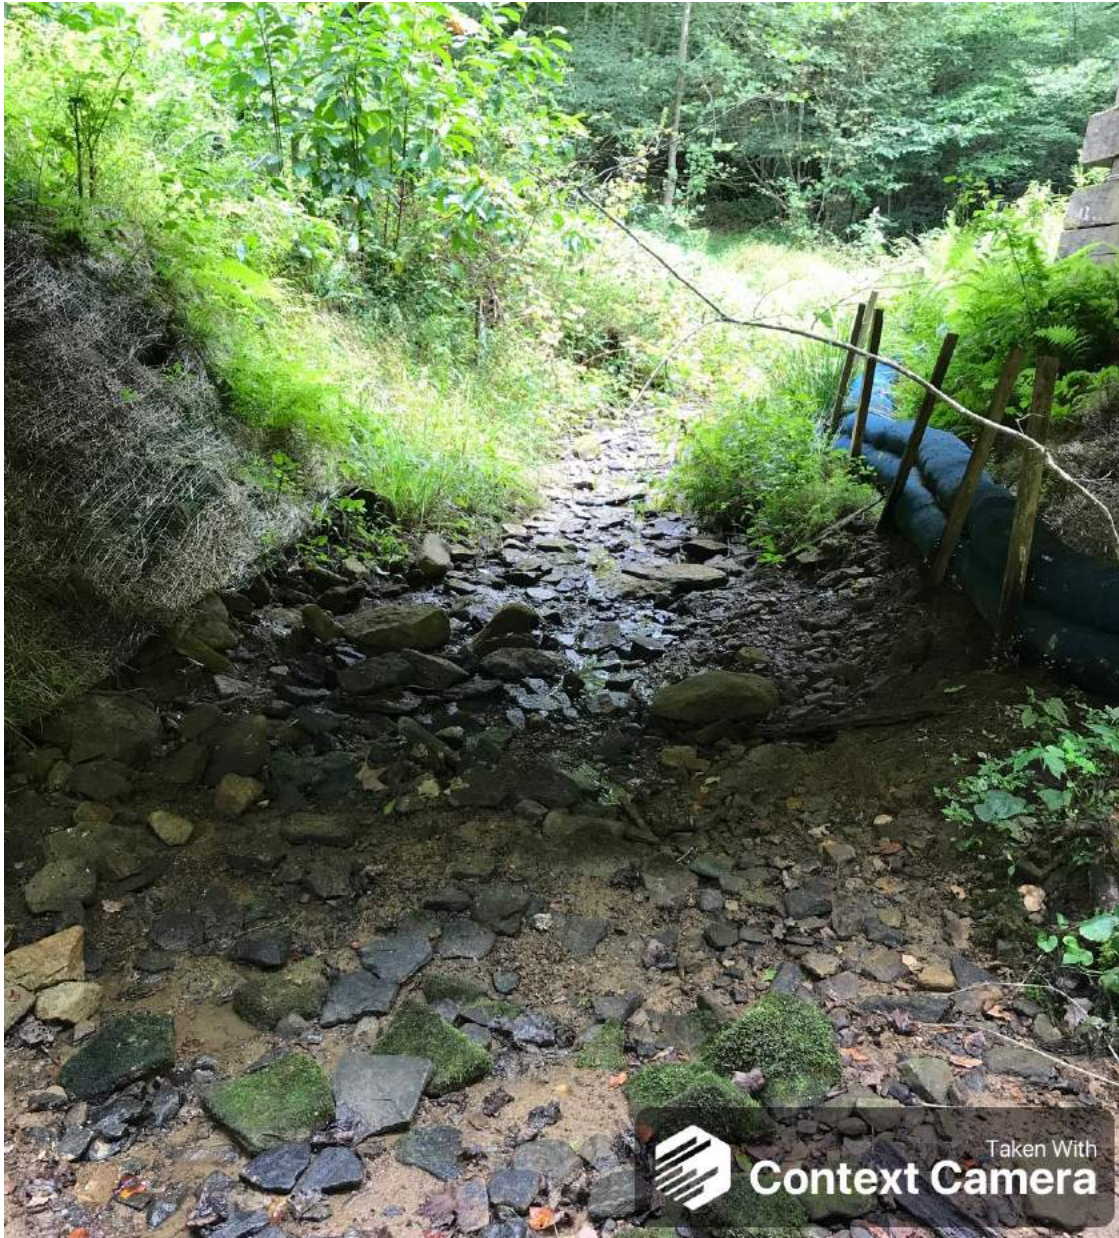
Photo Type: US, DS View
Location, Orientation, Photographer Initials: Upstream Edge of ROW, Downstream View, LC, DD
Lat: 38.760426 Long: -80.513624
