# **Baseline Assessment – Stream Attributes**

# Reach S-H132 (Timber Mat Crossing) Perennial Spread C Braxton County, West Virginia

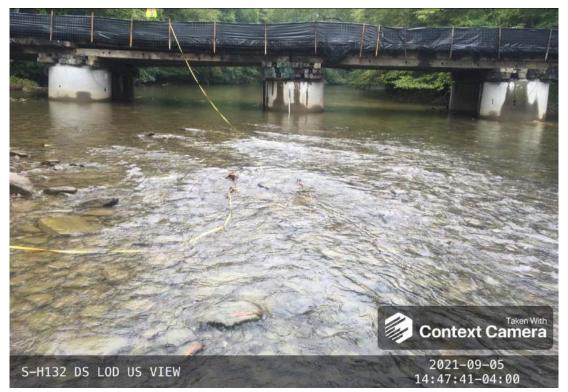
Photo Type: DS, US View Location, Orientation, Photographer Initials: Downstream Edge of ROW, Upstream View, RH/HK Lat: 38.751499 Long: -80.514919

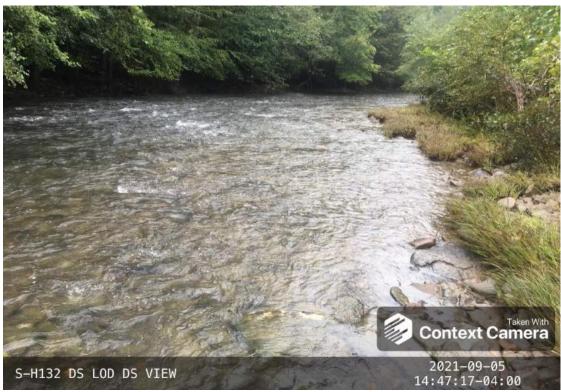
Photo Type: DS, DS View Location, Orientation, Photographer Initials: Downstream Edge of ROW, Downstream View, RH/HK Lat: 38.751499 Long: -80.514919

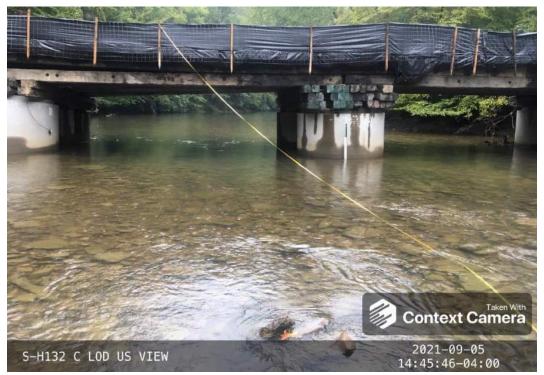
Photo Type: US View at Center Location, Orientation, Photographer Initials: Center ROW, Upstream View, RH/HK Lat: 38.751499 Long: -80.514919

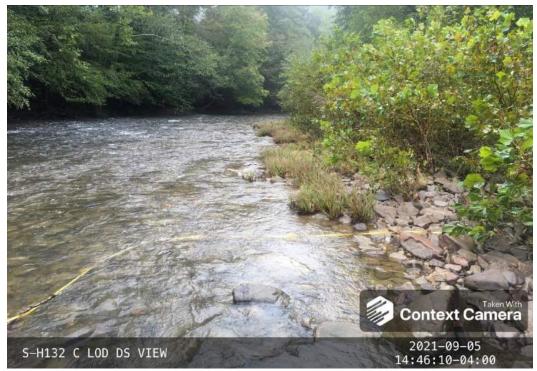
Photo Type: DS View at Center Location, Orientation, Photographer Initials: Center ROW, Downstream View, RH/HK Lat: 38.751499 Long: -80.514919

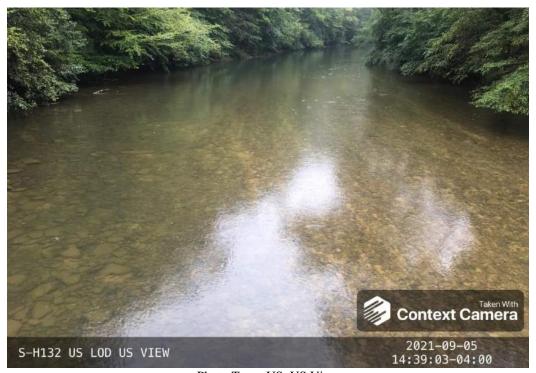
Photo Type: US, US View Location, Orientation, Photographer Initials: Upstream Edge of ROW, Upstream View, RH/HK Lat: 38.751499 Long: -80.514919

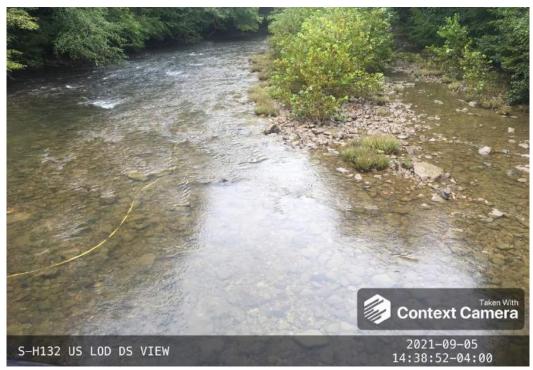
Photo Type: US, DS View Location, Orientation, Photographer Initials: Upstream Edge of ROW, Downstream View, RH/HK Lat: 38.751499 Long: -80.514919

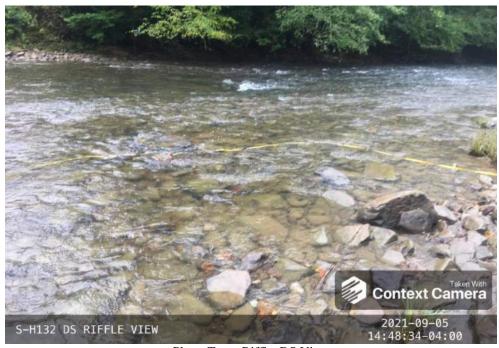
Photo Type: Riffle, DS View
Location, Orientation, Photographer Initials: Upstream of Riffle, Downstream View, RH/HK
Lat: 38.751499 Long: -80.514919

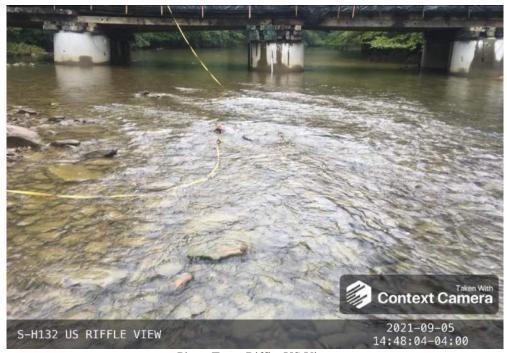
Photo Type: Riffle, US View Location, Orientation, Photographer Initials: Downstream of Riffle, Upstream View, RH/HK Lat: 38.751499 Long: -80.514919

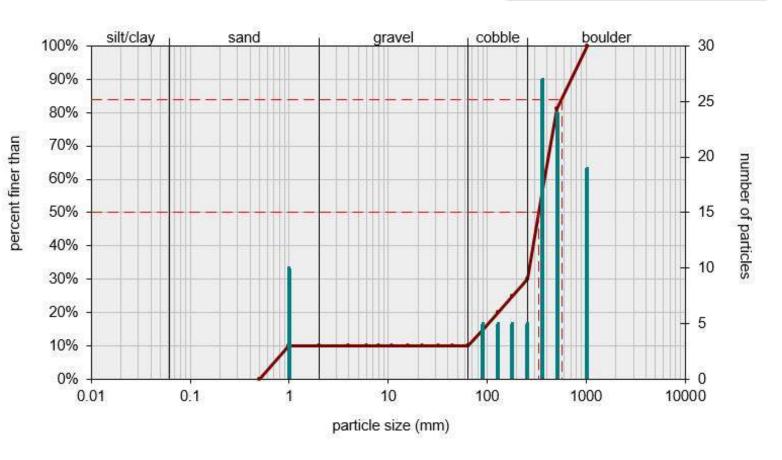
Size (n	nm)	
92	D16	97	
	D35	270	
	D50	330	
	D65	410	
	D84	570	
	D95	850

Size Distribution					
mean	235.1				
dispersion	2.6				
skewness	-0.17

Type	
silt/clay	0%	6
sand	10%	
grave	0%	
cobble	20%	
boulder	70%

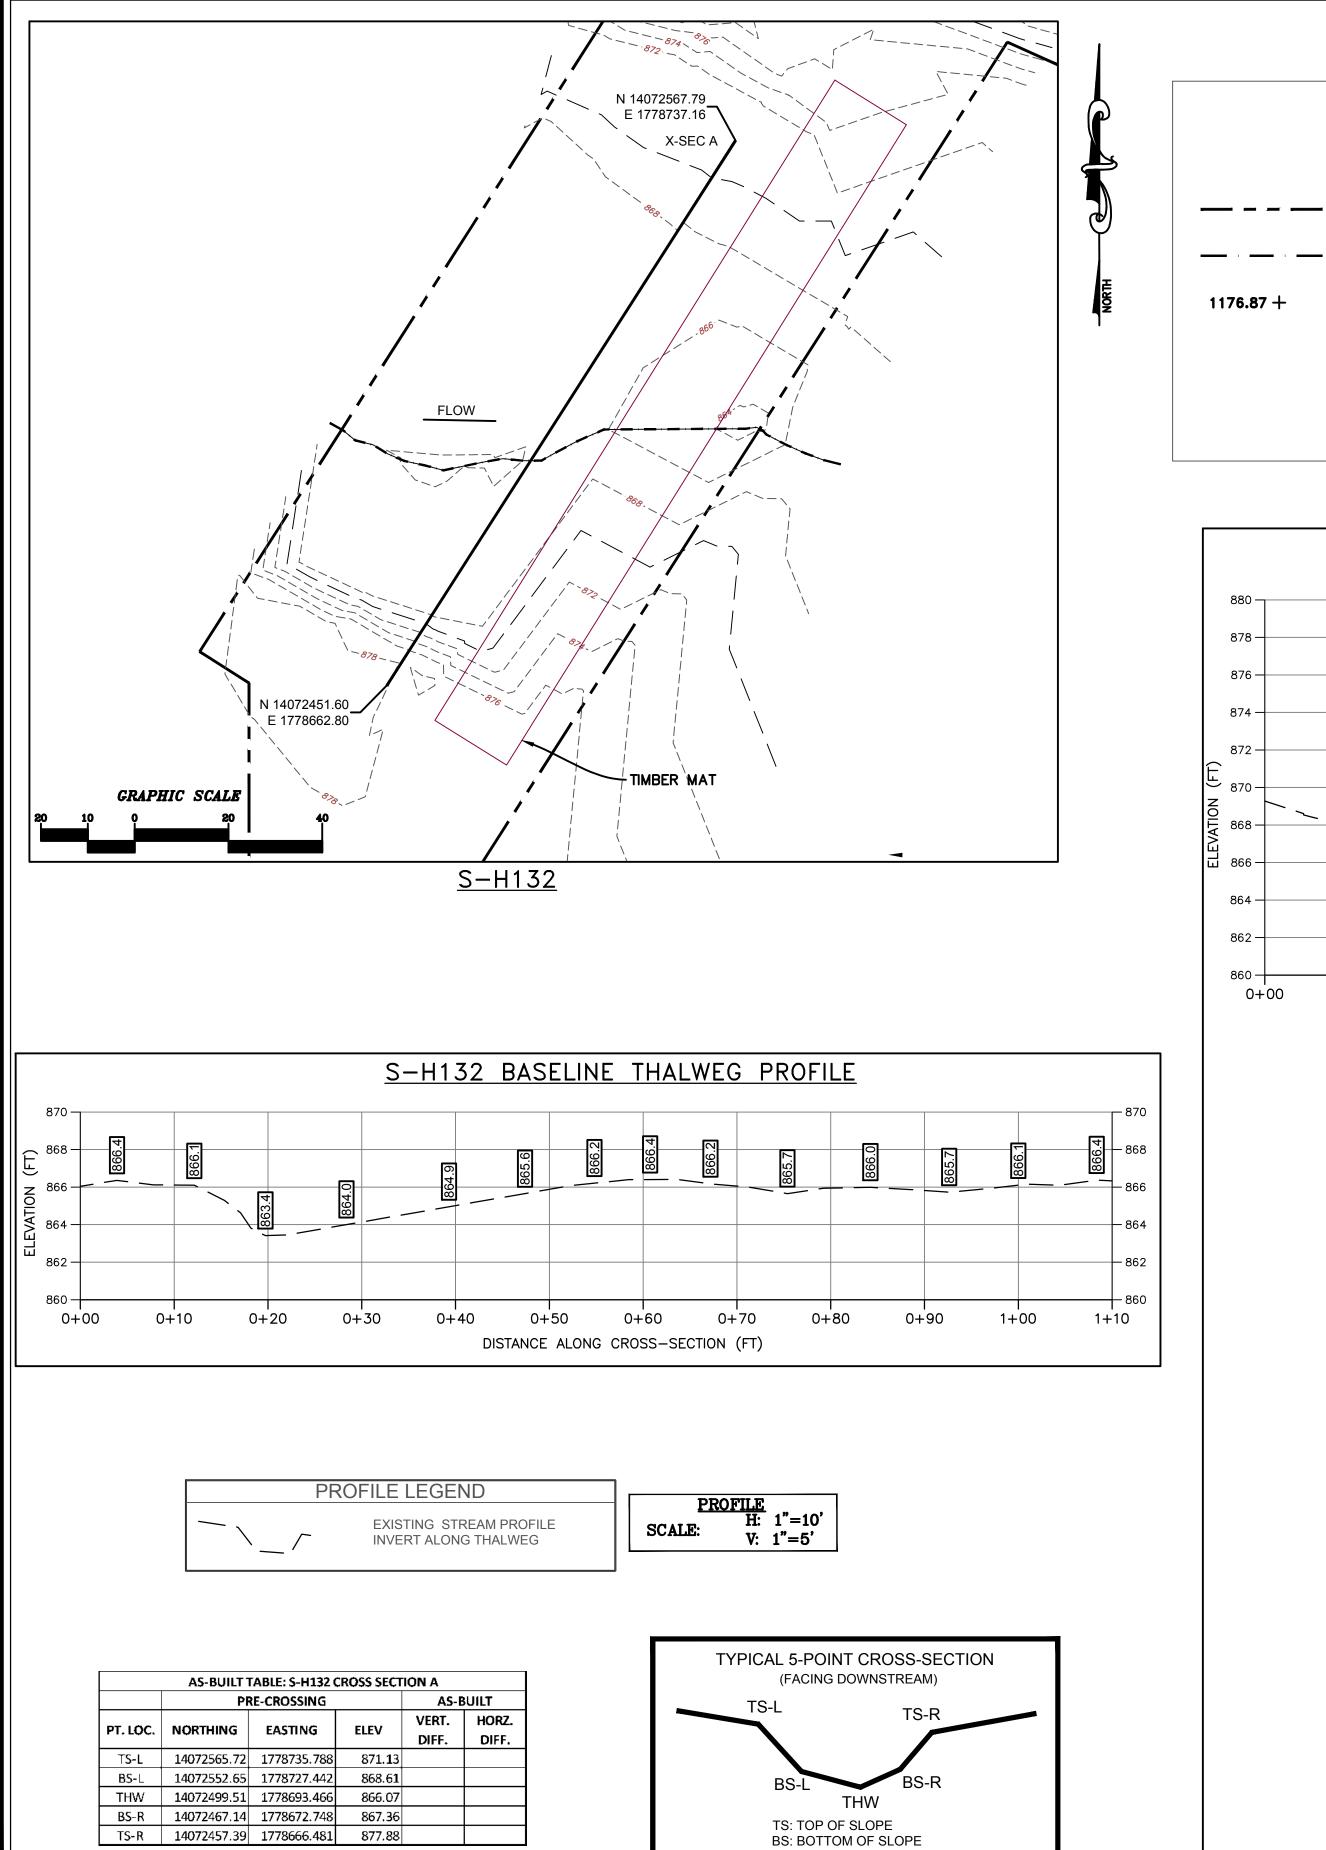
THW: THALWEG (INVERT)

- 1. THIS MAP HAS BEEN ORIENTED TO NAD 1983 UTM ZONE 17N, AND VERTICALLY TO THE NORTH AMERICAN VERTICAL DATUM OF 1988 (NAVD 88), USING REAL TIME DGPS. FIELD LOCATIONS WERE COMPLETED ON SEPTEMBER 5, 2021.

- 2. EASEMENT LINES SHOWN ON PLAN VIEW WERE PROVIDED BY MOUNTAIN VALLEY PIPELINE.
- 3. SURVEY POINTS FOR CROSS SECTIONS AND THALWEG PROFILES COLLECTED IN 2021 HAVE BEEN USED IN COMBINATION WITH SURVEY POINTS COLLECTED PREVIOUSLY IN 2020 IN ORDER TO GENERATE THE PRE-CROSSING SURFACE SHOWN IN PLAN. DUE TO NATURAL EROSIONAL STREAM PROCESSES THAT CAN OCCUR OVER TIME, MINOR ADJUSTMENTS TO THE PROFILE ALIGNMENTS MAY HAVE BEEN REQUIRED IN ORDER TO GENERATE A CLEAN PRE-CROSSING SURFACE.

- 4. ALL SECTION VIEWS SHOWN LEFT TO RIGHT FACING DOWNSTREAM.
- 5. POST-CROSSING SURVEY INFORMATION SHOWN IN RED. DATA PENDING.
- 6. POST-CROSSING SURVEY POINTS FOR CROSS SECTIONS AND THALWEG ARE PROJECTED ONTO PRE-CROSSING SECTION AND PROFILE VIEWS FOR COMPARISON.

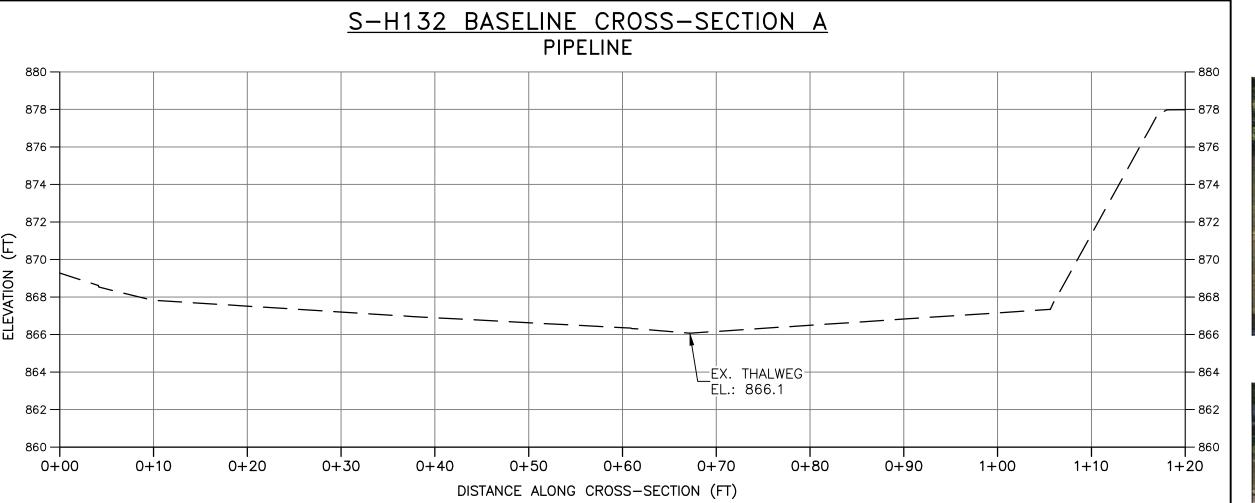
CROSS SECTION

H: 1"=10'
V: 1"=5'

NOTE: ALL SECTIONS VIEWS SHOWN LEFT TO RIGHT FACING DOWNSTREAM.

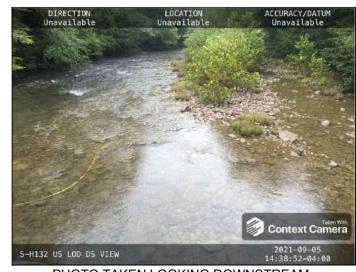
PHOTO TAKEN LOOKING DOWNSTREAM FROM UPSTREAM IMPACT LIMITS

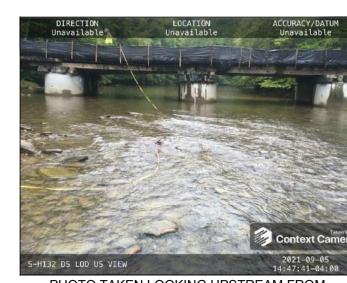
PHOTO TAKEN LOOKING UPSTREAM FROM DOWNSTREAM IMPACT LIMITS
