## Baseline Assessment – Stream Attributes

**Reach S-H145 (Pipeline ROW)**

**Lewis County, West Virginia**

Title  
PROFILE AND CROSS-SECTIONS  
BASELINE SURVEY  
CROSSING S-H145 - UNNAMED  
TRIB. TO INDIAN FORK (MP 59.89)  
LEWIS COUNTY, WV

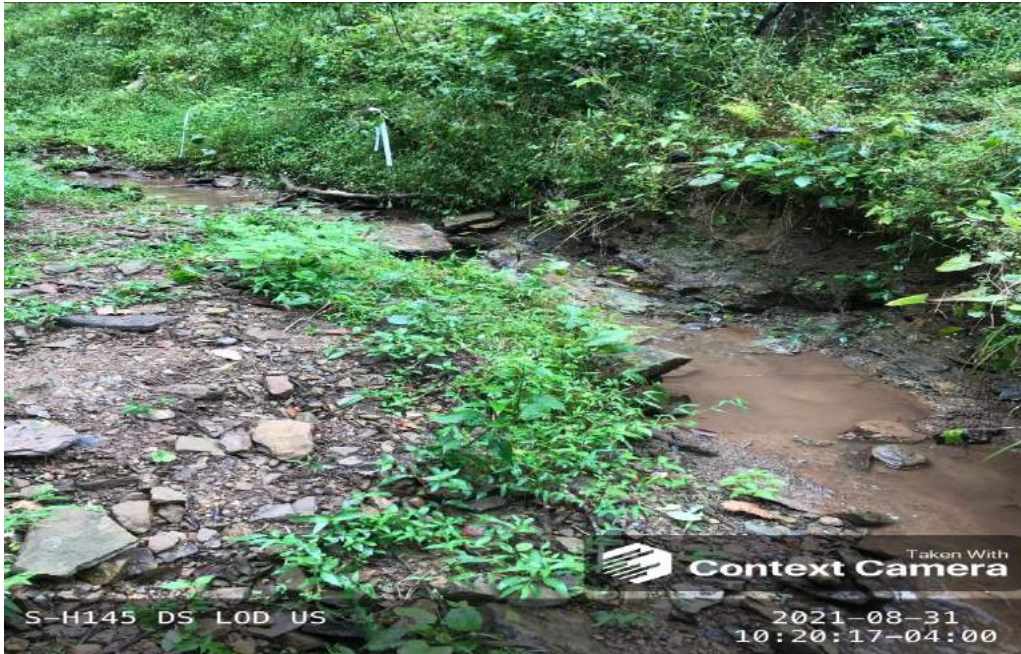
Photo Type: DS, US View

Location, Orientation, Photographer Initials: Downstream Edge of ROW, Upstream View, PL, AE  
Lat: 38.918986 Long: -80.573838

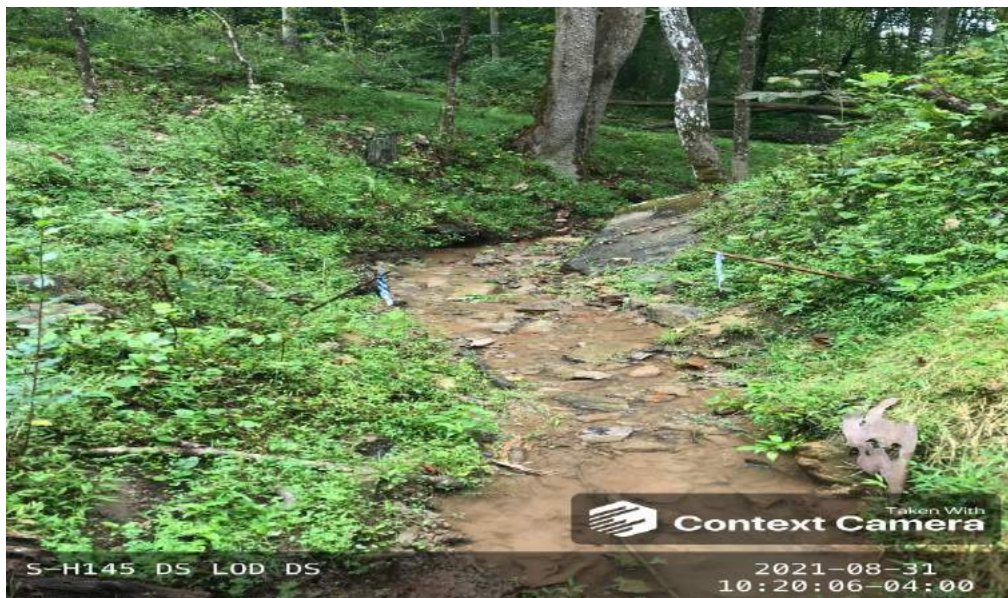
Photo Type: DS, DS View

Location, Orientation, Photographer Initials: Downstream Edge of ROW, Downstream View, PL, AE  
Lat: 38.918986 Long: -80.573838

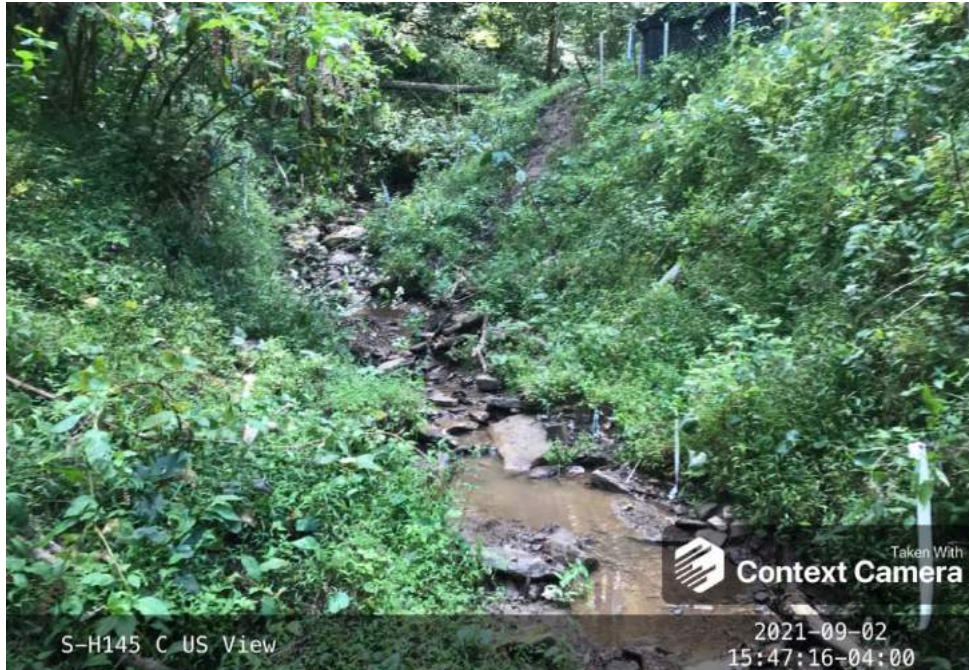
Photo Type: US View at Center  
Location, Orientation, Photographer Initials: Center ROW, Upstream View, PL, AE  
Lat: 38.918986 Long: -80.573838

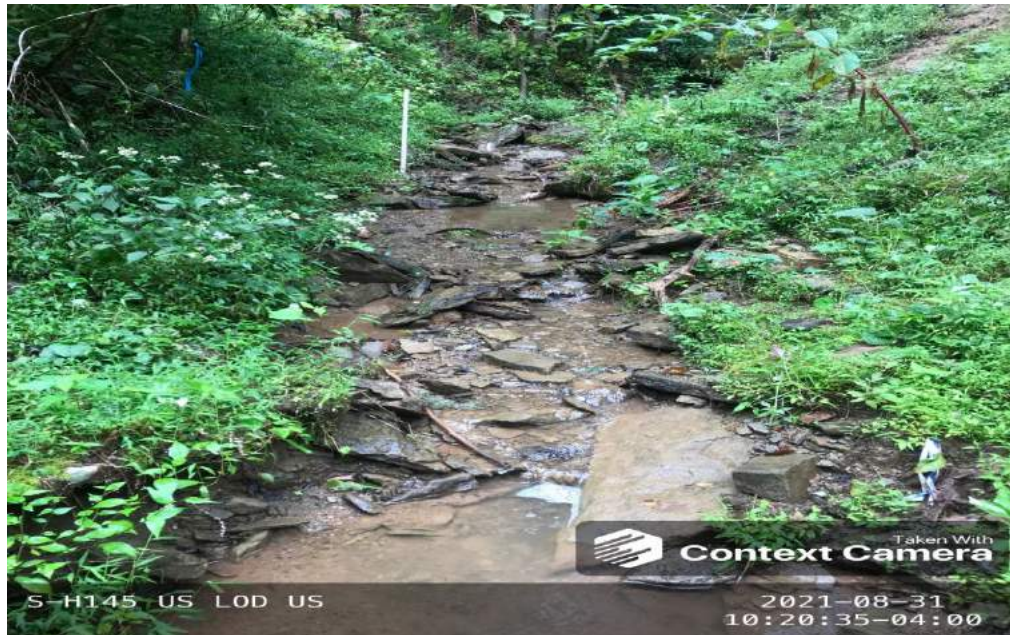
Photo Type: US, US View

Location, Orientation, Photographer Initials: Upstream Edge of ROW, Upstream View, PL, AE  
Lat: 38.918986 Long: -80.573838

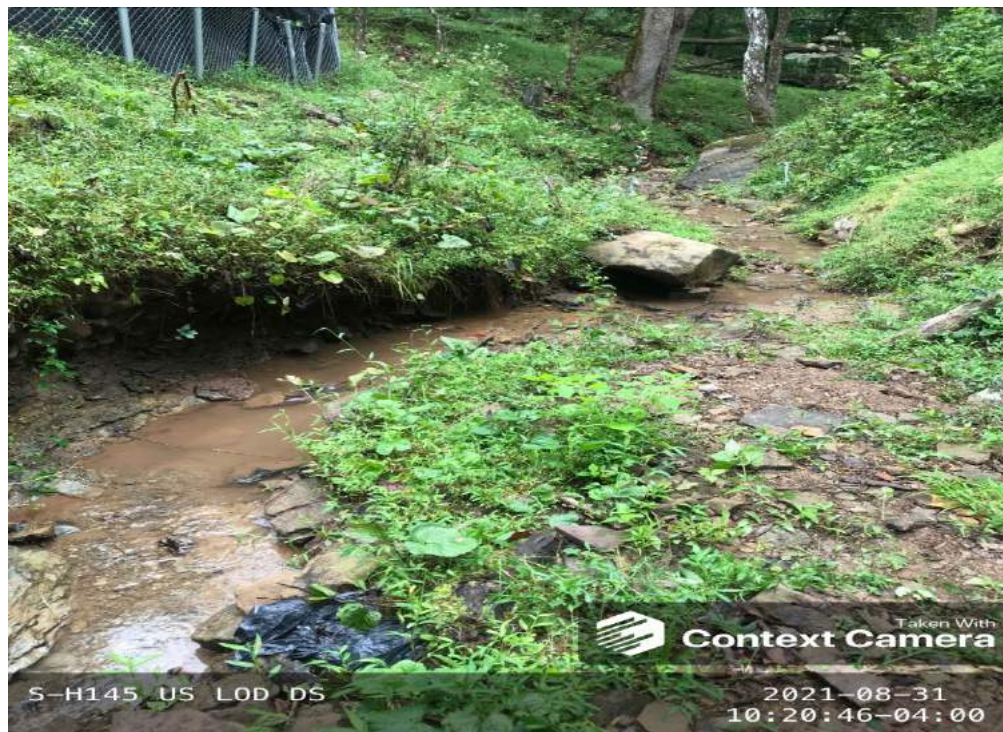
Photo Type: US, DS View

Location, Orientation, Photographer Initials: Upstream Edge of ROW, Downstream View, PL, AE  
Lat: 38.918986 Long: -80.573838

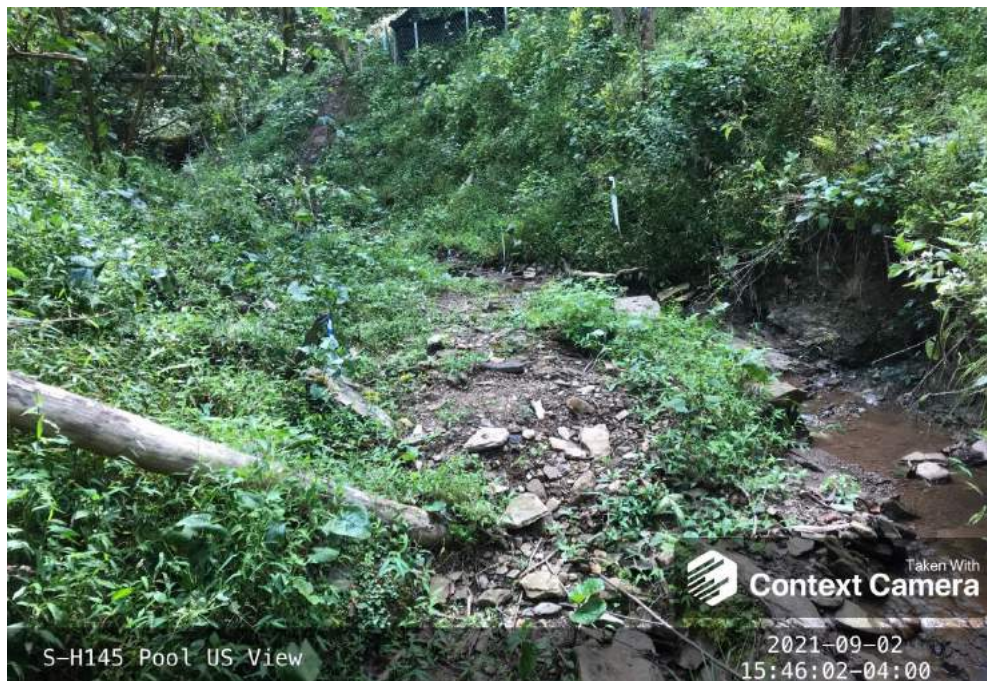
Photo Type: Pool, US View

Location, Orientation, Photographer Initials: Downstream of Pool, Upstream View, PL, AE  
Lat: 38.918986 Long: -80.573838

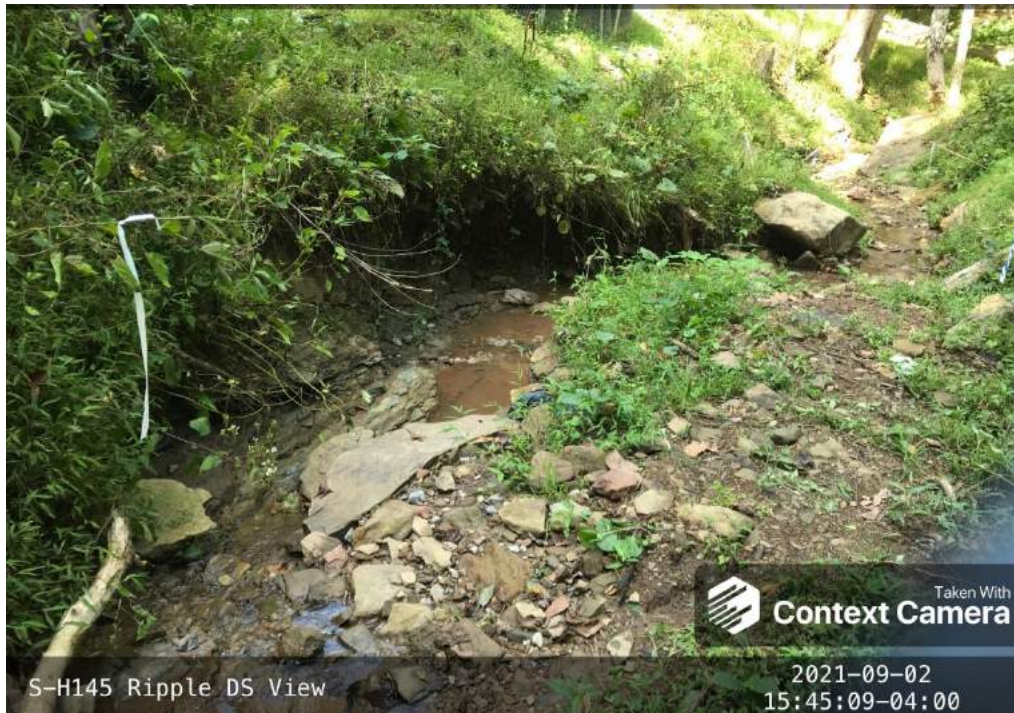
Photo Type: Riffle DS View

Location, Orientation, Photographer Initials: Upstream at ROW looking downstream, PL, AE  
Lat: 38.918986 Long: -80.573838

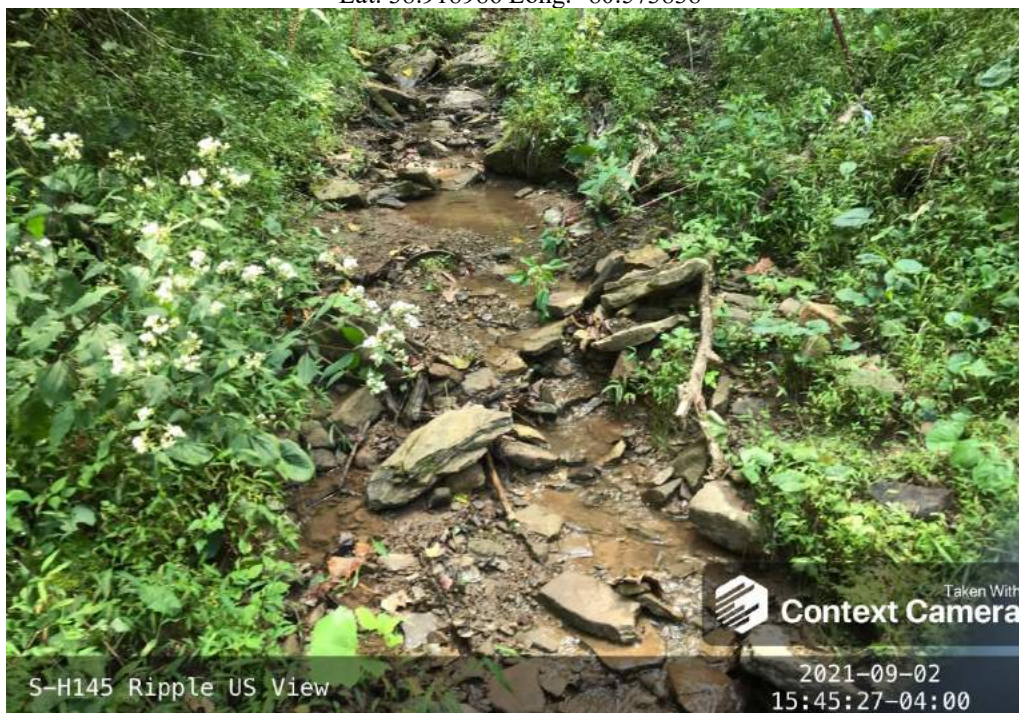
Photo Type: Riffle US View

Location, Orientation, Photographer Initials: Upstream at ROW looking downstream, PL, AE  
Lat: 38.918986 Long: -80.573838

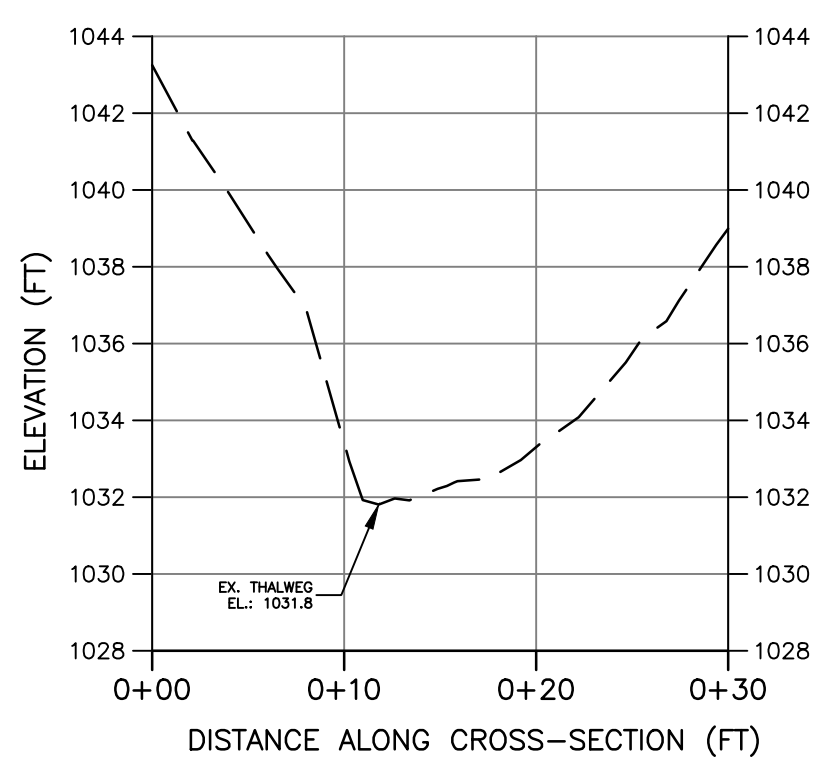
S-H145 BASELINE CROSS-SECTION B  
RIFFLE

AS-BUILT TABLE: S-H145 CROSS SECTION B					
PRE-CROSSING				AS-BUILT	
PT. LOC.	NORTHING	EASTING	ELEV.	VERT. DIFF.	HORZ. DIFF.
TS-L	14133414.53	1761617.06	1036.92		
BS-L	14133413.24	1761619.87	1033.92		
THW	14133412.61	1761621.27	1031.97		
BS-R	14133409.89	1761627.24	1032.97		
TS-R	14133409.15	1761628.87	1033.65
