Baseline Assessment – Stream Attributes

Reach S-I21 (2) (Pipeline ROW) Perennial Spread E Greenbrier County, West Virginia

Spread E Stream S-I21(2) (Pipeline ROW) Greenbrier County

Title PROFILE AND CROSS-SECTIONS
BASELINE SURVEY
CROSSING S-21-2 - UNNAMED TRIBE
BOGGS CREEK (MP 149.93)
GREENBRIER COUNTY WV

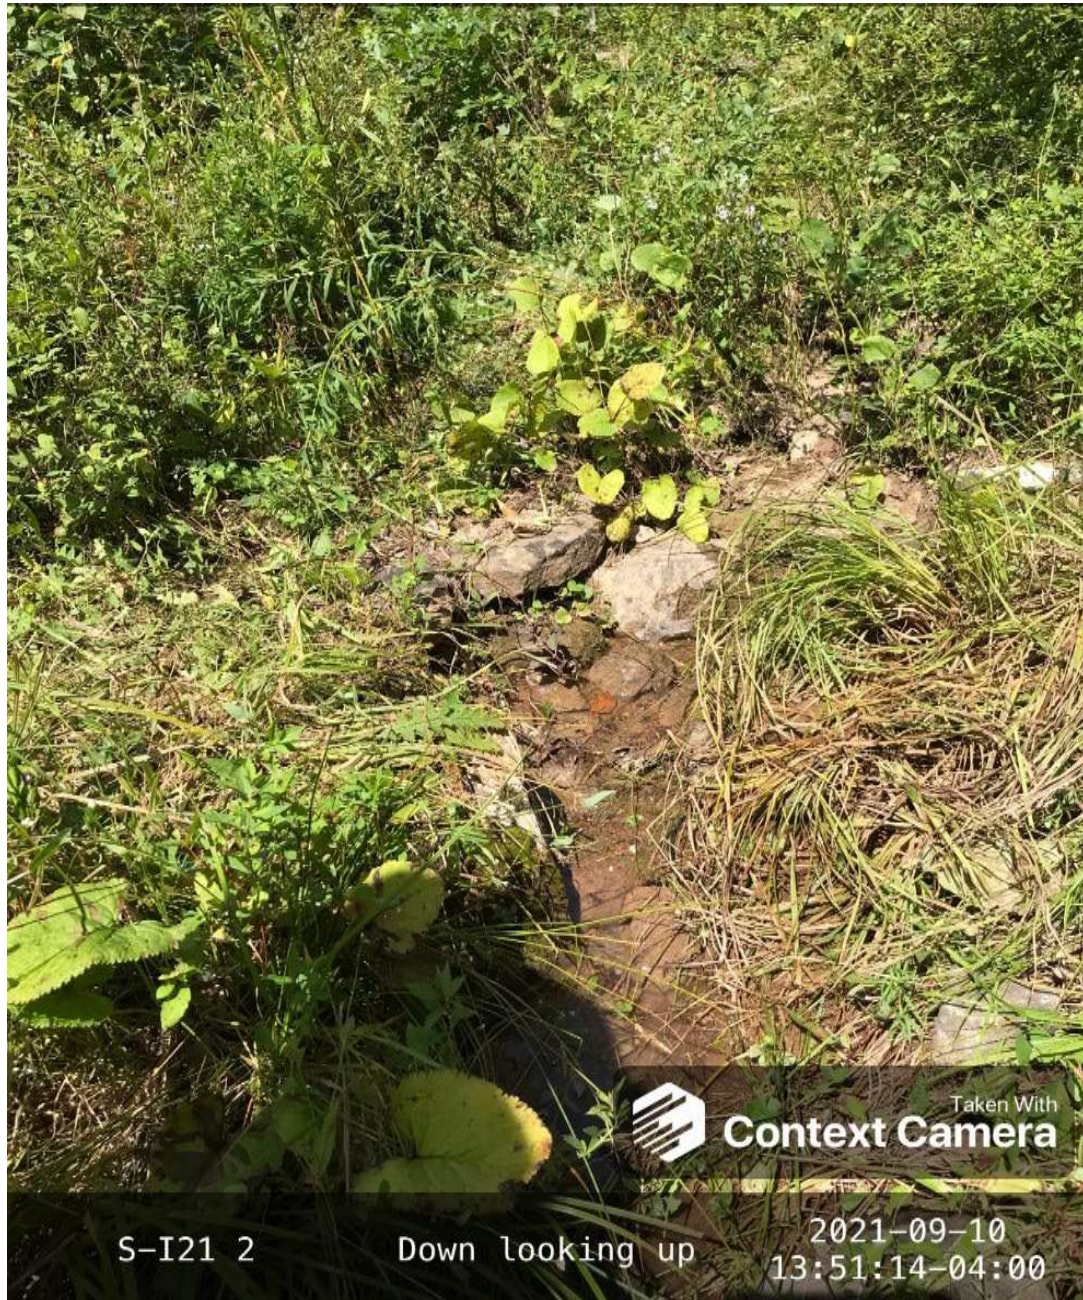
Photo Type: DS, US View
Location, Orientation, Photographer Initials: Downstream Edge of ROW, Upstream View, MD
Lat: 37.918164 Long: -80.736852

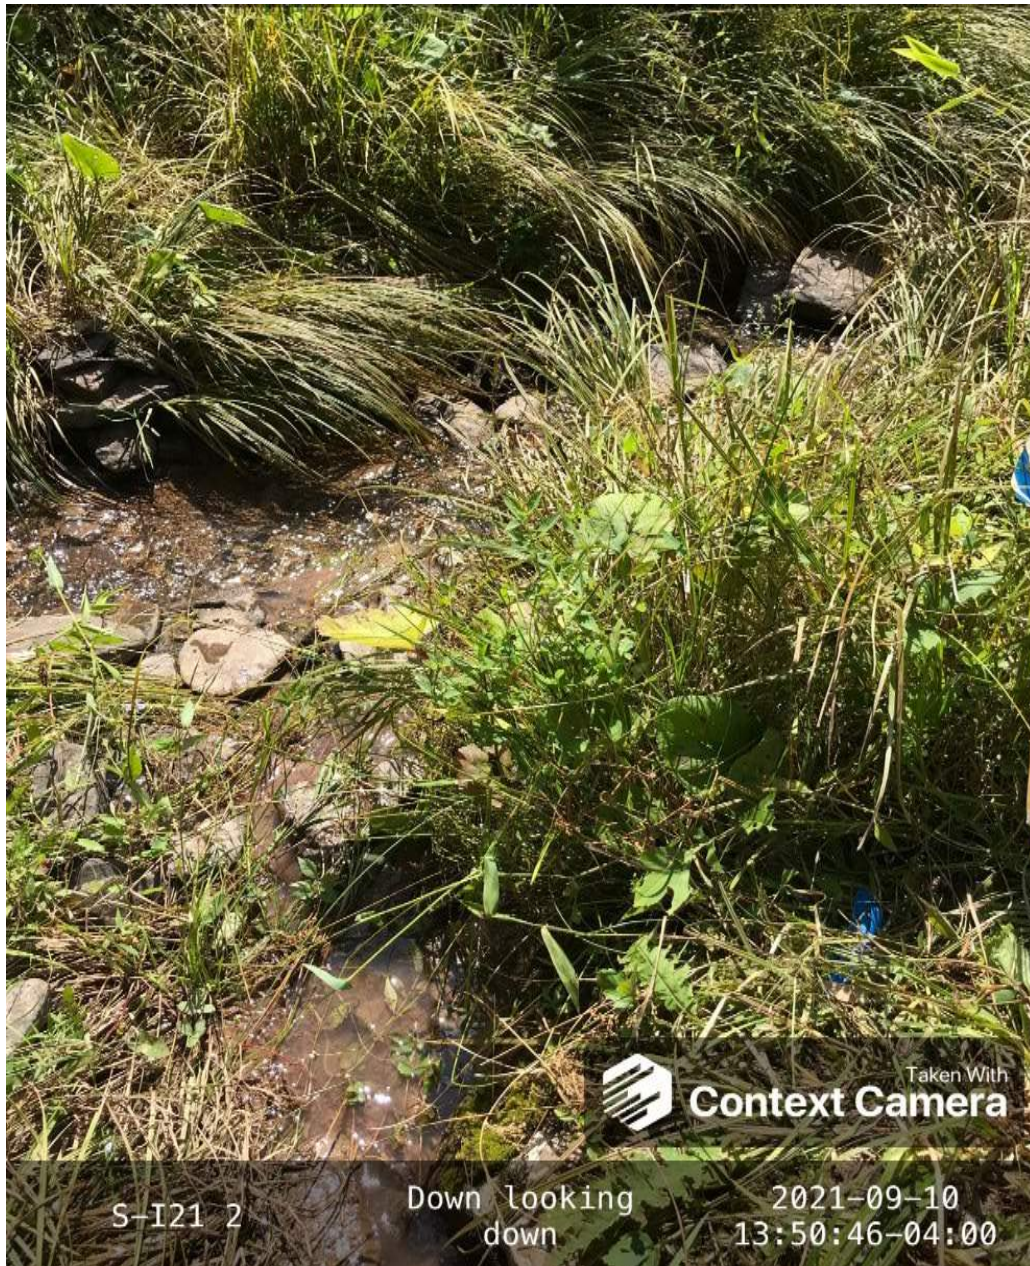
Photo Type: DS, DS View

Location, Orientation, Photographer Initials: Downstream Edge of ROW, Downstream View, MD
Lat: 37.918164 Long: -80.736852

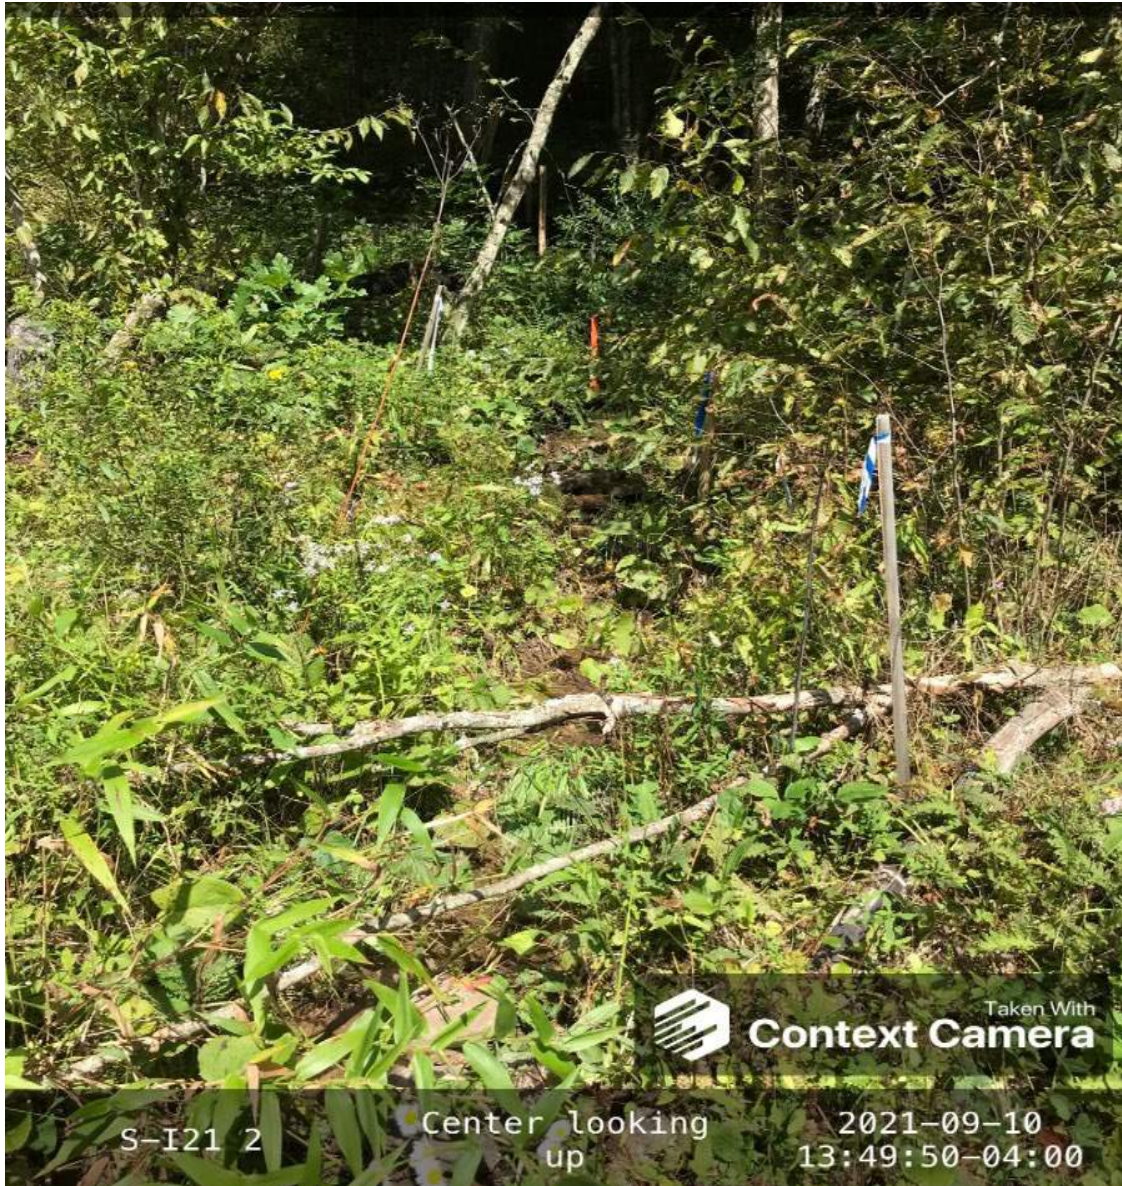
Photo Type: US View at Center
Location, Orientation, Photographer Initials: Center ROW, Upstream View, MD
Lat: 37.918164 Long: -80.736852

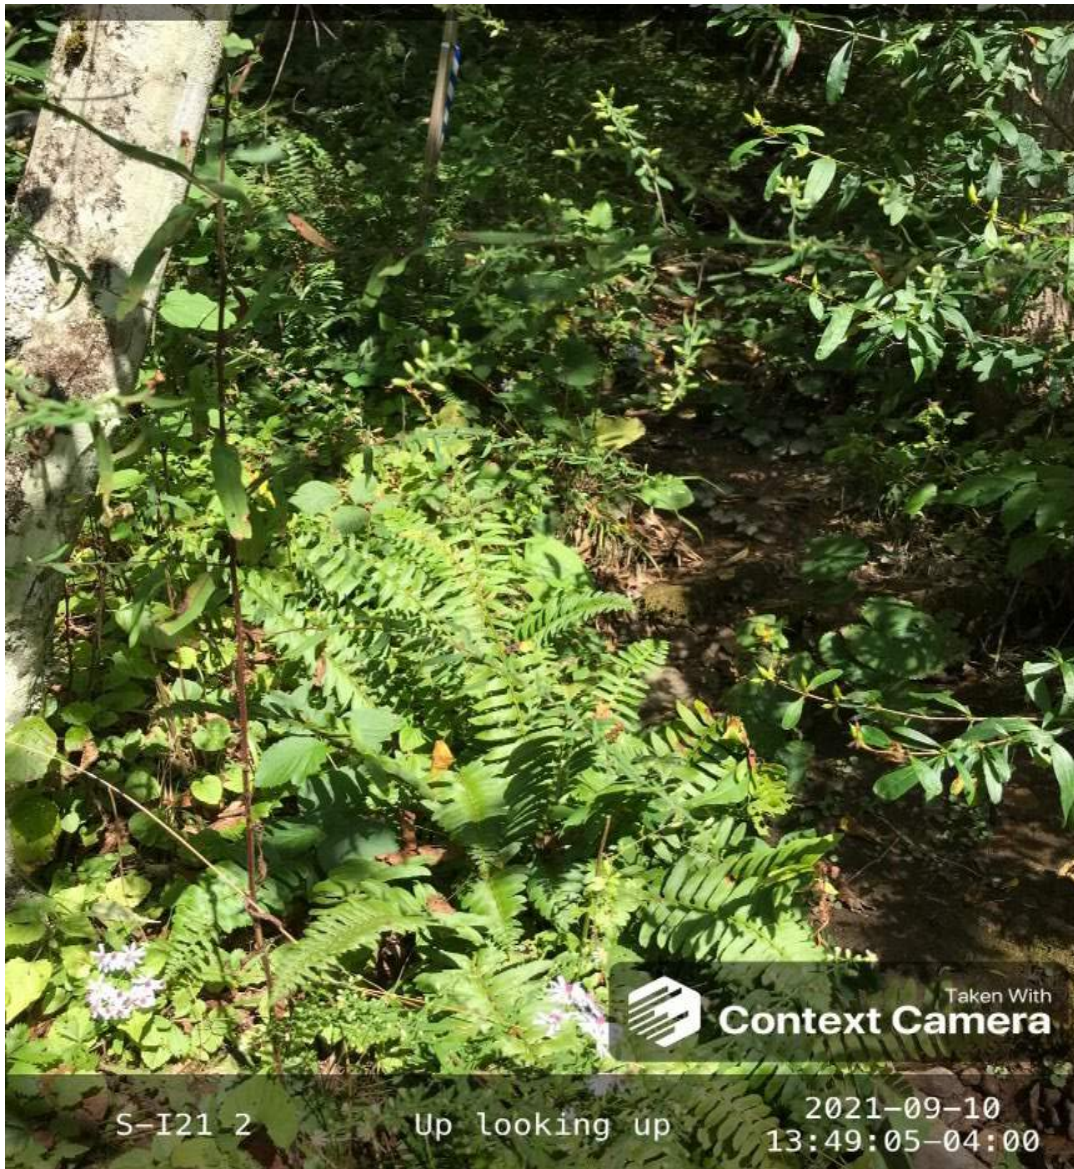
Photo Type: US, US View
Location, Orientation, Photographer Initials: Upstream Edge of ROW, Upstream View, MD
Lat: 37.918164 Long: -80.736852

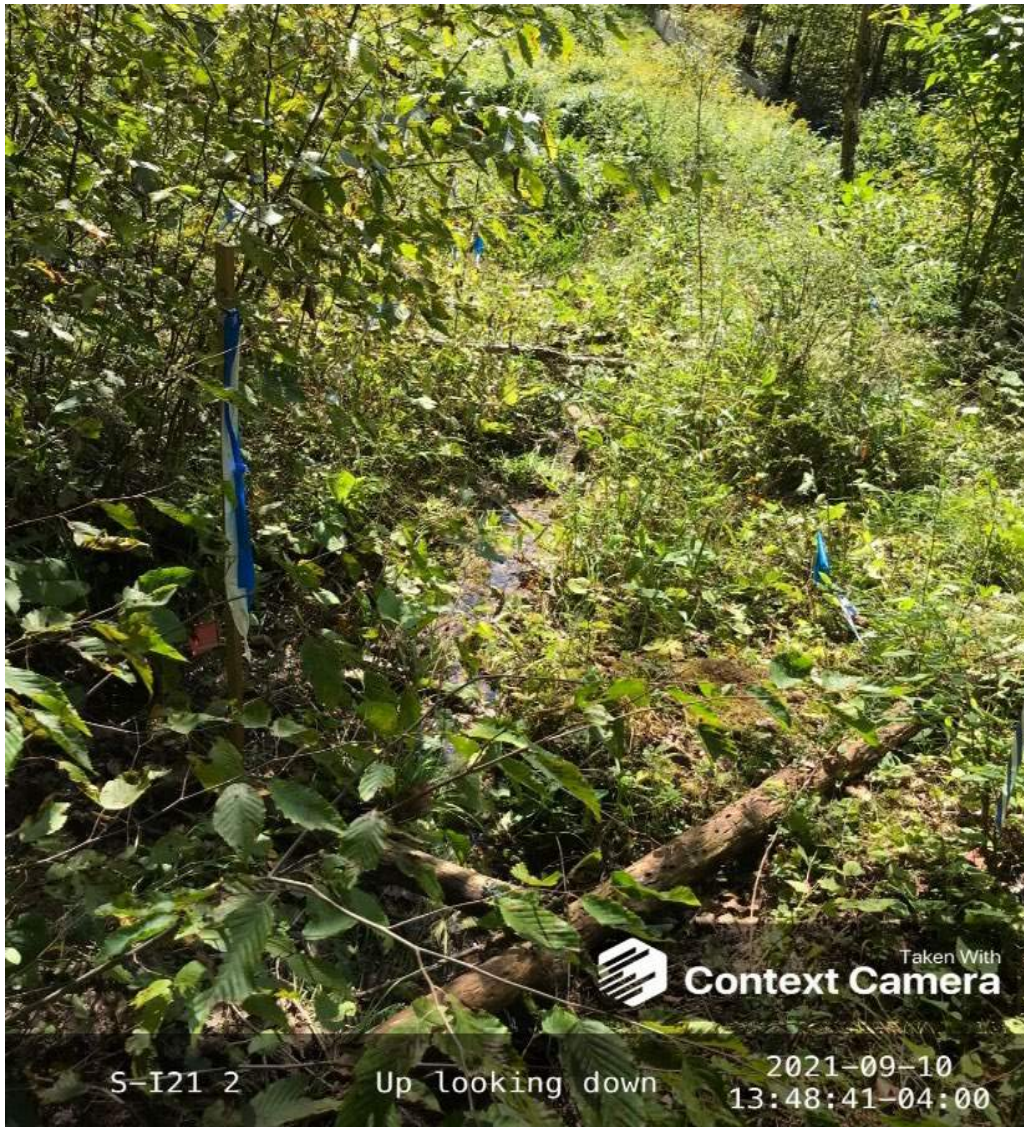
Photo Type: US, DS View

Location, Orientation, Photographer Initials: Upstream Edge of ROW, Downstream View, MD

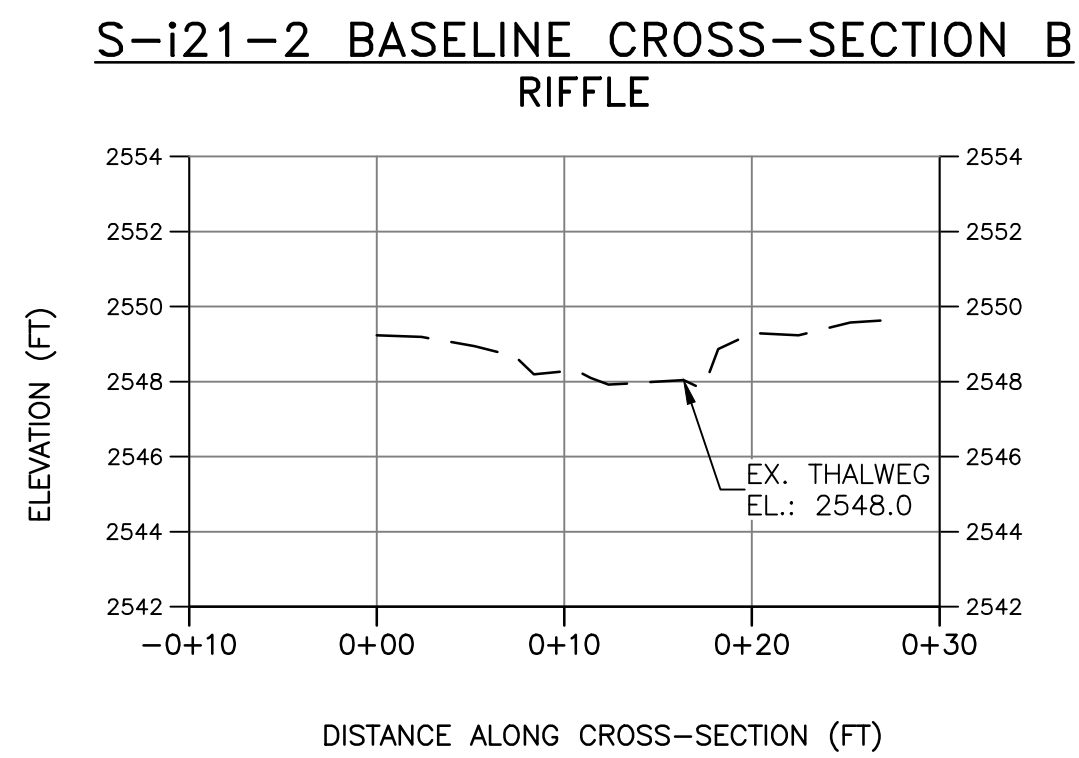
4. ALL SECTION VIEWS SHOWN LEFT TO RIGHT FACING DOWNSTREAM.
5. POST-CROSSING SURVEY INFORMATION SHOWN IN RED. DATA PENDING.
6. POST-CROSSING SURVEY POINTS FOR CROSS SECTIONS AND THALWEG ARE PROJECTED ONTO PRE-CROSSING SECTION AND PROFILE VIEWS FOR COMPARISON.

SCALE: H: 1"=10'
V: 1"=5'
