## **Baseline Assessment – Stream Attributes**

# Reach S-I21 (1) (Pipeline ROW) Perennial Spread E Greenbrier County, West Virginia

Spread E Stream S-I21(1) (Pipeline ROW) Greenbrier County

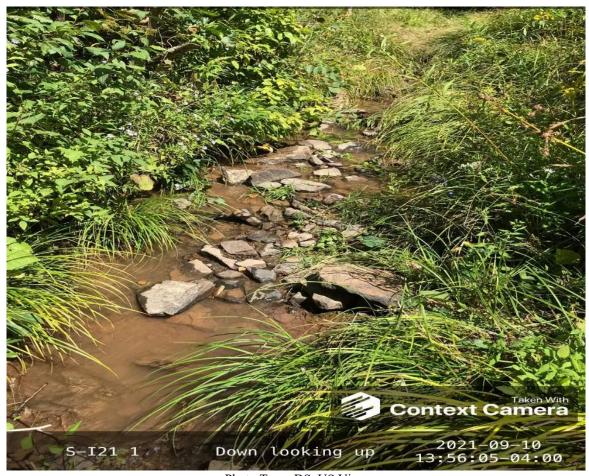
Photo Type: DS, US View Location, Orientation, Photographer Initials: Downstream Edge of ROW, Upstream View, MD Lat: 37.918228 Long: -80.736774

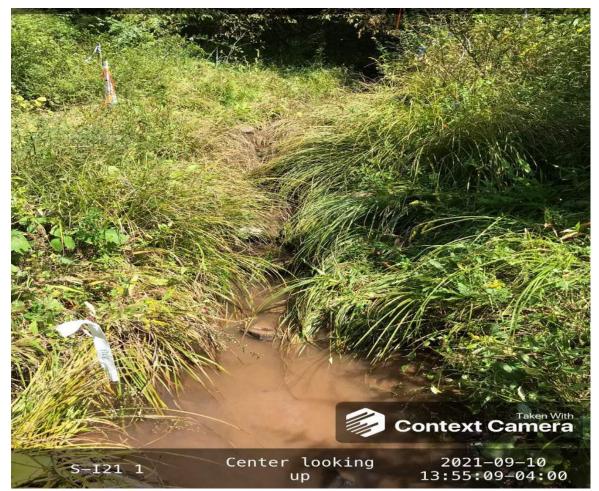
Photo Type: US View at Center Location, Orientation, Photographer Initials: Center ROW, Upstream View, MD Lat: 37.918228 Long: -80.736774

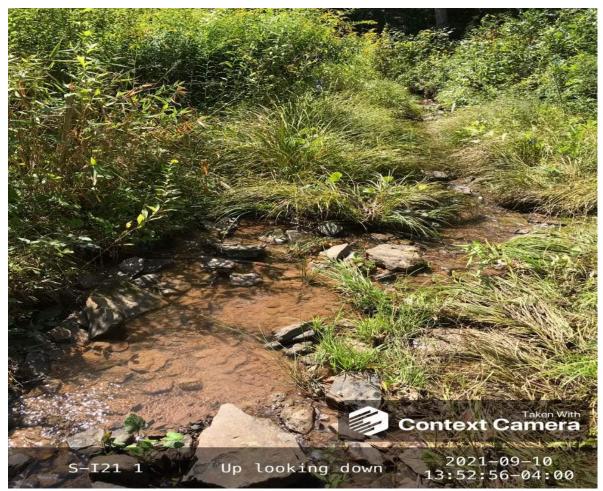
Photo Type: US, DS View Location, Orientation, Photographer Initials: Upstream Edge of ROW, Downstream View, MD Lat: 37.918228 Long: -80.736774

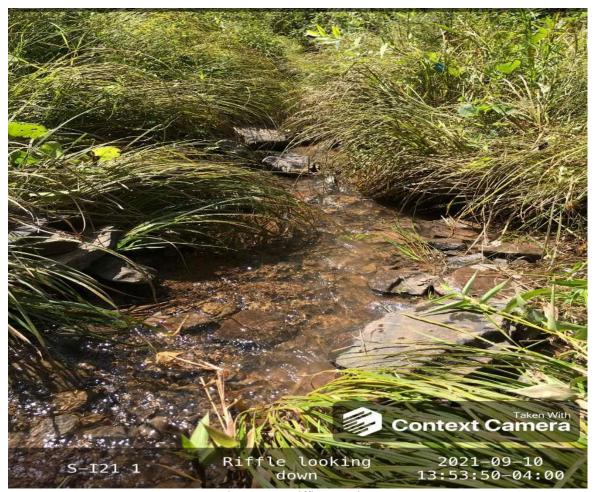
Photo Type: Riffle, DS View Location, Orientation, Photographer Initials: Upstream of Riffle, Downstream View, MD Lat: 37.918228 Long: -80.736774

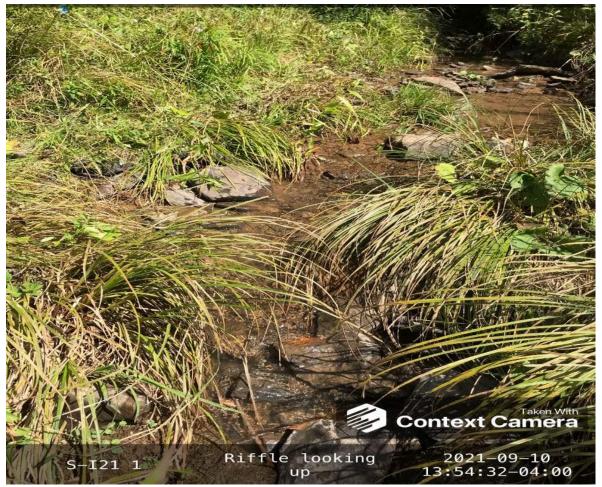
Photo Type: Riffle, US View Location, Orientation, Photographer Initials: Downstream of Riffle, Upstream View, MD Lat: 37.918228 Long: -80.736774

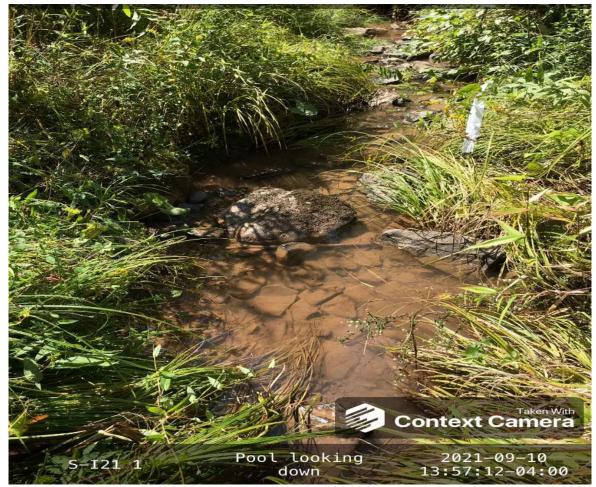
Photo Type: Pool, DS View Location, Orientation, Photographer Initials: Upstream of Pool, Downstream View, MD Lat: 37.918228 Long: -80.736774

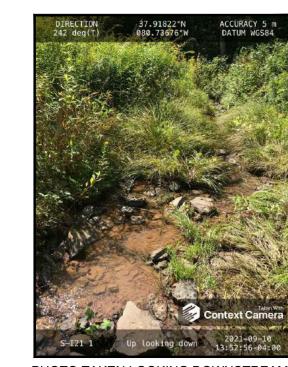
PHOTO TAKEN LOOKING DOWNSTREAM FROM UPSTREAM IMPACT LIMITS

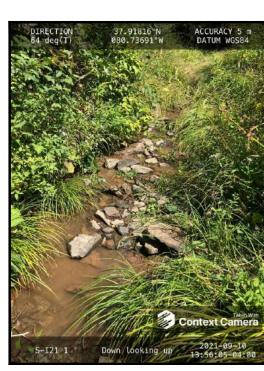
PHOTO TAKEN LOOKING UPSTREAM FROM DOWNSTREAM IMPACT LIMITS
