Baseline Assessment – Stream Attributes

Reach S-I43 (Timber Mat Crossing) Intermittent Spread D Nicholas County, West Virginia

Spread D Stream S-I43 (Timber Mat Crossing) Nicholas County

FILE AND CROSS-SECTIONS
BASELINE SURVEY
G S-I43 - UNNAMED TRIB.
BIG RUN (MP 117.28)
NICHOLAS COUNTY, WV

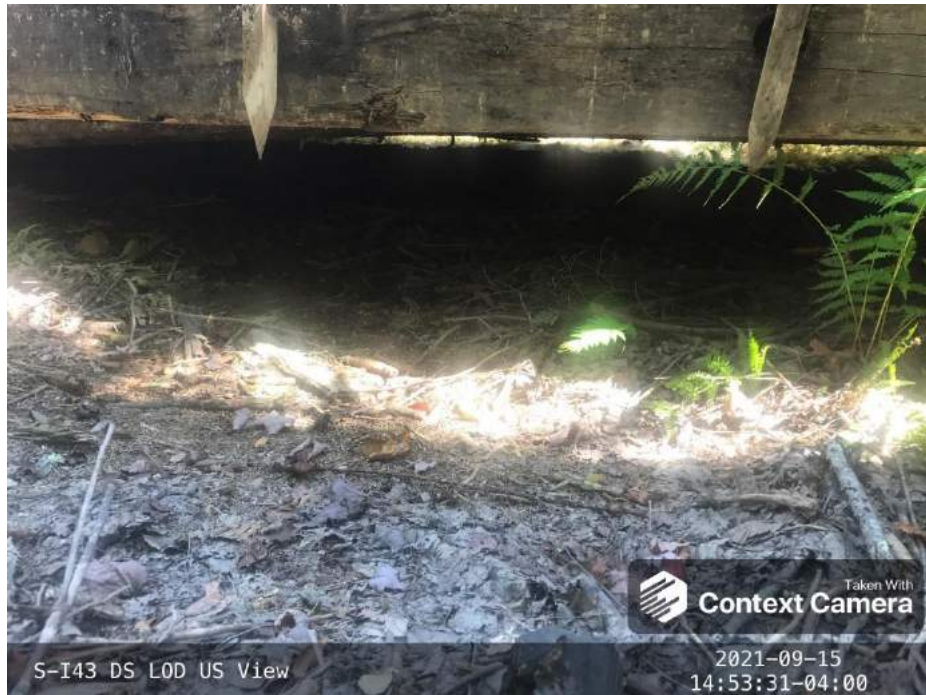
S-I43 DS LOD US View

Photo Type: DS, US View

Location, Orientation, Photographer Initials: Downstream Edge of ROW, Upstream View, AJE/MAG
Lat: 38.293473 Long: -80.677158

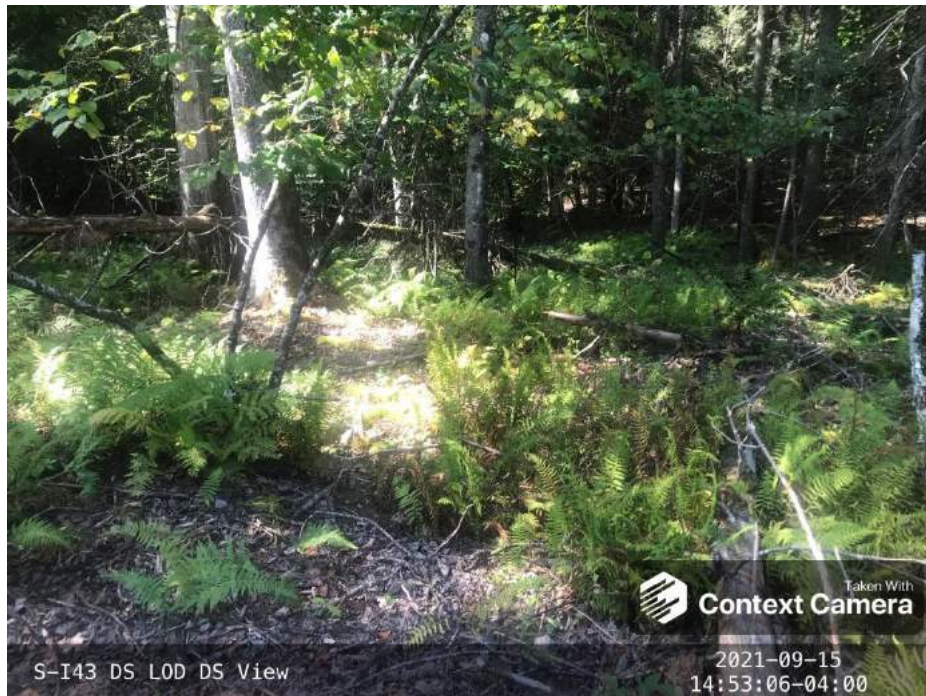
S-I43 DS LOD DS View

Photo Type: DS, DS View

Location, Orientation, Photographer Initials: Downstream Edge of ROW, Downstream View, AJE/MAG
Lat: 38.293473 Long: -80.677158

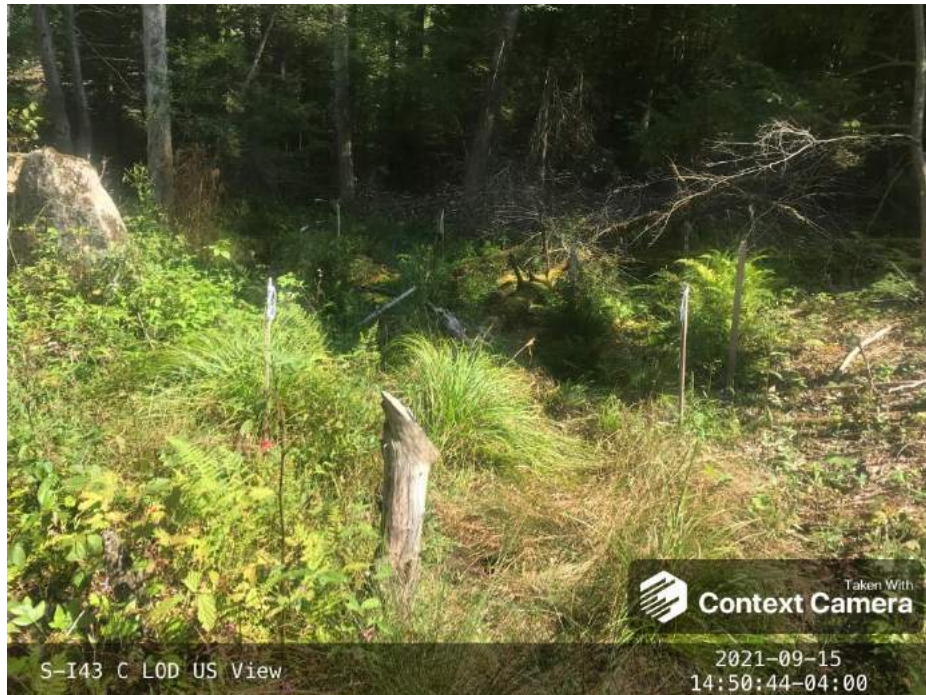
Photo Type: US View at Center
Location, Orientation, Photographer Initials: Center ROW, Upstream View, AJE/MAG
Lat: 38.293473 Long: -80.677158

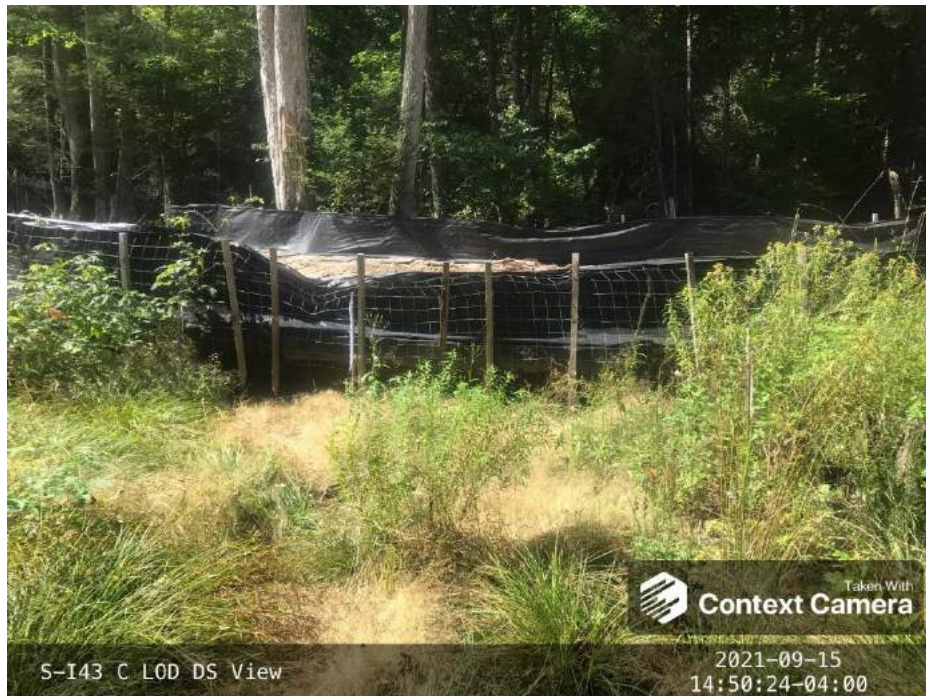
Photo Type: DS View at Center
Location, Orientation, Photographer Initials: ROW Center, Downstream View, AJE/MAG
Lat: 38.293473 Long: -80.677158

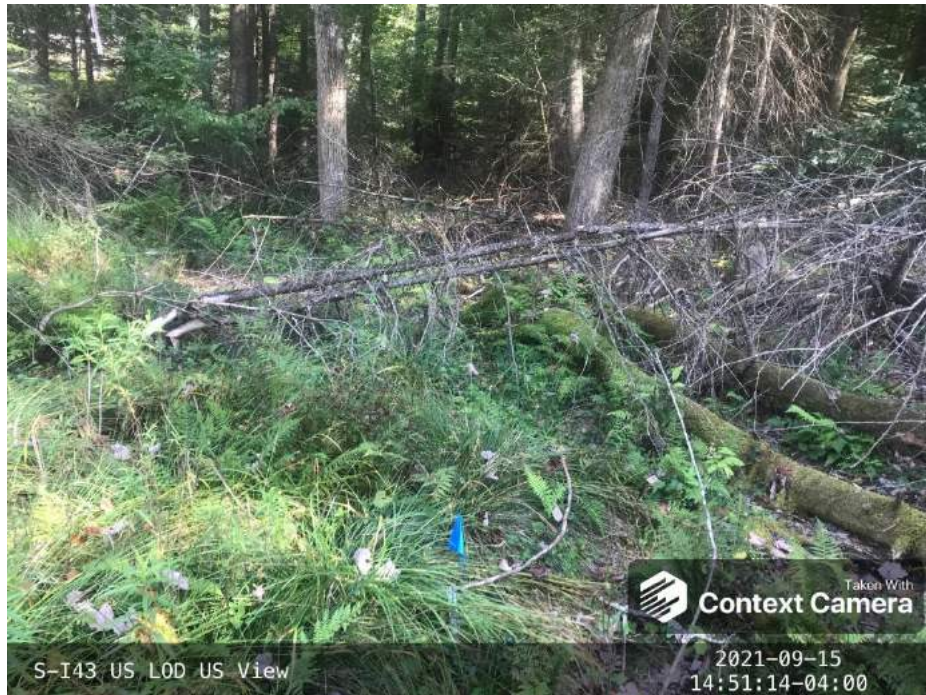
Photo Type: US, US View

Location, Orientation, Photographer Initials: Upstream Edge of ROW, Upstream View, AJE/MAG
Lat: 38.293473 Long: -80.677158

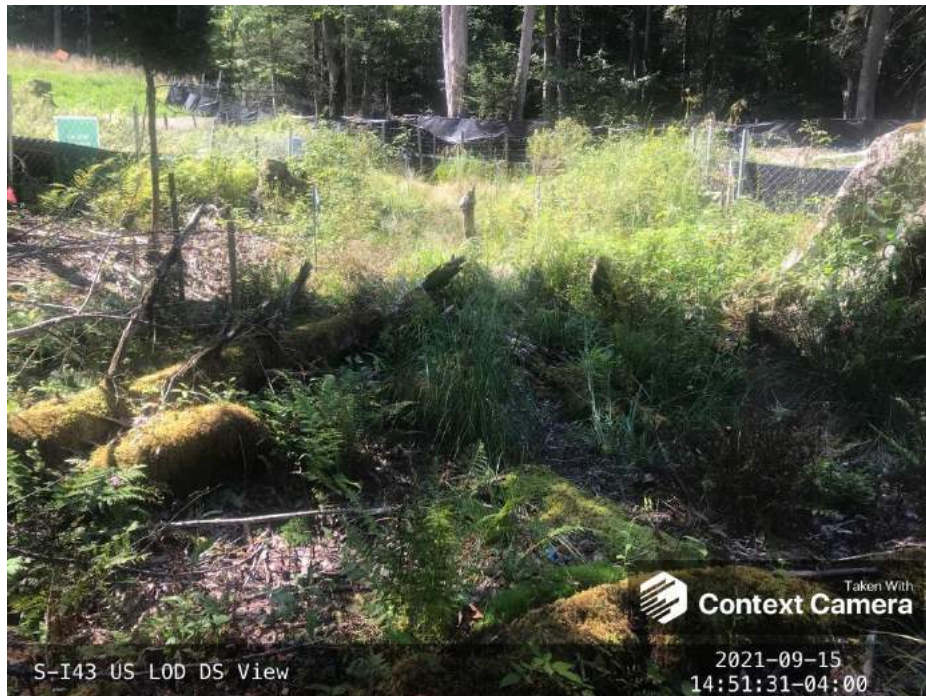
Photo Type: US, DS View

Location, Orientation, Photographer Initials: Upstream Edge of ROW, Downstream View, AJE/MAG
Lat: 38.293473 Long: -80.677158
