Baseline Assessment – Stream Attributes

Reach S-I44 (Timber Mat Crossing) Perennial Spread D Nicholas County, West Virginia

FILE AND CROSS-SECTIONS
BASELINE SURVEY
CROSSING S-144 - BIG RUN
(MP 117.47)
NICHOLAS COUNTY WV

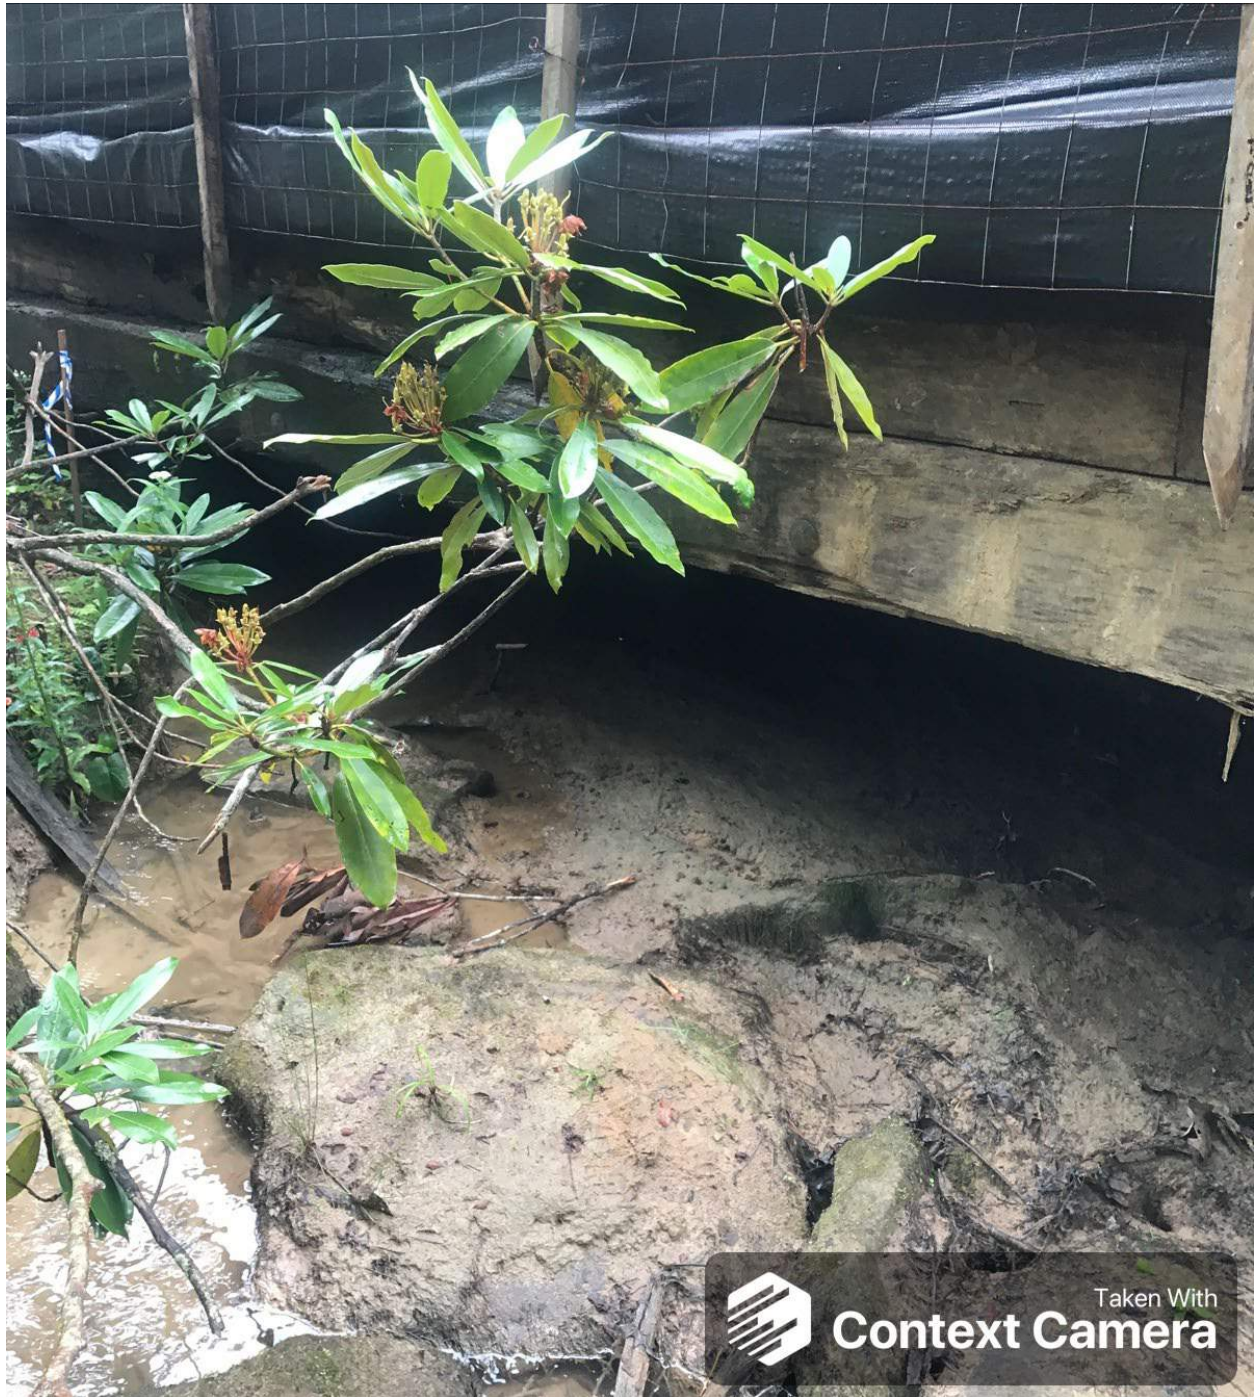
Spread D Stream S-I44 (Timber Mat Crossing) Nicholas County

Photo Type: DS, US View
Location, Orientation, Photographer Initials: Downstream Edge of ROW, Upstream View, JM/SM
Lat: 38.291332 Long: -80.679265

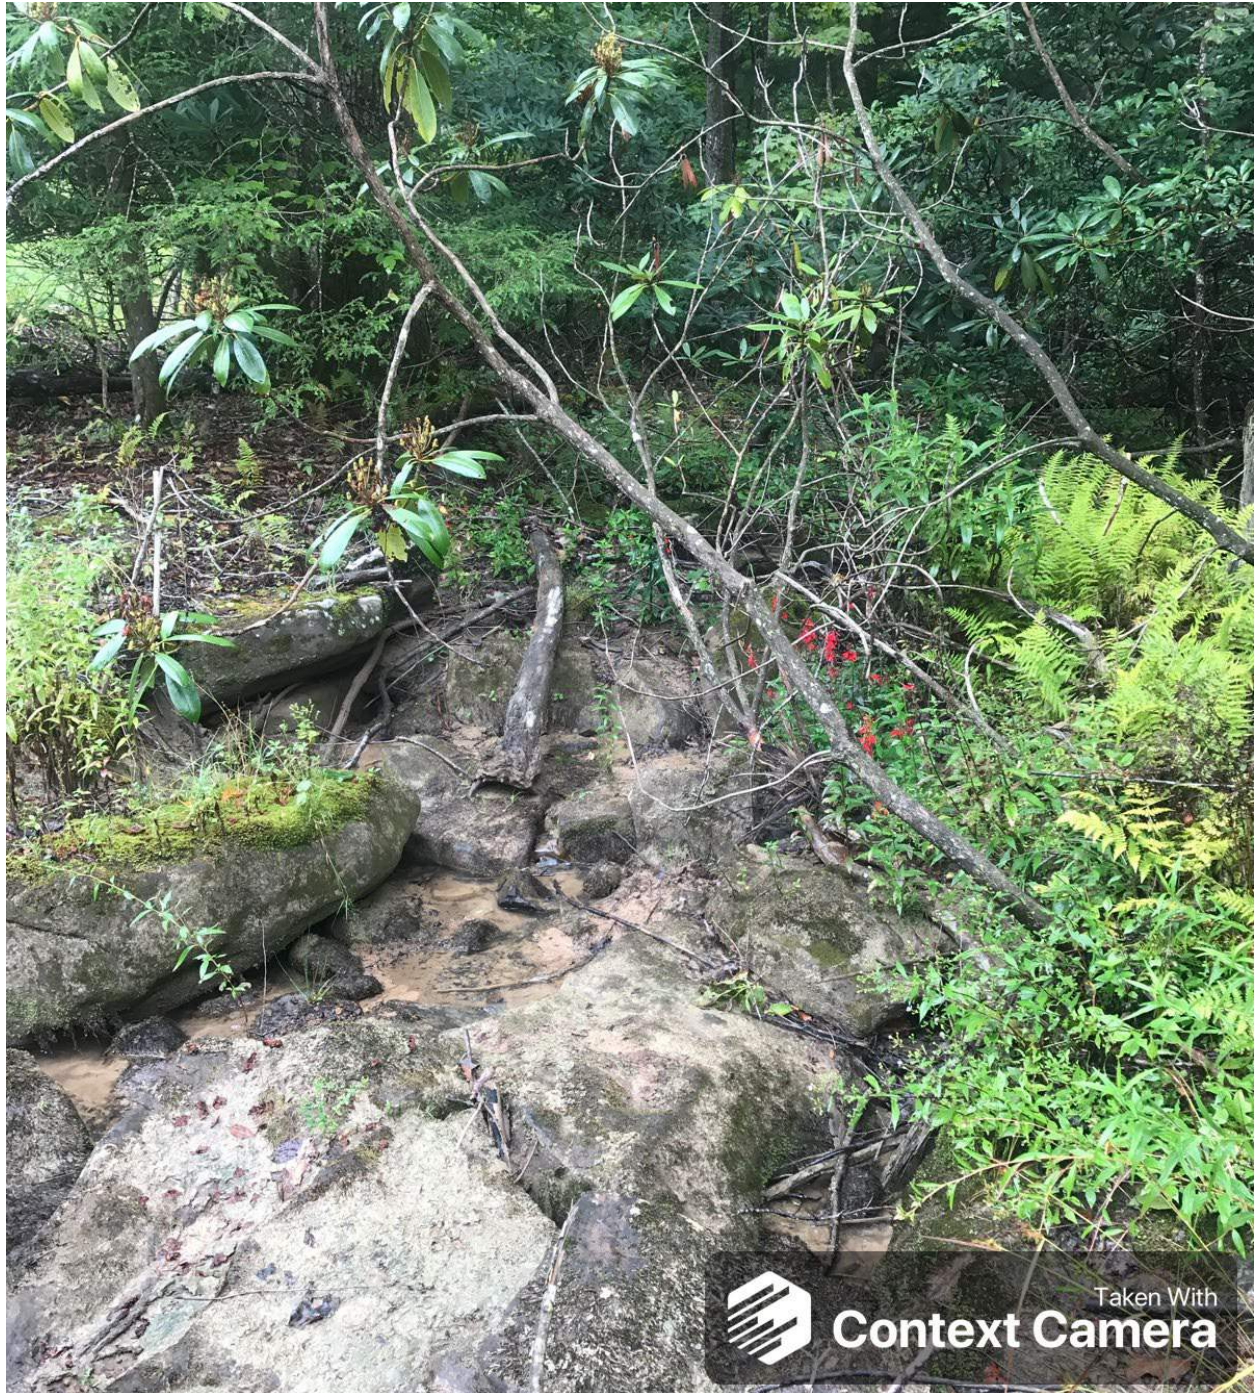
Spread D Stream S-I44 (Timber Mat Crossing) Nicholas County

Photo Type: DS, DS View

Location, Orientation, Photographer Initials: Downstream Edge of ROW, Downstream View, JM/SM

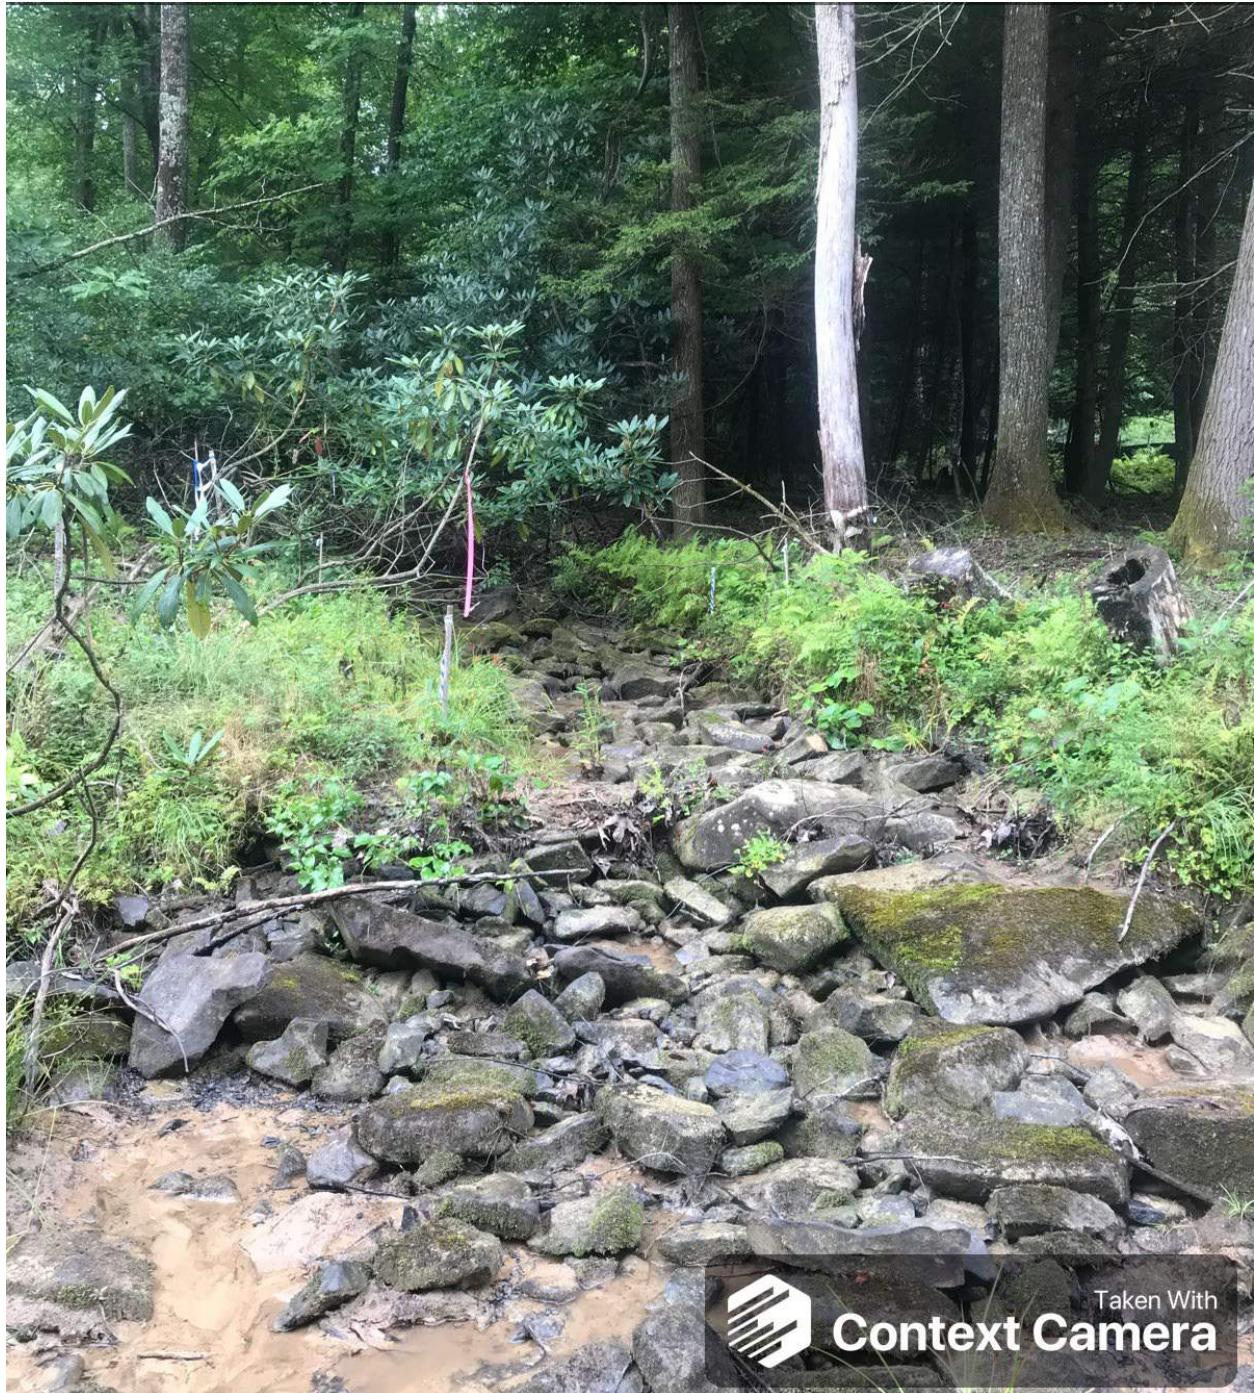
Spread D Stream S-I44 (Timber Mat Crossing) Nicholas County

Photo Type: US View at Center
Location, Orientation, Photographer Initials: Center ROW, Upstream View, JM/SM
Lat: 38.291332 Long: -80.679265

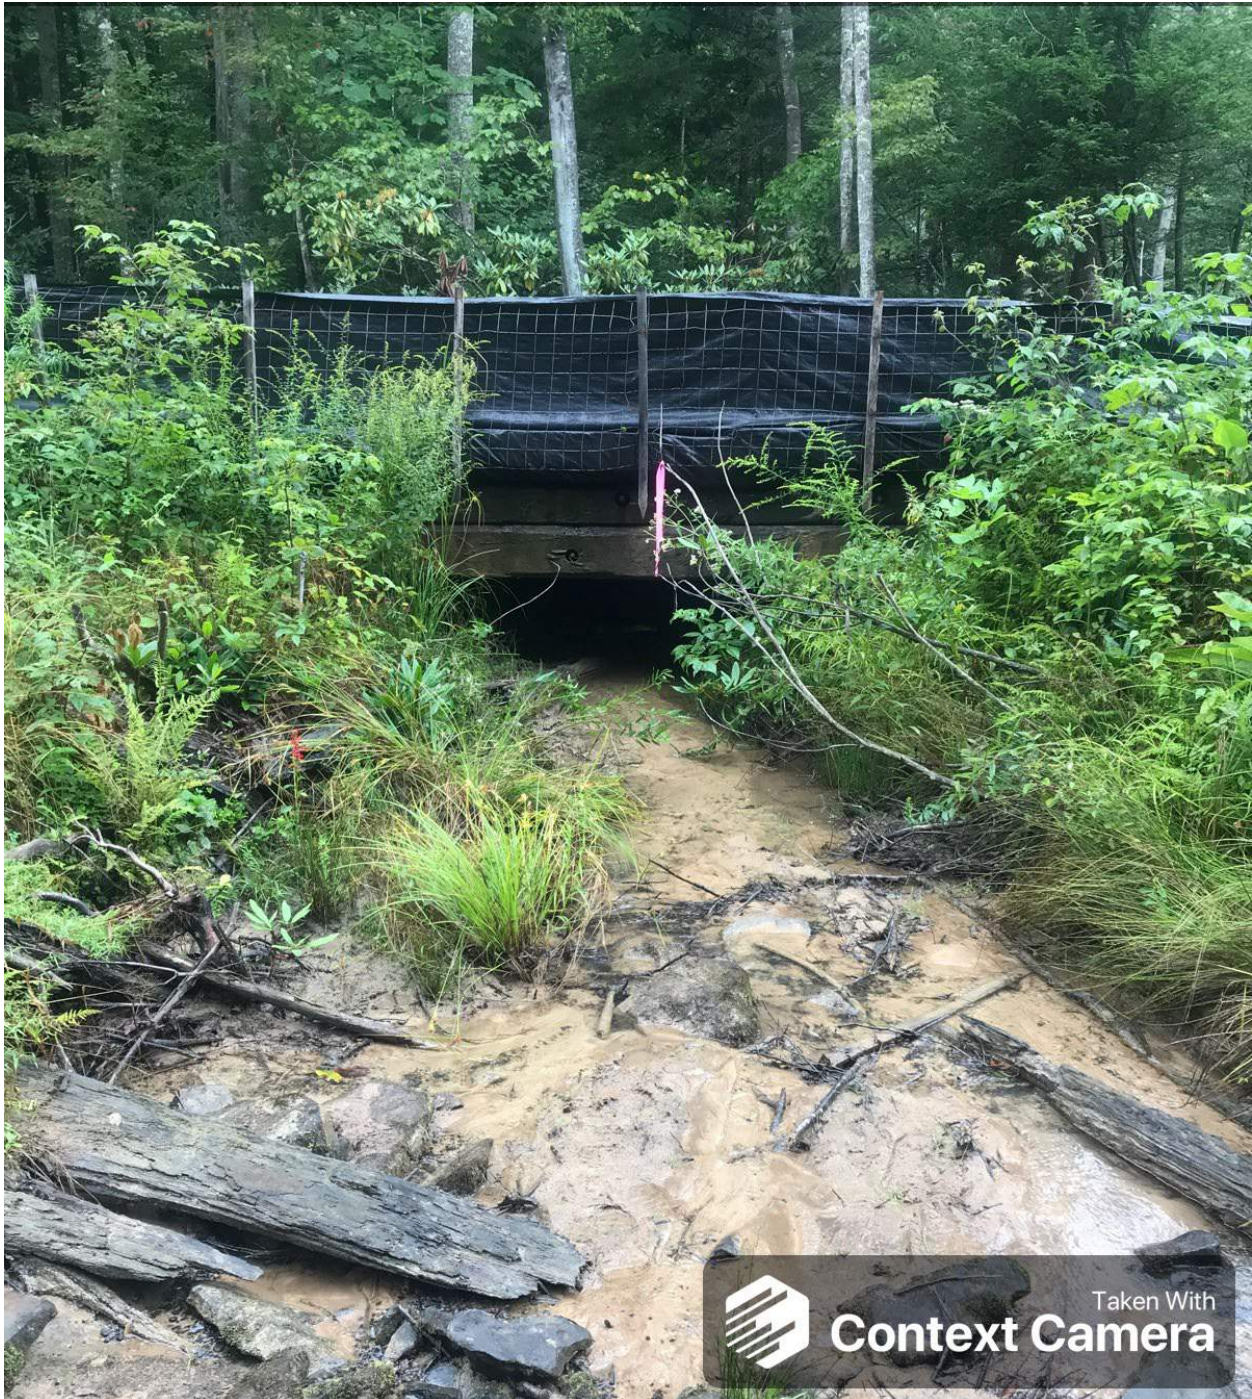
Spread D Stream S-I44 (Timber Mat Crossing) Nicholas County

Photo Type: DS View at Center
Location, Orientation, Photographer Initials: Center ROW, Downstream View, JM/SM
Lat: 38.291332 Long: -80.679265

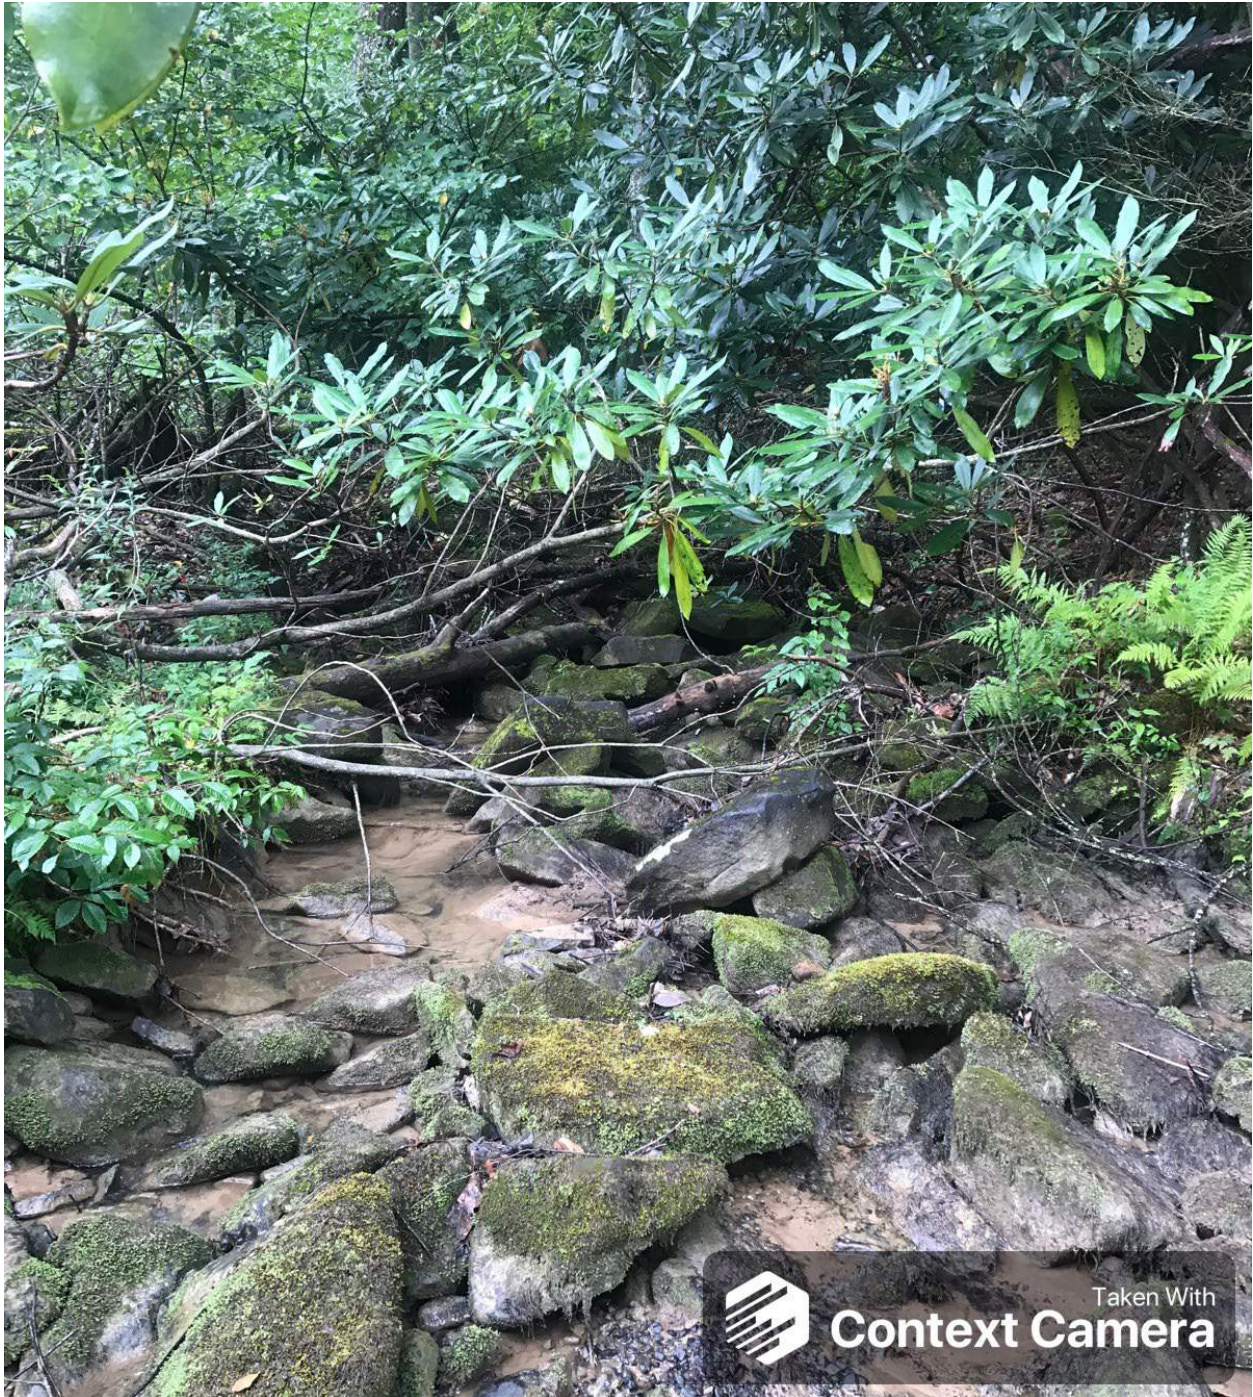
Spread D Stream S-I44 (Timber Mat Crossing) Nicholas County

Photo Type: US, US View
Location, Orientation, Photographer Initials: Upstream Edge of ROW, Upstream View, JM/SM
Lat: 38.291332 Long: -80.679265

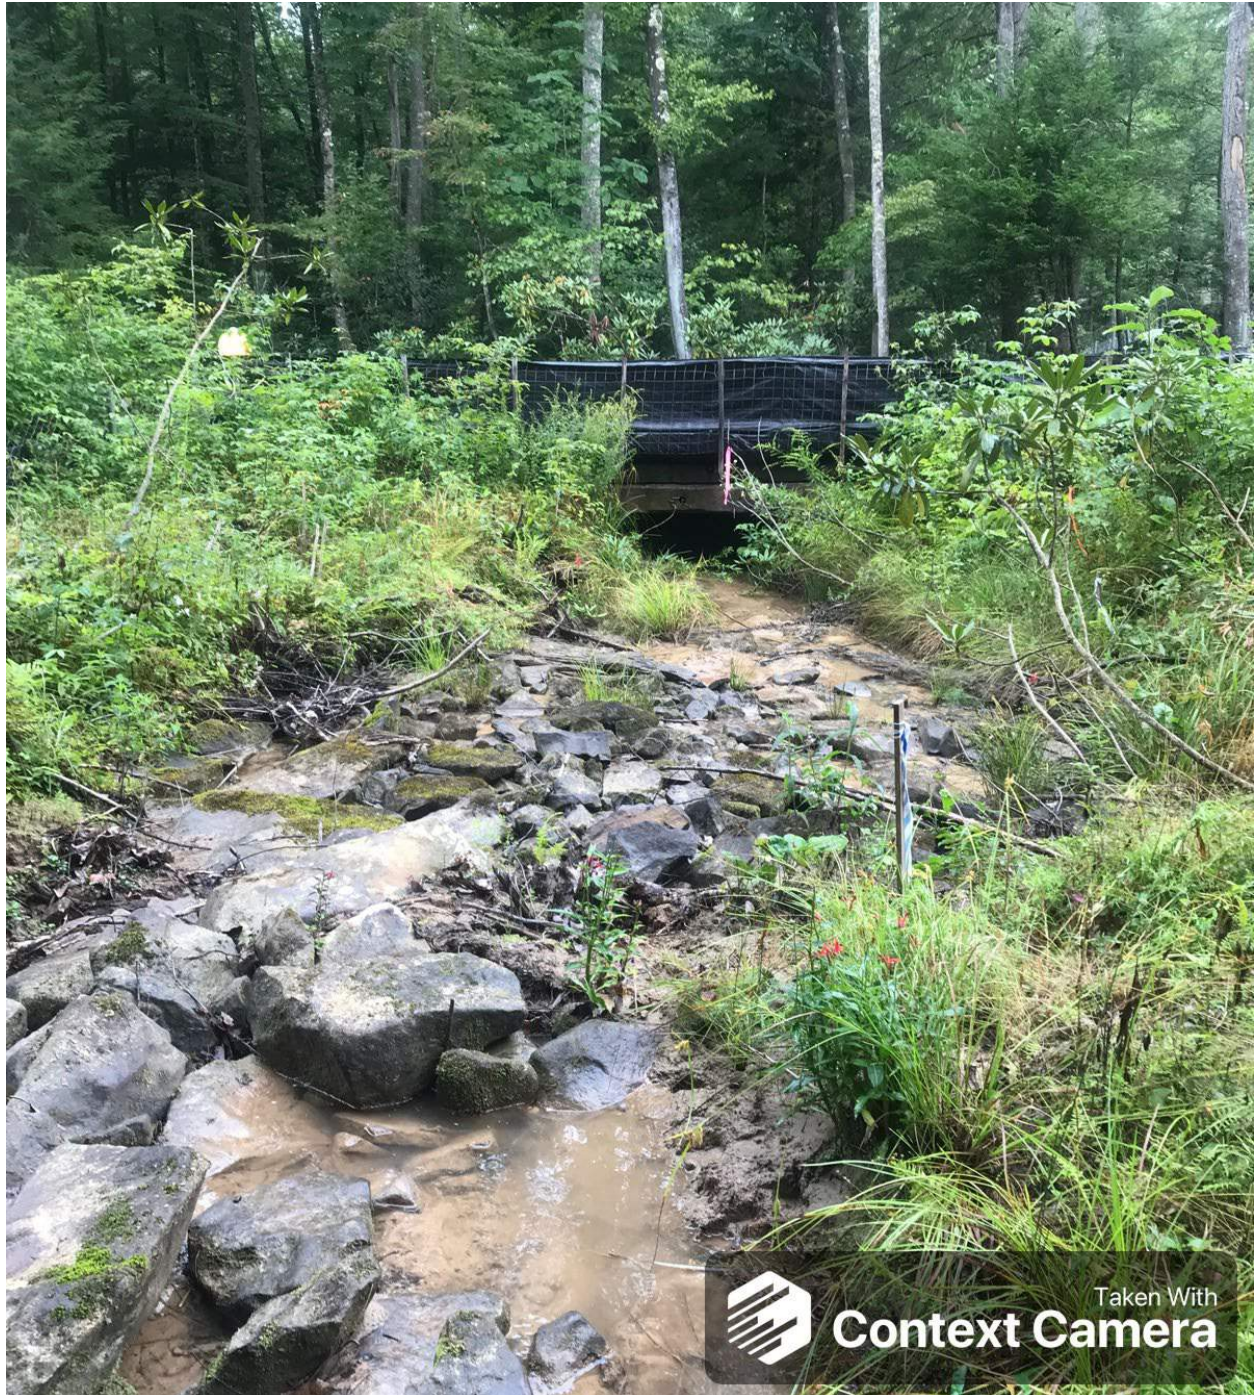
Spread D Stream S-I44 (Timber Mat Crossing) Nicholas County

Photo Type: US, DS View
Location, Orientation, Photographer Initials: Upstream Edge of ROW, Downstream View, JM/SM
Lat: 38.291332 Long: -80.679265

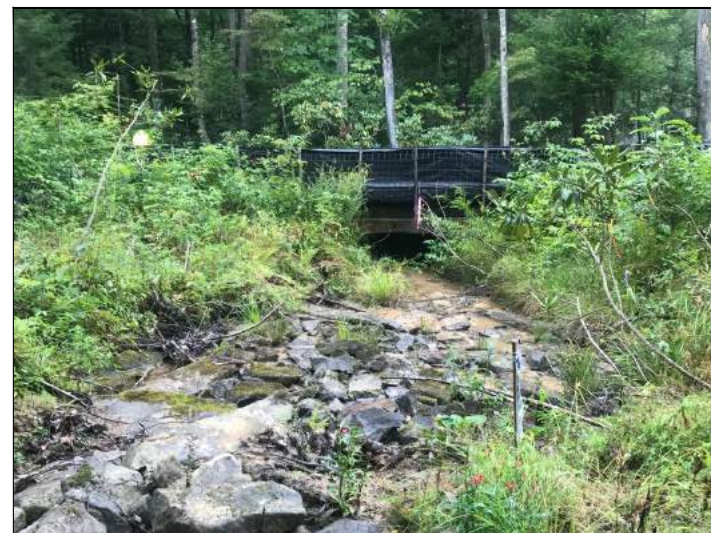
PHOTO TAKEN LOOKING DOWNSTREAM
FROM UPSTREAM IMPACT LIMITS

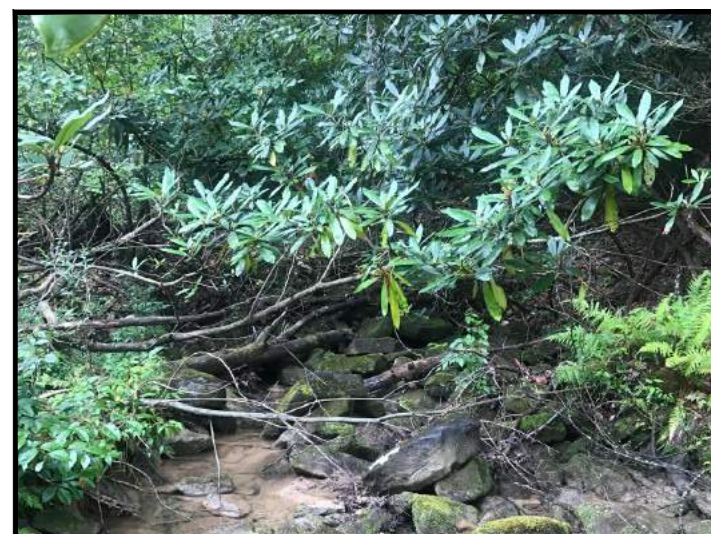
PHOTO TAKEN LOOKING UPSTREAM FROM
DOWNSTREAM IMPACT LIMITS

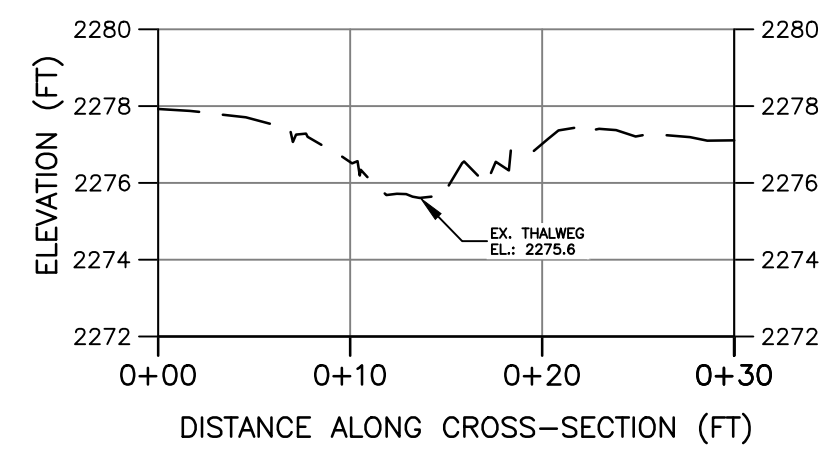
Figure 10 is a cross-section profile of a road. The vertical axis is labeled "ELEVATION (FT)" and ranges from 2270 to 2278 in increments of 2. The horizontal axis is labeled "DISTANCE ALONG CROSS-SECTION (FT)" and has markers at 0+00, 0+10, 0+20, and 0+30. The profile shows a road surface with a dip. A callout points to a specific location with the text "EX. THALWEG" and "EL.: 2273.6".

SCALE: H: 1"=10'
V: 1"=5'
