Baseline Assessment – Stream Attributes

Reach S-I47 (Pipeline ROW) Intermittent Spread D Nicholas County, West Virginia

Client: PROFILE AND CROSS-SECTIONS
BASELINE SURVEY
CROSSING S-147 - UNNAMED TRIB. TO
GAULEY RIVER (MP 118.1)
NICHOLAS COUNTY, WV

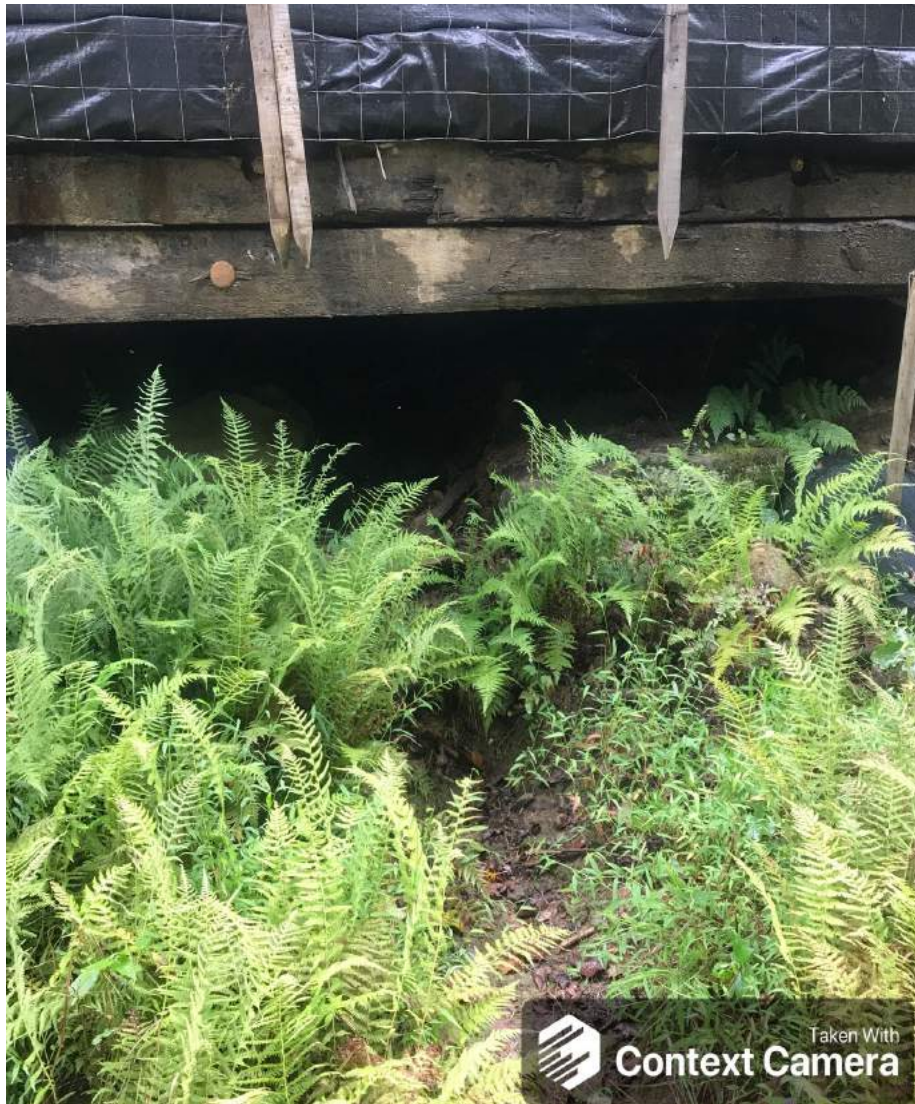
Photo Type: DS, US View

Location, Orientation, Photographer Initials: Downstream Edge of ROW, Upstream View, JM/SM
Lat: 38.284291 Long: -80.685885

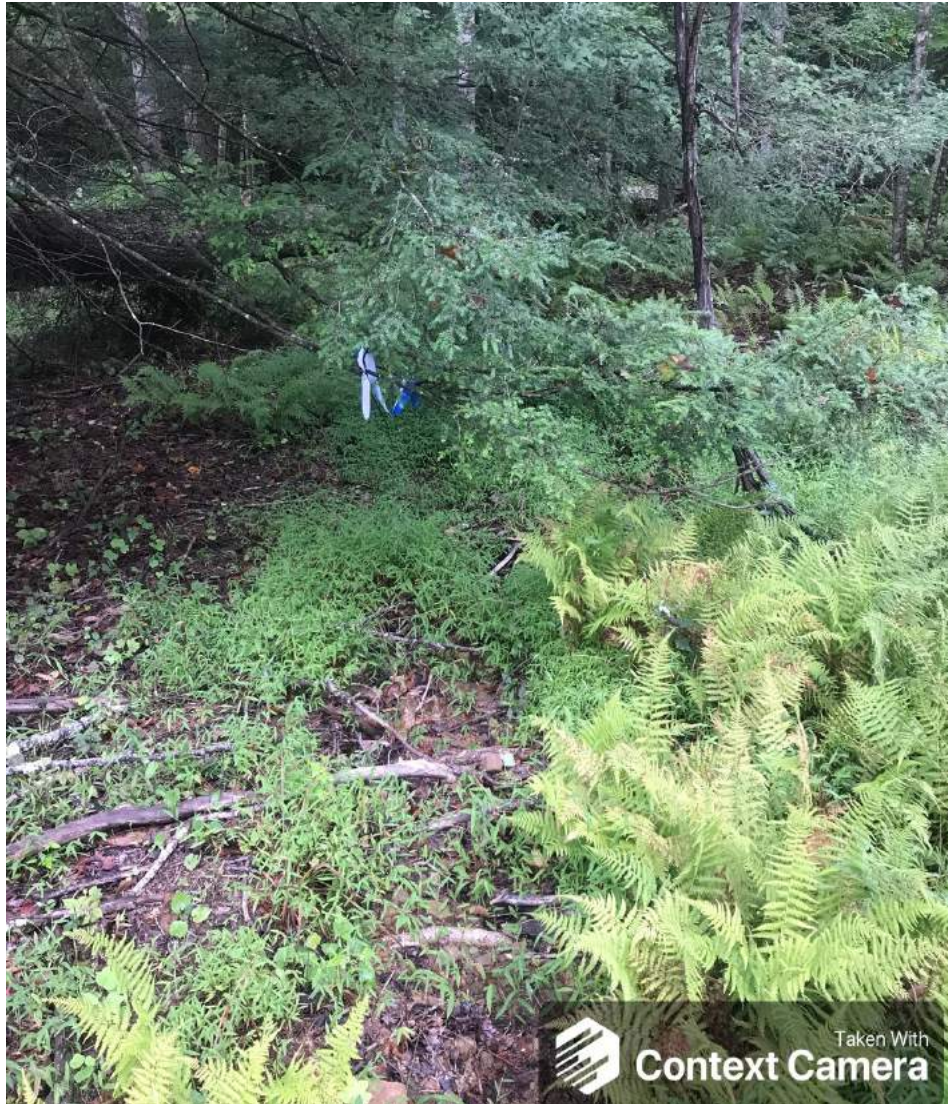
Photo Type: DS, DS View

Location, Orientation, Photographer Initials: Downstream Edge of ROW, Downstream View, JM/SM
Lat: 38.284291 Long: -80.685885

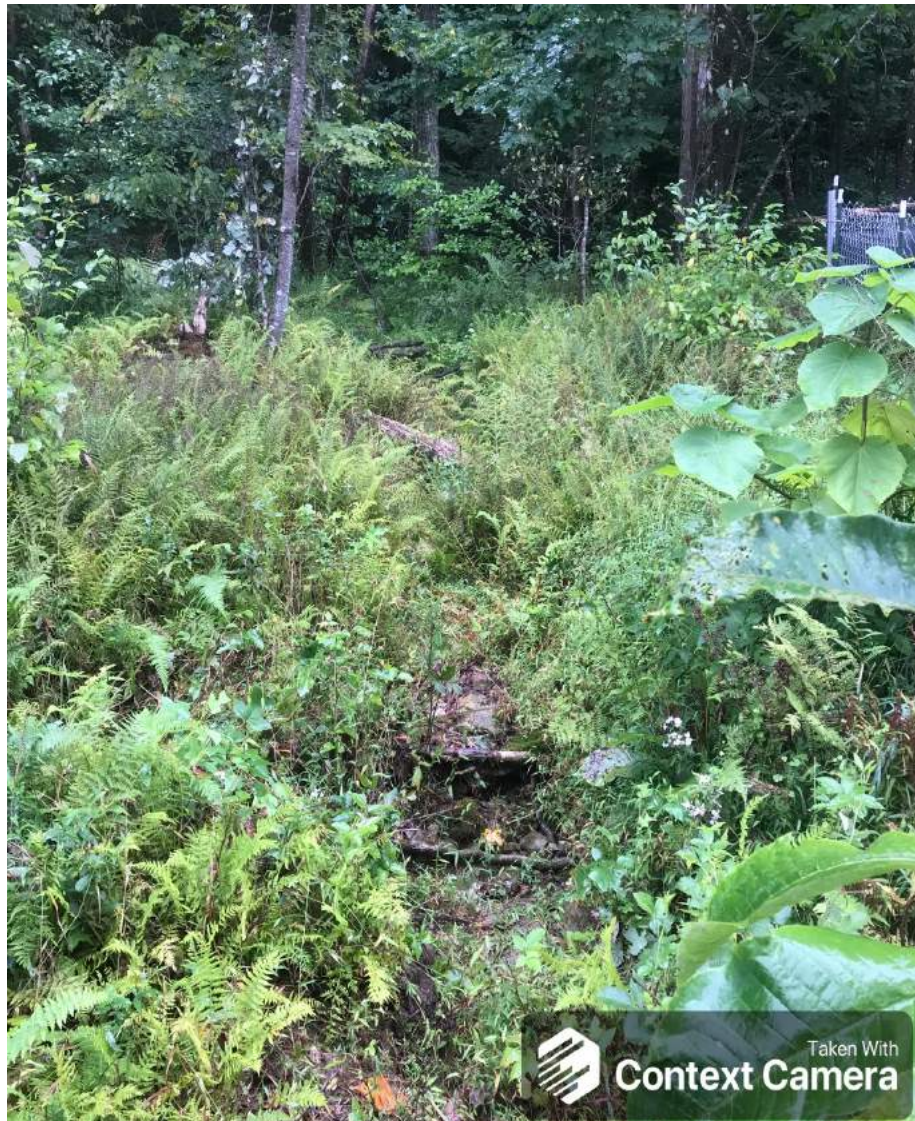
Photo Type: US View at Center
Location, Orientation, Photographer Initials: Center ROW, Upstream View, JM/SM
Lat: 38.284291 Long: -80.685885

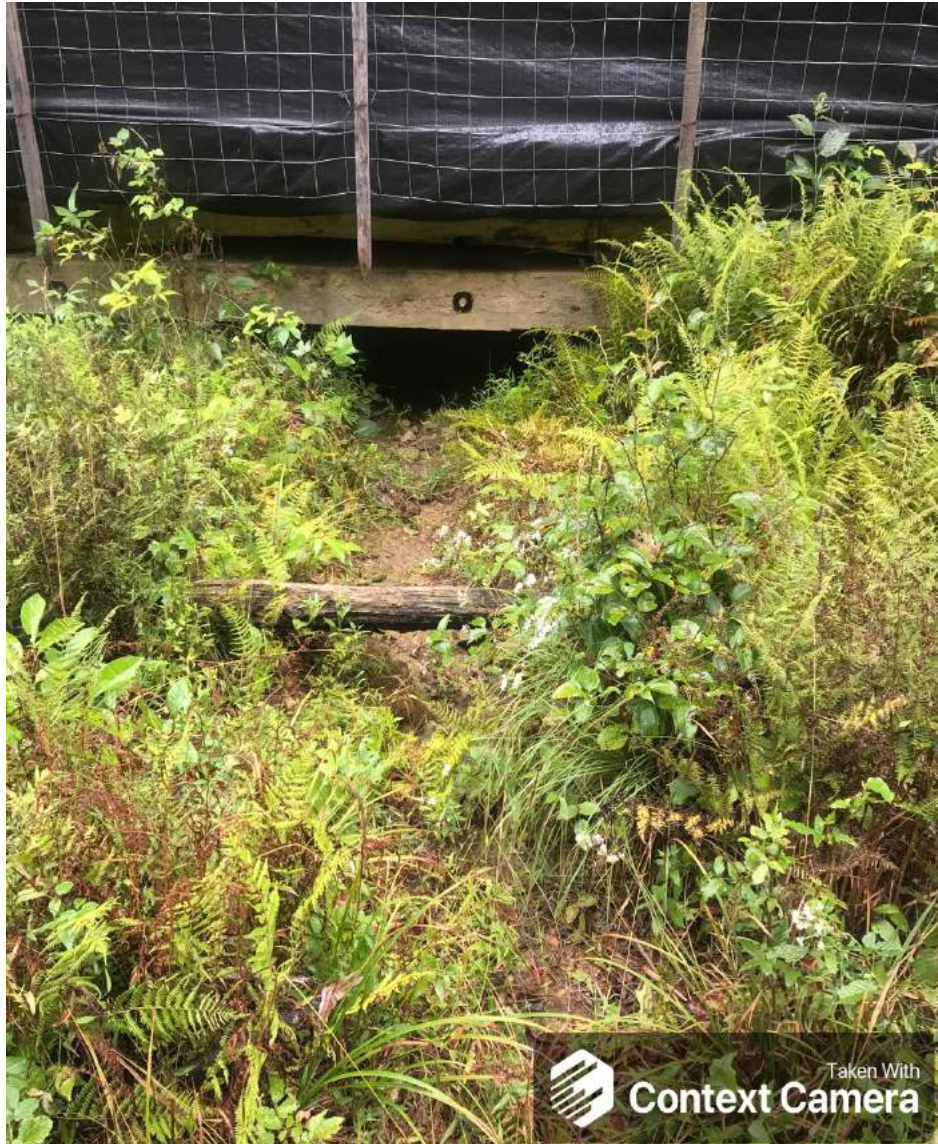
Photo Type: DS View at Center
Location, Orientation, Photographer Initials: ROW Center, Downstream View, JM/SM
Lat: 38.284291 Long: -80.685885

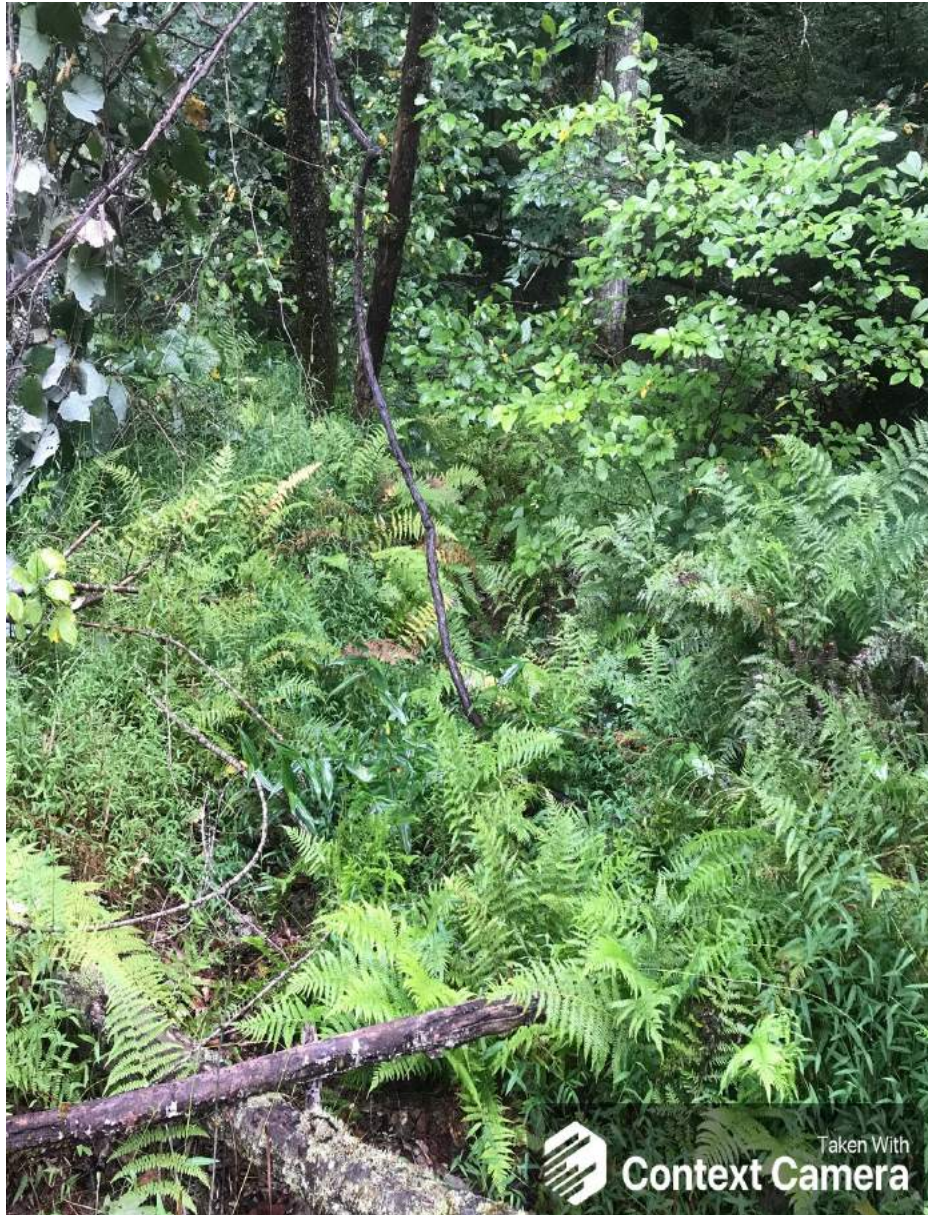
Photo Type: US, US View

Location, Orientation, Photographer Initials: Upstream Edge of ROW, Upstream View, JM/SM

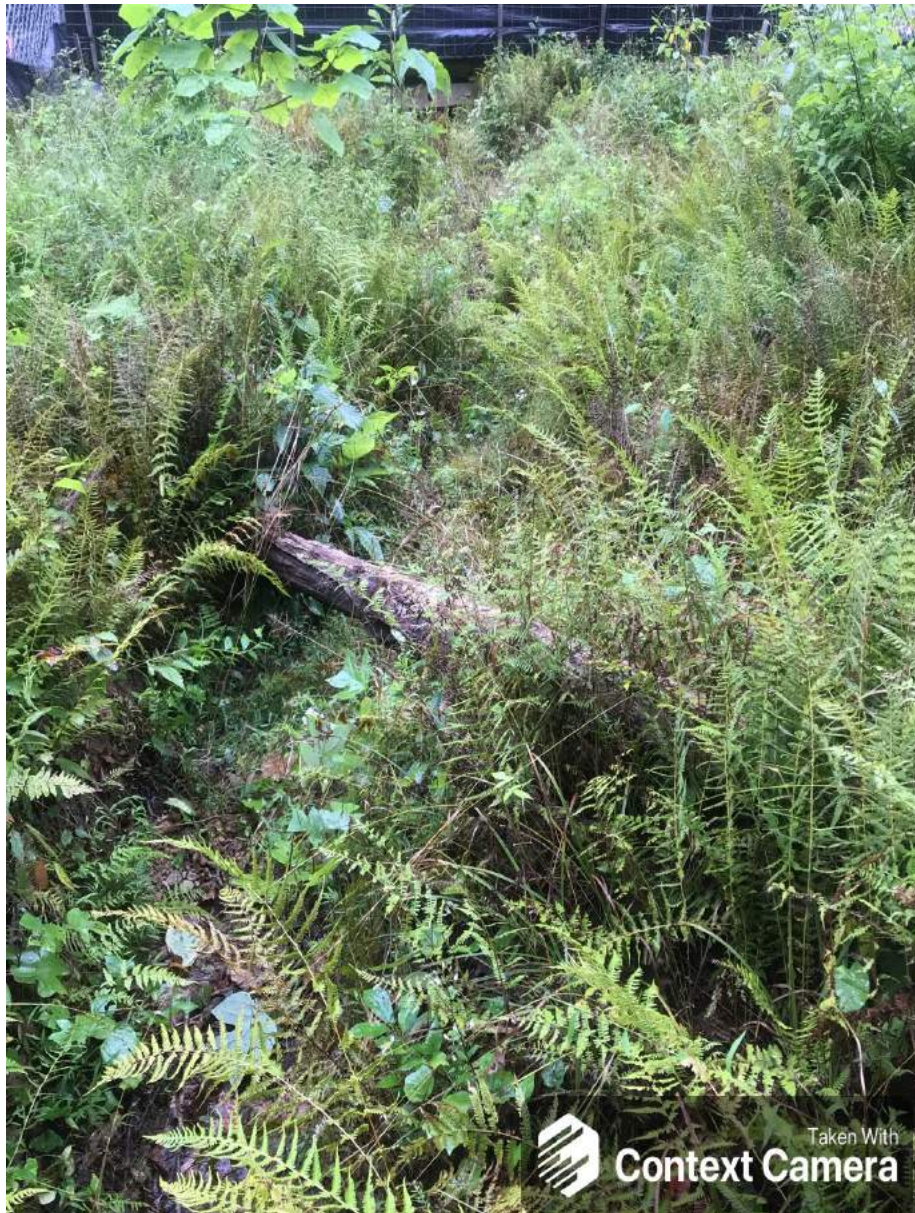
Photo Type: US, DS View
Location, Orientation, Photographer Initials: Upstream Edge of ROW, Downstream View, JM/SM
Lat: 38.284291 Long: -80.685885

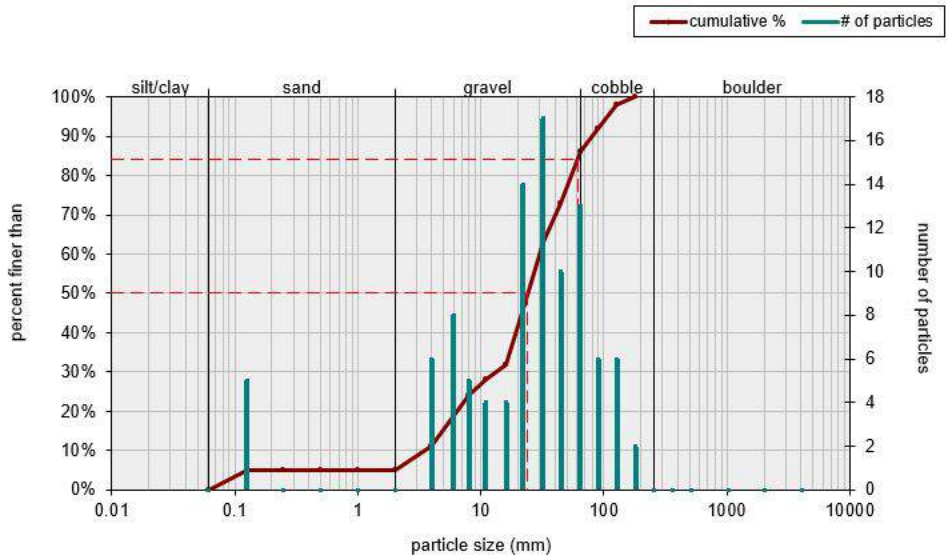
Bankfull Channel Pebble Count, S-I47

Size (mm)		Size Distribution		Type	
D16	5.2	mean	17.8	silt/clay	0%
D35	17	dispersion	3.6	sand	5%
D50	24	skewness	-0.13	gravel	81%
D65	34			cobble	14%
D84	61			boulder	0%
D95	110

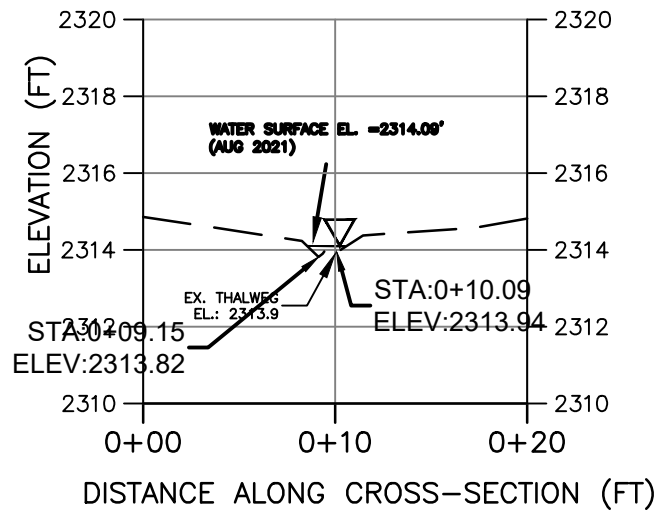
S-147 BASELINE CROSS-SECTION A
PIPE CENTERLINE

PT. LOC.	PRE-CROSSING			AS-BUILT	
	NORTHING	EASTING	ELEV.	VERT. DIFF.	HORZ. DIFF.
TS-L	13902217.07	1730546.41	2314.23		
BS-L	13902217.86	1730546.80	2313.82		
THW	13902218.61	1730547.19	2313.89		
BS-R	13902218.69	1730547.23	2313.94		
TS-R	13902219.90	1730547.85	2314.37

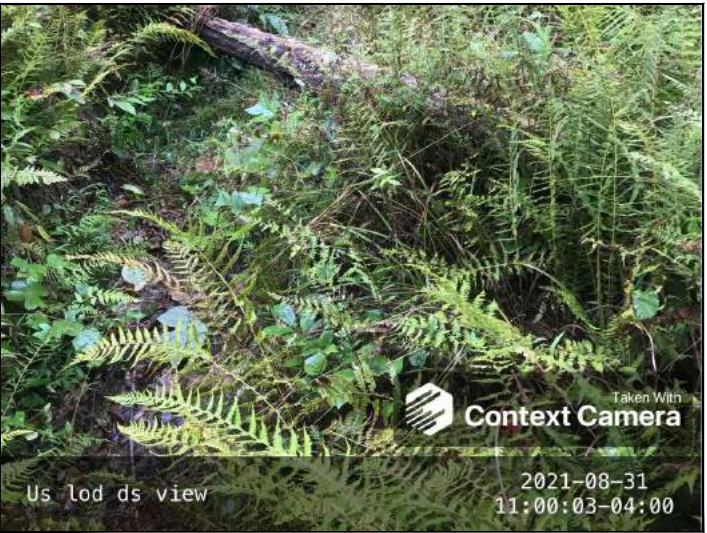
PHOTO TAKEN LOOKING DOWNSTREAM
FROM UPSTREAM IMPACT LIMITS

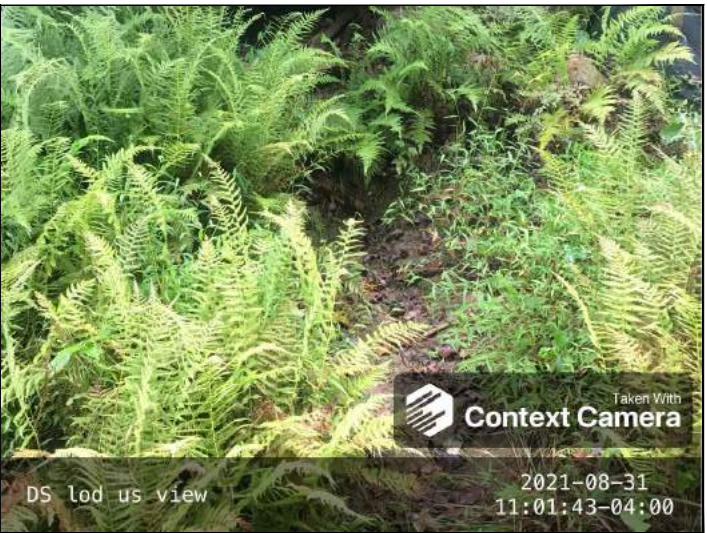
PHOTO TAKEN LOOKING UPSTREAM FROM
DOWNSTREAM IMPACT LIMITS

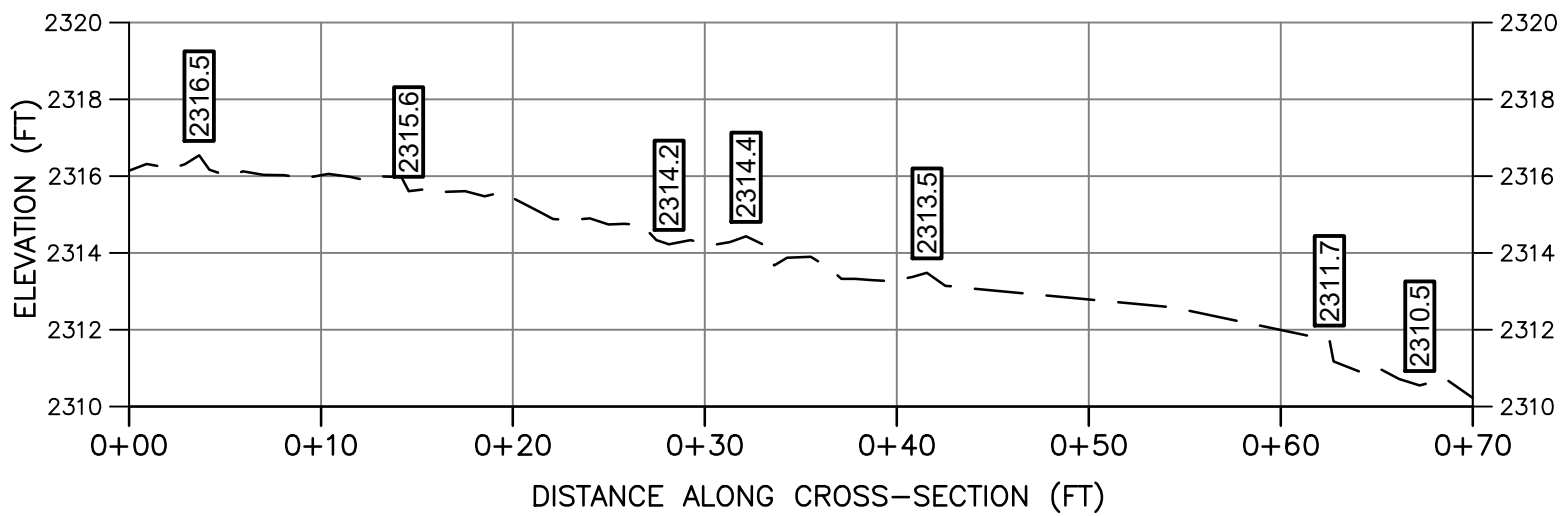
S-147 BASELINE THALWEG PROFILE

EXISTING STREAM PROFILE
INVERT ALONG THALWEG

SCALE: H: 1"=10'
V: 1"=5'

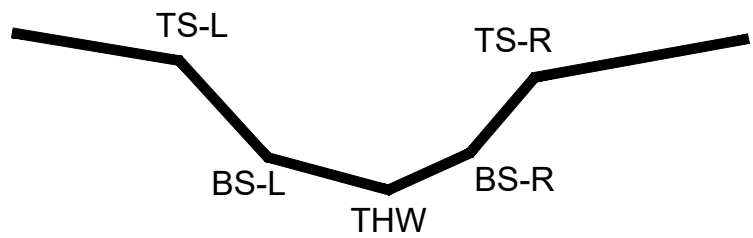
TYPICAL 5-POINT CROSS-SECTION
(FACING DOWNSTREAM)

TS: TOP OF SLOPE
BS: BOTTOM OF SLOPE
THW: THALWEG (INVERT)
