# **Baseline Assessment – Stream Attributes**

# Reach S-I63 TEMP AR (Temporary Access Road) Perennial Spread B Lewis County, West Virginia

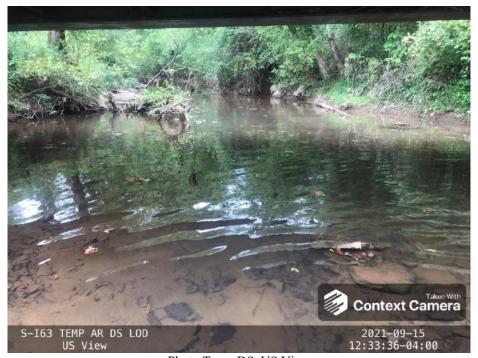
Photo Type: DS, US View
Location, Orientation, Photographer Initials: Downstream Edge of ROW, Upstream View, MAG/DPF
Lat: 38.969239 Long: -80.593244

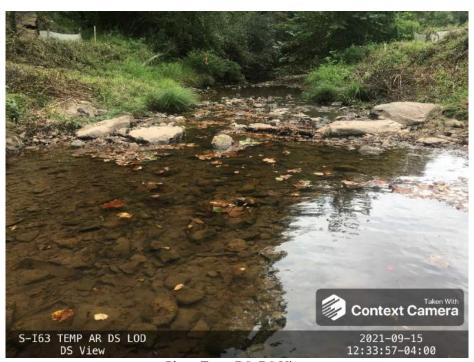
Photo Type: DS, DS View Location, Orientation, Photographer Initials: Downstream Edge of ROW, Downstream View, MAG/DPF Lat: 38.969239 Long: -80.593244

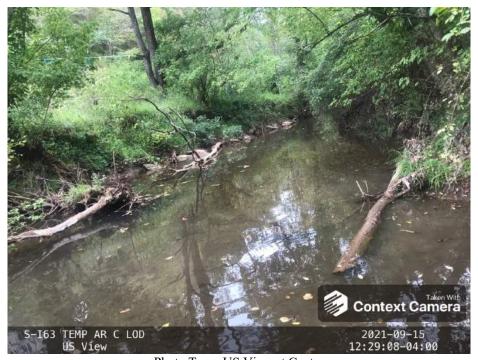
Photo Type: US View at Center Location, Orientation, Photographer Initials: Center ROW, Upstream View, MAG/DPF Lat: 38.969239 Long: -80.593244

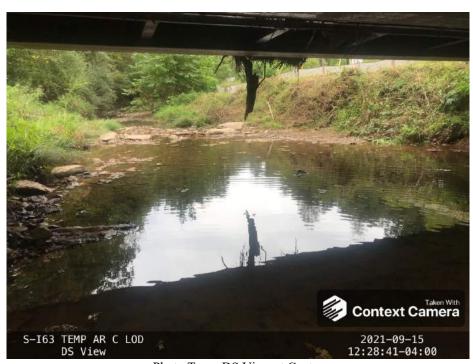
Photo Type: DS View at Center Location, Orientation, Photographer Initials: ROW Center, Downstream View, MAG/DPF Lat: 38.969239 Long: -80.593244

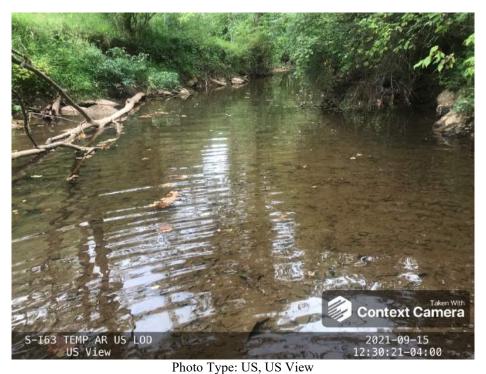
Location, Orientation, Photographer Initials: Upstream Edge of ROW, Upstream View, MAG/DPF
Lat: 38.969239 Long: -80.593244

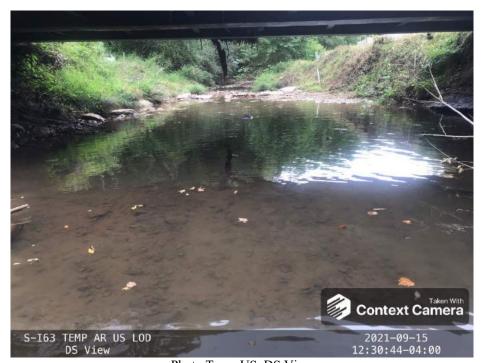
Photo Type: US, DS View
Location, Orientation, Photographer Initials: Upstream Edge of ROW, Downstream View, MAG/DPF
Lat: 38.969239 Long: -80.593244

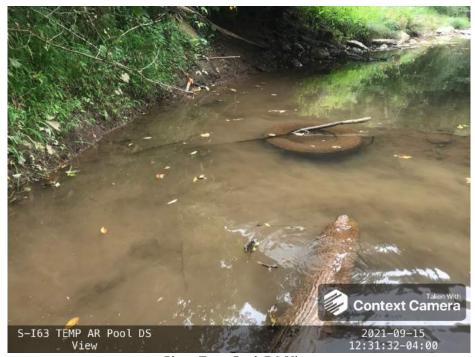
Photo Type: Pool, DS View Location, Orientation, Photographer Initials: Upstream of Pool, Downstream View, MAG/DPF Lat: 38.969239 Long: -80.593244

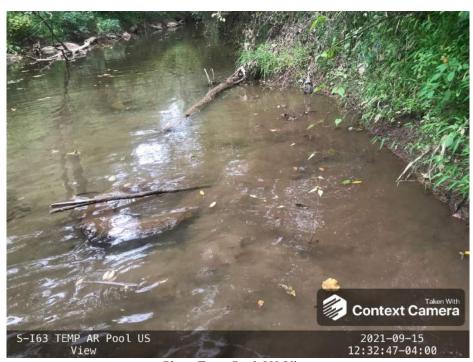
Photo Type: Pool, US View Location, Orientation, Photographer Initials: Downstream of Pool, Upstream View, MAG/DPF Lat: 38.969239 Long: -80.593244

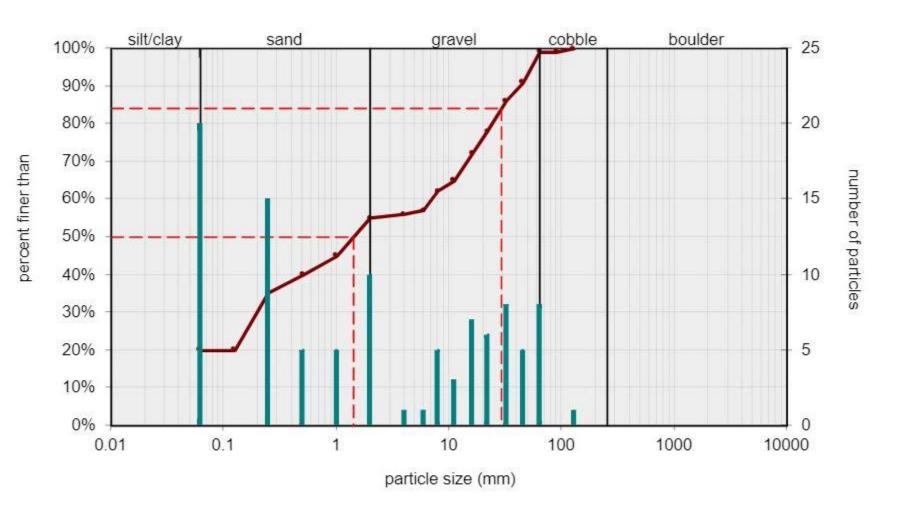
Size (	mm) 📑 📑
35	D16	0.062
	D35	0.25
	D50	1.4
	D65	11
	D84	29
	D95	54

1	ype	
silt/clay	20%	
sand	35%	
gravel	44%	
cobble	1%	
boulder	0%

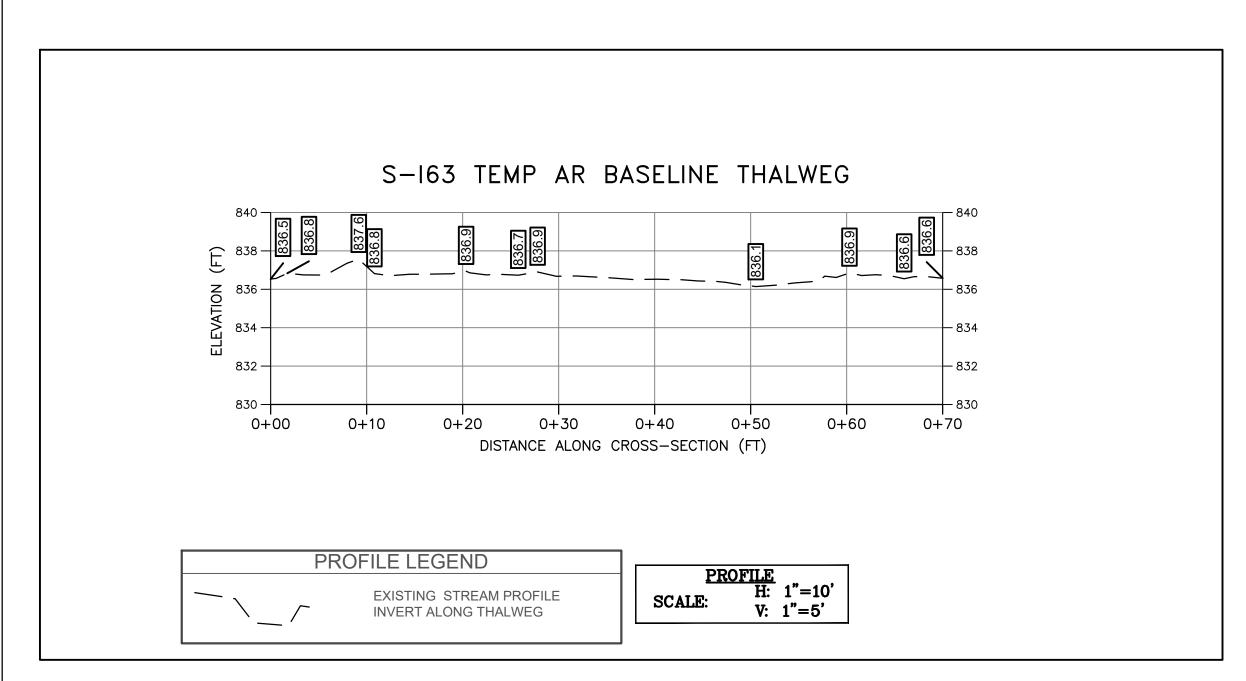
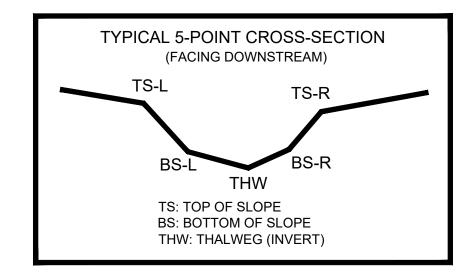
AS-BUILT TAB	LE: S-I63 TEMP	AR CROSS S	SECTION A	
	PRE-CROSSING			AŞ-E	BUILT
PT. LOC.	NORTHING	EASTING	ELEV	VERT. DIFF.	HORZ. DIFF.
TS-L	14151714.31	1756082.41	842.94		
BS-L	14151719.45	1756075.37	838.38		
THW	14151725.72	1756066.77	837.03		
BS-R	14151735.41	1756053.49	837.80		
TS-R	14151738.35	1756049.46	842.93

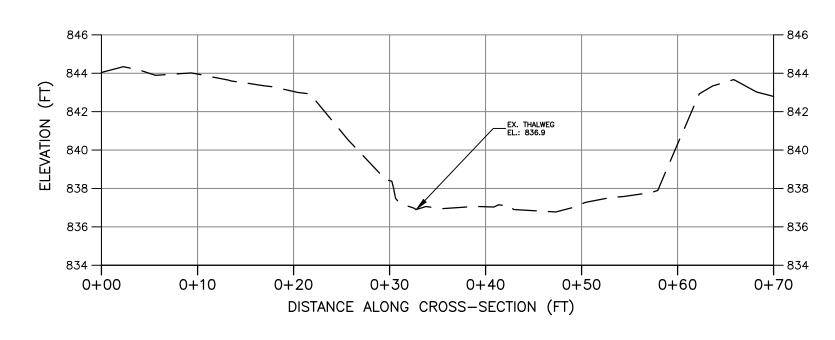
# S-163 TEMP AR BASELINE CROSS-SECTION A <u> POOL</u>

NOTE: ALL SECTIONS VIEWS SHOWN LEFT TO RIGHT FACING DOWNSTREAM.
