## Baseline Assessment – Stream Attributes

### Reach S-I67 (Timber Mat Crossing) Perennial Spread B Lewis County, West Virginia

**Title** PROFILE AND CROSS-SECTIONS  
BASELINE SURVEY  
CROSSING S-167 - SMOKE CAMP RUN  
LEWIS COUNTY, WV

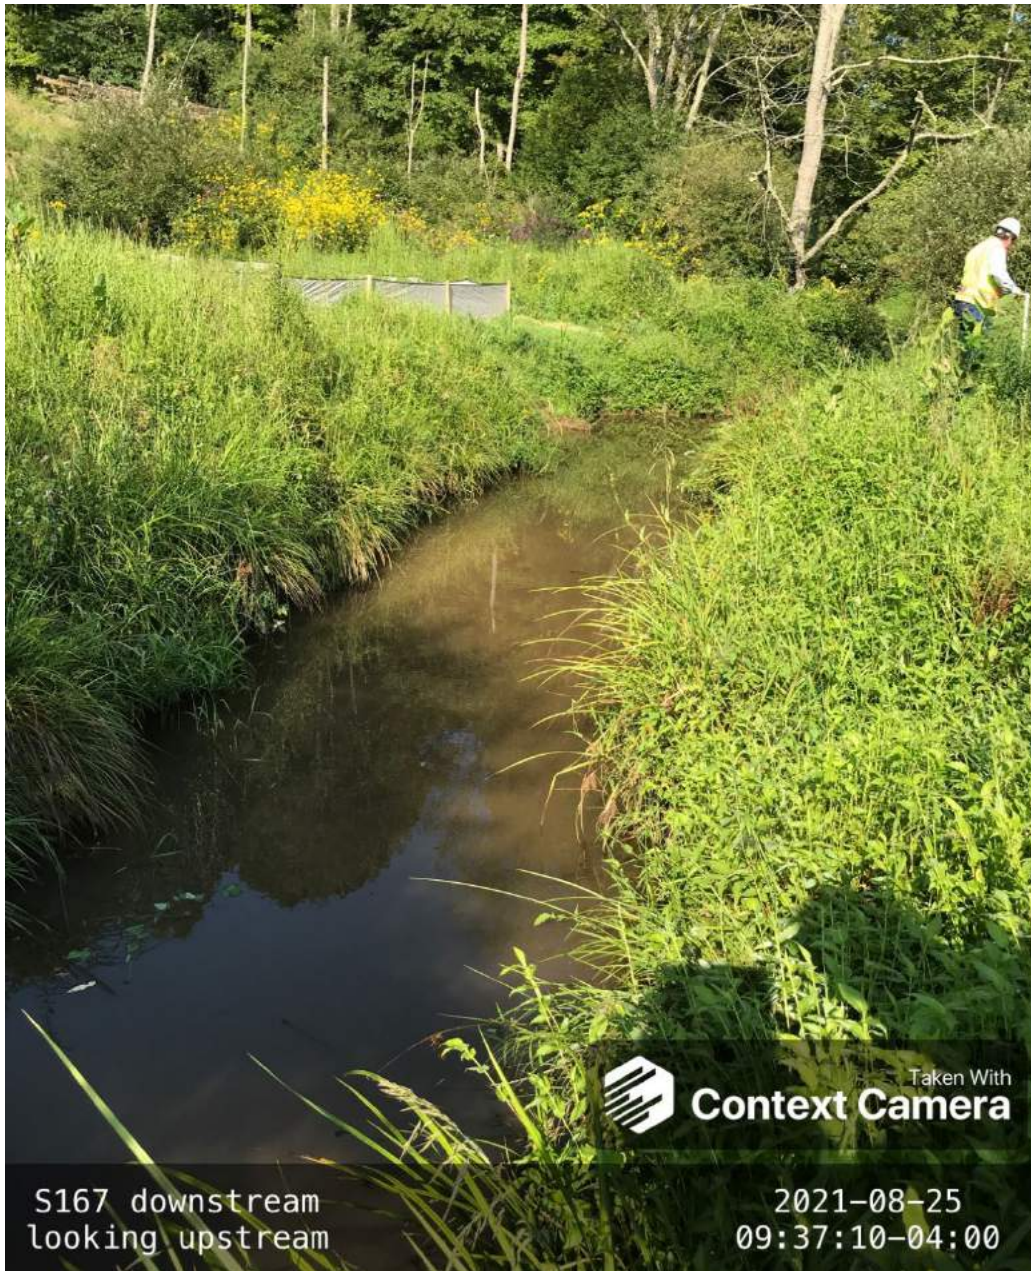
Photo Type: DS, US View  
Location, Orientation, Photographer Initials: Downstream Edge of ROW, Upstream View, DD/PL/LC/KP  
Lat: 39.137145 Long: -80.577026

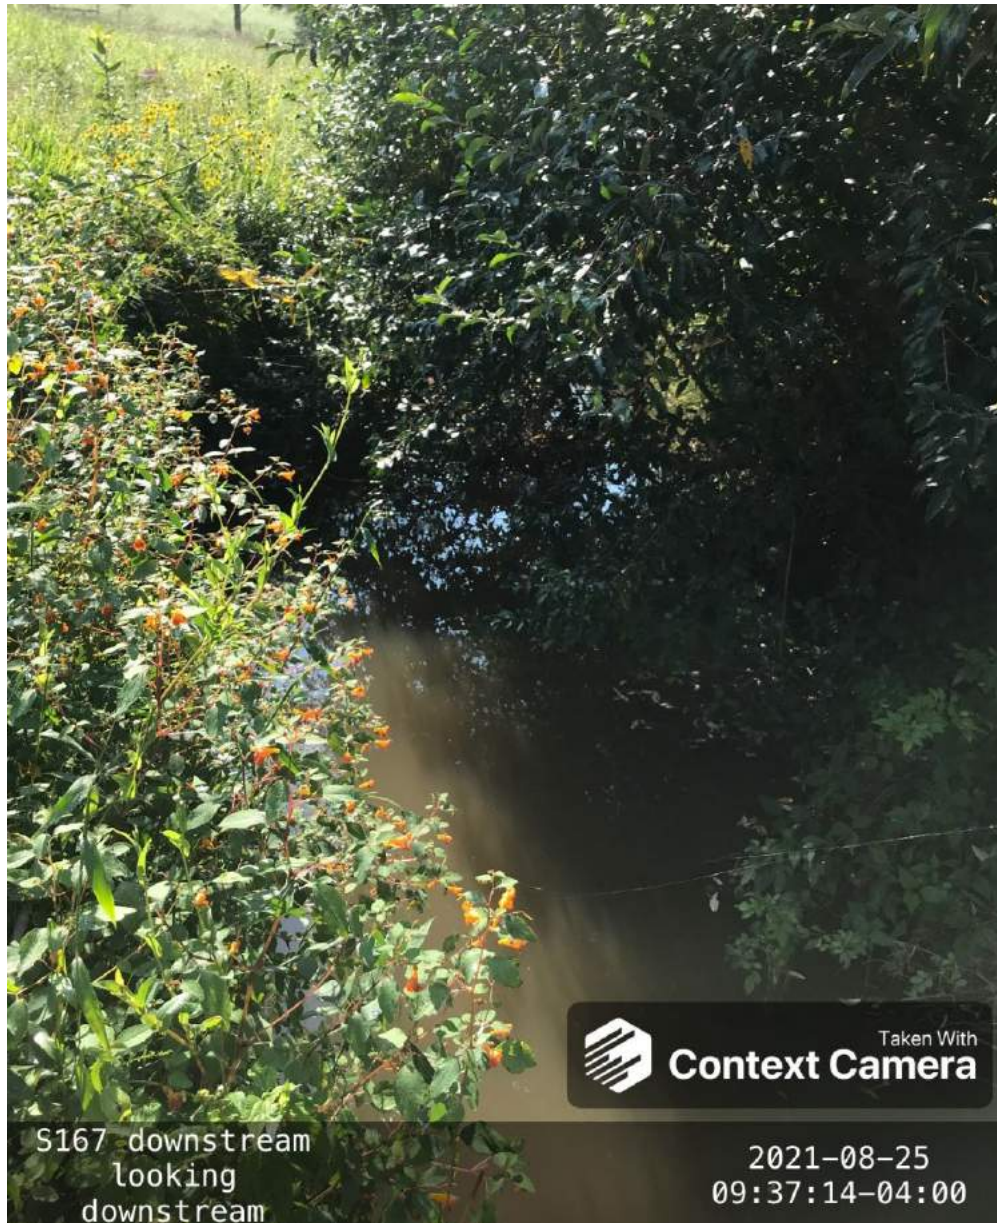
Photo Type: DS, DS View

Location, Orientation, Photographer Initials: Downstream Edge of ROW, Downstream View, DD/PL/LC/KP

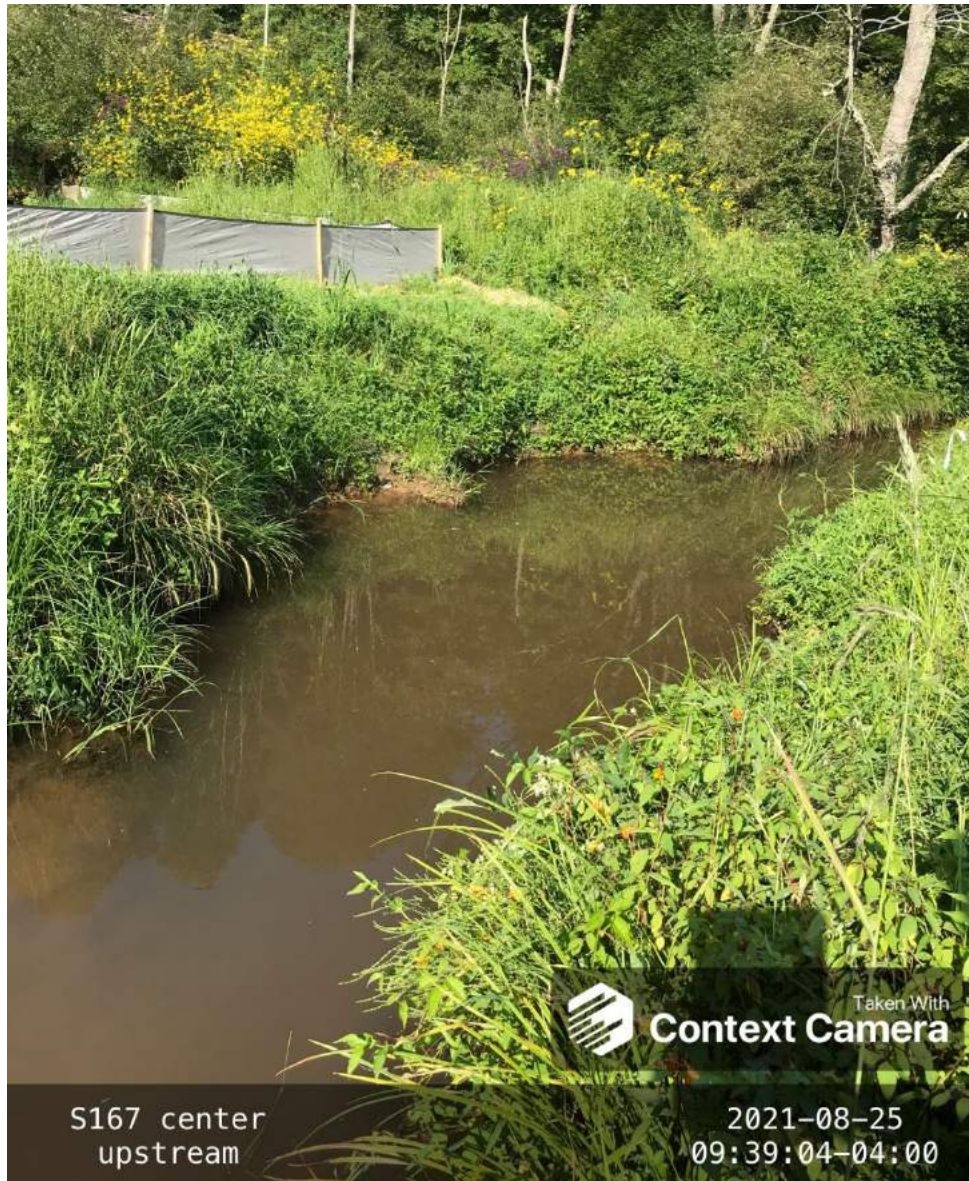
Photo Type: US View at Center  
Location, Orientation, Photographer Initials: Center ROW, Upstream View, DD/PL/LC/KP  
Lat: 39.137145 Long: -80.577026

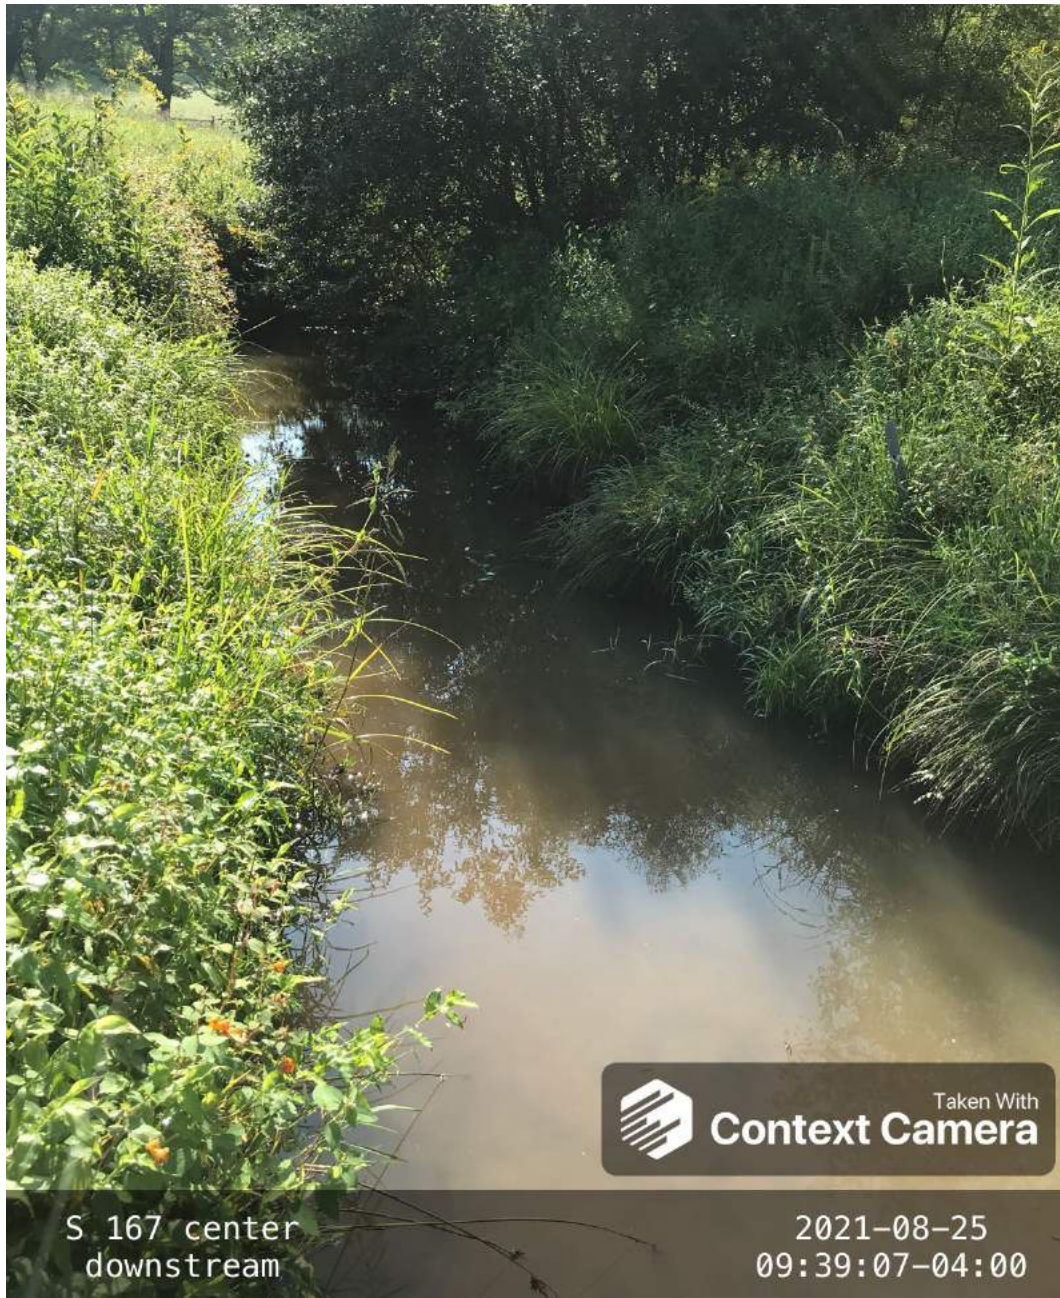
Photo Type: DS View at Center  
Location, Orientation, Photographer Initials: ROW Center, Downstream View, DD/PL/LC/KP  
Lat: 39.137145 Long: -80.577026

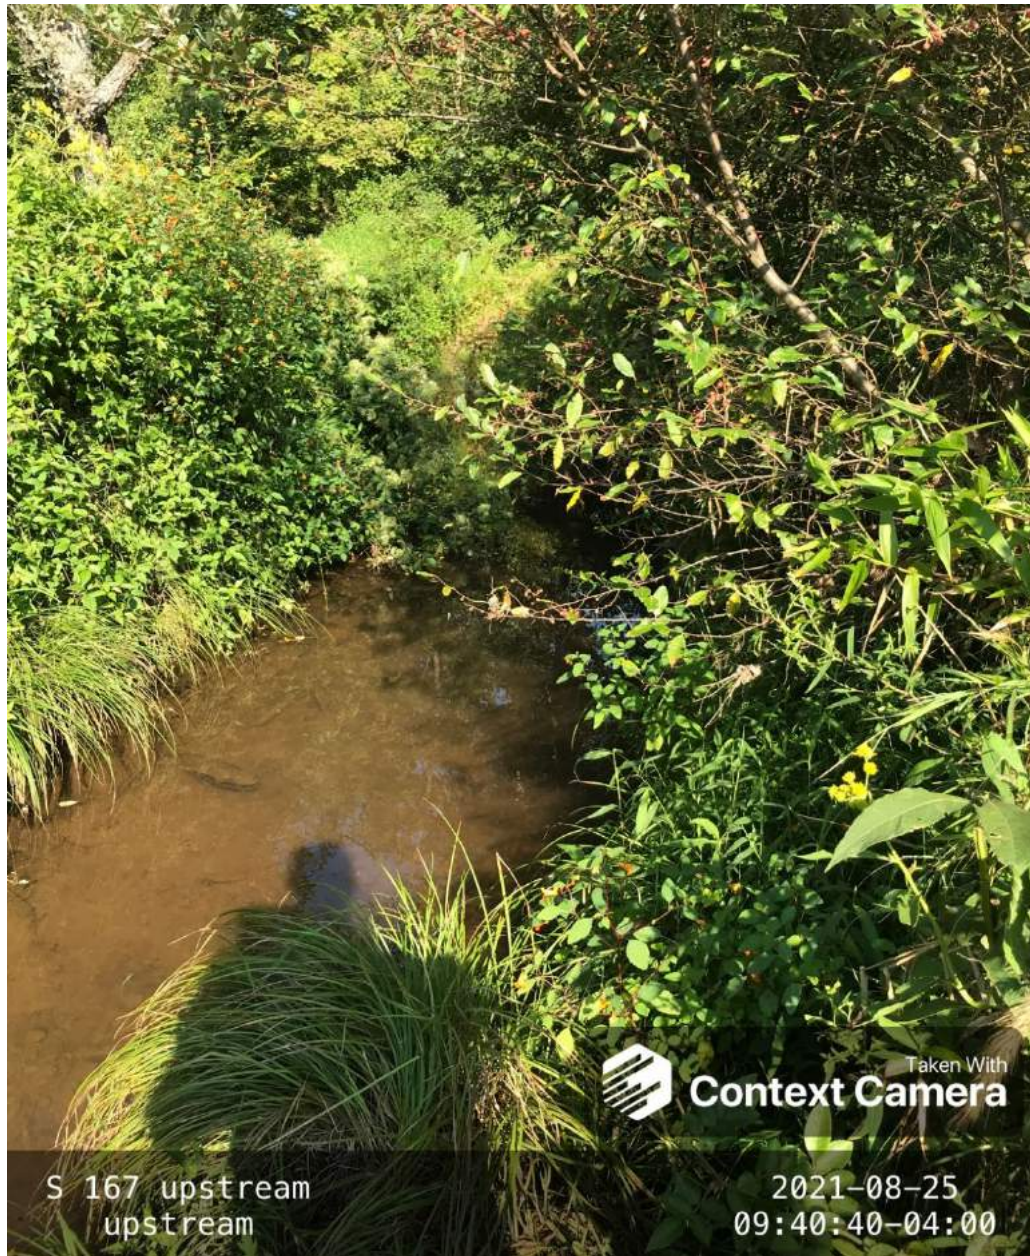
Photo Type: US, US View  
Location, Orientation, Photographer Initials: Upstream Edge of ROW, Upstream View, DD/PL/LC/KP  
Lat: 39.137145 Long: -80.577026

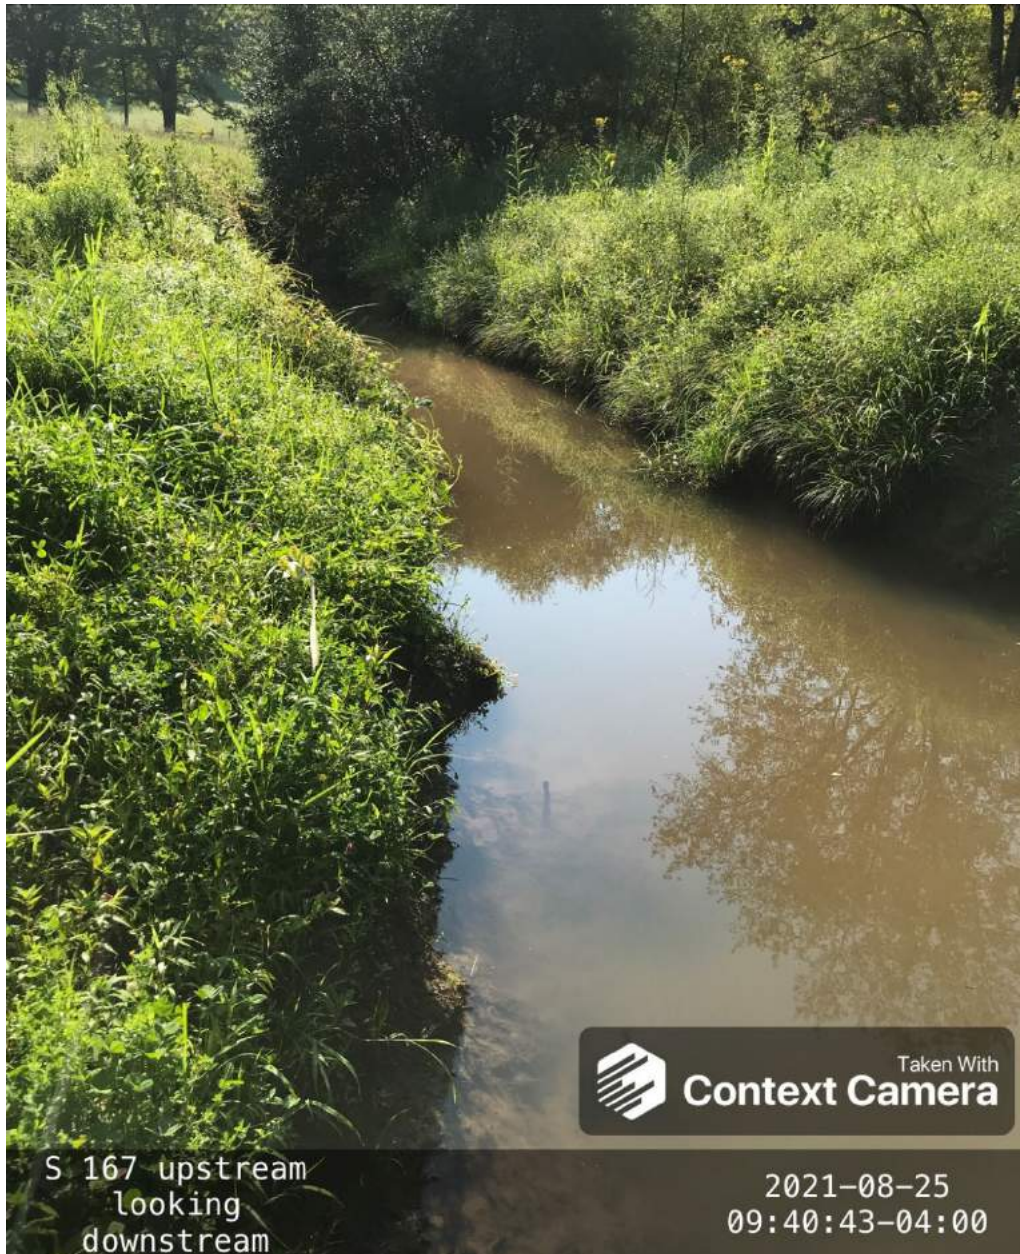
Photo Type: US, DS View  
Location, Orientation, Photographer Initials: Upstream Edge of ROW, Downstream View, DD/PL/LC/KP  
Lat: 39.137145 Long: -80.577026

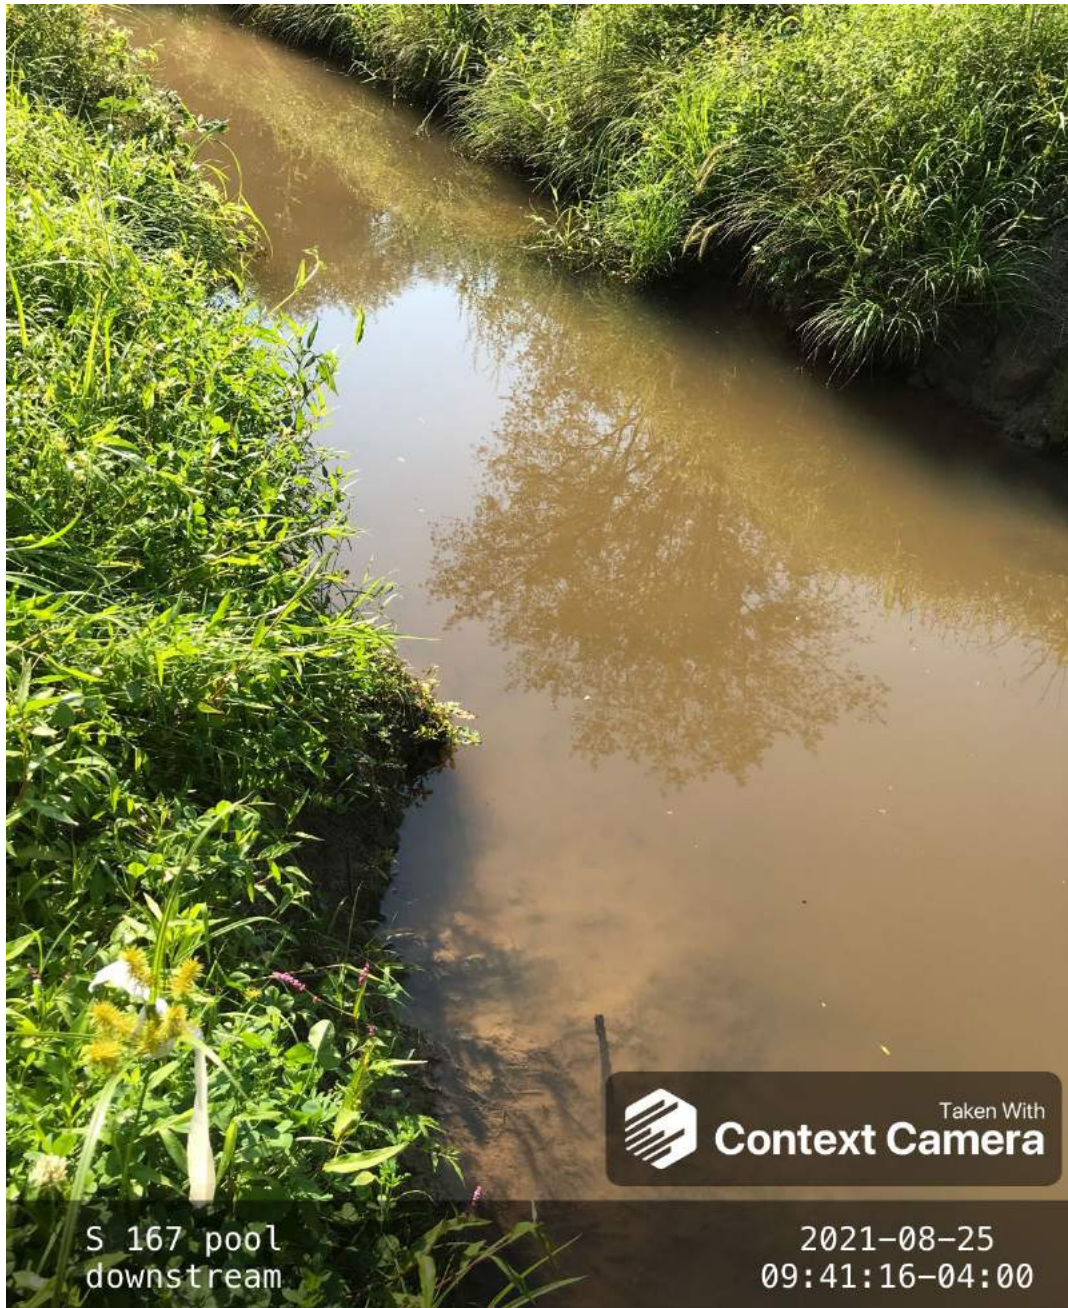
Photo Type: Pool, DS View  
Location, Orientation, Photographer Initials: Upstream of Pool, Downstream View, DD/PL/LC/KP  
Lat: 39.137145 Long: -80.577026

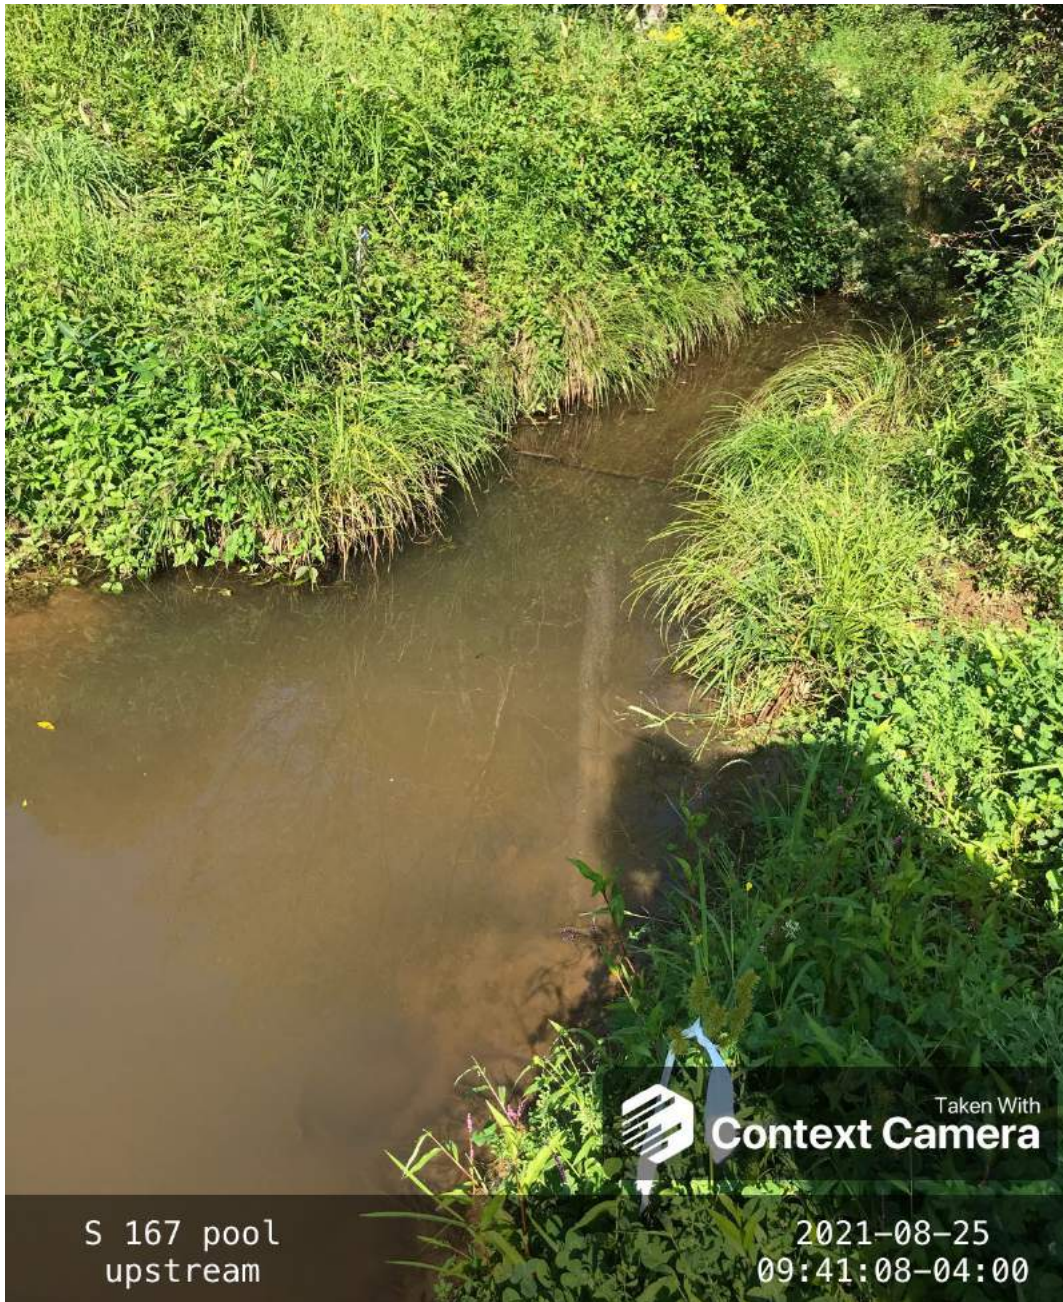
Photo Type: Pool, US View

Location, Orientation, Photographer Initials: Downstream of Pool, Upstream View, DD/PL/LC/KP  
Lat: 39.137145 Long: -80.577026

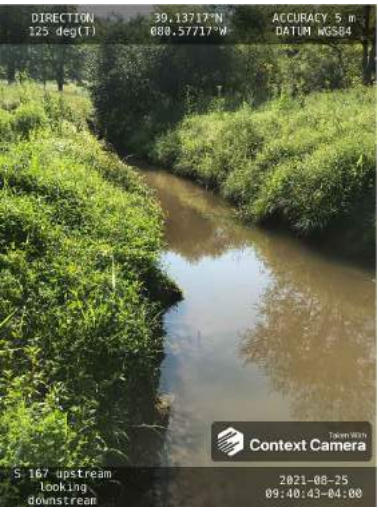
PHOTO TAKEN LOOKING DOWNSTREAM  
FROM UPSTREAM IMPACT LIMITS

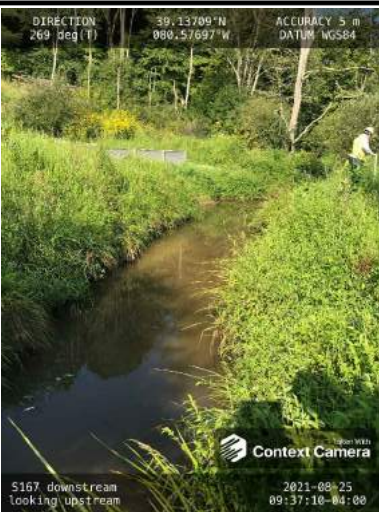
PHOTO TAKEN LOOKING UPSTREAM FROM  
DOWNSTREAM IMPACT LIMITS
