Baseline Assessment – Stream Attributes

Reach S-IJ27 (Permanent Access Road)

Perennial Spread C

Braxton County, West Virginia

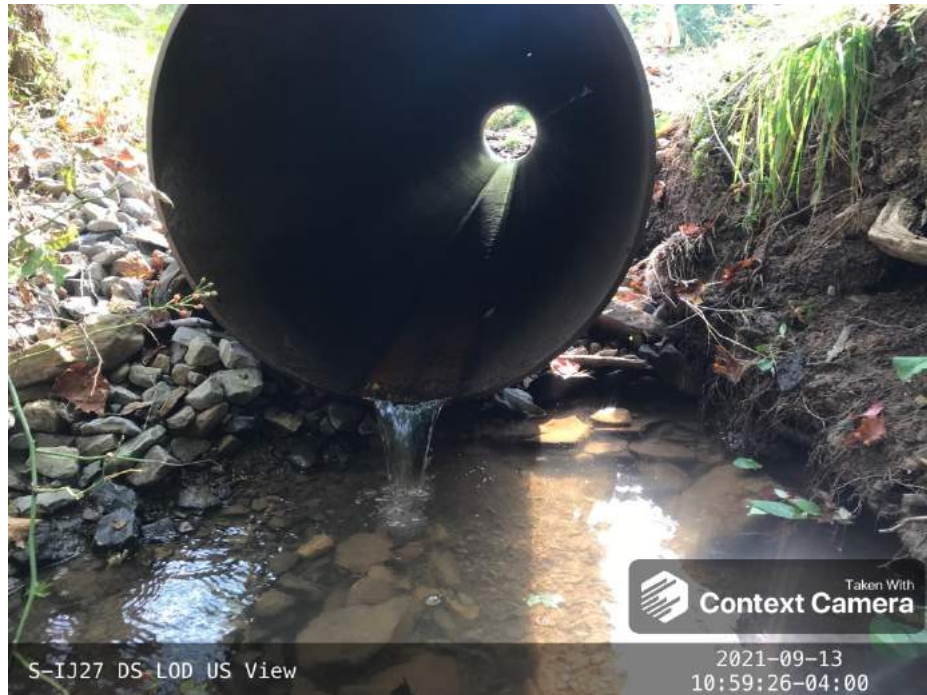
Photo Type: DS, US View

Location, Orientation, Photographer Initials: Downstream Edge of ROW, Upstream View, MAG/DPF
Lat: 38.809593 Long: -80.541252

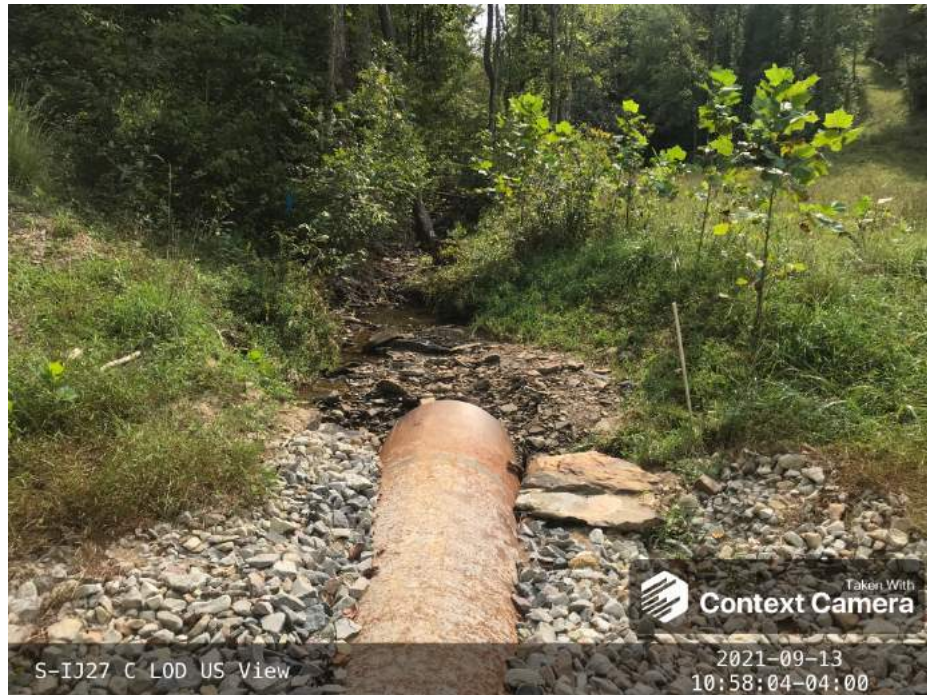
Photo Type: US View at Center
Location, Orientation, Photographer Initials: Center ROW, Upstream View, MAG/DPF
Lat: 38.809593 Long: -80.541252

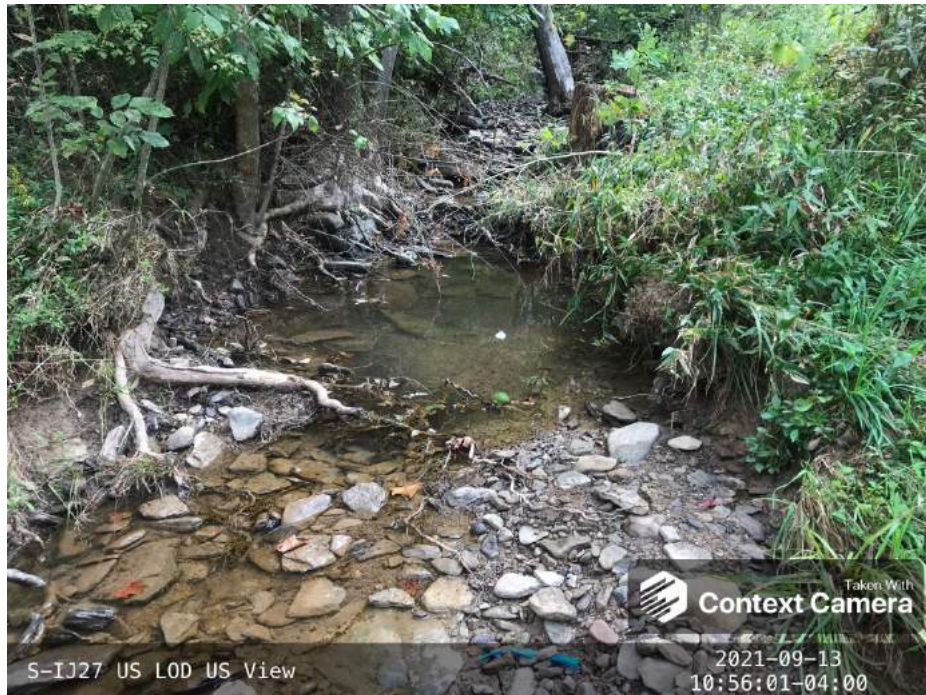
Photo Type: US, US View

Location, Orientation, Photographer Initials: Upstream Edge of ROW, Upstream View, MAG/DPF
Lat: 38.809593 Long: -80.541252

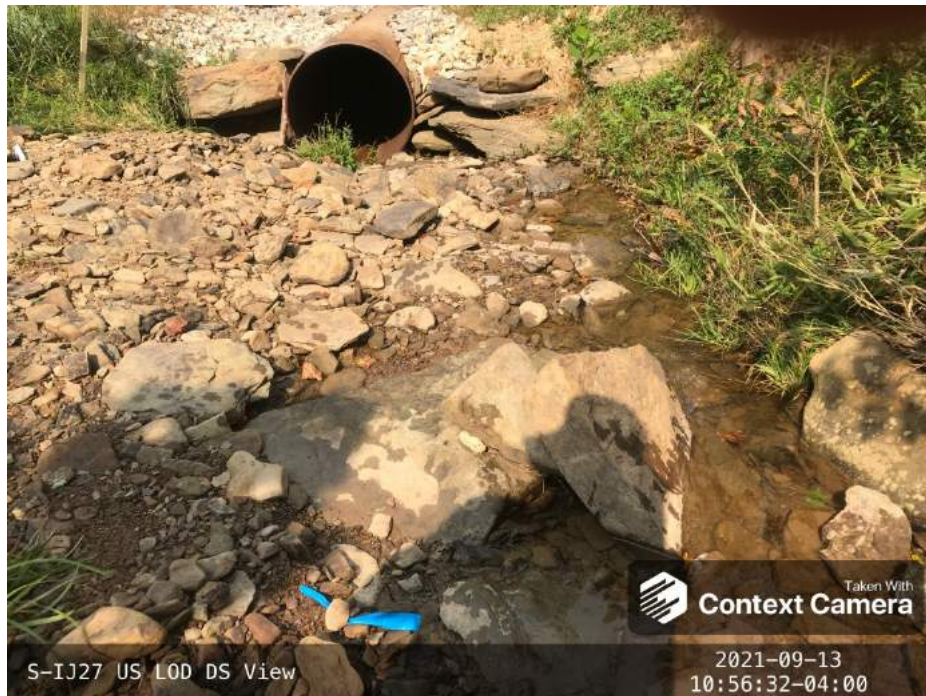
Photo Type: US, DS View

Location, Orientation, Photographer Initials: Upstream Edge of ROW, Downstream View, MAG/DPF
Lat: 38.809593 Long: -80.541252

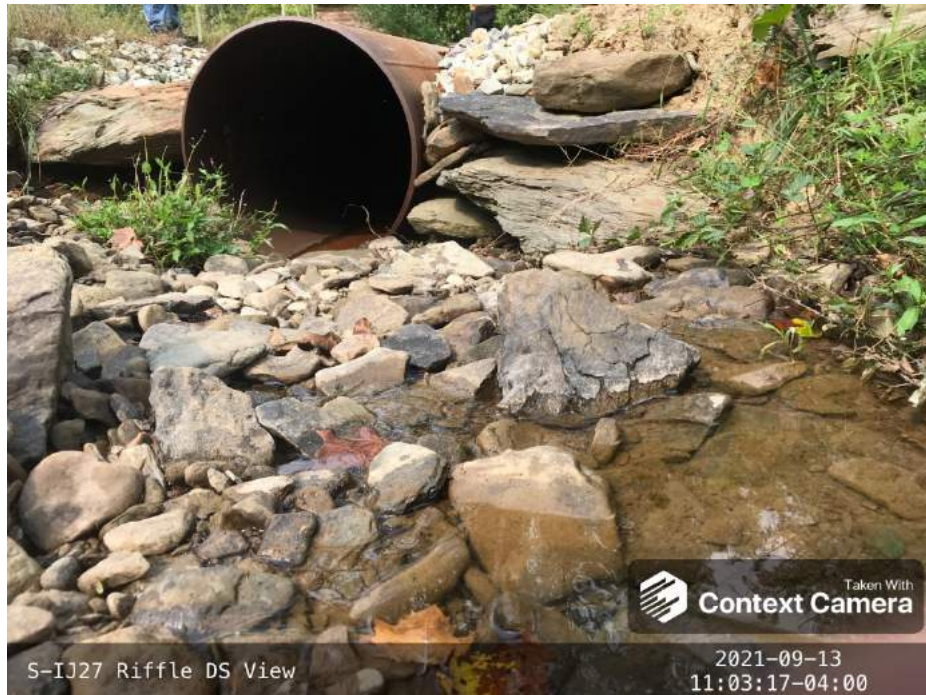
Photo Type: Riffle, DS View
Location, Orientation, Photographer Initials: Upstream of Riffle, Downstream View, MAG/DPF
Lat: 38.809593 Long: -80.541252

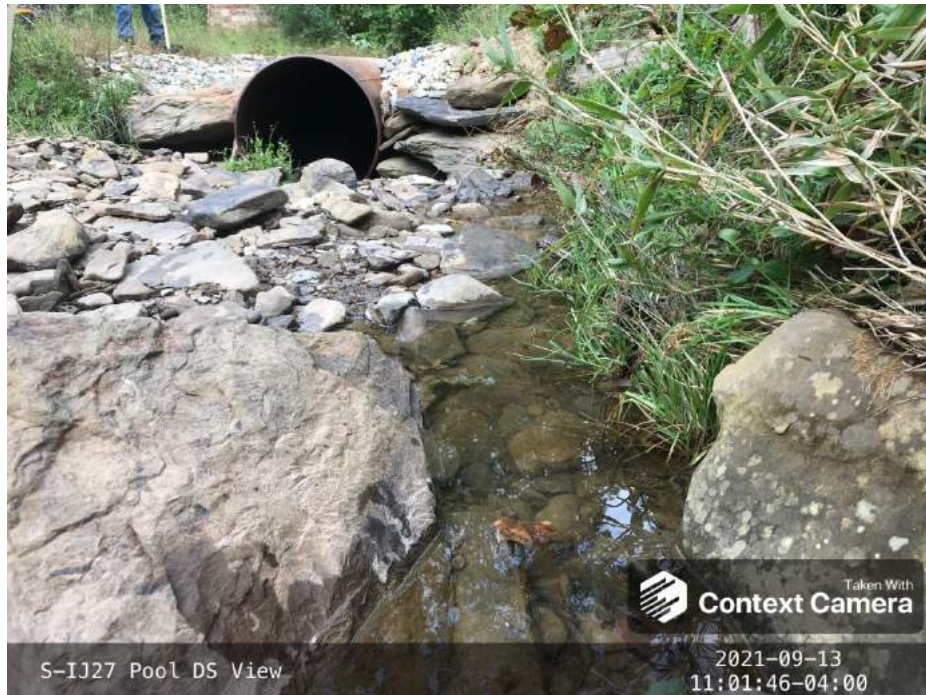
Photo Type: Pool, DS View

Location, Orientation, Photographer Initials: Upstream of Pool, Downstream View, MAG/DPF
Lat: 38.809593 Long: -80.541252

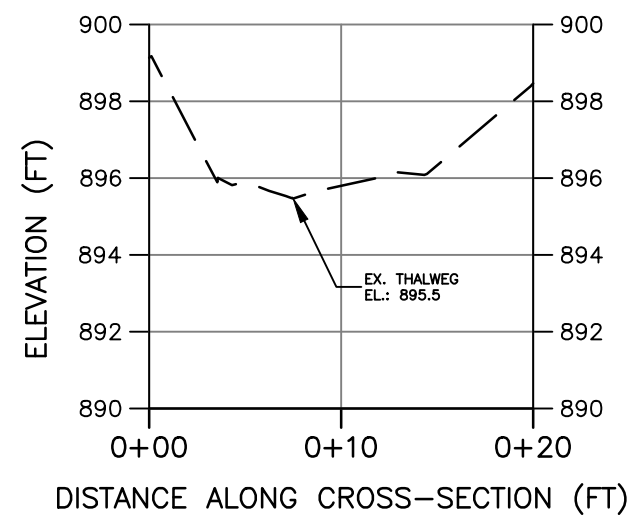
Figure 1 is a cross-section profile of a road. The vertical axis is labeled "ELEVATION (FT)" and ranges from 890 to 900. The horizontal axis is labeled "DISTANCE ALONG CROSS-SECTION (FT)" and ranges from 0+00 to 0+20. The profile shows a road surface with a dip. A point on the dip is labeled "EX. THALWEG EL.: 895.6" with an arrow pointing to it.

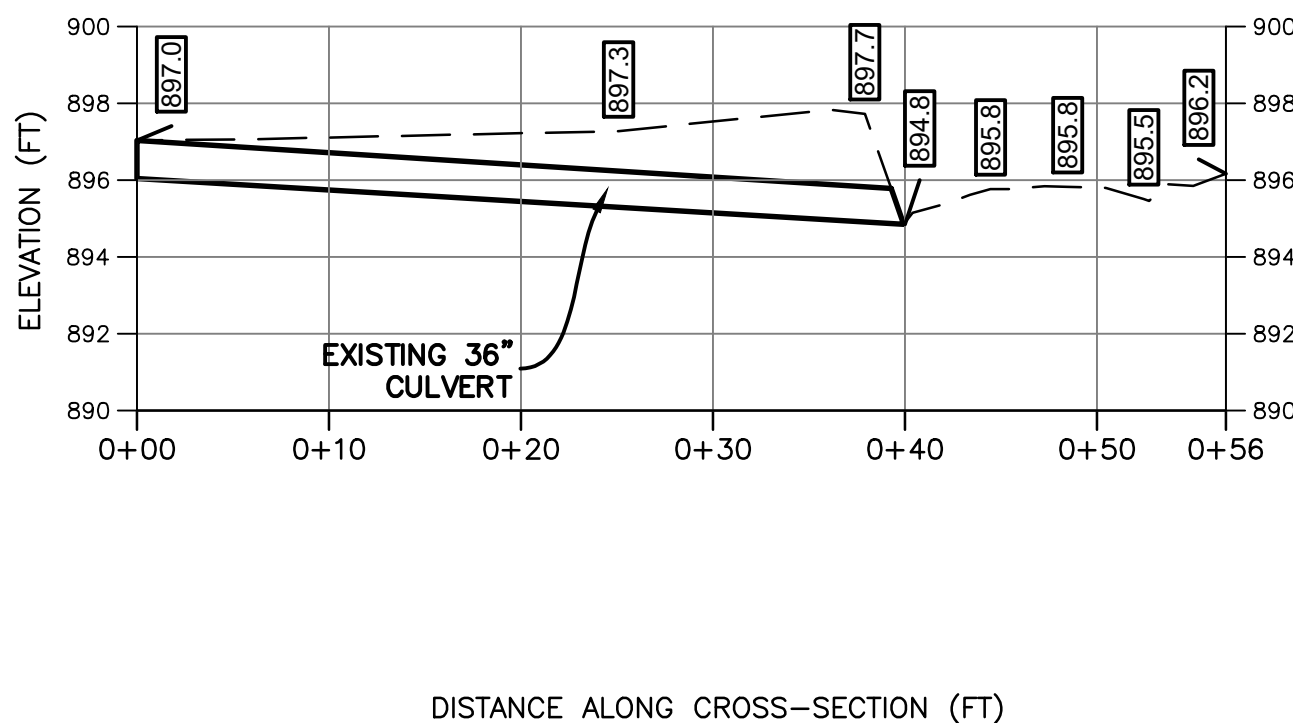
EXISTING STREAM PROFILE
INVERT ALONG THALWEG

SCALE: H: 1"=10'
V: 1"=5'

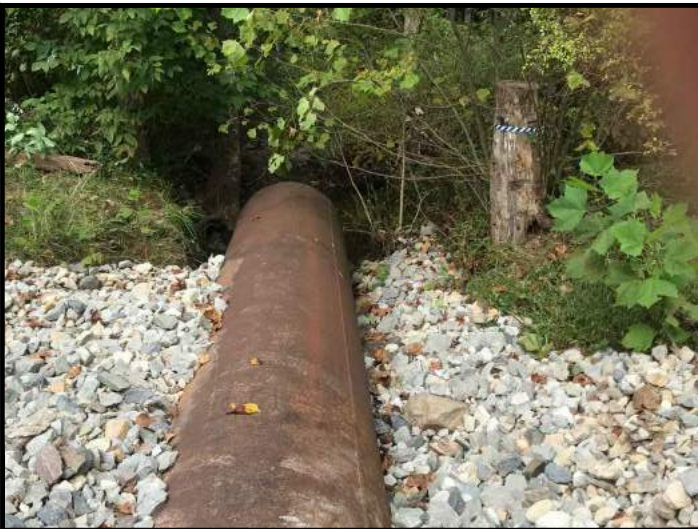
PHOTO TAKEN LOOKING DOWNSTREAM
FROM UPSTREAM IMPACT LIMITS

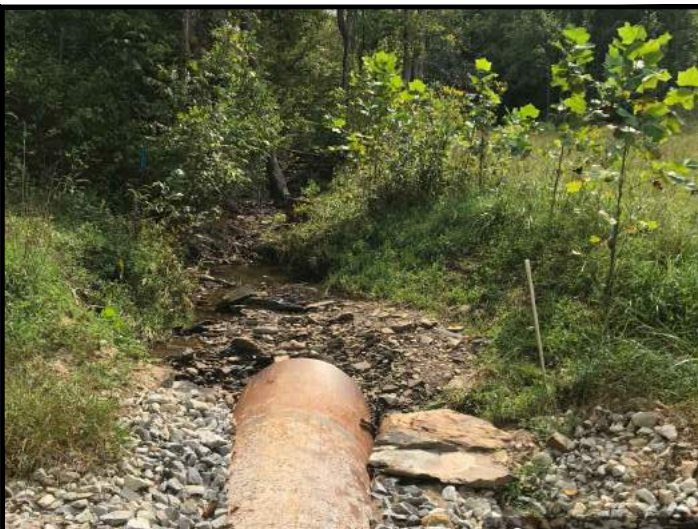
PHOTO TAKEN LOOKING UPSTREAM FROM
DOWNSTREAM IMPACT LIMITS
