Baseline Assessment – Stream Attributes

Reach S-IJ60 (Pipeline ROW)
Perennial
Spread D
Nicholas County, West Virginia

Client
Title
PROFILE AND CROSS-SECTIONS
BASELINE SURVEY
CROSSING S-IJ60 - UNNAMED TRIB. TO
ROCKCAMP RUN (MP 112.6)
NICHOLAS COUNTY, WV

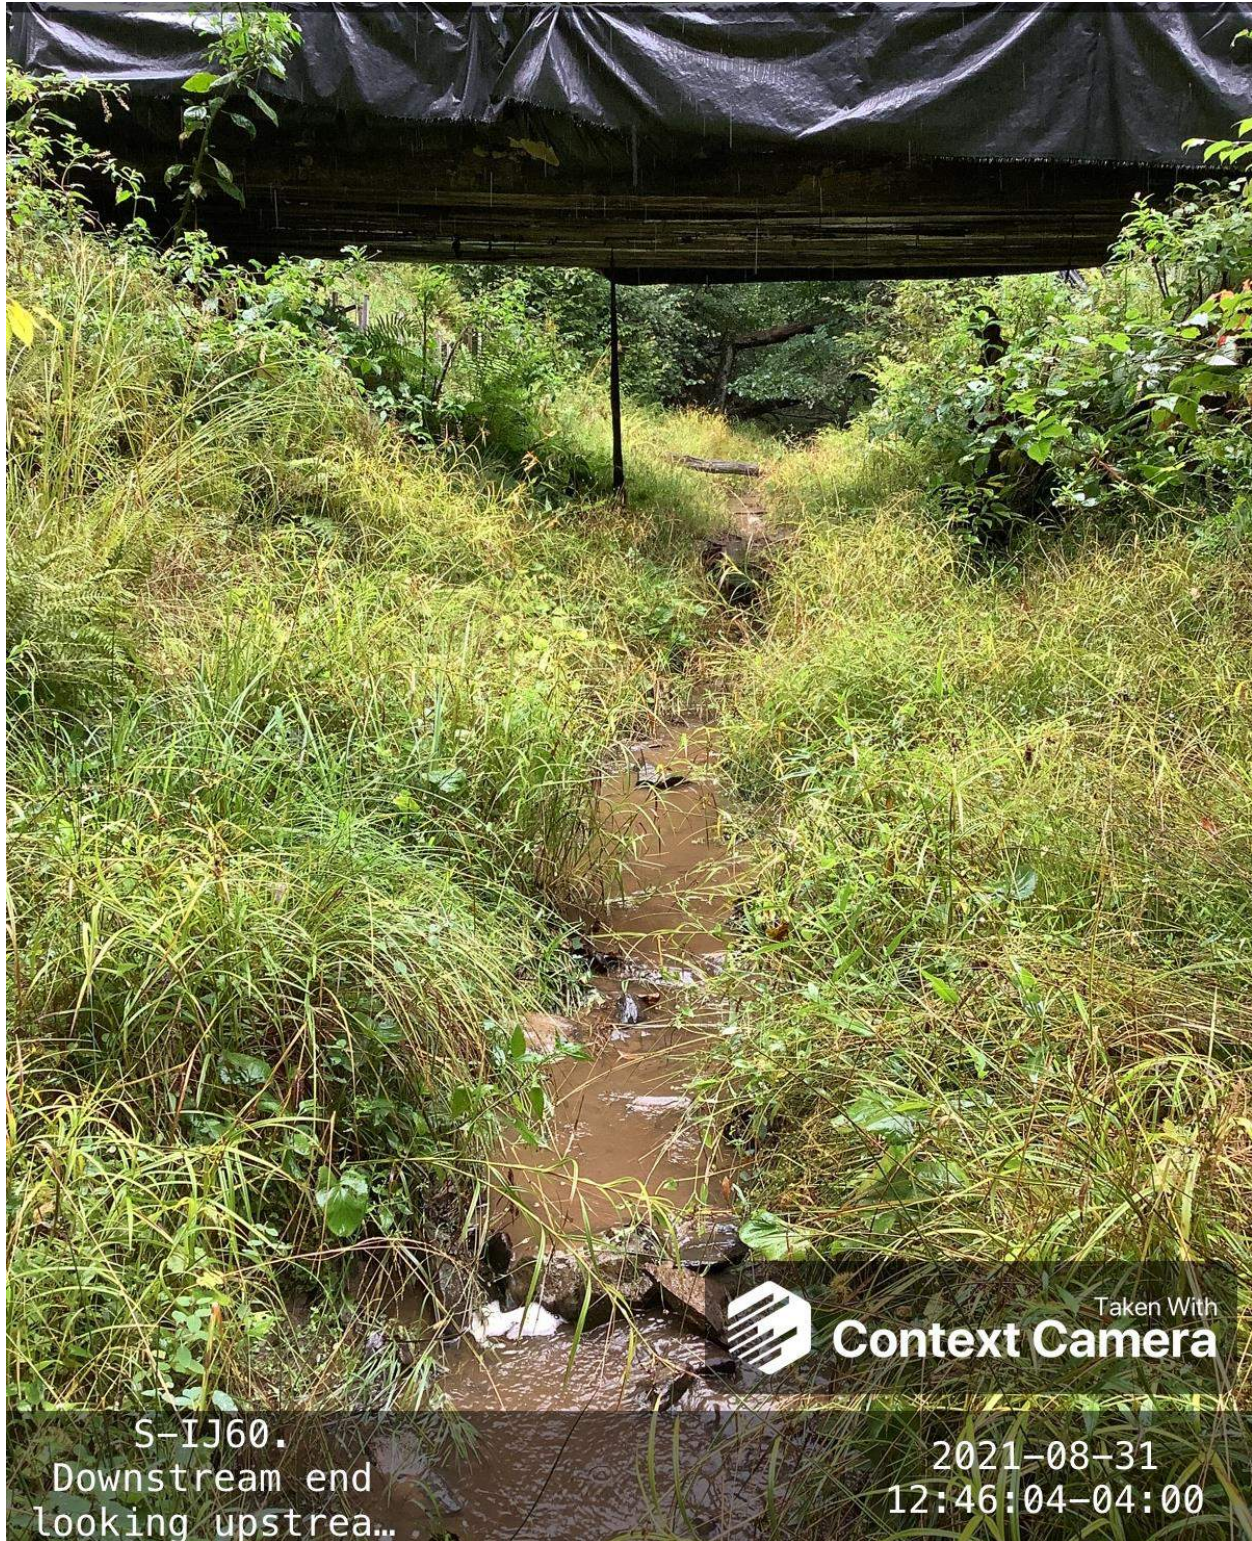
S-IJ60.
Downstream end
looking upstream...

Photo Type: DS, US View

Location, Orientation, Photographer Initials: Downstream Edge of ROW, Upstream View, JR/KP
Lat: 38.343699 Long: -80.644721

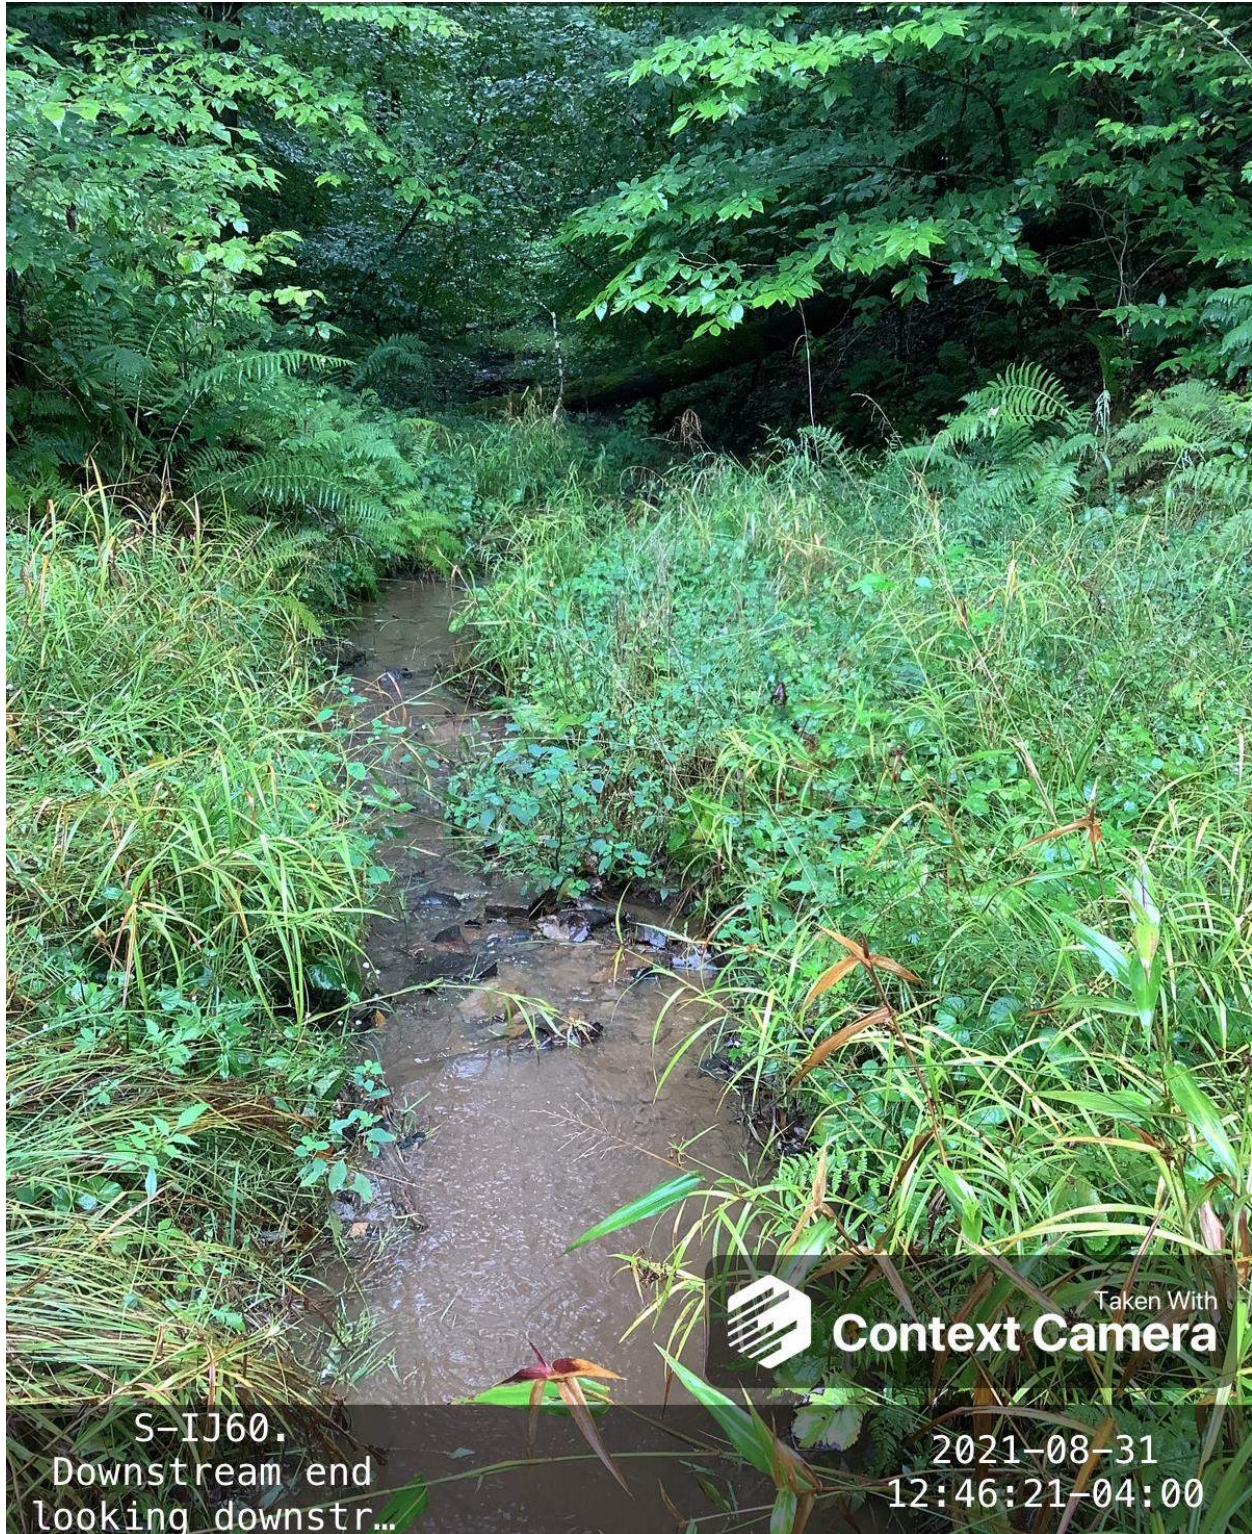
Photo Type: DS, DS View
Location, Orientation, Photographer Initials: Downstream Edge of ROW, Downstream View, JR/KP
Lat: 38.343699 Long: -80.644721

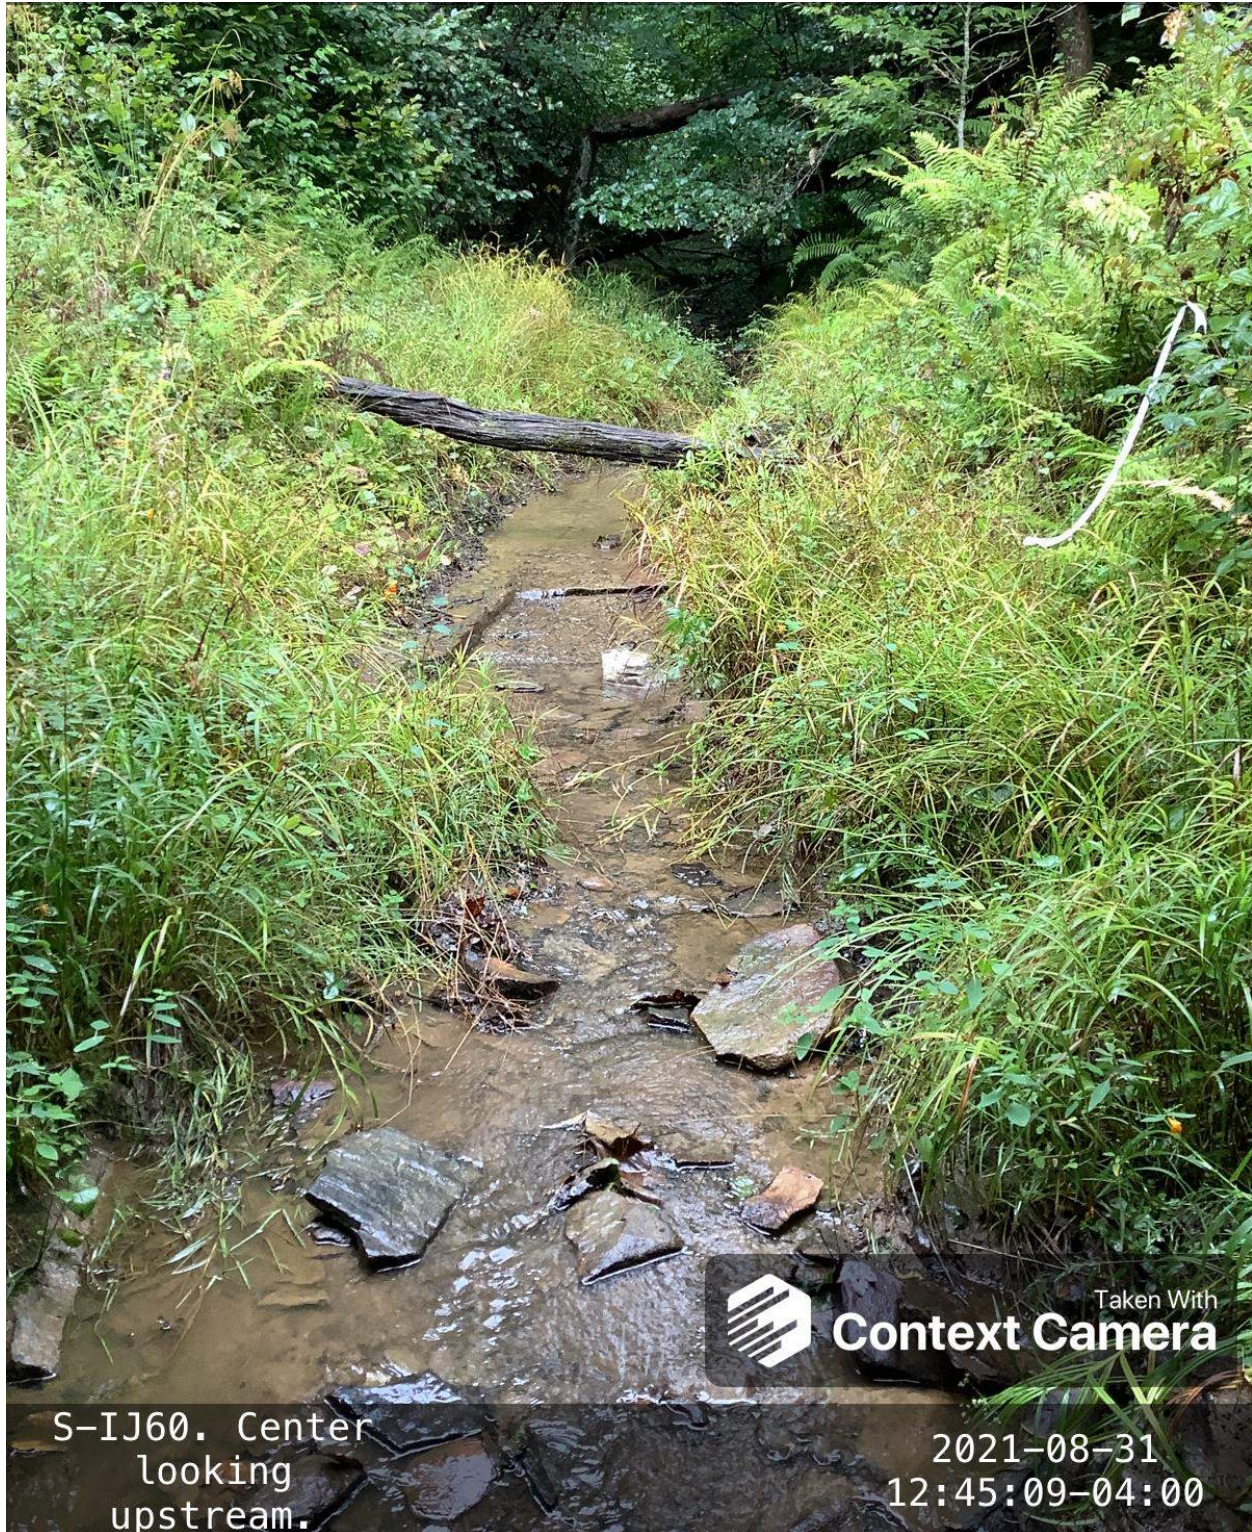
S-IJ60. Center
looking
upstream.

Photo Type: US View at Center
Location, Orientation, Photographer Initials: Center ROW, Upstream View, JR/KP
Lat: 38.343699 Long: -80.644721

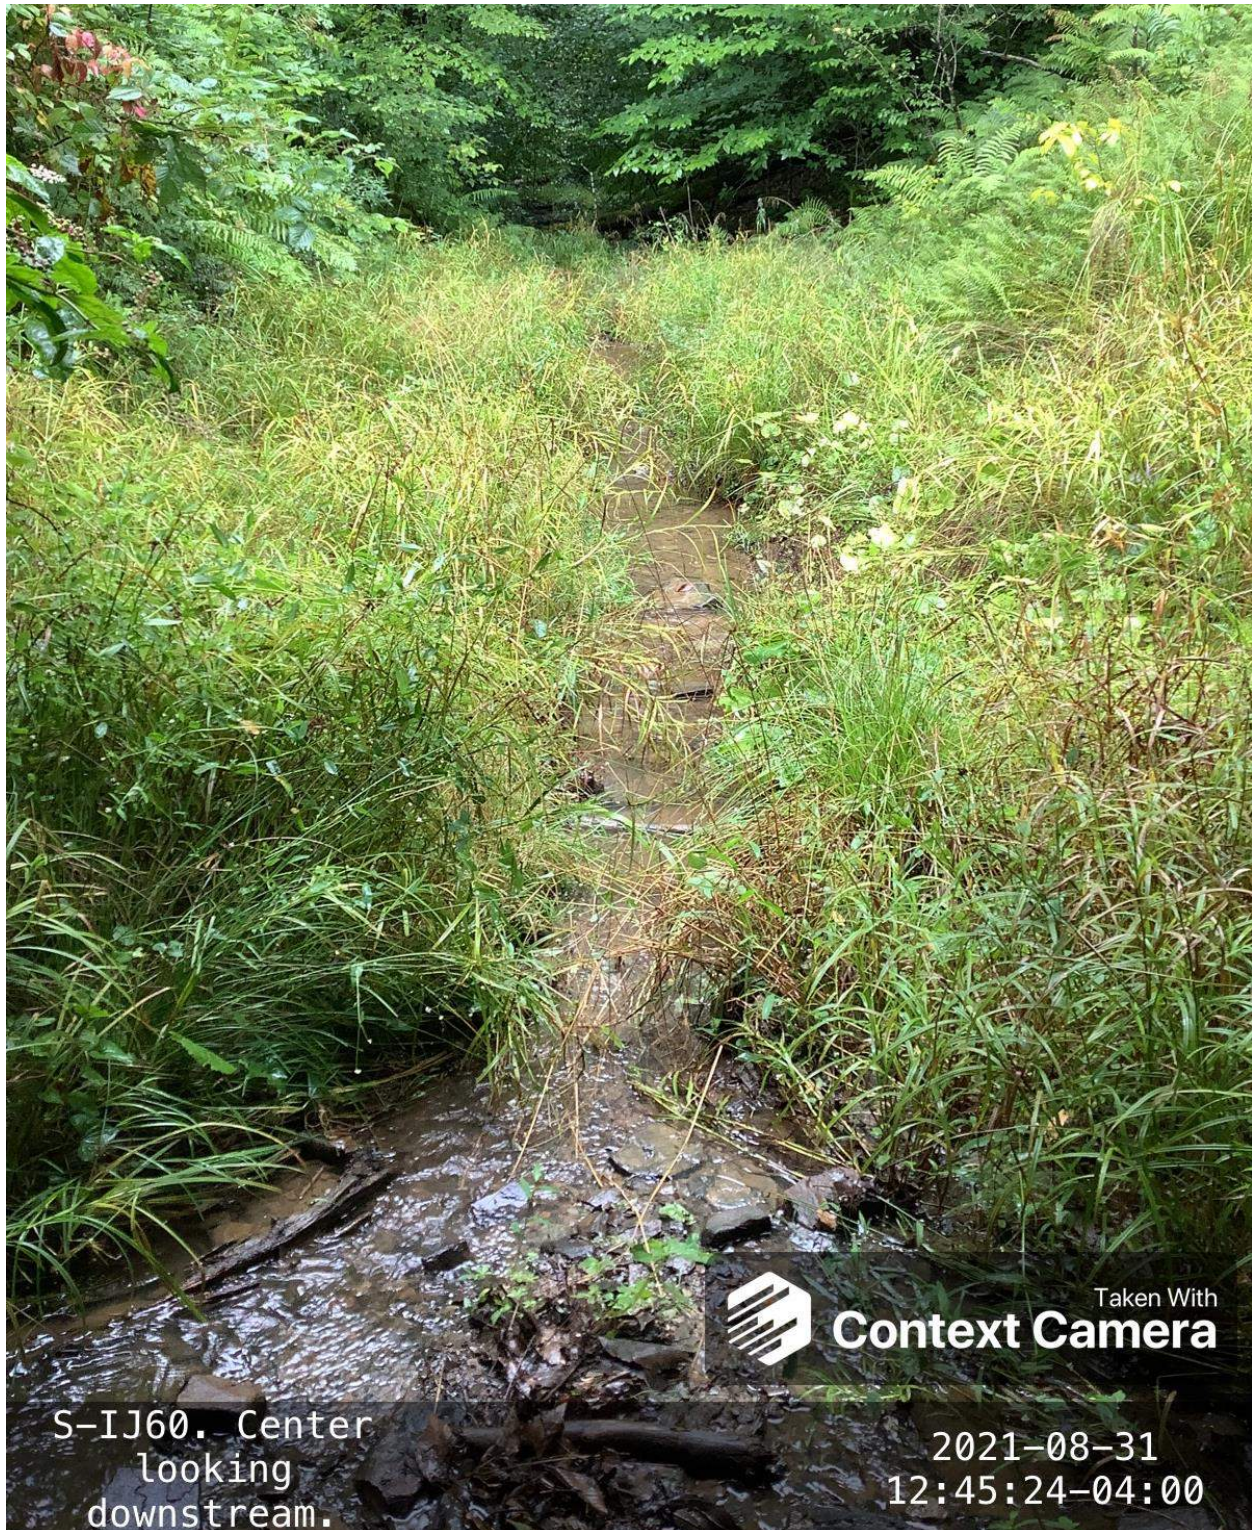
Photo Type: DS View at Center
Location, Orientation, Photographer Initials: Center ROW, Downstream View, JR/KP
Lat: 38.343699 Long: -80.644721

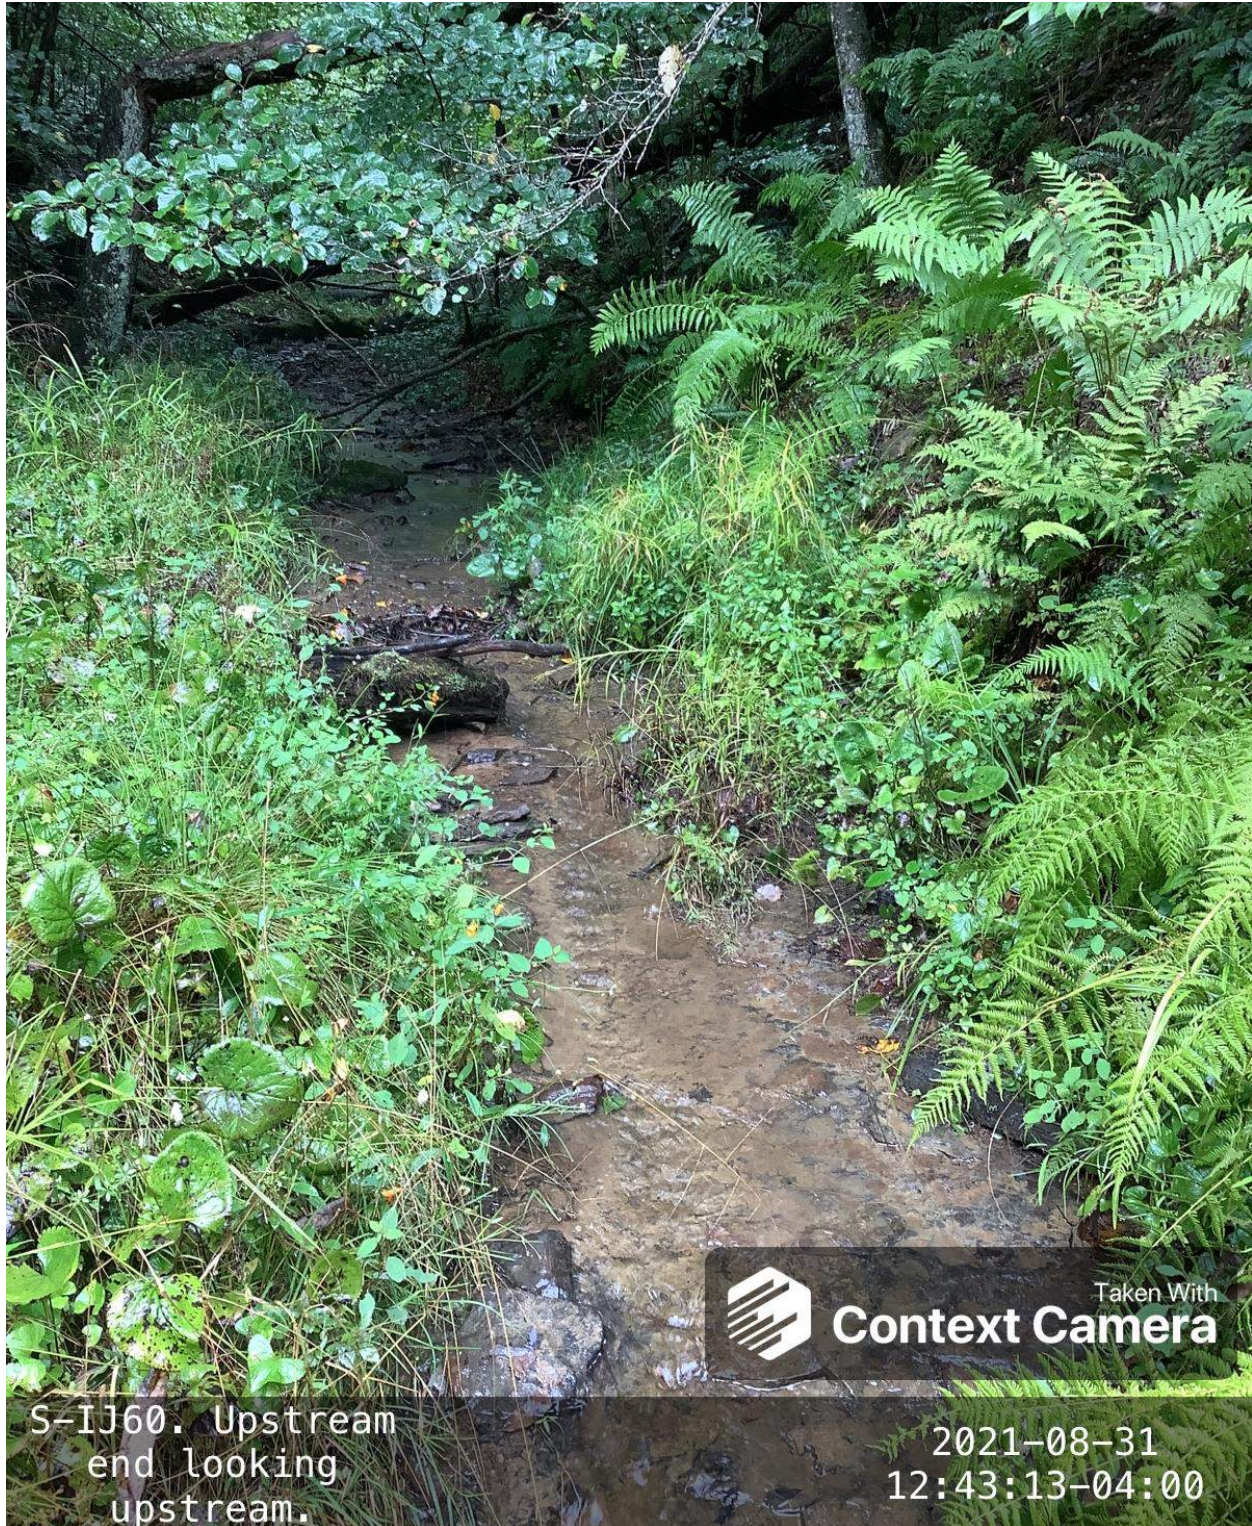
Photo Type: US, US View
Location, Orientation, Photographer Initials: Upstream Edge of ROW, Upstream View, JR/KP
Lat: 38.343699 Long: -80.644721

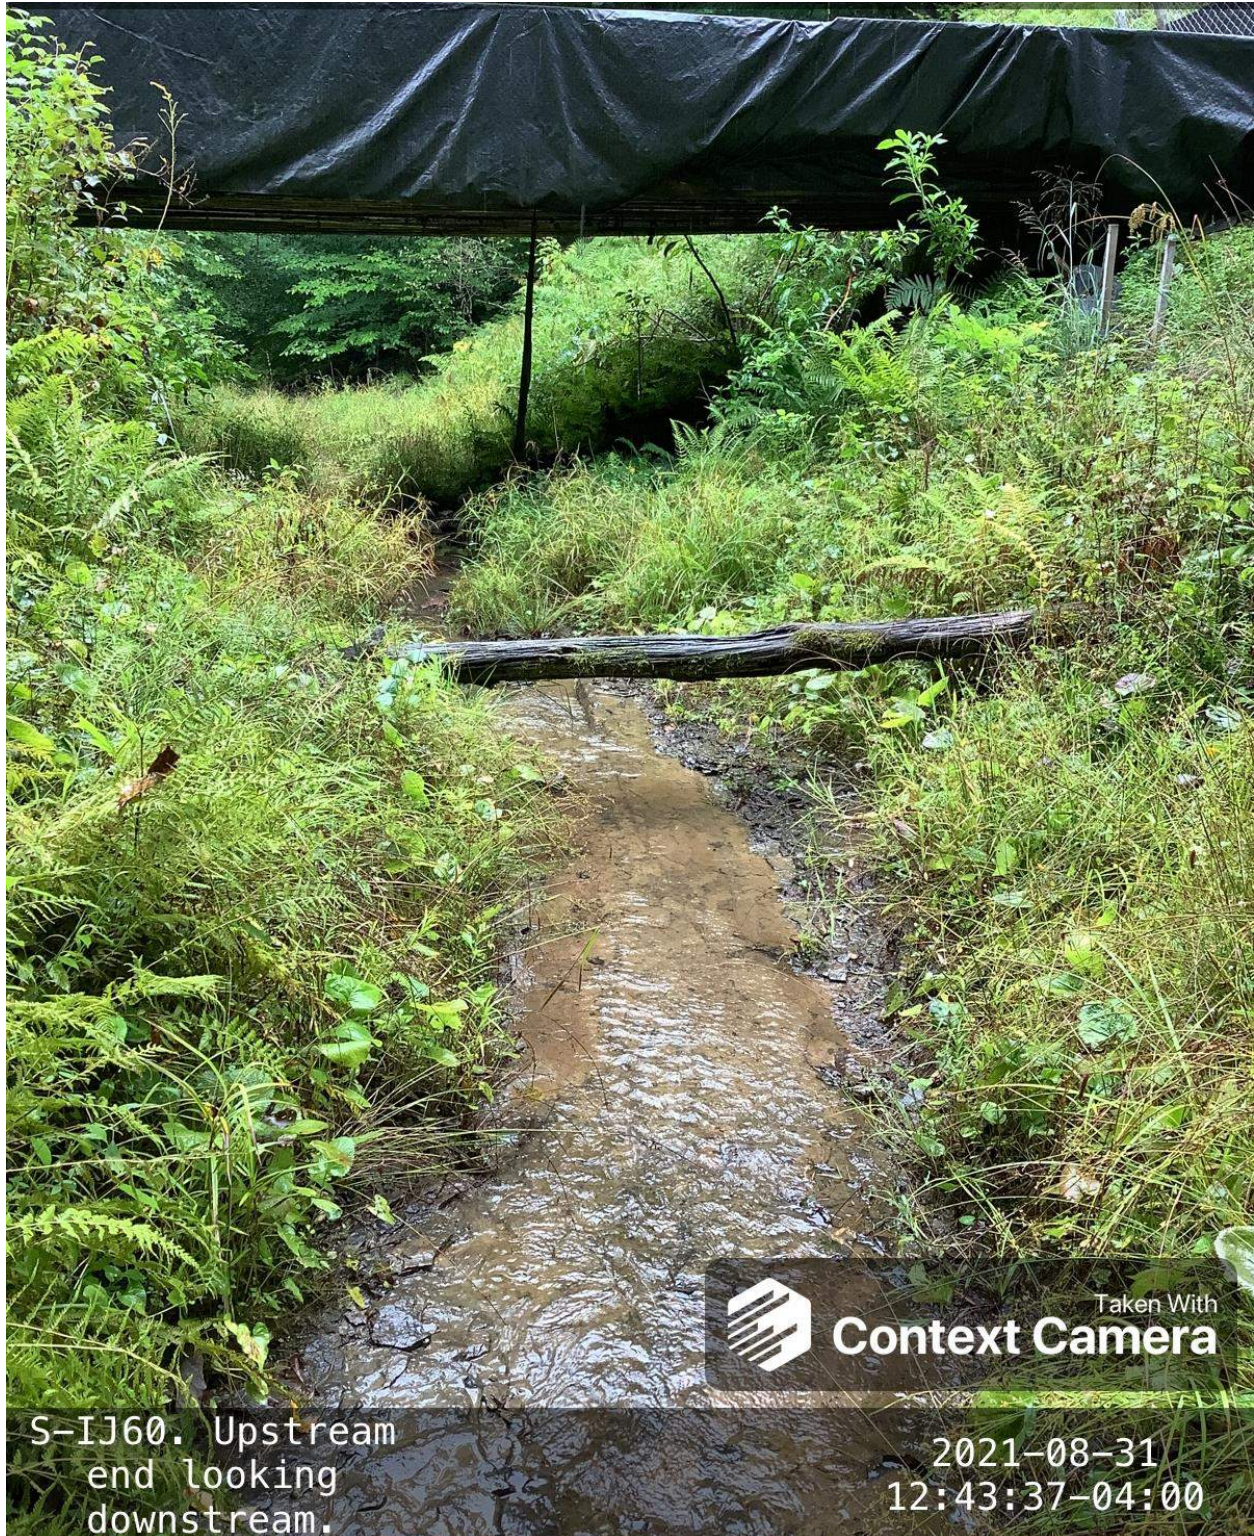
S-IJ60. Upstream
end looking
downstream.

Photo Type: US, DS View
Location, Orientation, Photographer Initials: Upstream Edge of ROW, Downstream View, JR/KP
Lat: 38.343699 Long: -80.644721

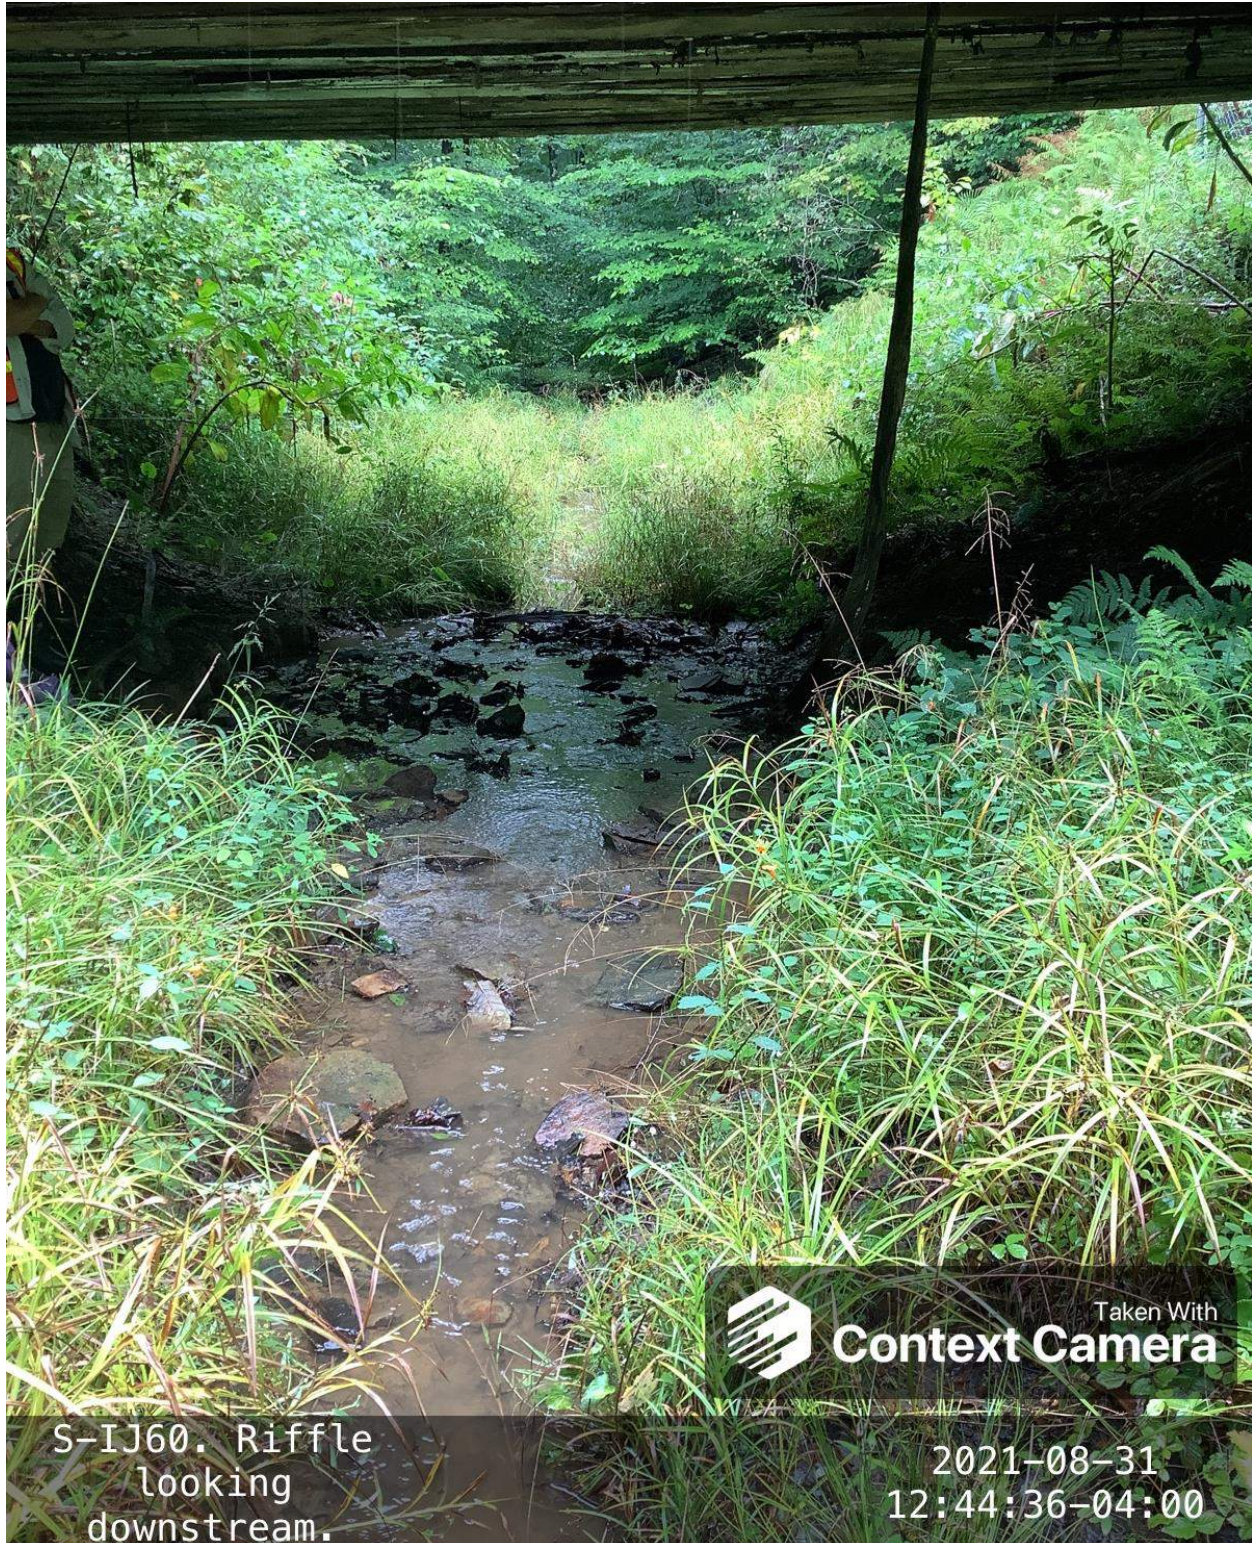
Photo Type: Riffle, DS View
Location, Orientation, Photographer Initials: Upstream of Riffle, Downstream View, JR/KP
Lat: 38.343699 Long: -80.644721

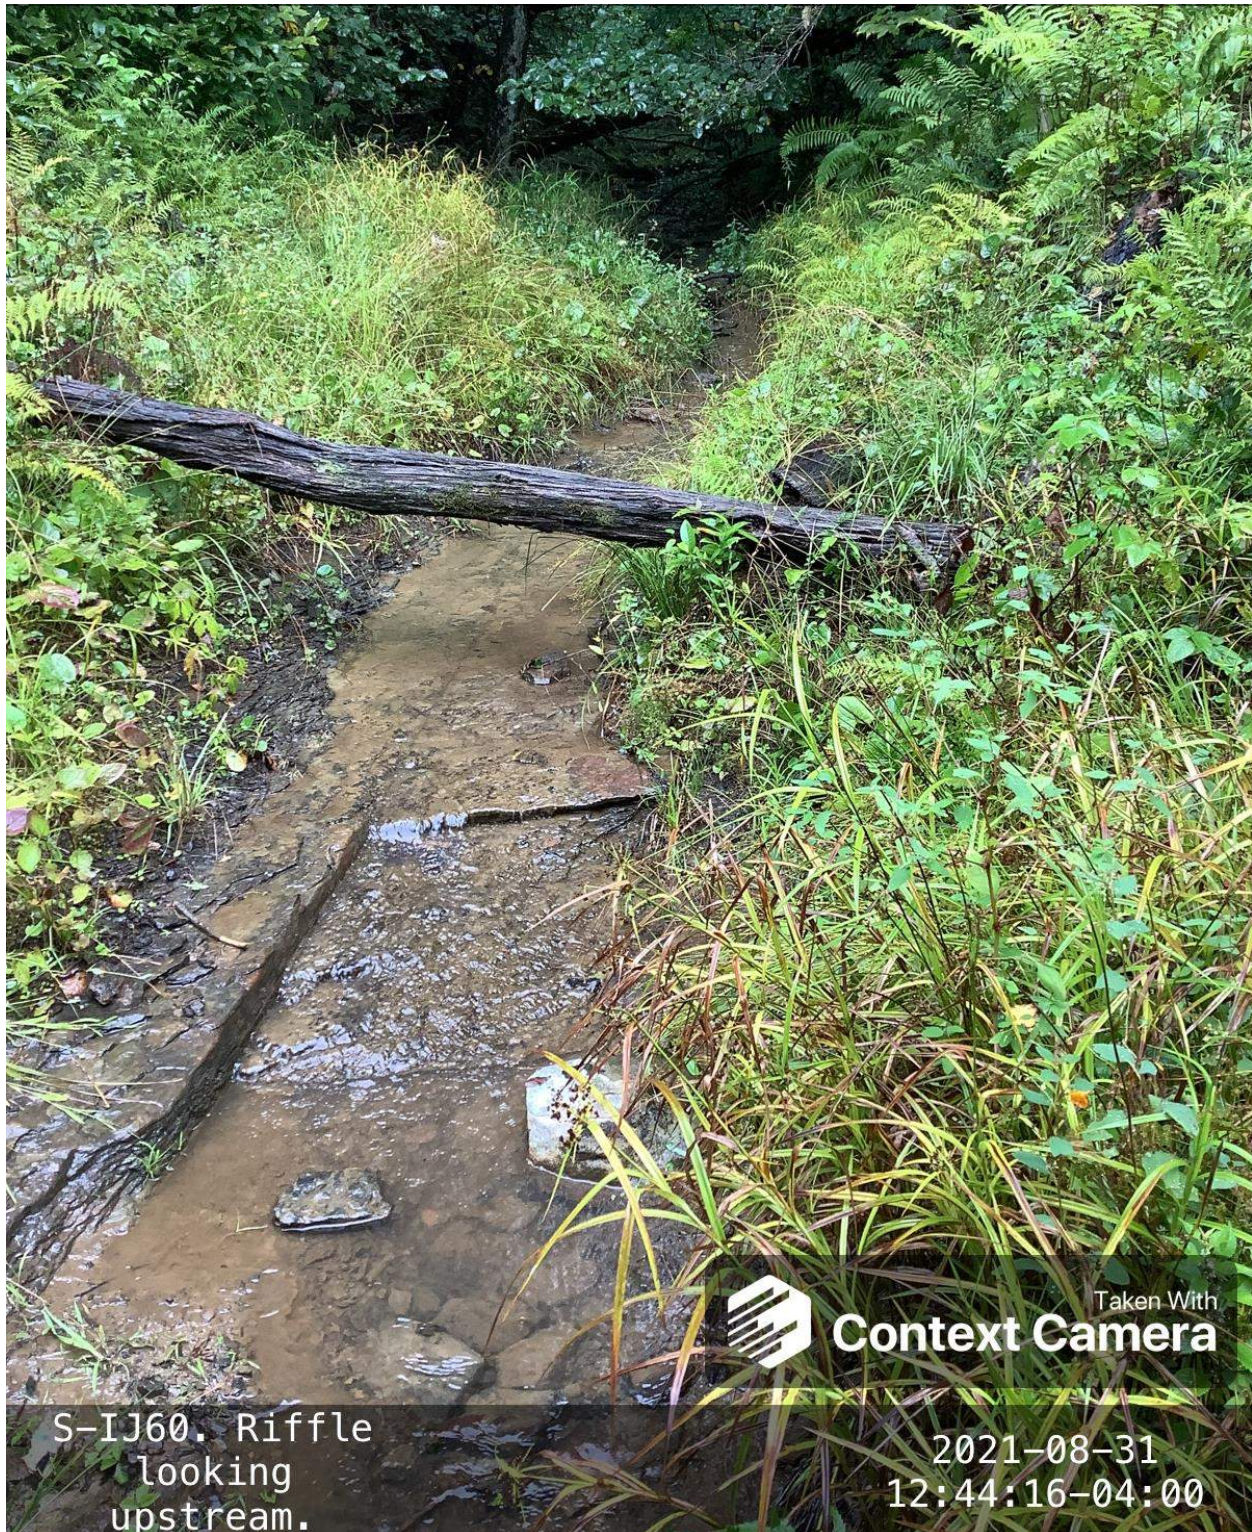
S-IJ60. Riffle
looking
upstream.

Photo Type: Riffle, US View

Location, Orientation, Photographer Initials: Downstream of Riffle, Upstream View, JR/KP

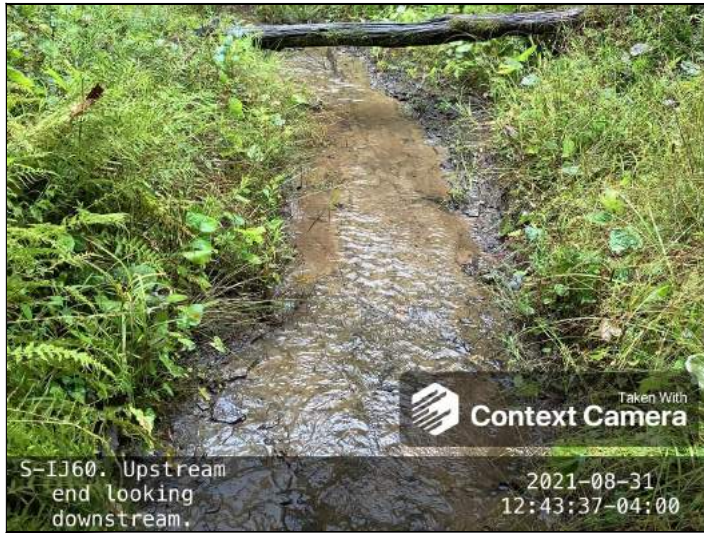
PHOTO TAKEN LOOKING DOWNSTREAM
FROM UPSTREAM IMPACT LIMITS

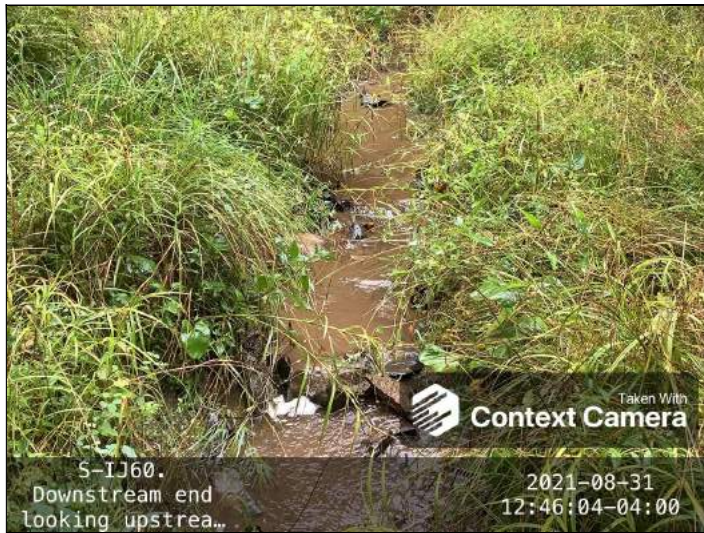
PHOTO TAKEN LOOKING UPSTREAM FROM
DOWNSTREAM IMPACT LIMITS
