Baseline Assessment – Stream Attributes

Reach S-J24 (1) (Pipeline ROW)

Nicholas County, West Virginia

Client	222 M(
Profile and Cross-Sections	
Baseline Survey	
Crossing S-J24 (1) – Unnamed Trib.	
to Little Laurel Creek (MP 120.25)

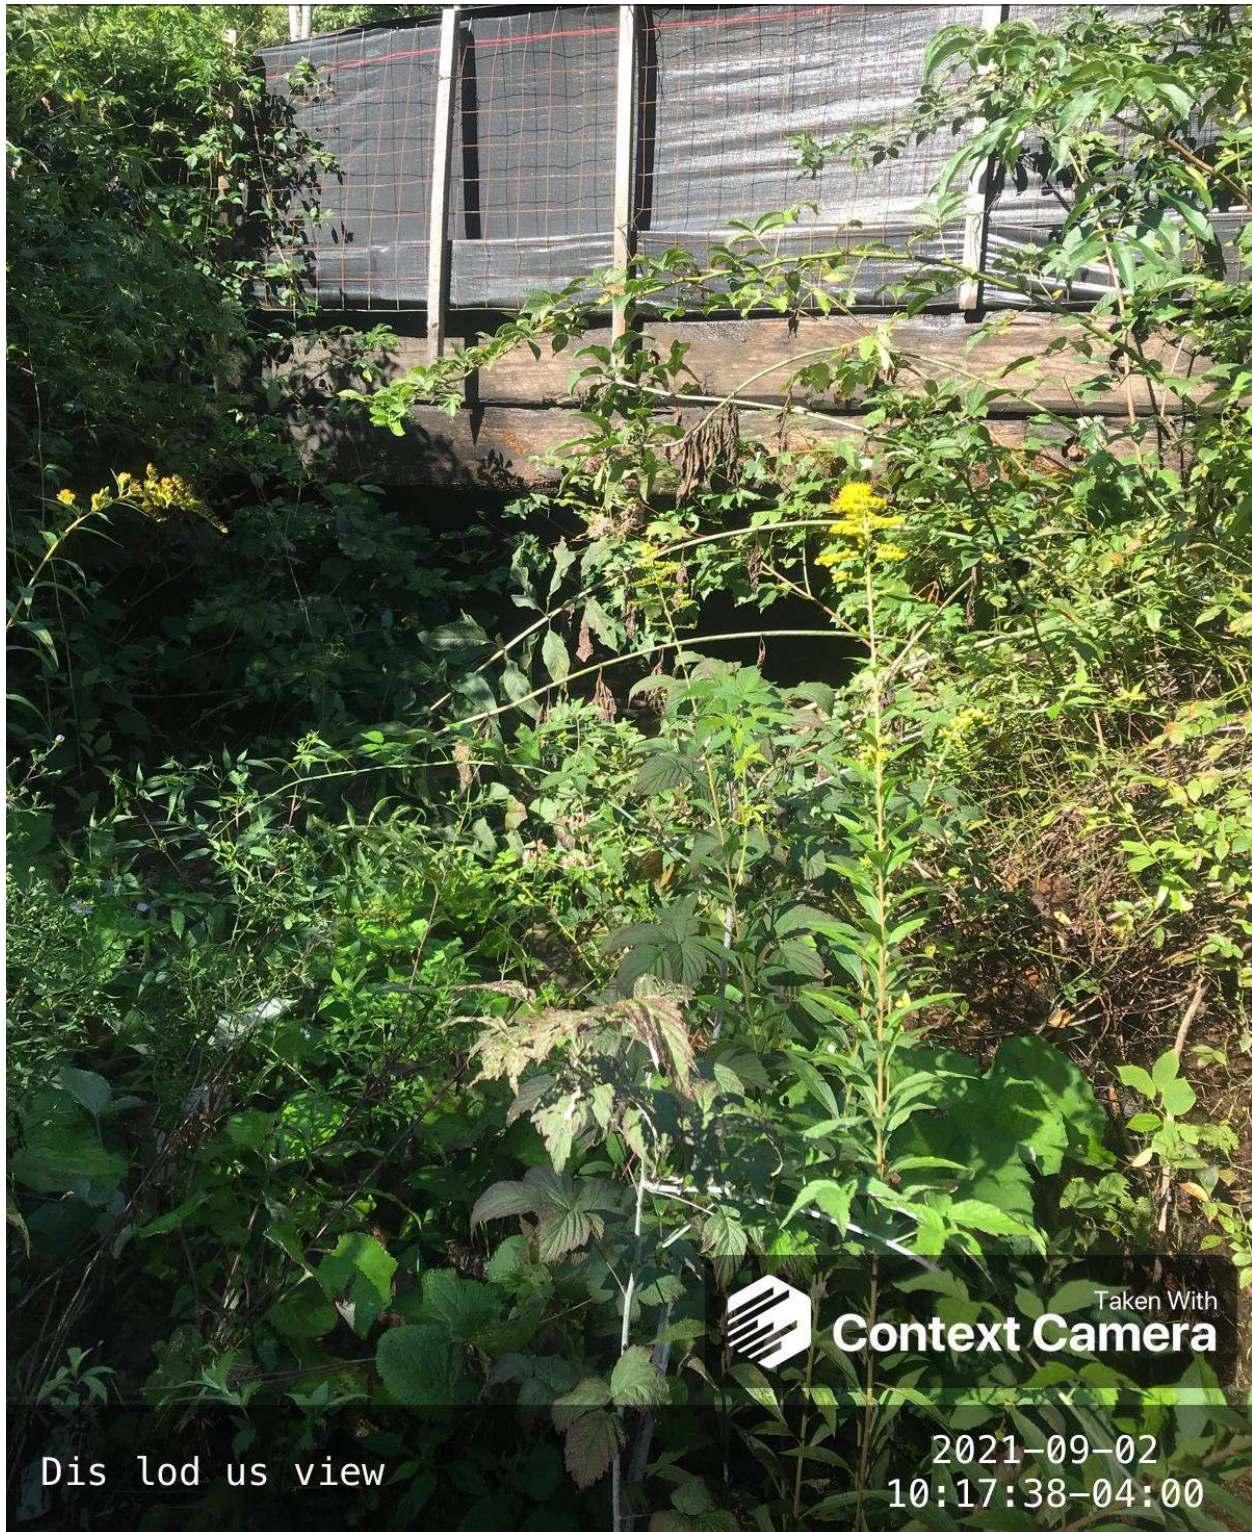
Photo Type: DS, US View
Location, Orientation, Photographer Initials: Downstream Edge of ROW, Upstream View, JM/SM
Lat: 38.256302 Long: -80.68735

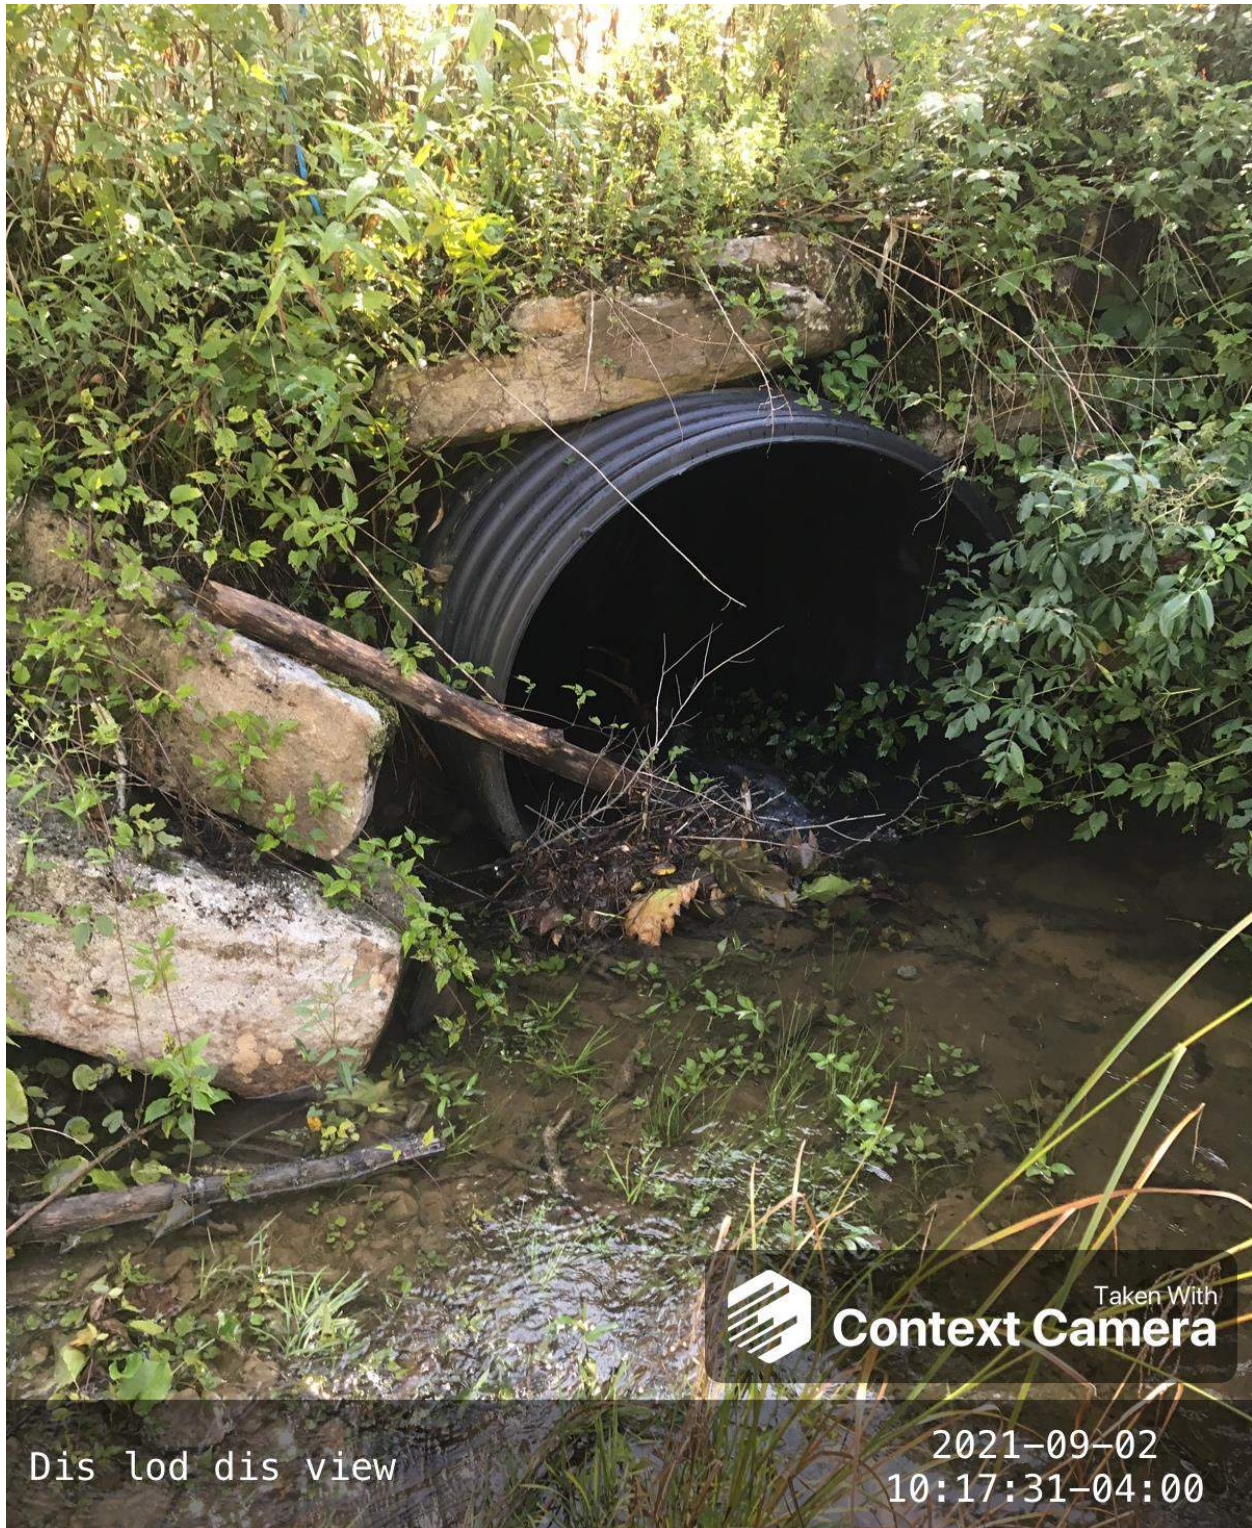
Photo Type: DS, DS View
Location, Orientation, Photographer Initials: Downstream Edge of ROW, Downstream View, JM/SM
Lat: 38.256302 Long: -80.68735

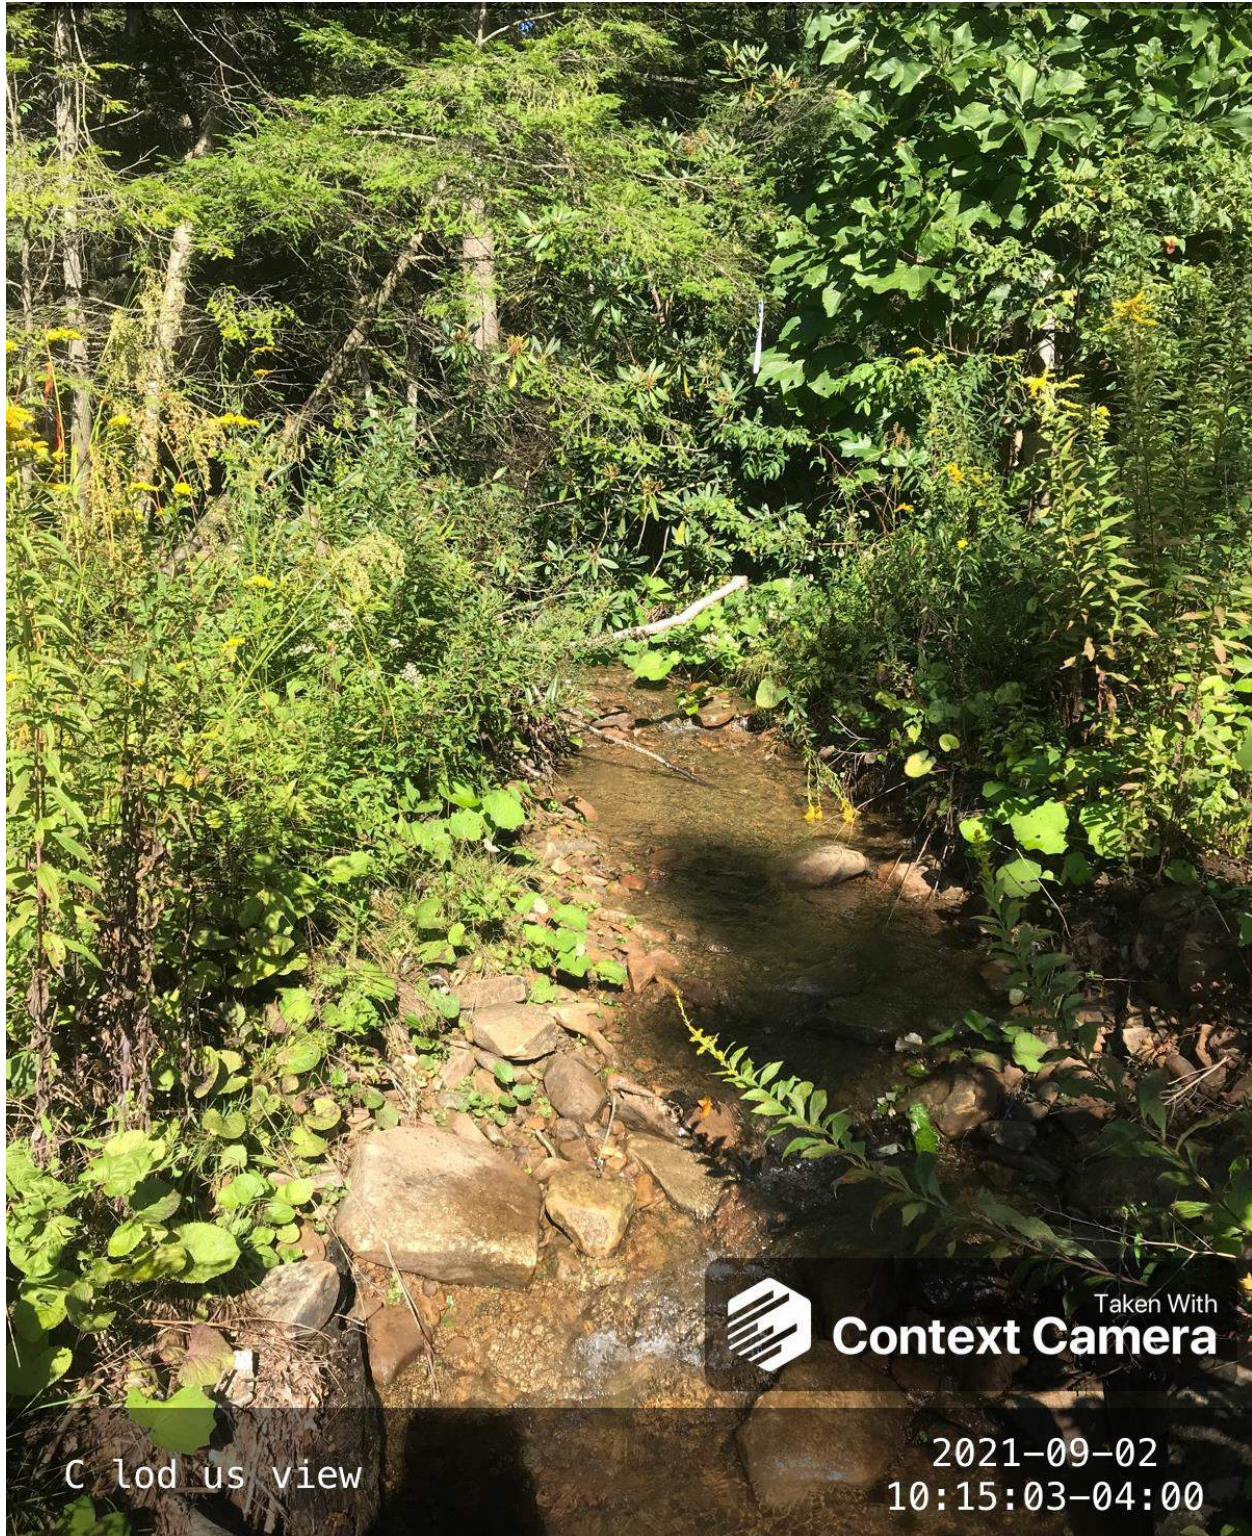
Photo Type: US View at Center
Location, Orientation, Photographer Initials: Center ROW, Upstream View, JM/SM
Lat: 38.256302 Long: -80.68735

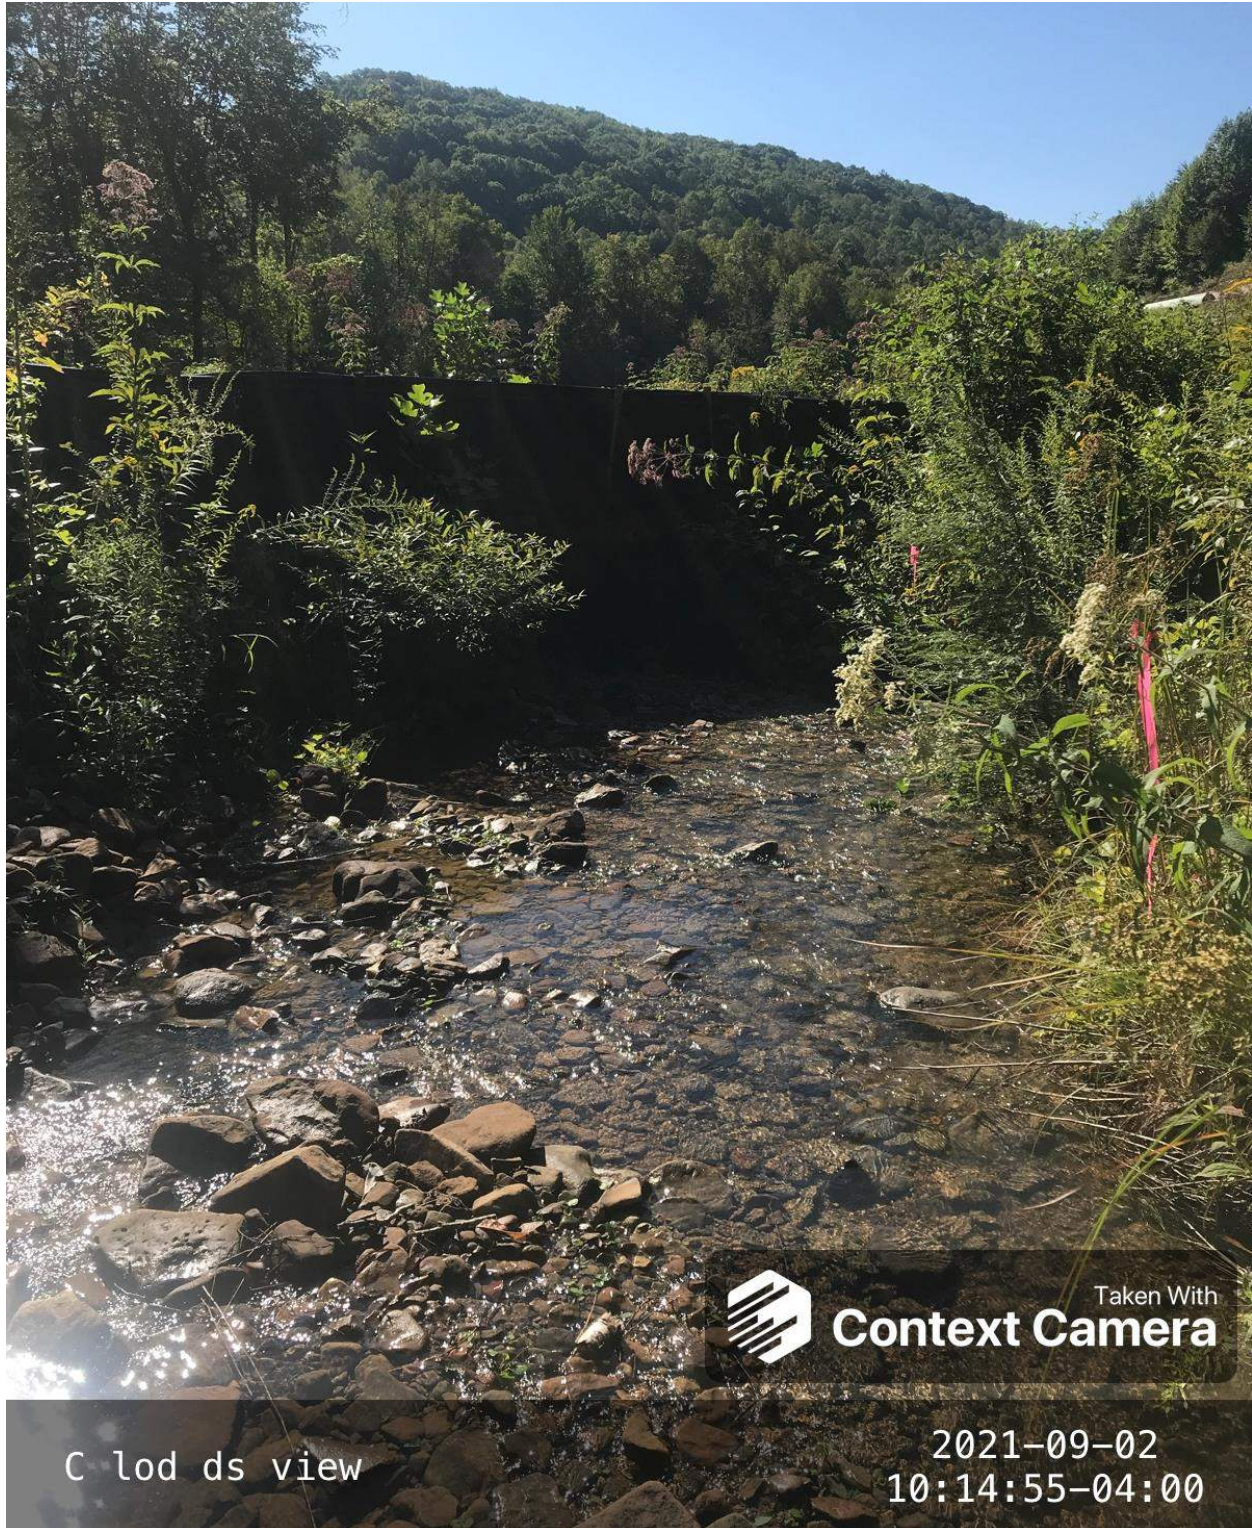
Photo Type: DS View at Center
Location, Orientation, Photographer Initials: Center ROW, Downstream View, JM/SM
Lat: 38.256302 Long: -80.68735

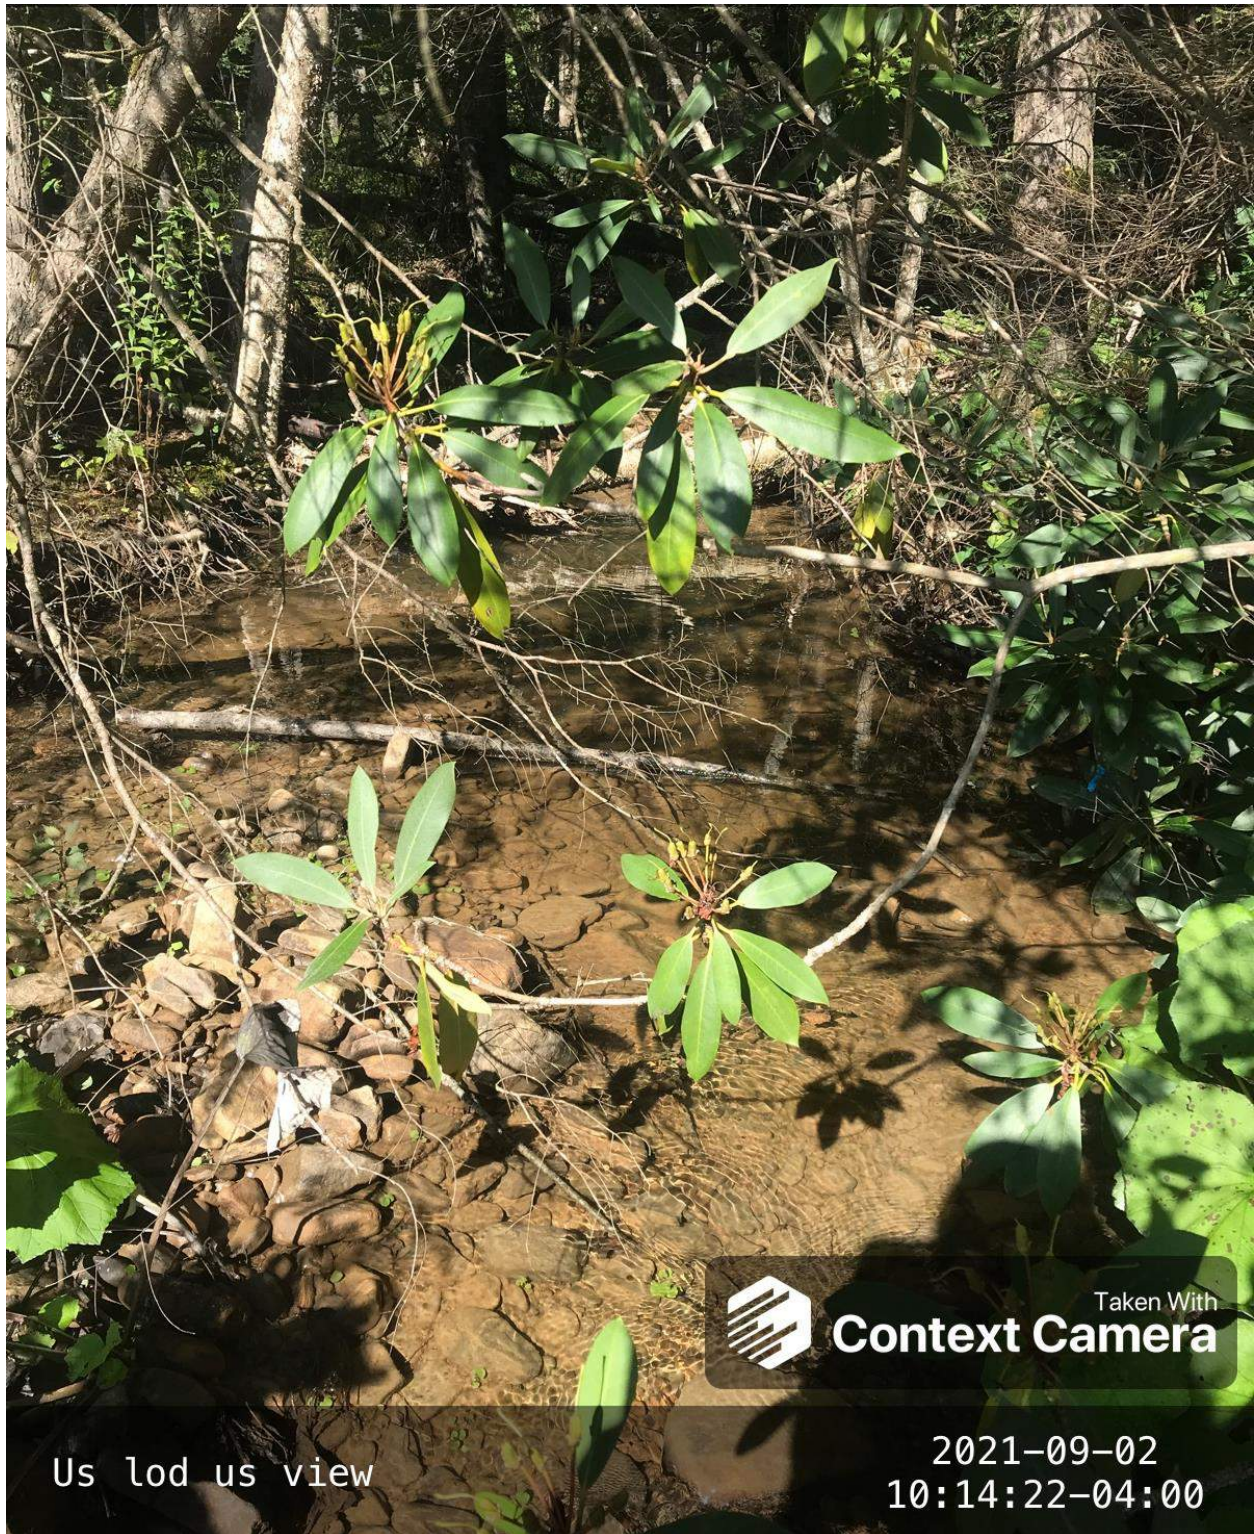
Photo Type: US, US View
Location, Orientation, Photographer Initials: Upstream Edge of ROW, Upstream View, JM/SM
Lat: 38.256302 Long: -80.68735

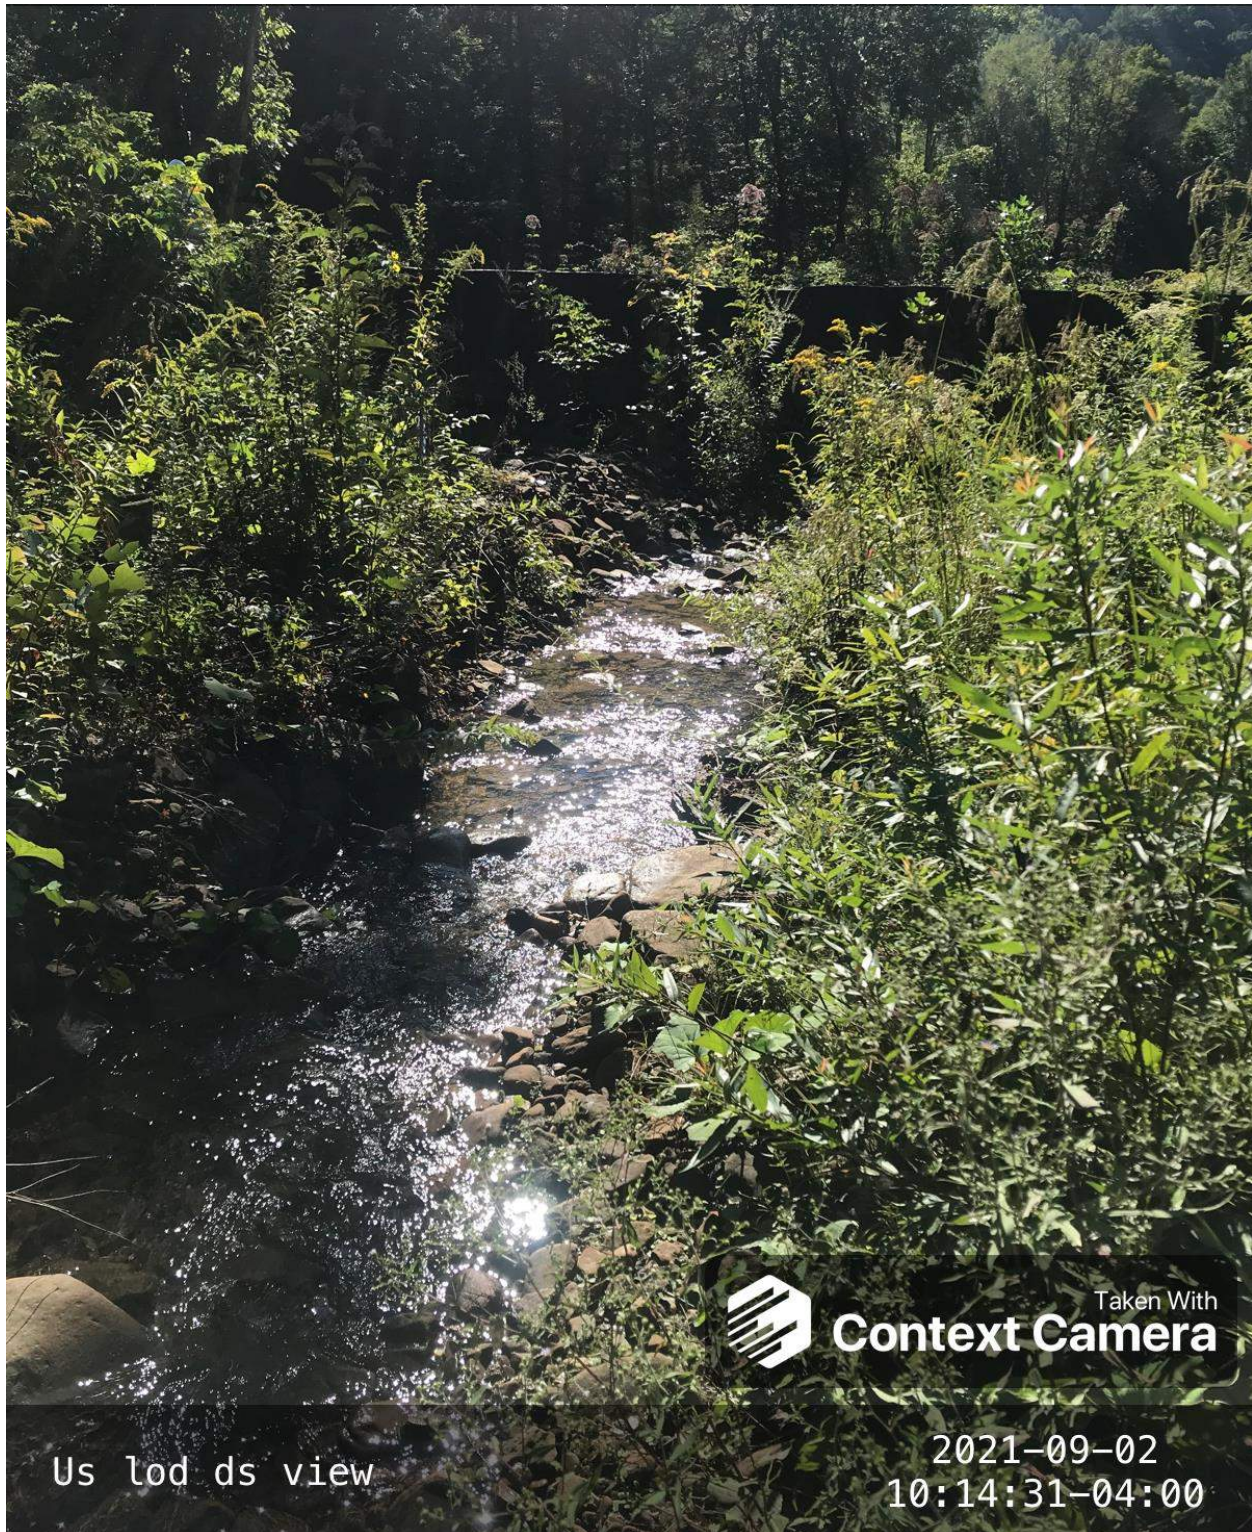
Photo Type: US, DS View
Location, Orientation, Photographer Initials: Upstream Edge of ROW, Downstream View, JM/SM
Lat: 38.256302 Long: -80.68735

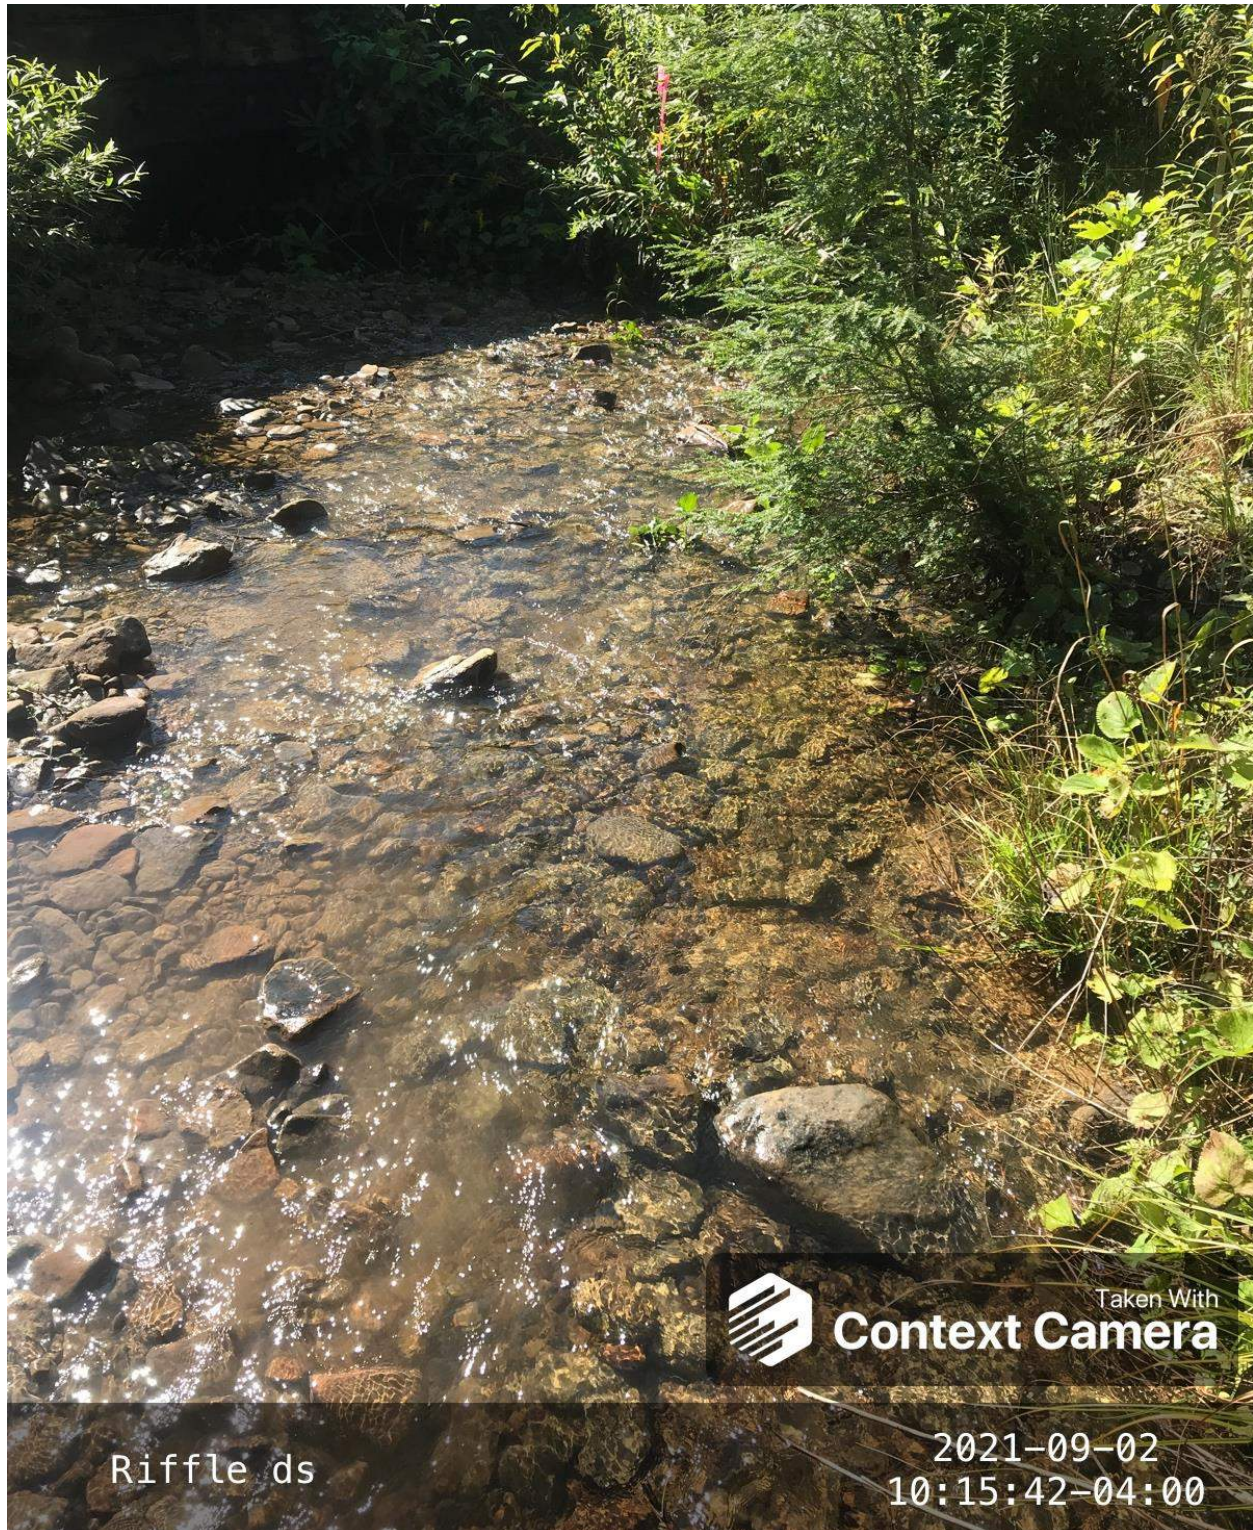
Photo Type: Riffle, DS View
Location, Orientation, Photographer Initials: Upstream of Riffle, Downstream View, JM/SM
Lat: 38.256302 Long: -80.68735

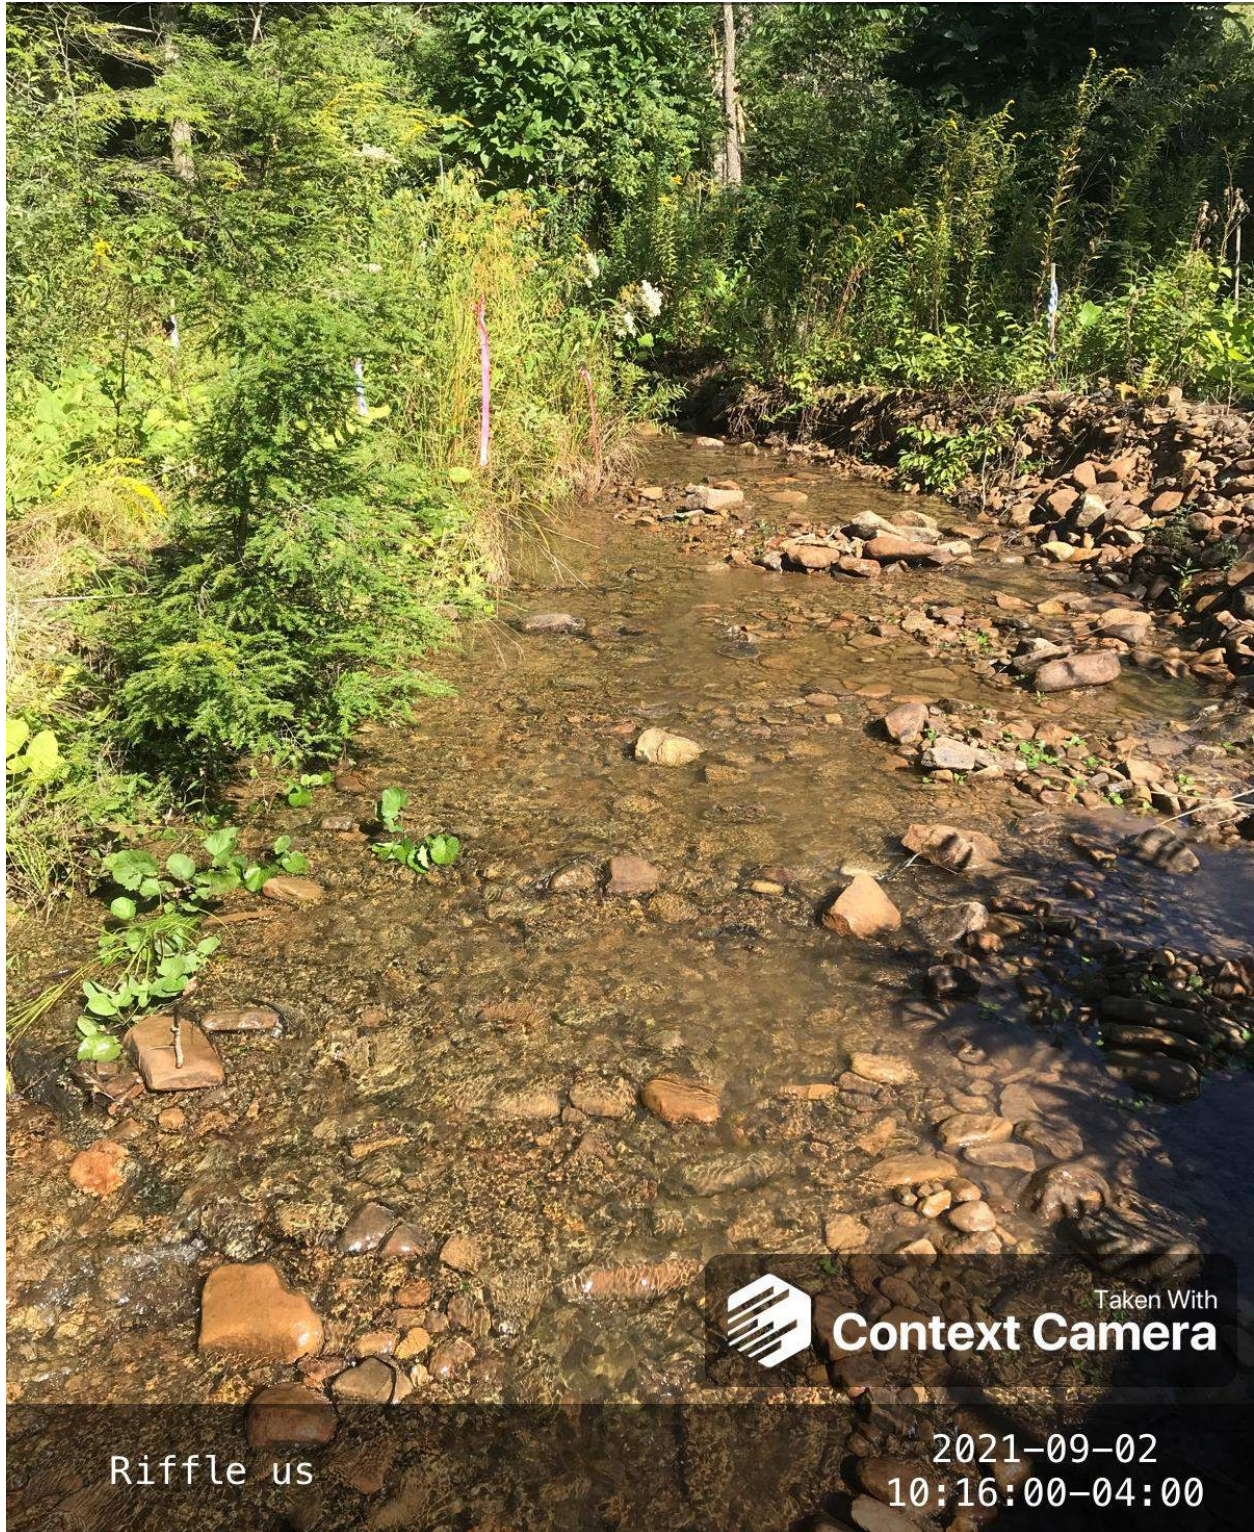
Photo Type: Riffle, US View
Location, Orientation, Photographer Initials: Downstream of Riffle, Upstream View, JM/SM
Lat: 38.256302 Long: -80.68735

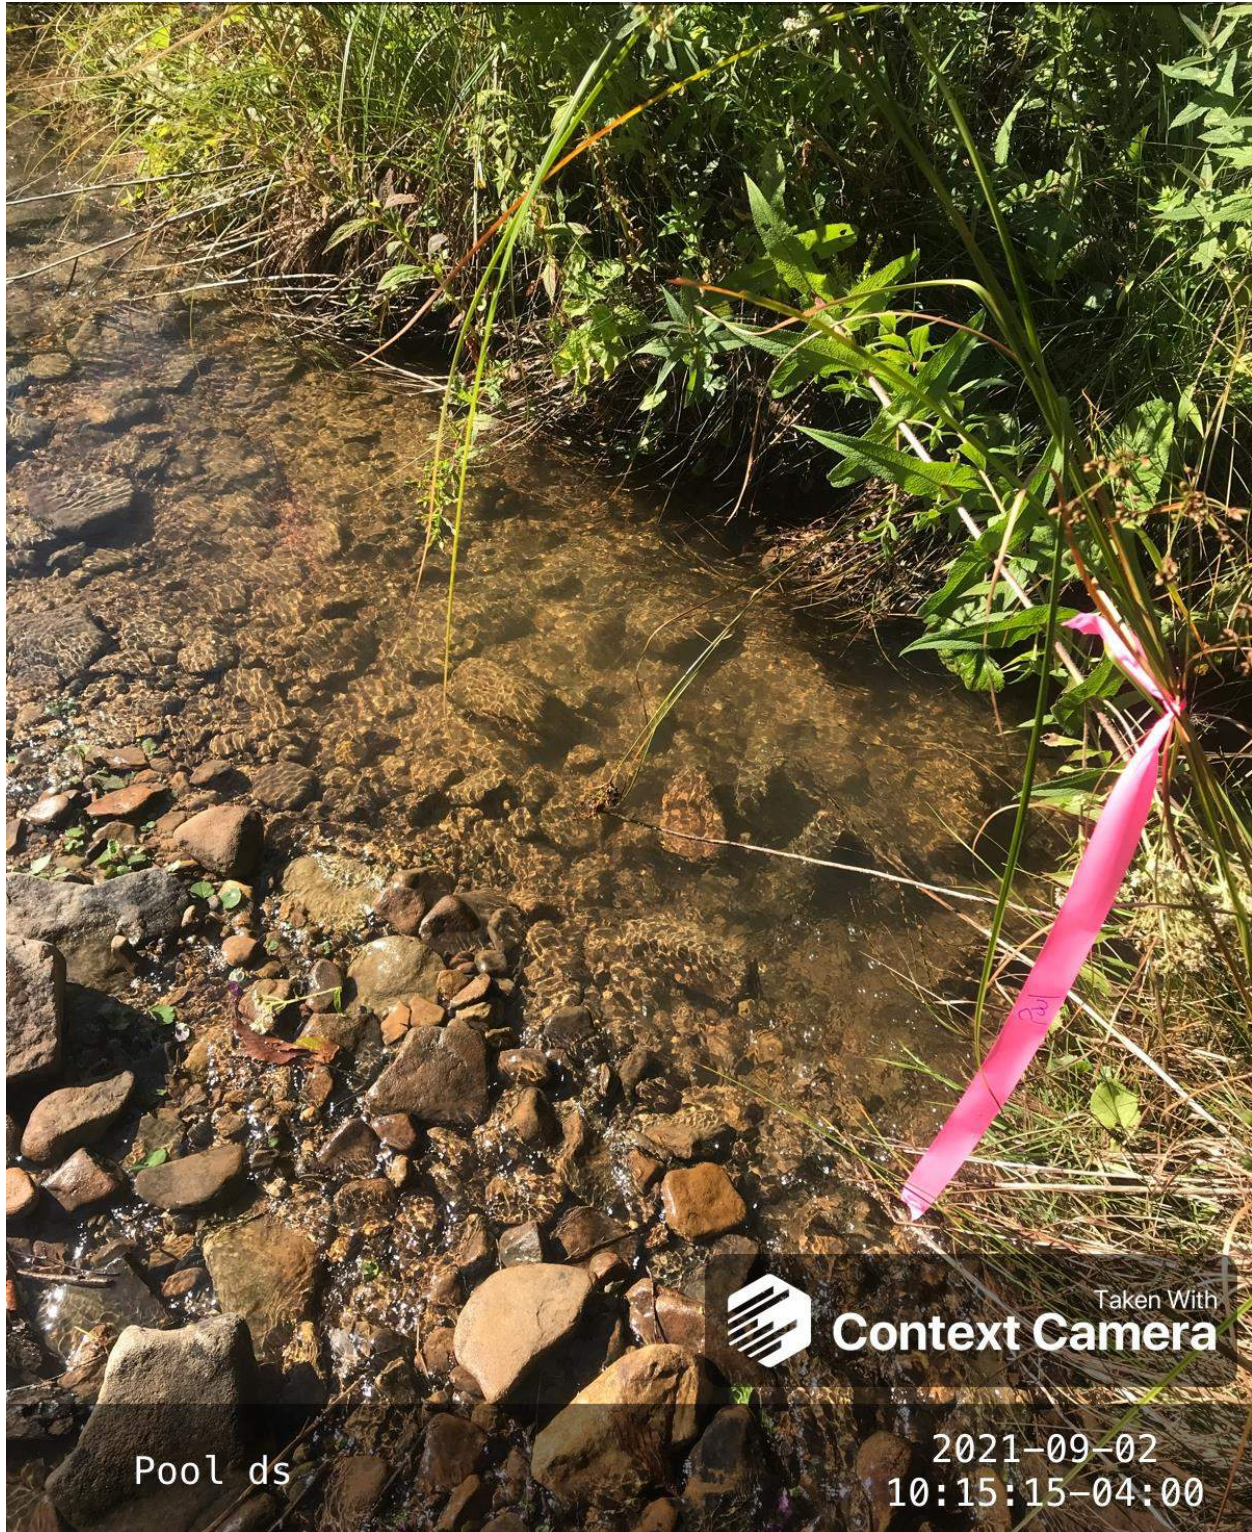
Photo Type: Pool, DS View
Location, Orientation, Photographer Initials: Upstream of Pool, Downstream View, JM/SM
Lat: 38.256302 Long: -80.68735

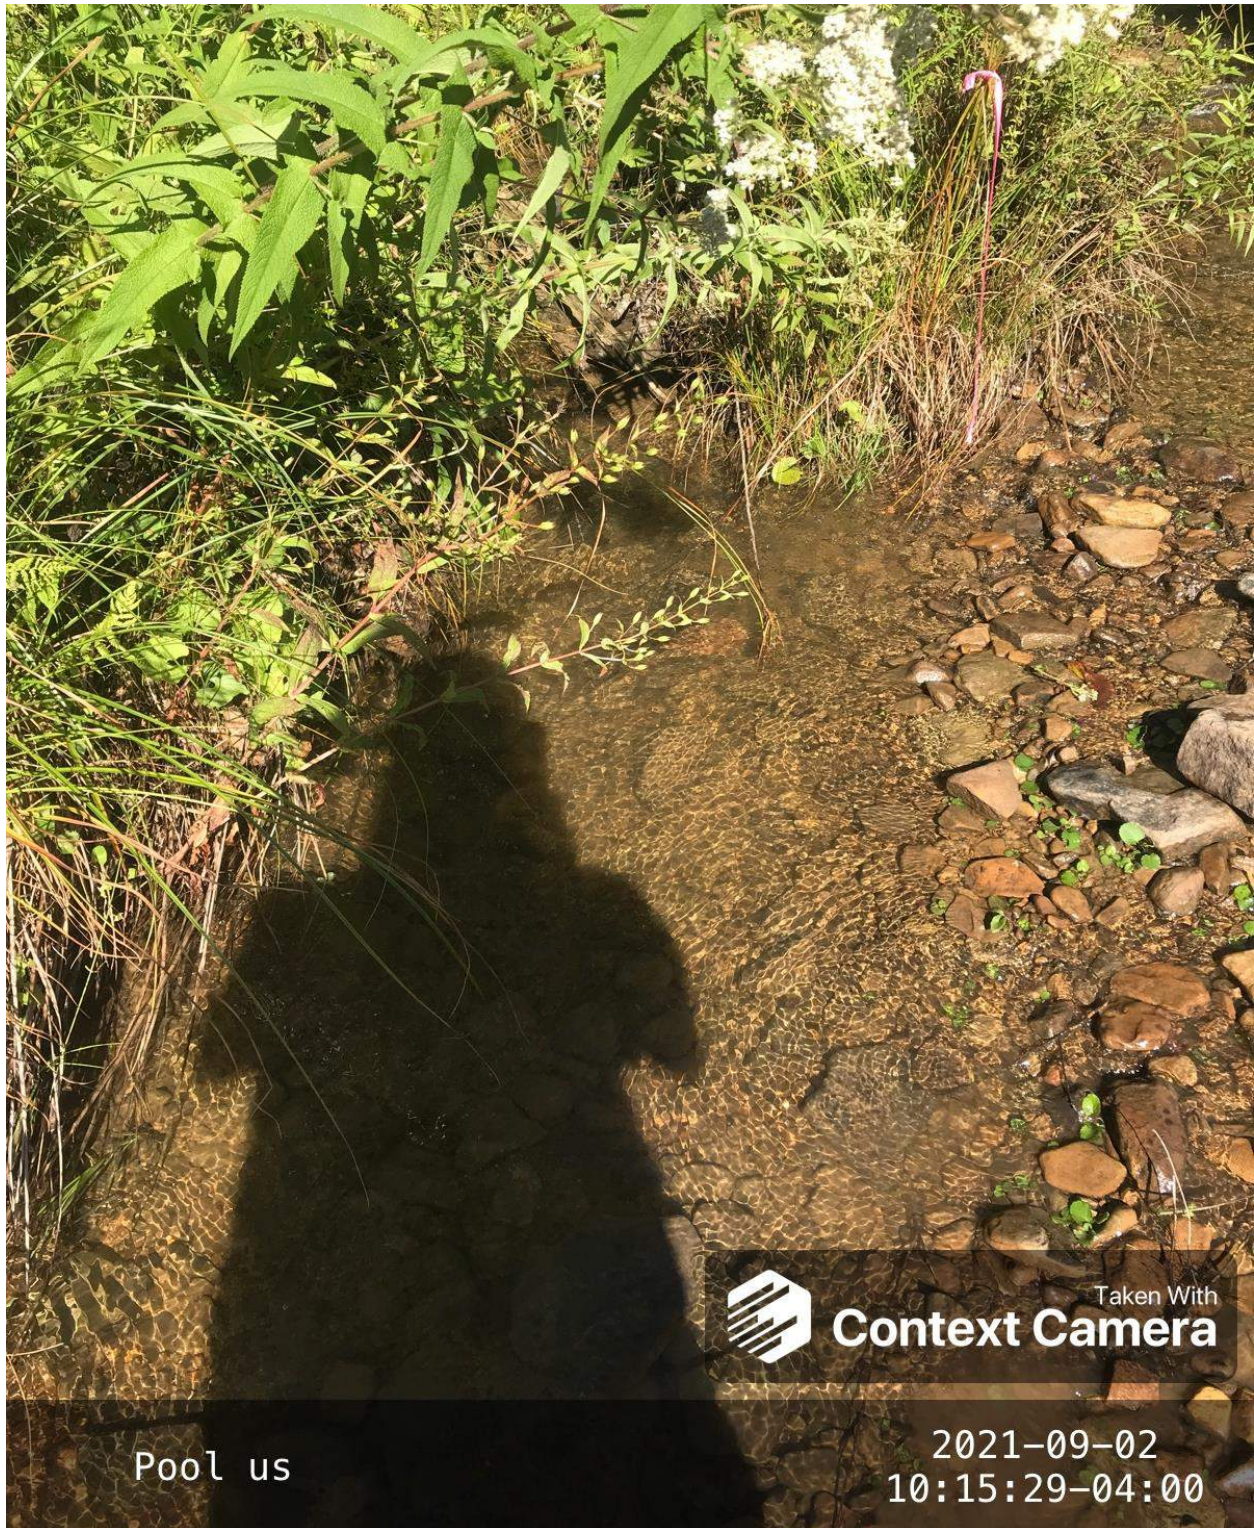
Photo Type: Pool, US View
Location, Orientation, Photographer Initials: Downstream of Pool, Upstream View, JM/SM
Lat: 38.256302 Long: -80.68735

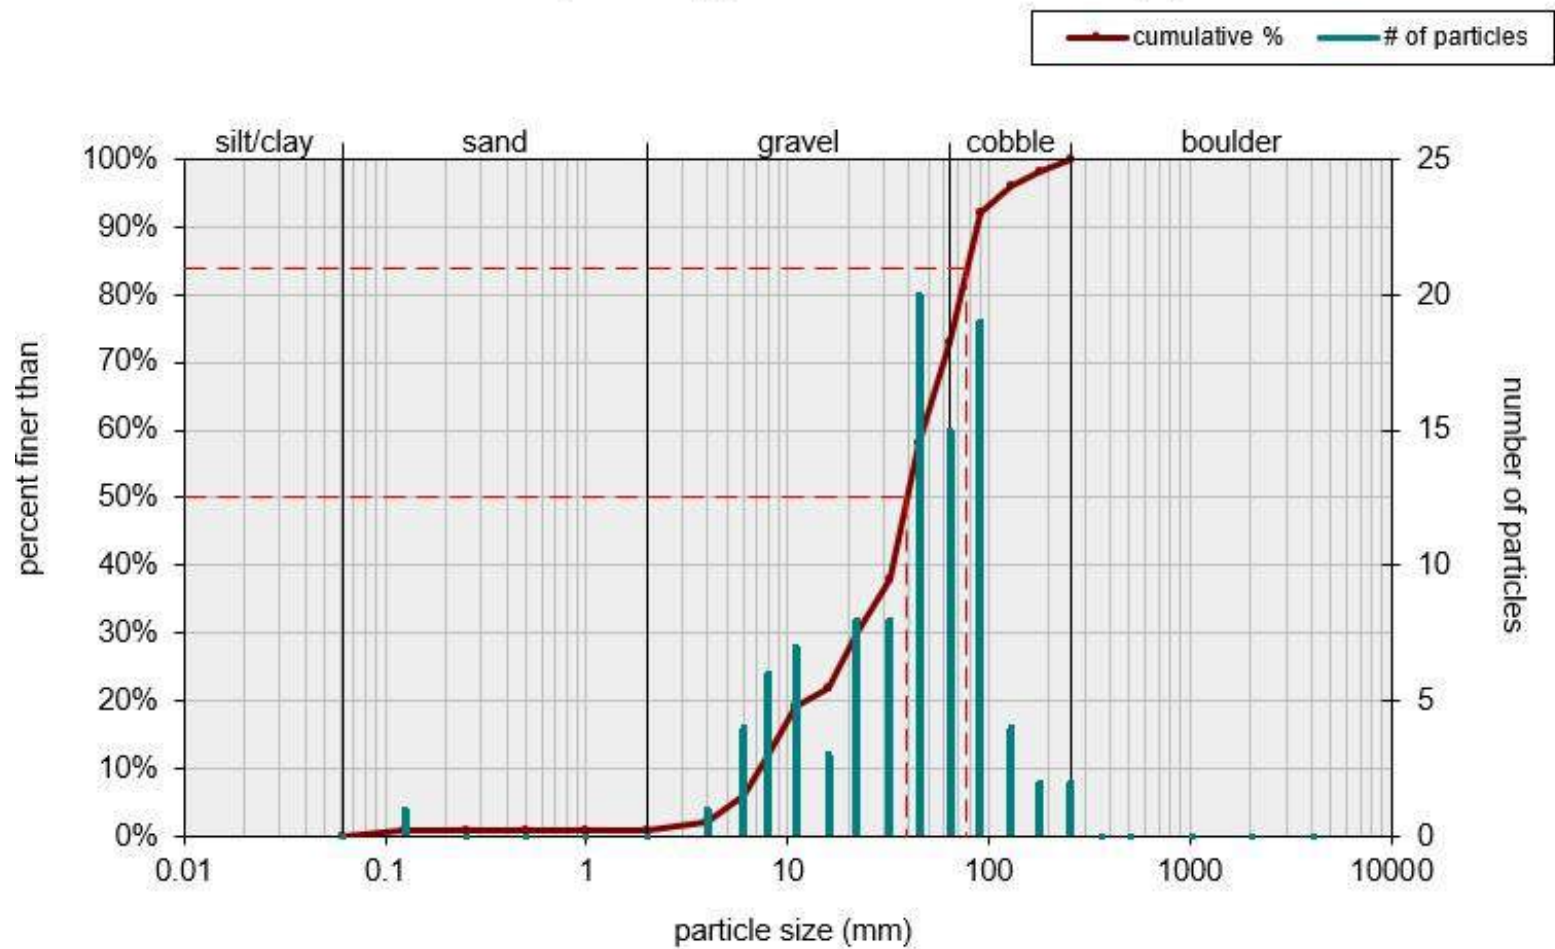
Bankfull Channel Pebble Count, S-J24 (1), UNT to Little Laurel Creek (1)

Size (mm)	
D16	9.6
D35	28
D50	39
D65	53
D84	78
D95	120

Size Distribution	
mean	27.4
dispersion	3.0
skewness	-0.16

Type	
silt/clay	0%
sand	1%
gravel	72%
cobble	27%
boulder	0%

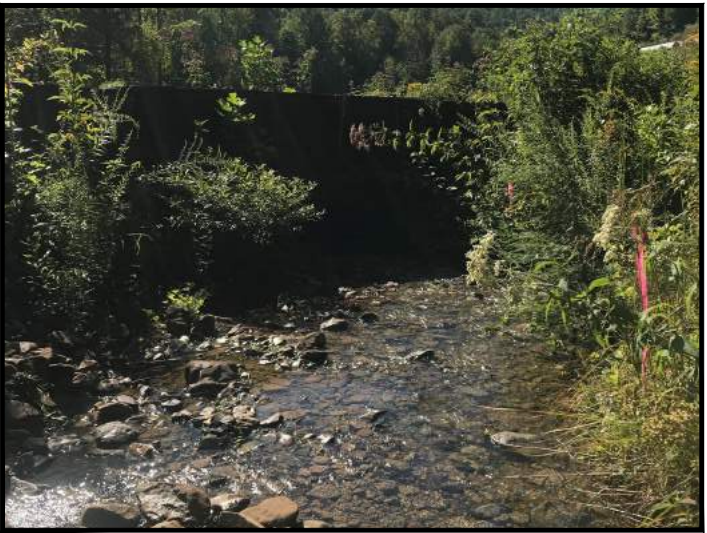
PHOTO TAKEN LOOKING DOWNSTREAM
FROM UPSTREAM IMPACT LIMITS

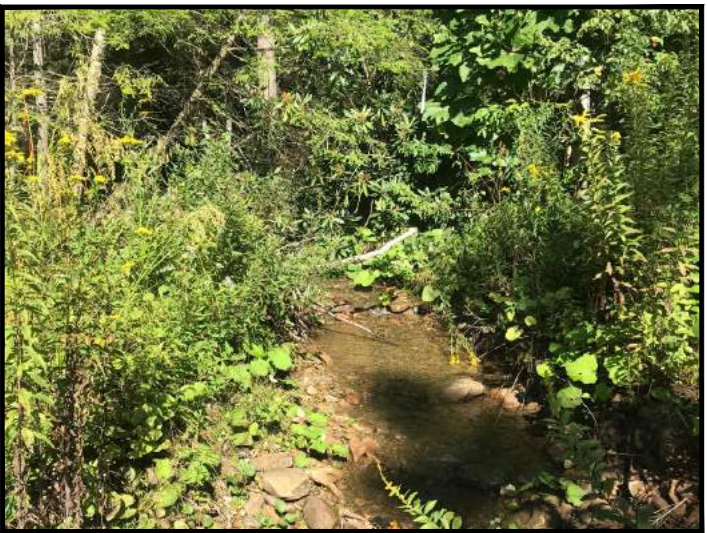
PHOTO TAKEN LOOKING UPSTREAM FROM
DOWNSTREAM IMPACT LIMITS
