Baseline Assessment – Stream Attributes

Reach S-J24 (2) (Pipeline ROW)

Nicholas County, West Virginia

Client	PROFILE AND CROSS-SECTIONS BASELINE SURVEY CROSSING S-J24 (2) - UNNAMED TRIB. TO LITTLE LAUREL CREEK (MP 120.25) NICHOLAS COUNTY, WV
Mile	22.22

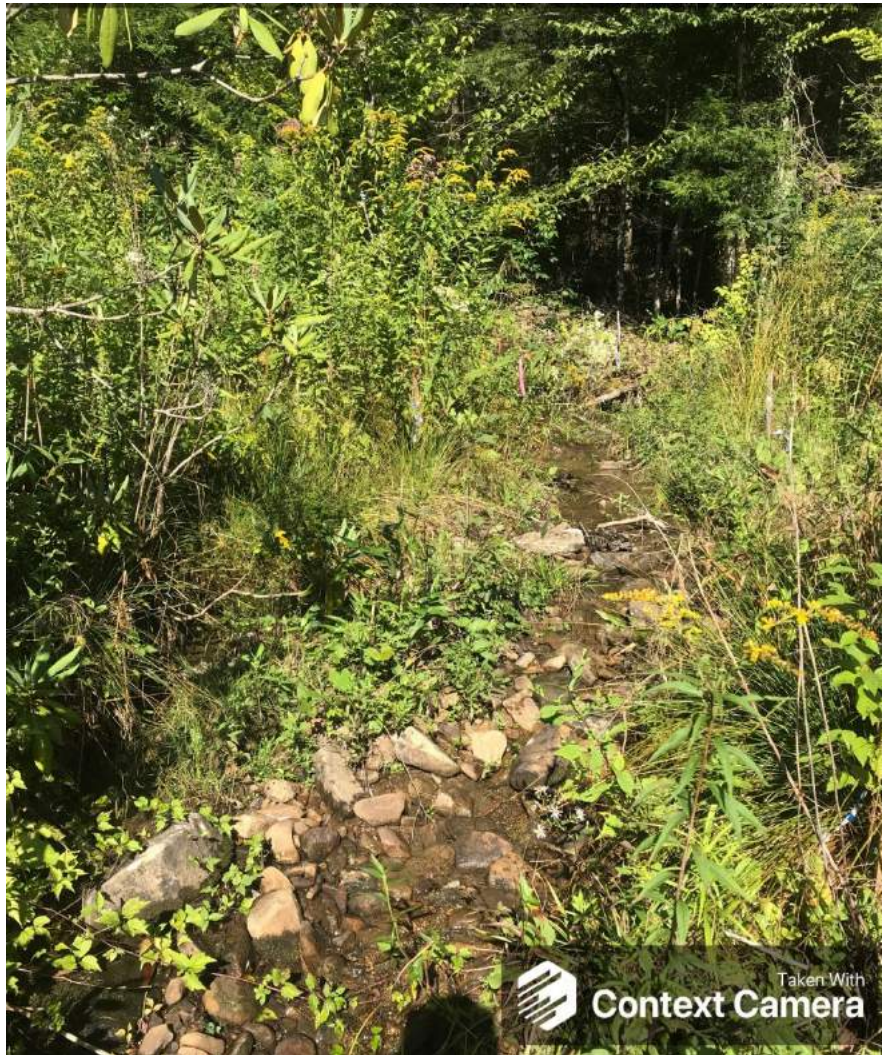
Photo Type: DS, US View

Location, Orientation, Photographer Initials: Downstream Edge of ROW, Upstream View, SM/JM
Lat: 38.256248 Long: -80.687358

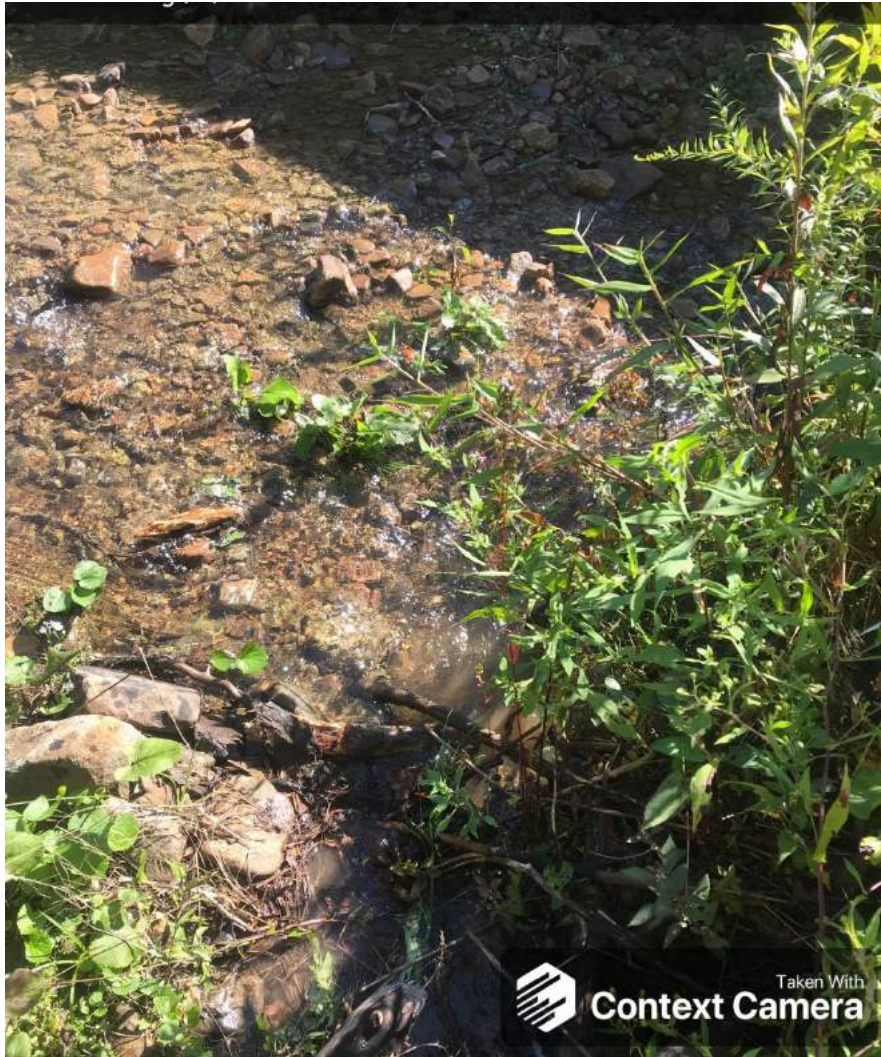
Photo Type: DS, DS View

Location, Orientation, Photographer Initials: Downstream Edge of ROW, Downstream View, SM/JM
Lat: 38.256248 Long: -80.687358

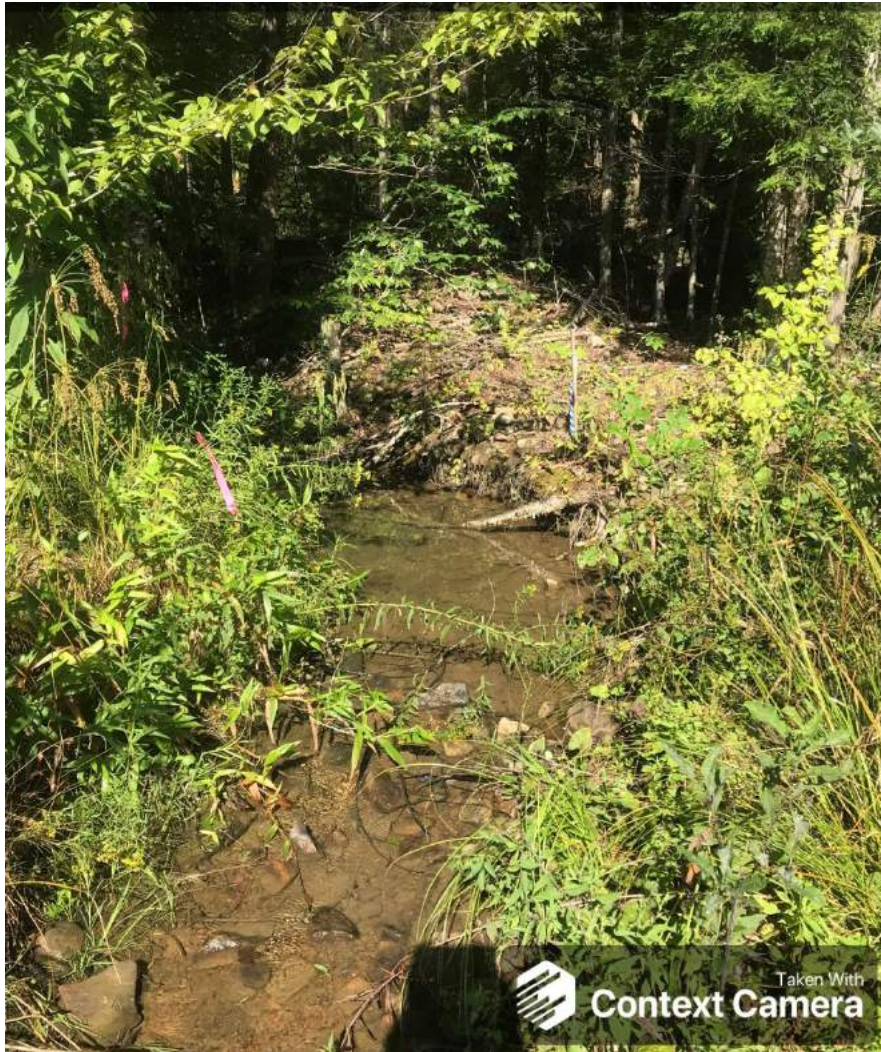
Photo Type: US View at Center
Location, Orientation, Photographer Initials: Center ROW, Upstream View, SM/JM
Lat: 38.256248 Long: -80.687358

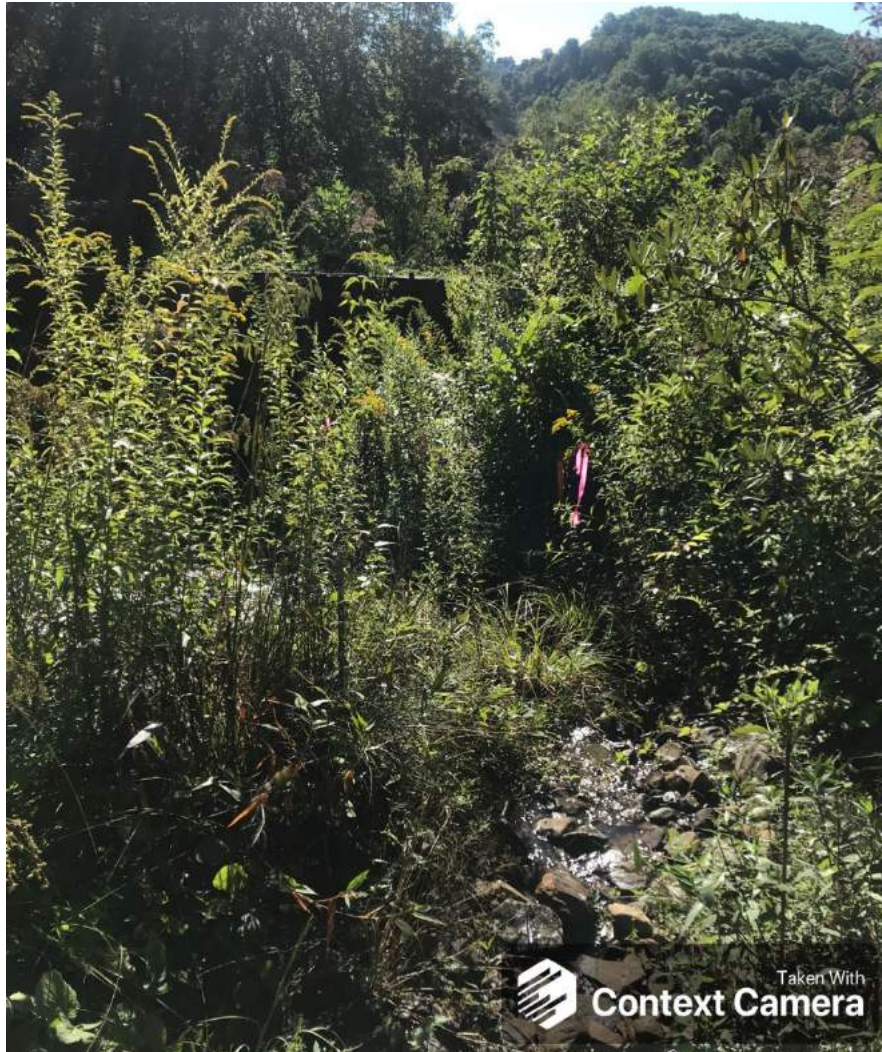
Photo Type: DS View at Center
Location, Orientation, Photographer Initials: ROW Center, Downstream View, SM/JM
Lat: 38.256248 Long: -80.687358

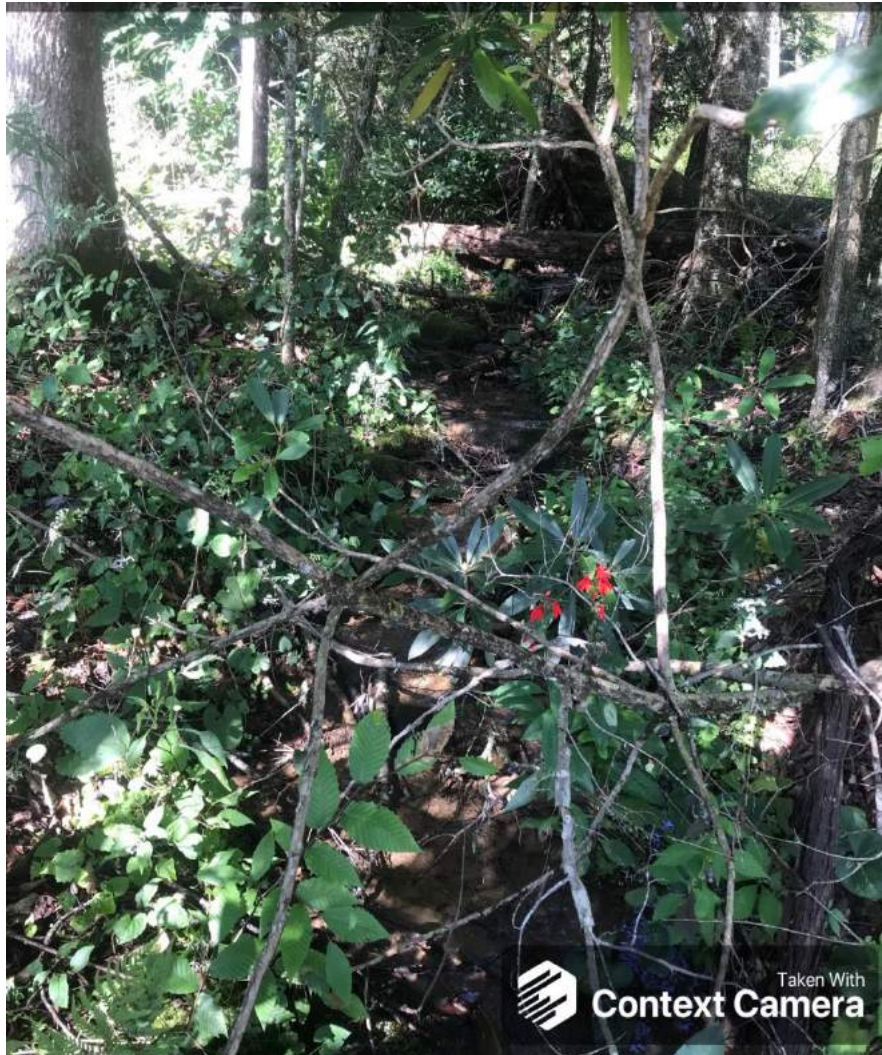
Photo Type: US, US View

Location, Orientation, Photographer Initials: Upstream Edge of ROW, Upstream View, SM/JM
Lat: 38.256248 Long: -80.687358

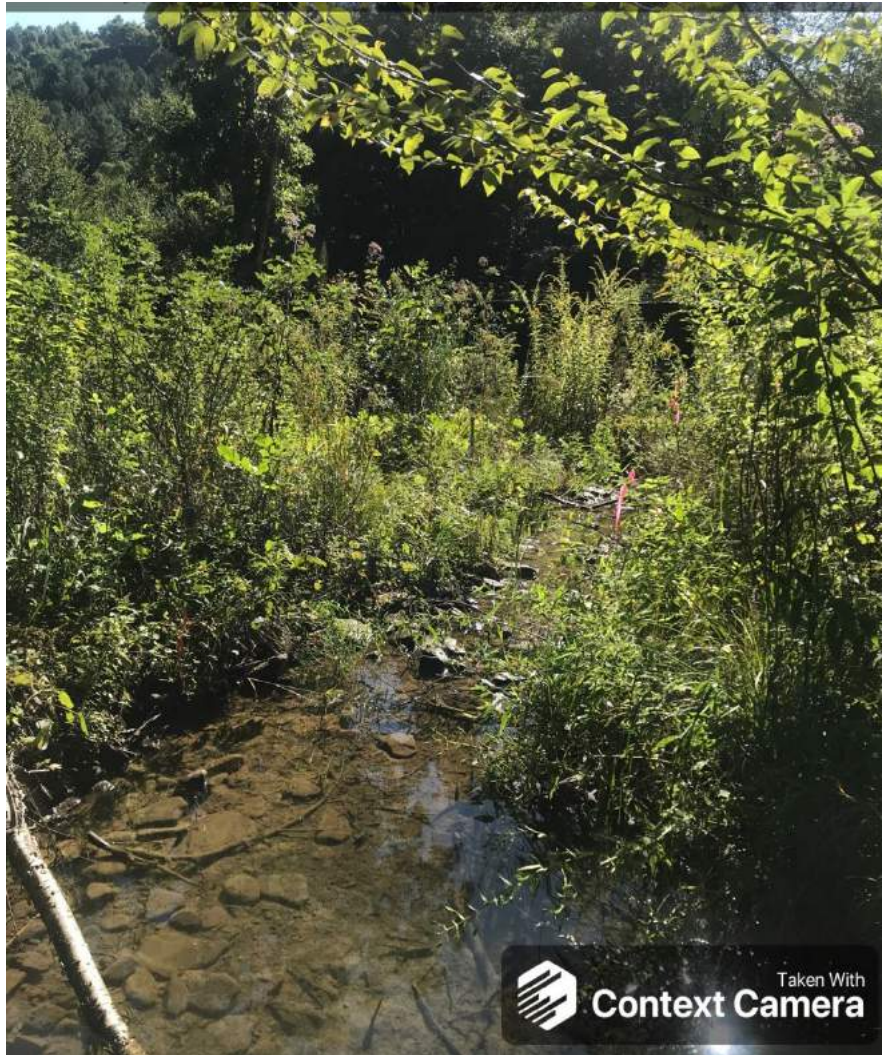
Photo Type: US, DS View
Location, Orientation, Photographer Initials: Upstream Edge of ROW, Downstream View, SM/JM
Lat: 38.256248 Long: -80.687358

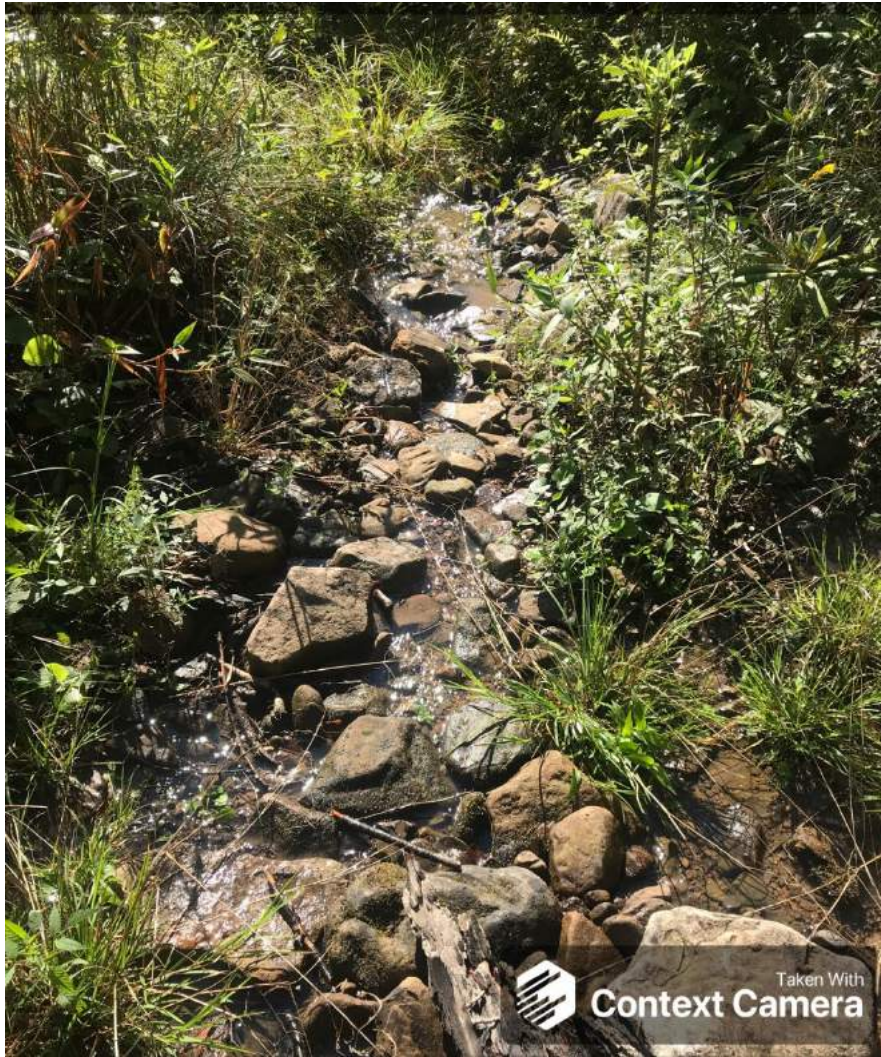
Photo Type: Riffle, DS View
Location, Orientation, Photographer Initials: Upstream of Riffle, Downstream View, SM/JM
Lat: 38.256248 Long: -80.687358

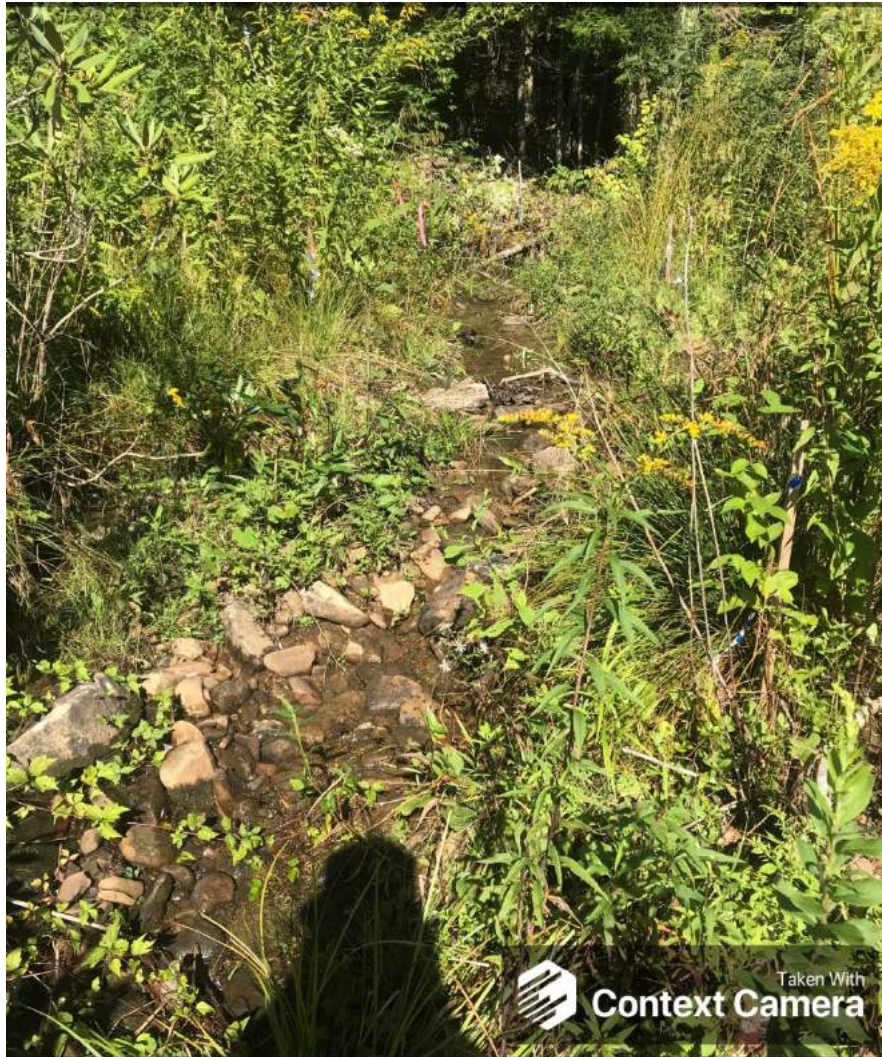
Photo Type: Riffle, US View
Location, Orientation, Photographer Initials: Downstream of Riffle, Upstream View, SM/JM
Lat: 38.256248 Long: -80.687358

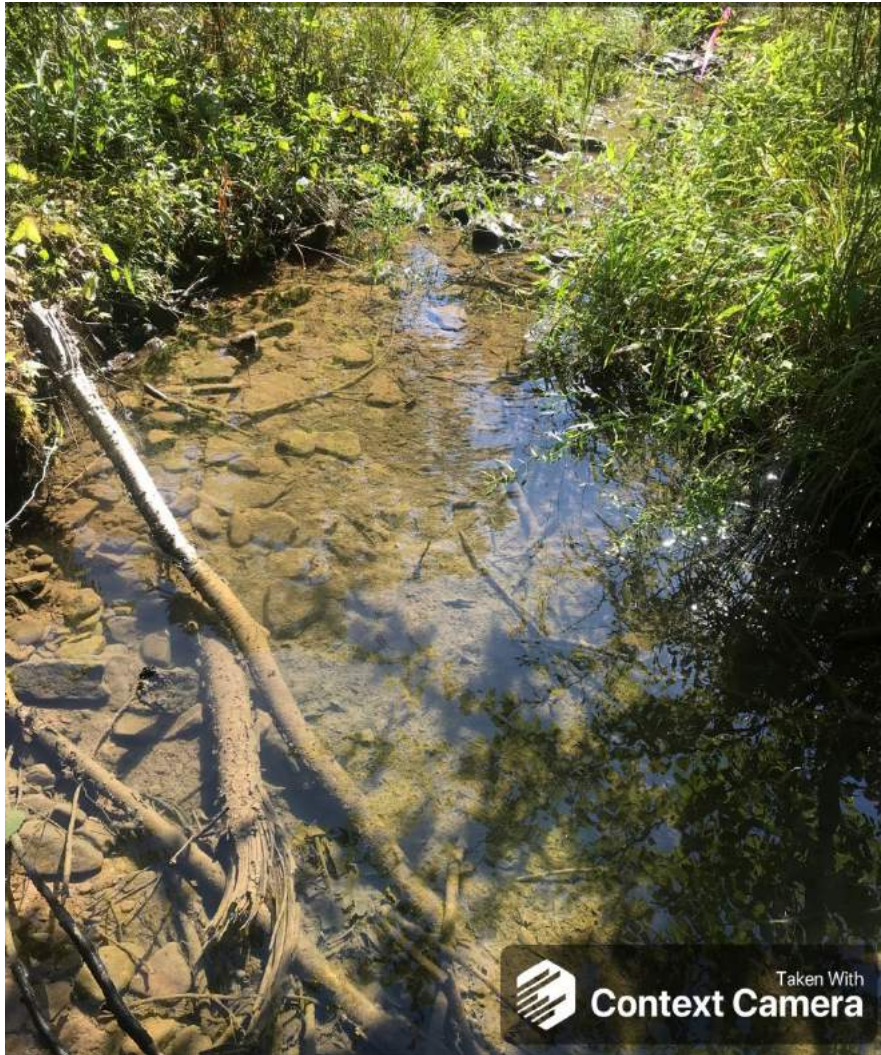
Photo Type: Pool, DS View
Location, Orientation, Photographer Initials: Upstream of Pool, Downstream View, SM/JM
Lat: 38.256248 Long: -80.687358

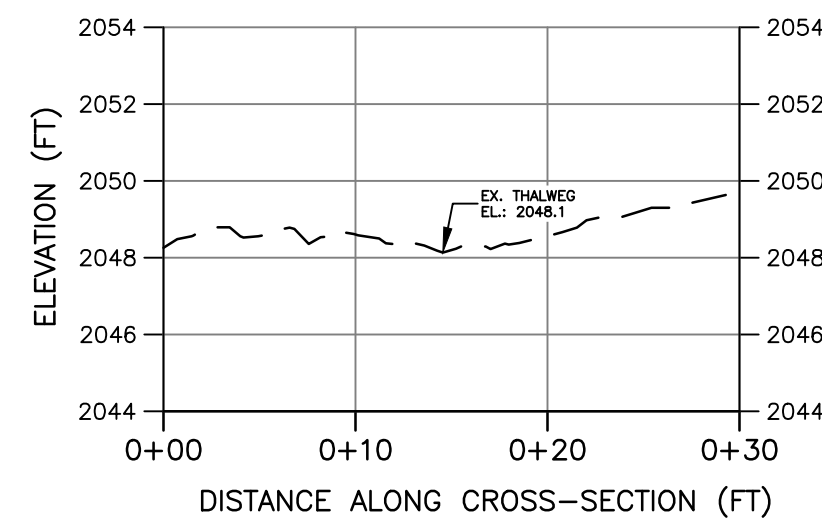
EXISTING STREAM PROFILE
INVERT ALONG THALWEG

TYPICAL 5-POINT CROSS-SECTION
(FACING DOWNSTREAM)

CROSS SECTION	
SCALE:	H: 1"=10' V: 1"=5'
