Baseline Assessment – Stream Attributes

Reach S-J25 (Pipeline ROW) Ephemeral Spread D Nicholas County, West Virginia

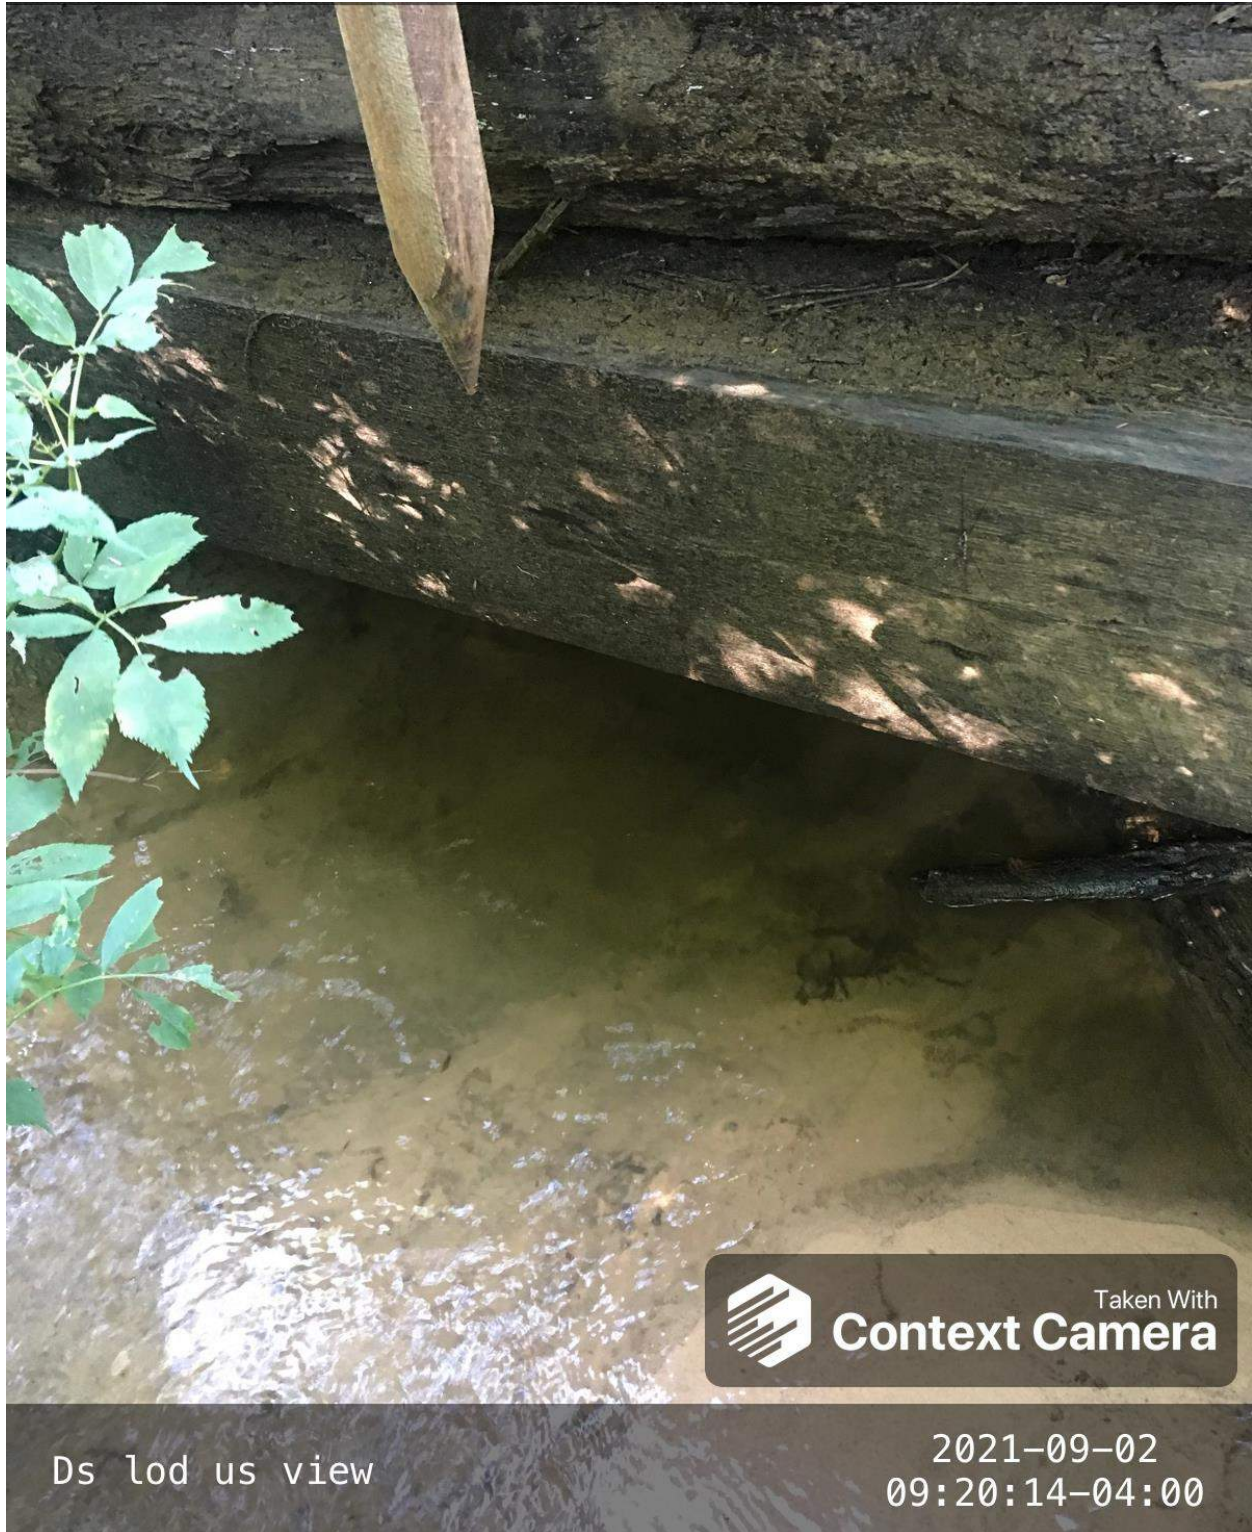
Ds lod us view

Photo Type: DS, US View
Location, Orientation, Photographer Initials: Downstream Edge of ROW, Upstream View, JM/SM
Lat: 38.256682 Long: -80.687348

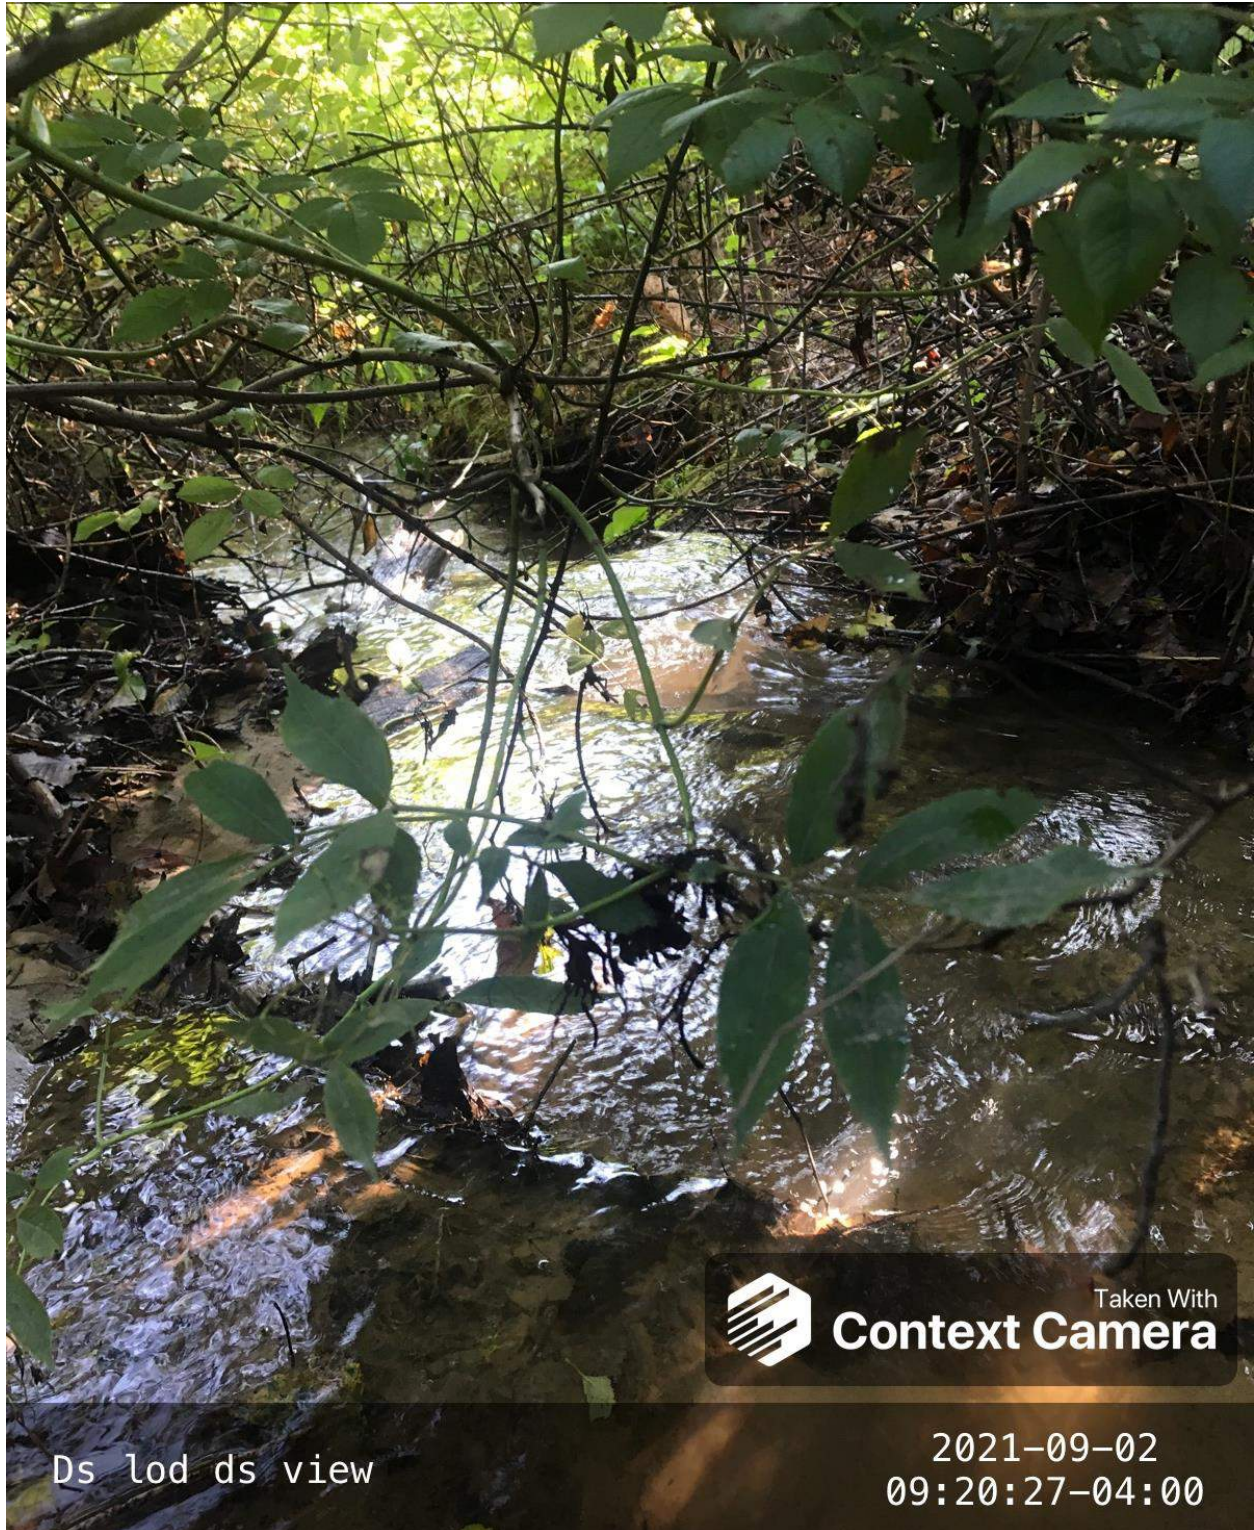
Photo Type: DS, DS View
Location, Orientation, Photographer Initials: Downstream Edge of ROW, Downstream View, JM/SM
Lat: 38.256682 Long: -80.687348

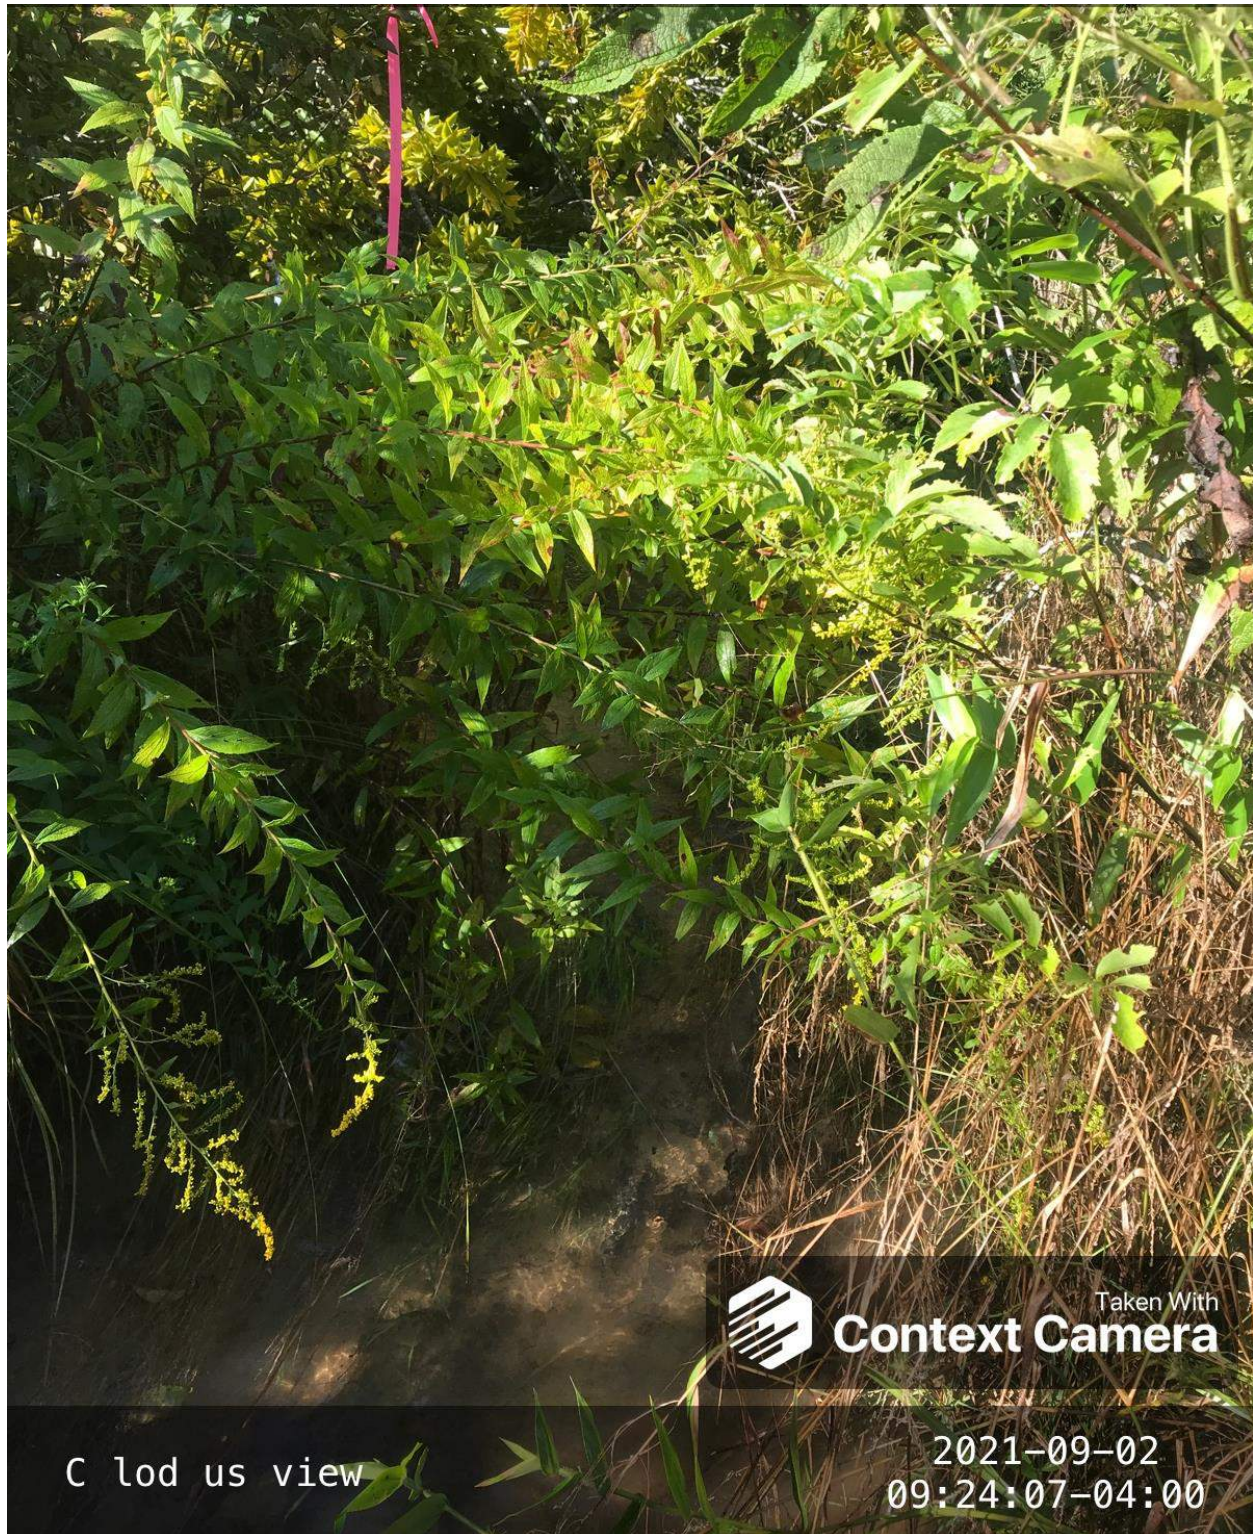
Photo Type: US View at Center
Location, Orientation, Photographer Initials: Center ROW, Upstream View, JM/SM
Lat: 38.256682 Long: -80.687348

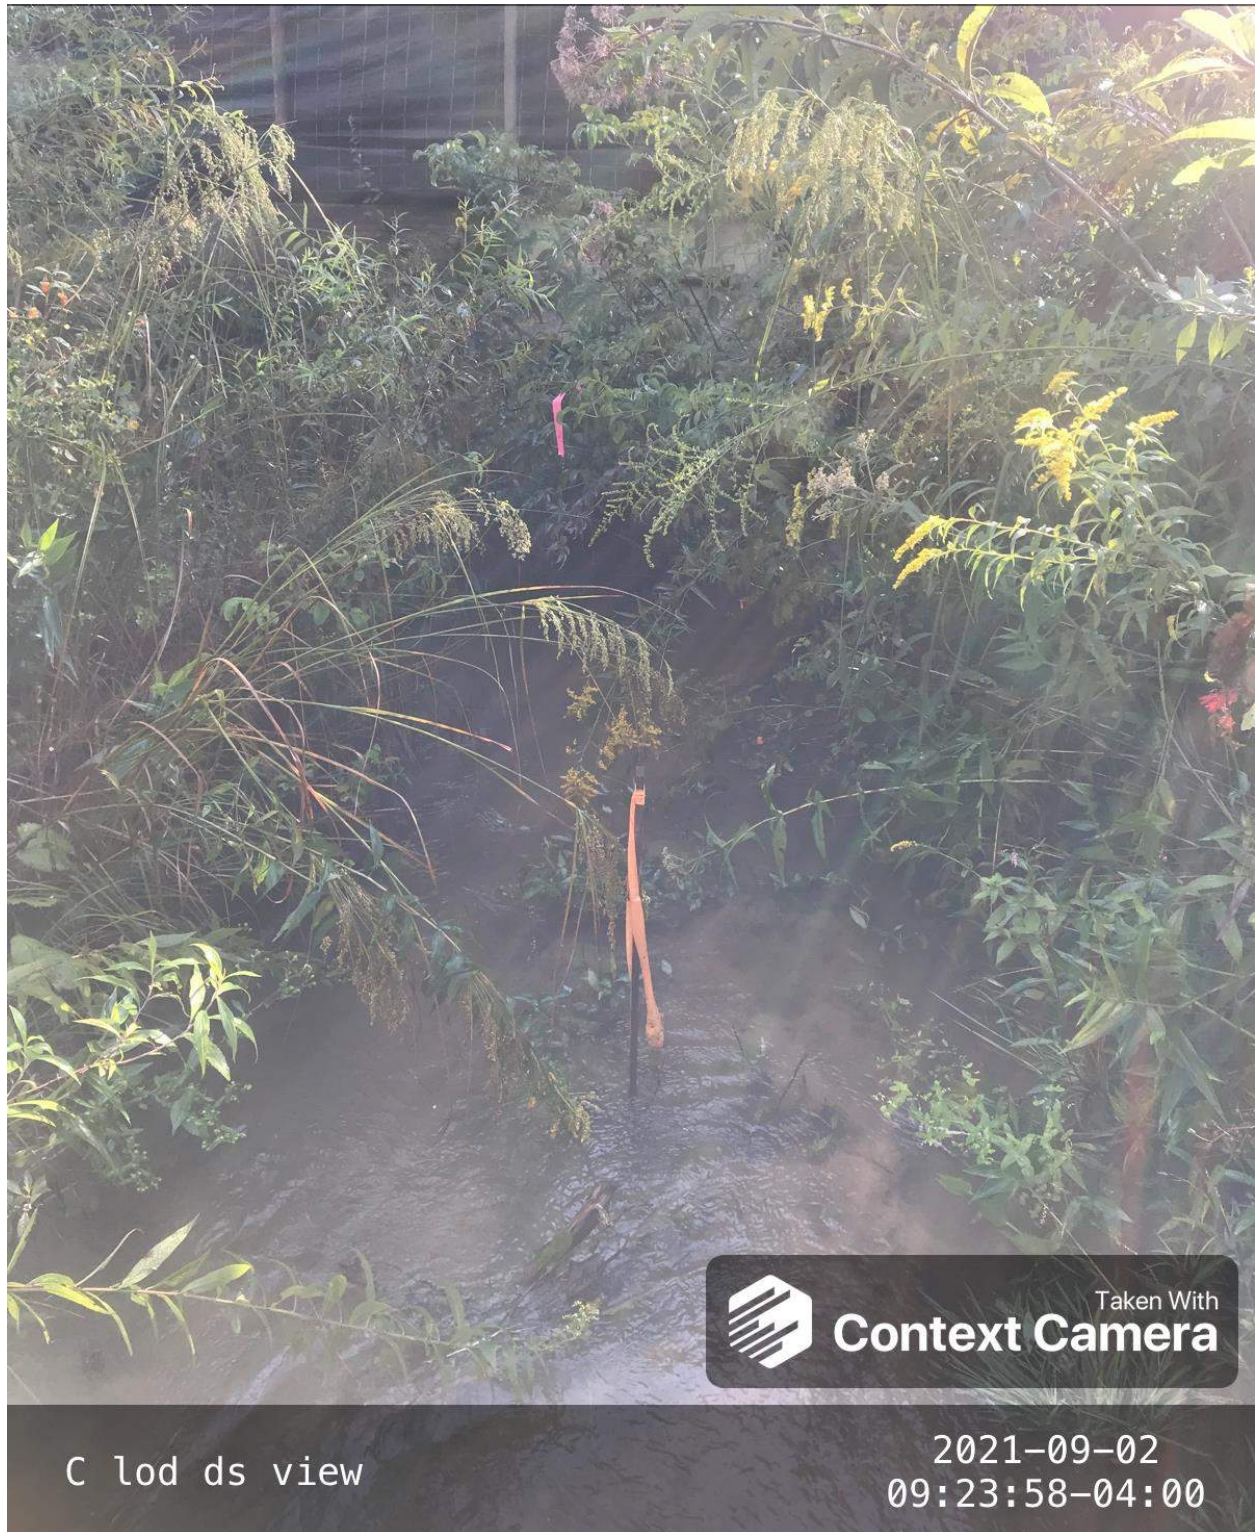
Photo Type: DS View at Center
Location, Orientation, Photographer Initials: Center ROW, Downstream View, JM/SM
Lat: 38.256682 Long: -80.687348

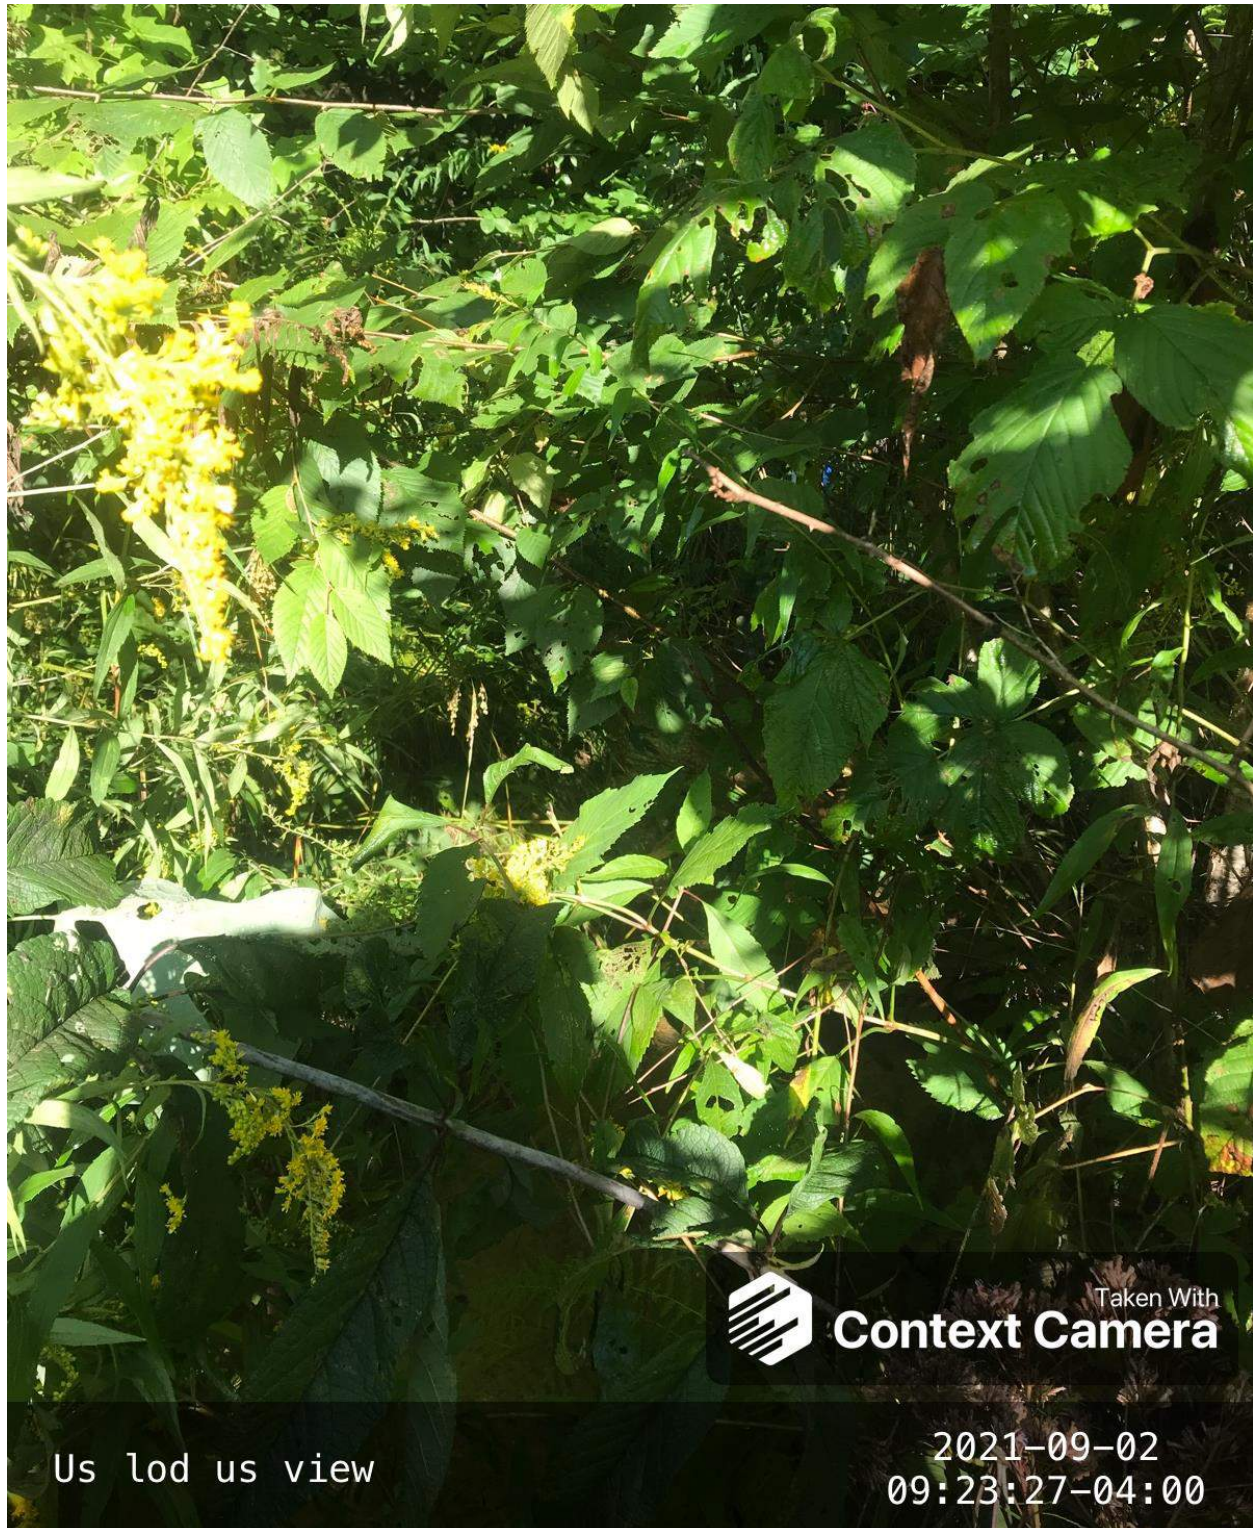
Photo Type: US, US View
Location, Orientation, Photographer Initials: Upstream Edge of ROW, Upstream View, JM/SM
Lat: 38.256682 Long: -80.687348

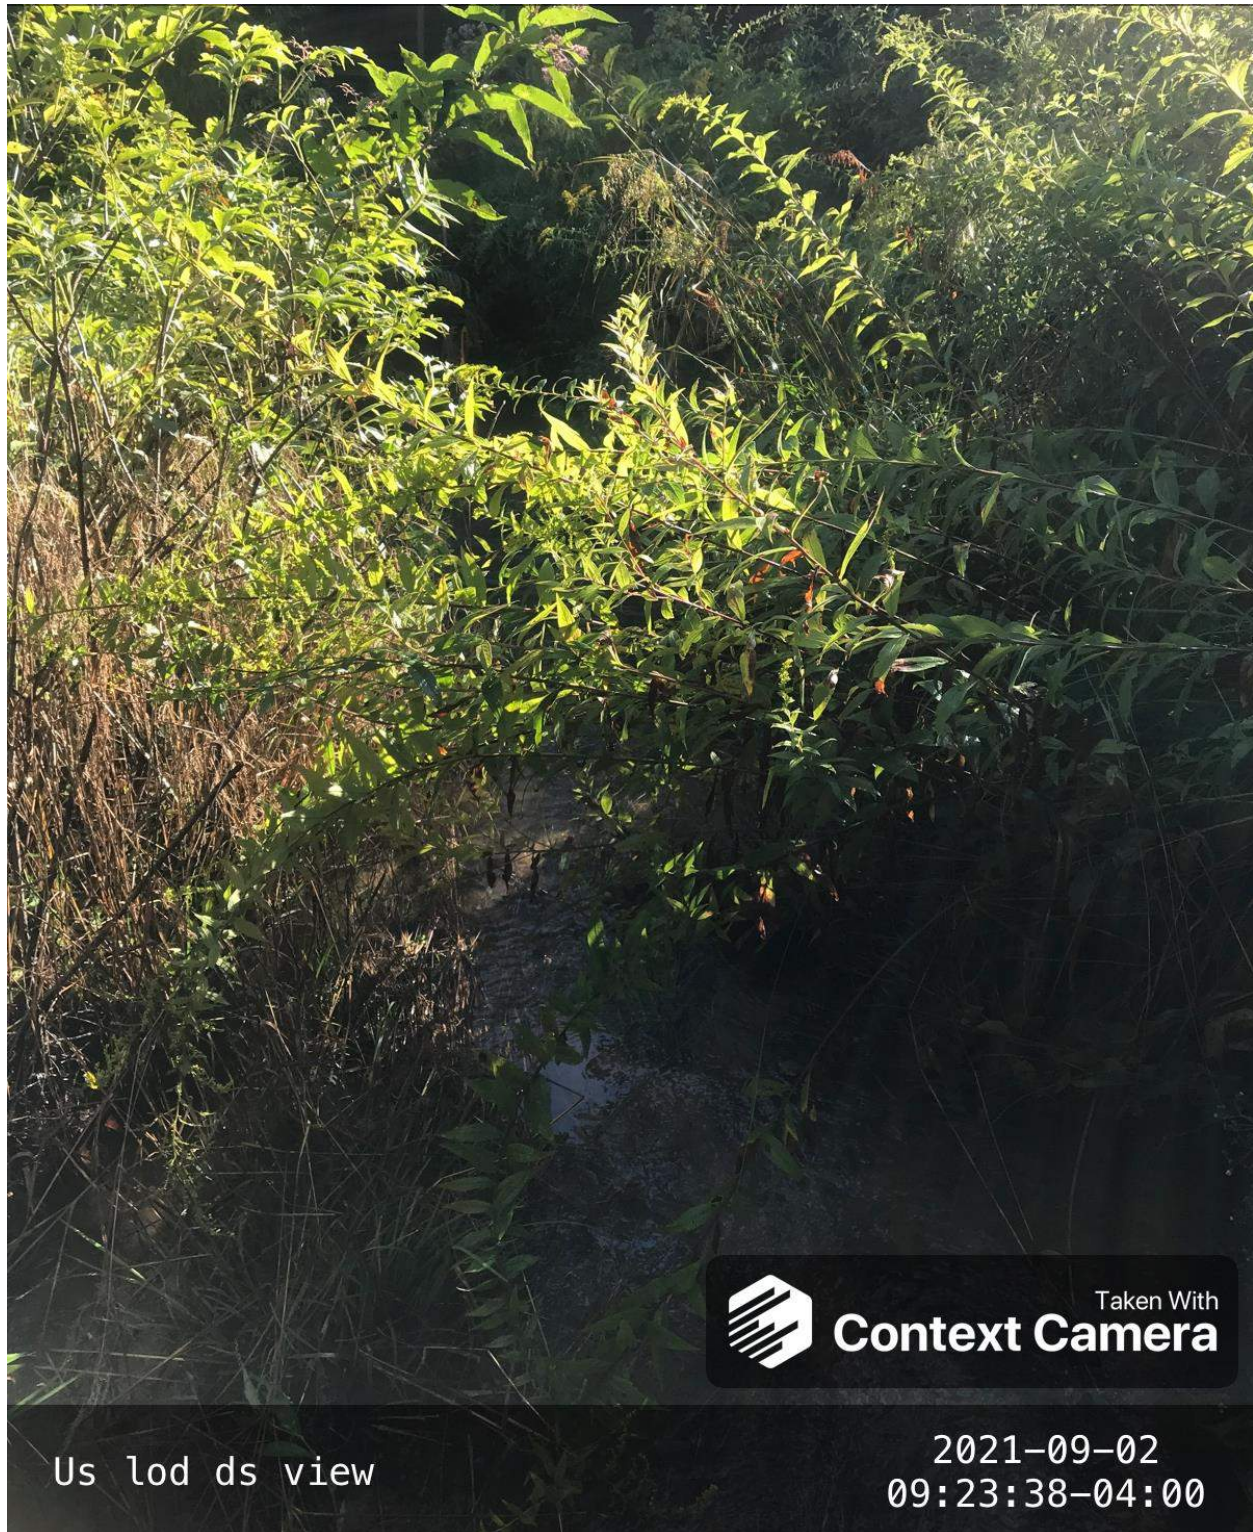
Photo Type: US, DS View
Location, Orientation, Photographer Initials: Upstream Edge of ROW, Downstream View, JM/SM
Lat: 38.256682 Long: -80.687348

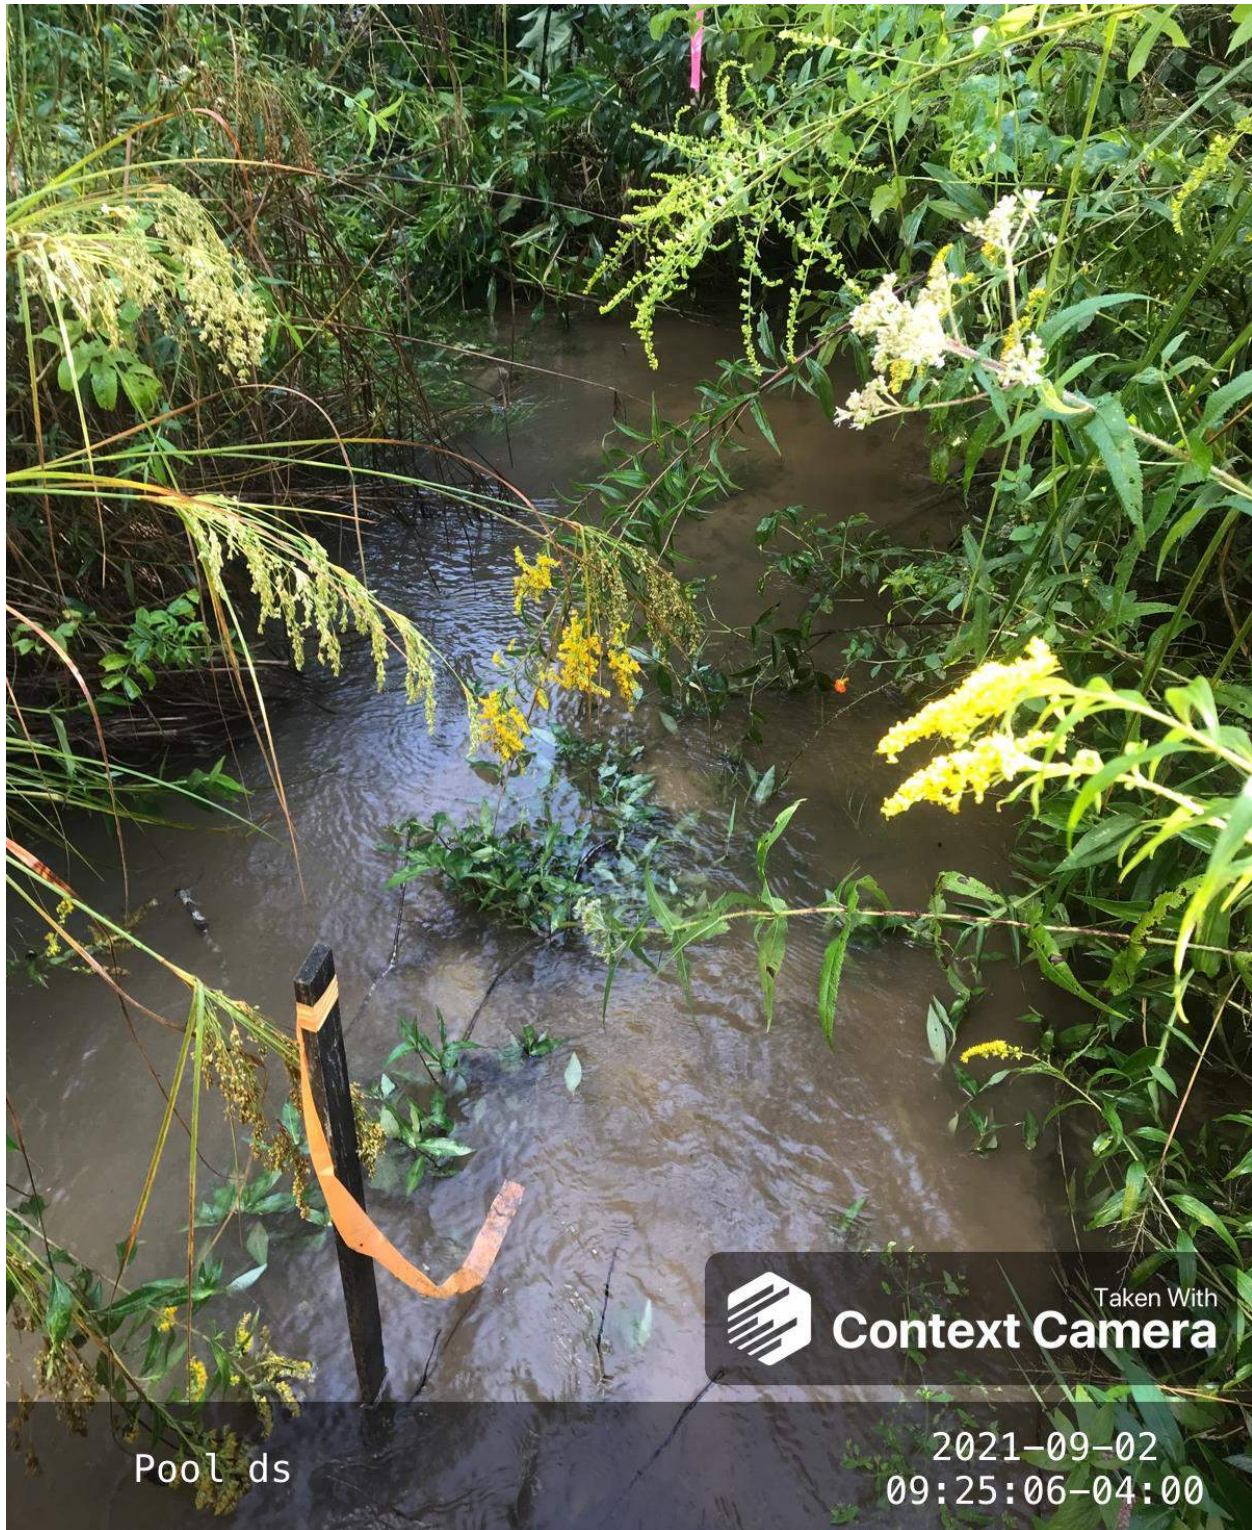
Photo Type: Pool, DS View
Location, Orientation, Photographer Initials: Upstream of Pool, Downstream View, JM/SM
Lat: 38.256682 Long: -80.687348

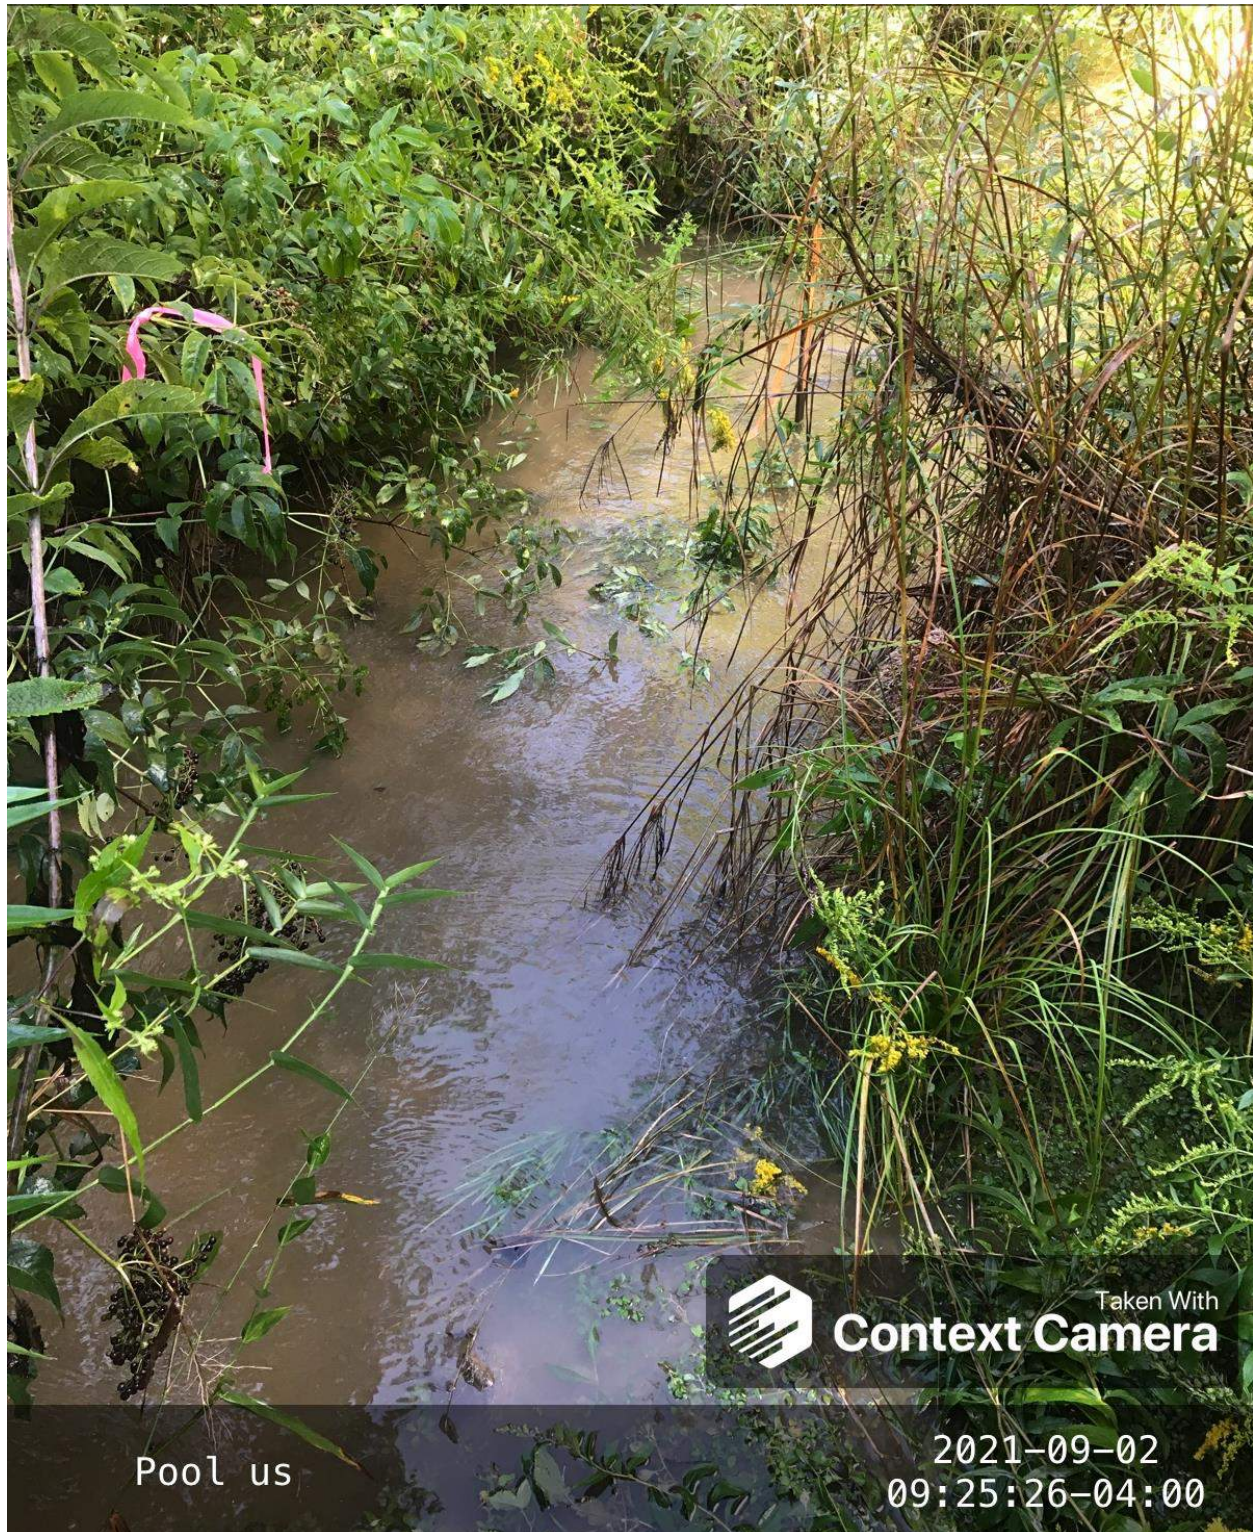
Photo Type: Pool, US View
Location, Orientation, Photographer Initials: Downstream of Pool, Upstream View, JM/SM
Lat: 38.256682 Long: -80.687348
