Baseline Assessment – Stream Attributes

Reach S-J44 (Pipeline ROW)

Lewis County, West Virginia

Title
PROFILE AND CROSS-SECTIONS
BASELINE SURVEY
CROSSING S-J44 - UNNAMED TRIB. TO
RIGHT FORK FREEMANS CREEK (MP 43.08)
LEWIS COUNTY, WV

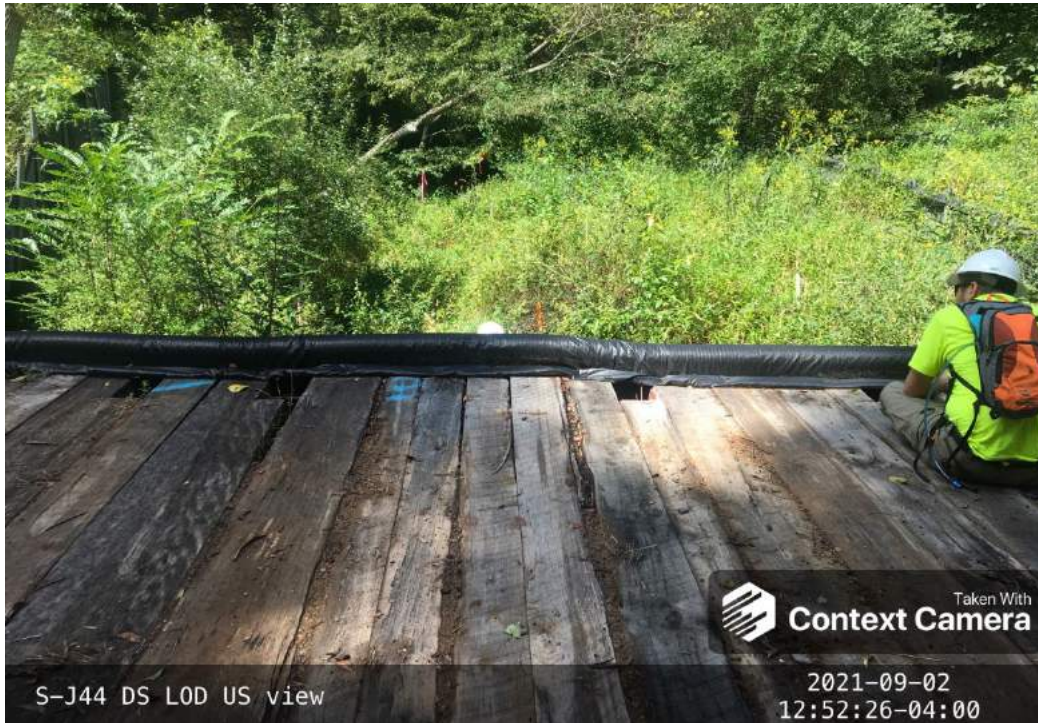
Photo Type: DS, US View

Location, Orientation, Photographer Initials: Downstream Edge of ROW, Upstream View, DP, HK, VM
Lat: 39.11473 Long: -80.586203

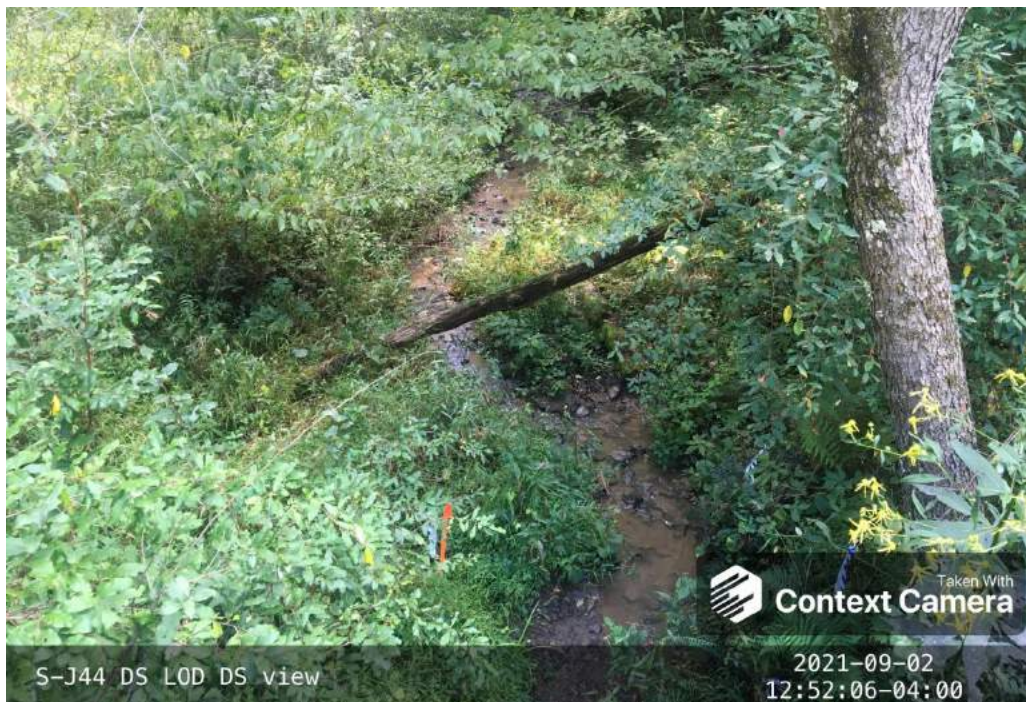
Photo Type: DS, DS View

Location, Orientation, Photographer Initials: Downstream Edge of ROW, Upstream View, , DP, HK, VM
Lat: 39.11473 Long: -80.586203

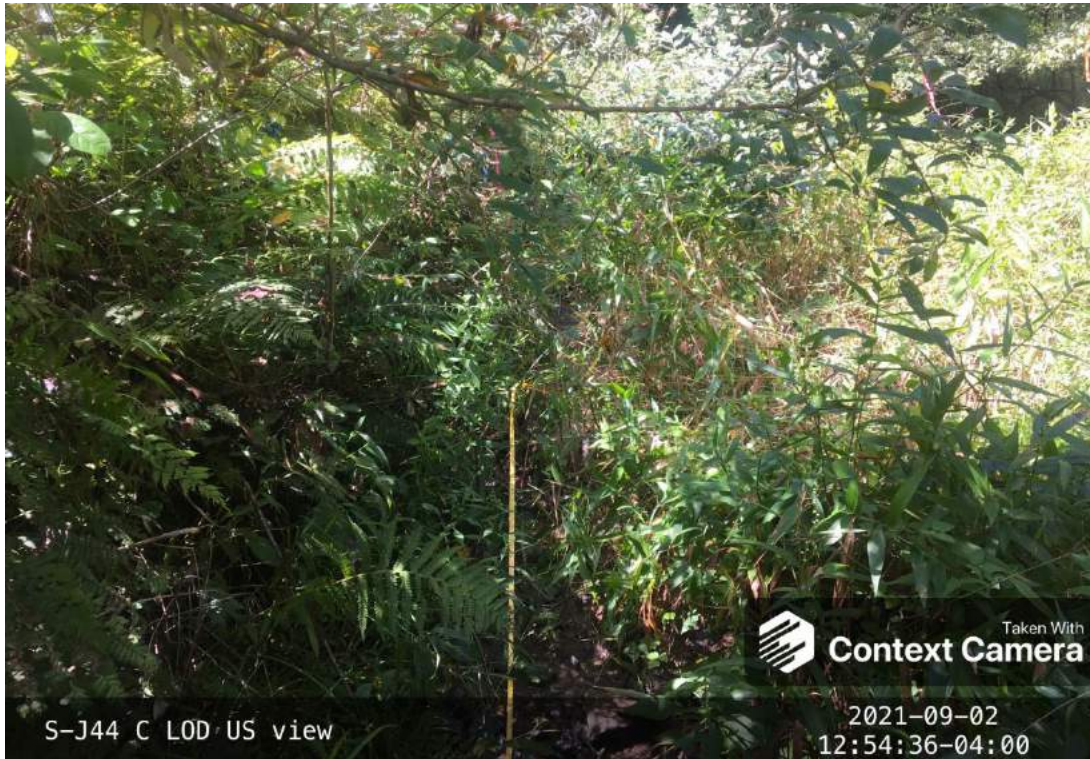
Photo Type: US View at Center
Location, Orientation, Photographer Initials: Downstream Edge of ROW, Upstream View, , DP, HK, VM
Lat: 39.11473 Long: -80.586203

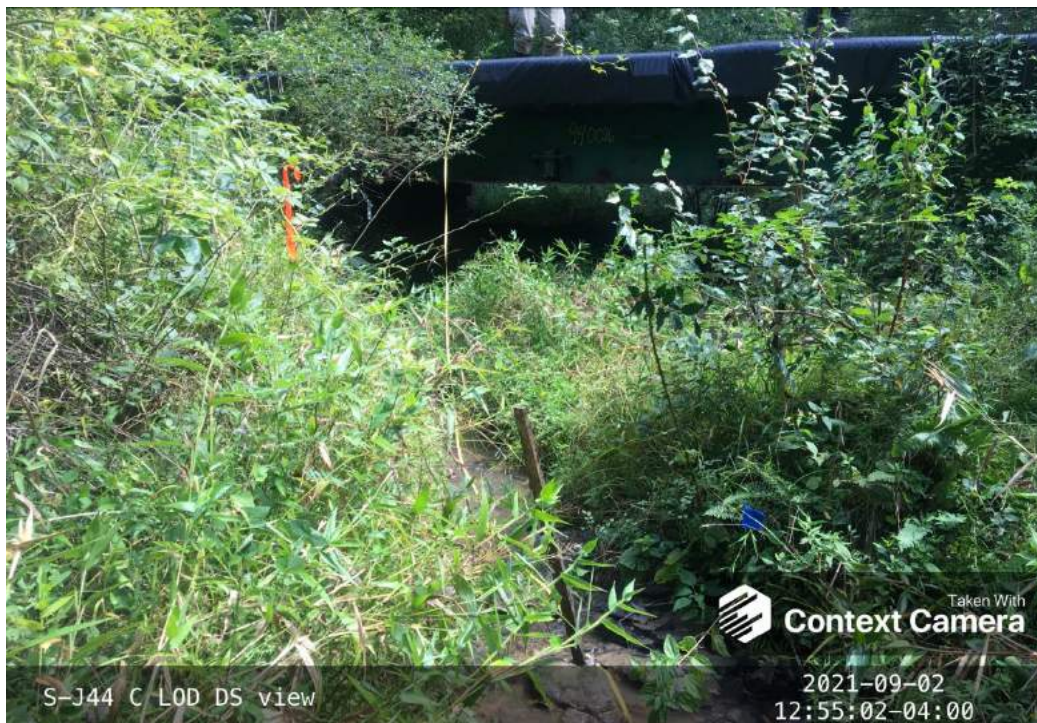
Photo Type: DS View at Center
Location, Orientation, Photographer Initials: Downstream Edge of ROW, Upstream View, DP, HK, VM
Lat: 39.11473 Long: -80.586203

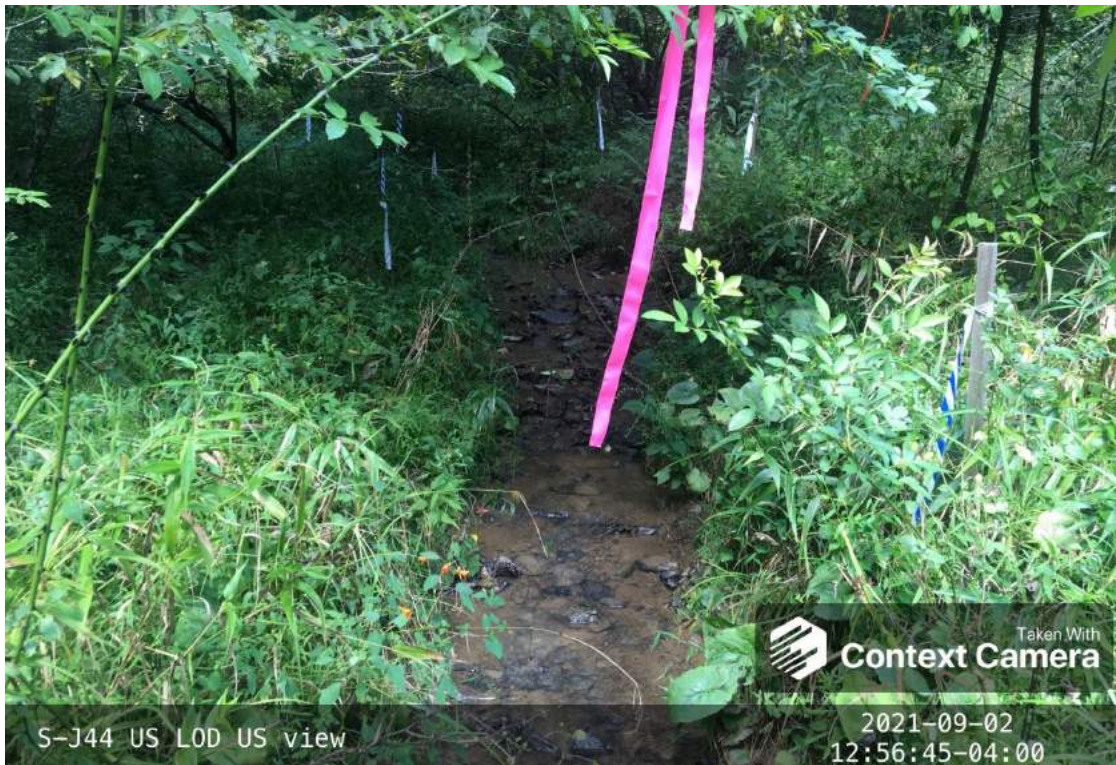
Photo Type: US, US View

Location, Orientation, Photographer Initials: Downstream Edge of ROW, Upstream View, DP, HK, VM
Lat: 39.11473 Long: -80.586203

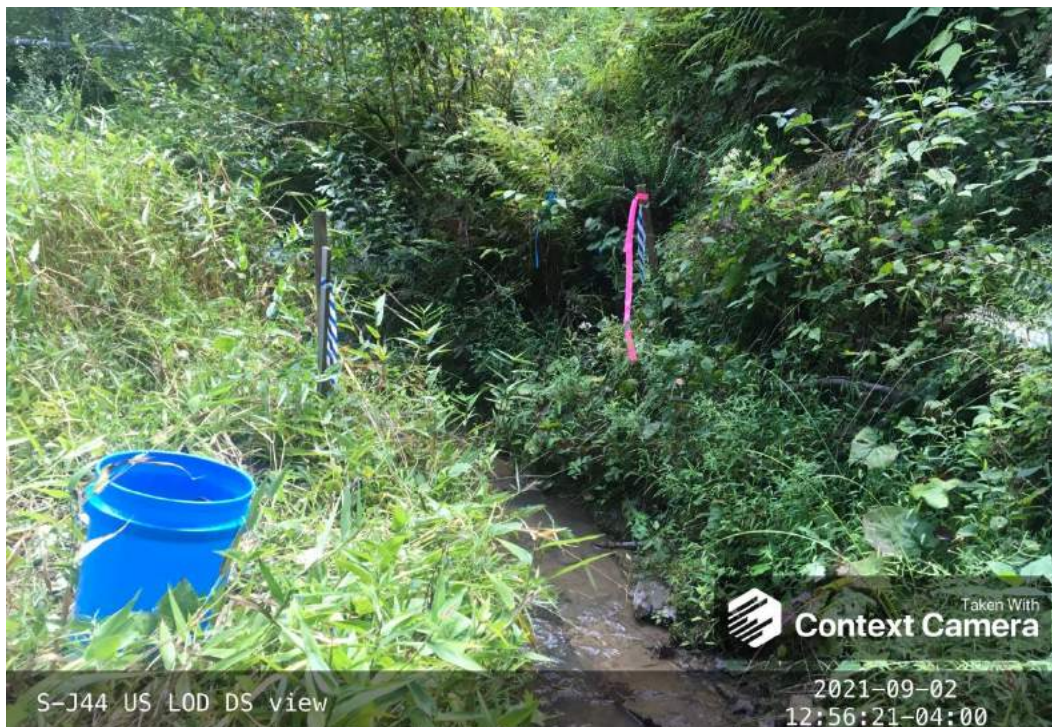
Photo Type: US, DS View

Location, Orientation, Photographer Initials: Downstream Edge of ROW, Upstream View, DP, HK, VM
Lat: 39.11473 Long: -80.586203

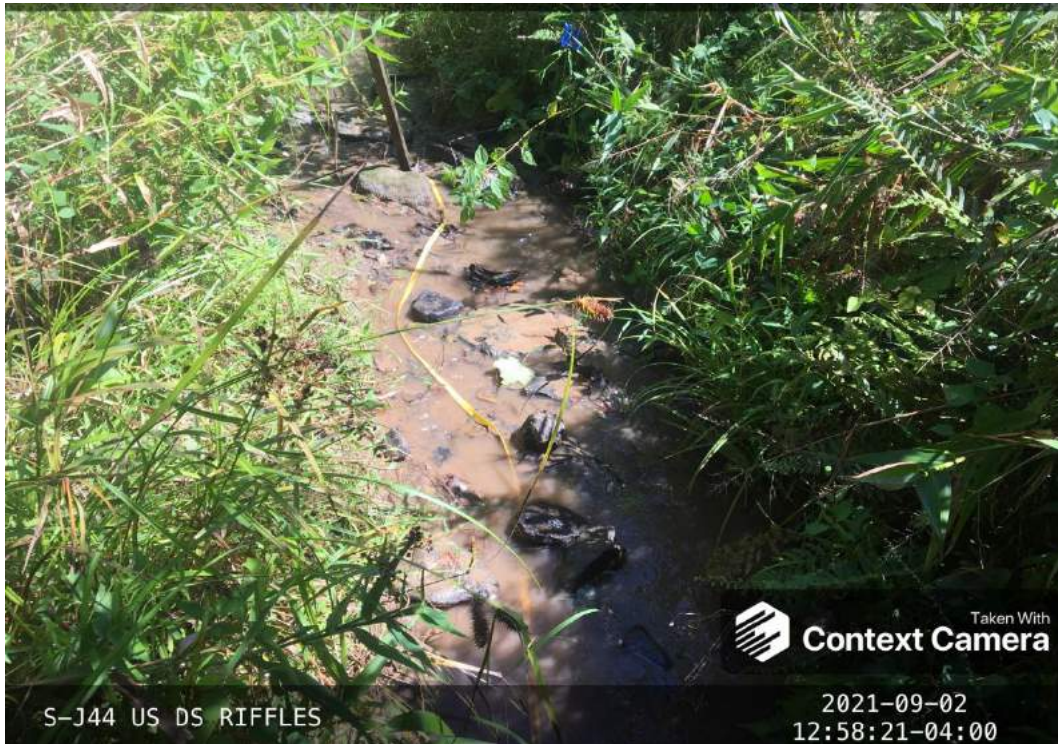
Photo Type: Riffle, DS View
Location, Orientation, Photographer Initials: Upstream of Riffle, Downstream View, DP, HK, VM
Lat: 39.11473 Long: -80.586203

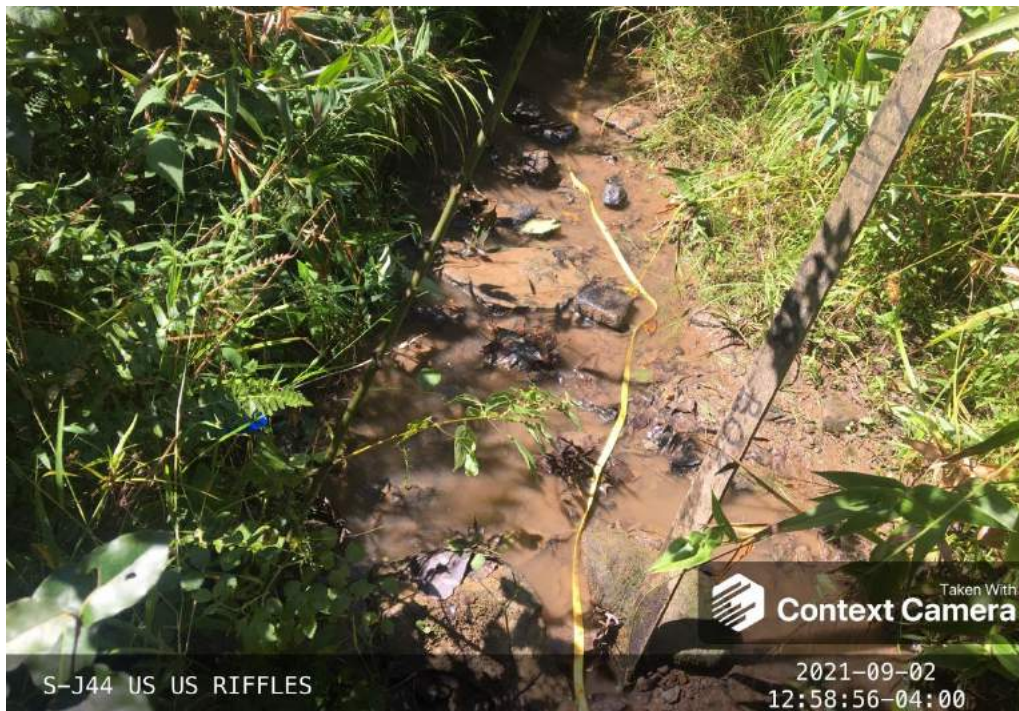
Photo Type: Riffle, US View
Location, Orientation, Photographer Initials: Downstream of Riffle, Upstream View, DP, HK, VM
Lat: 39.11473 Long: -80.586203

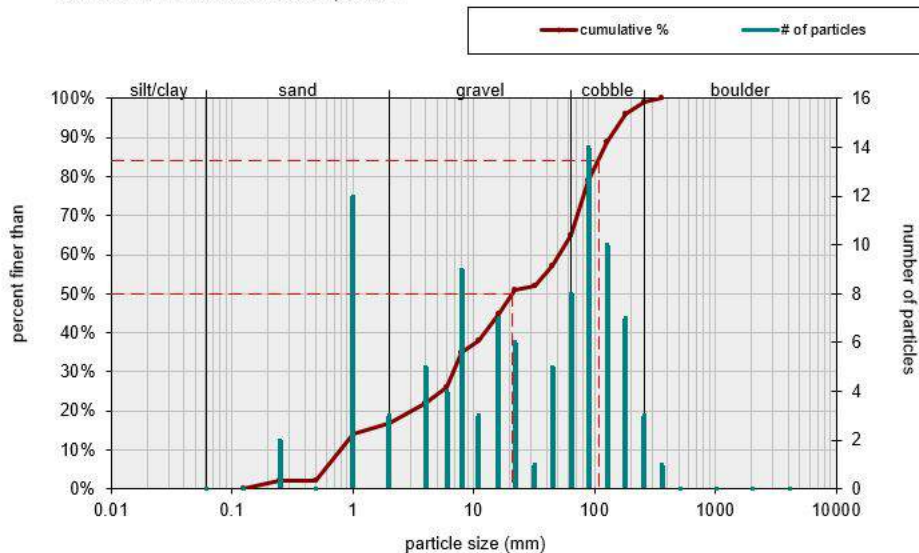
Bankfull Channel Pebble Count, S-J44

D16 1.6
D35 8
D50 21
D65 64
D84 110
D95 170

mean 13.3
dispersion 9.2
skewness -0.15

silt/clay 0%
sand 17%
gravel 48%
cobble 34%
boulder 1%

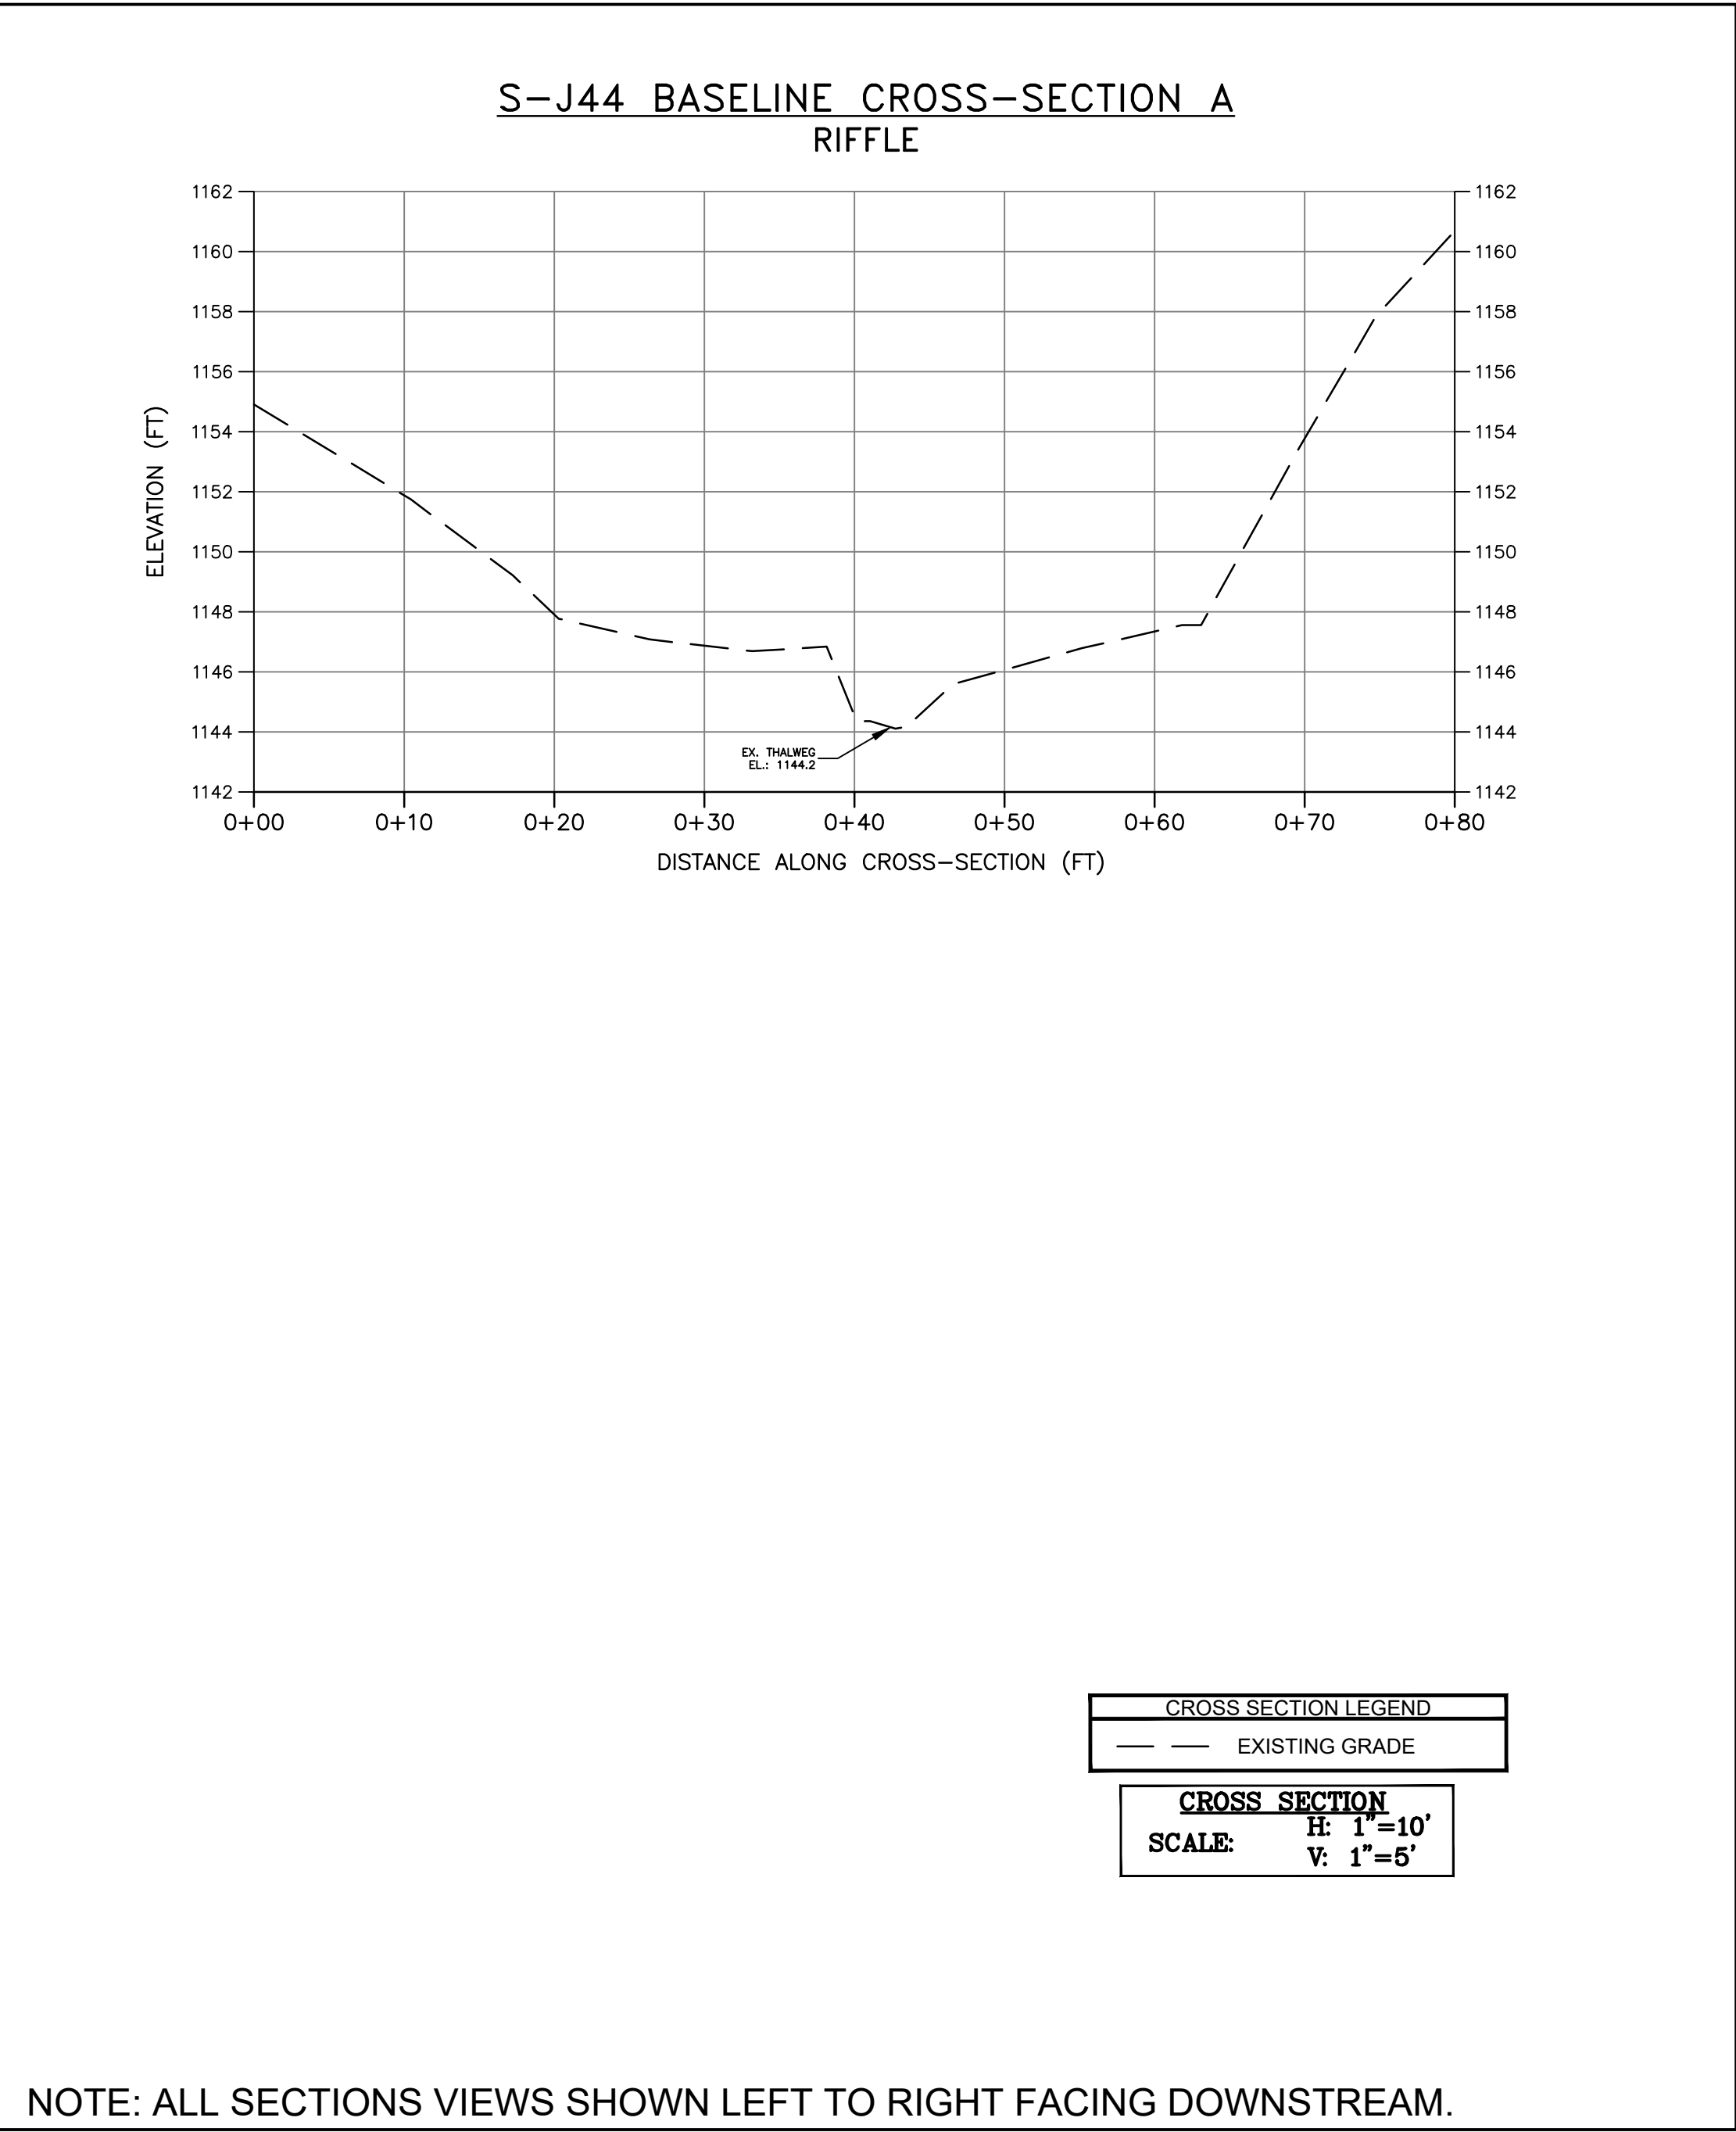
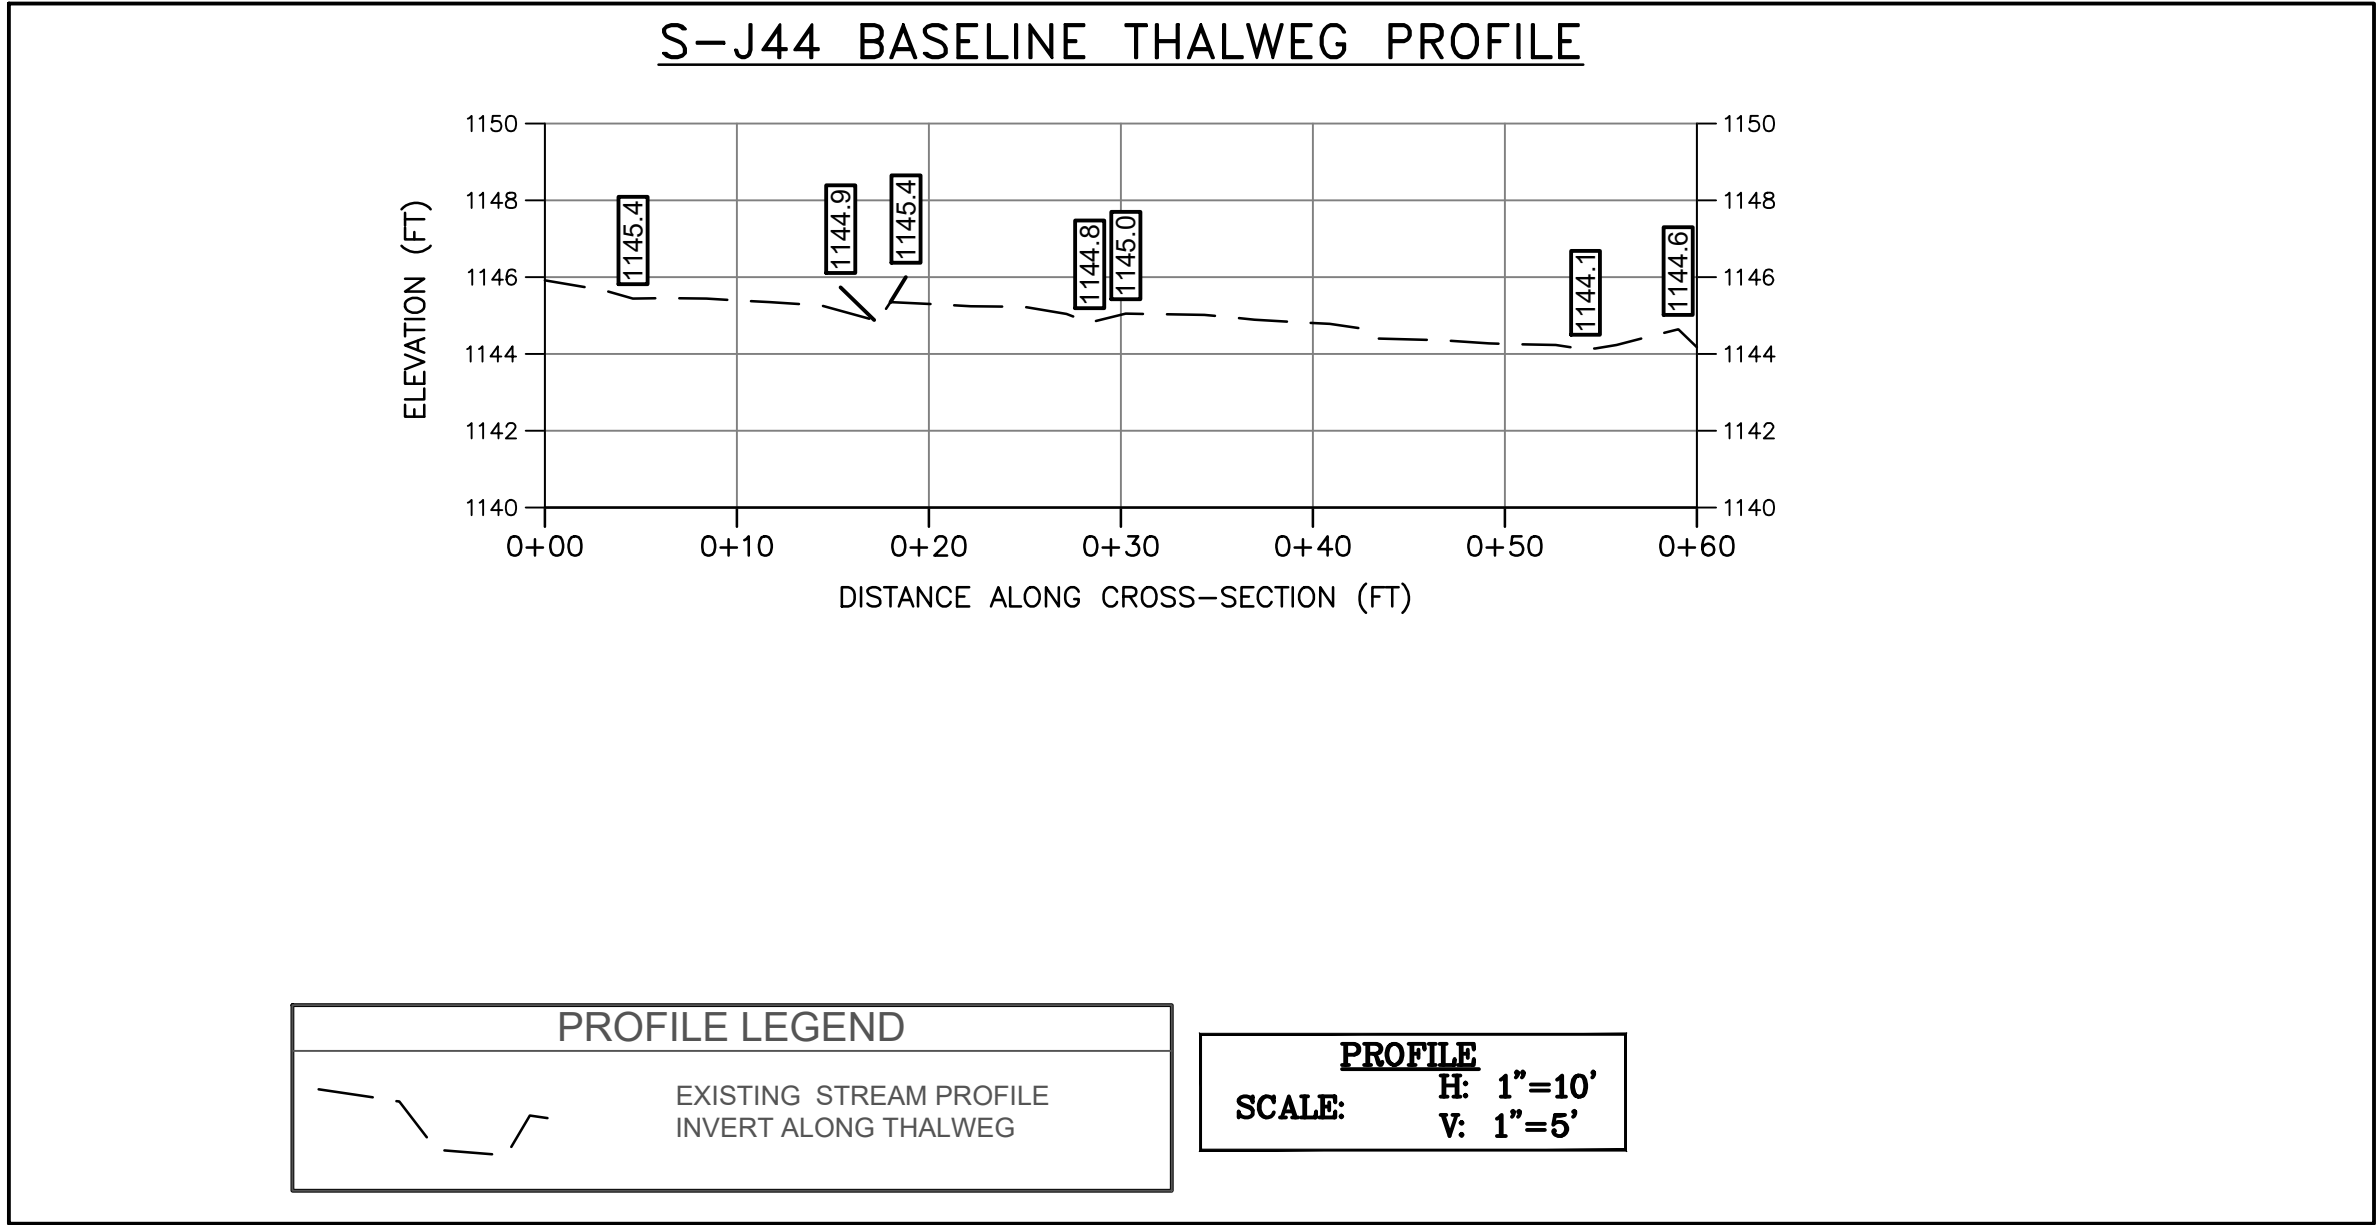
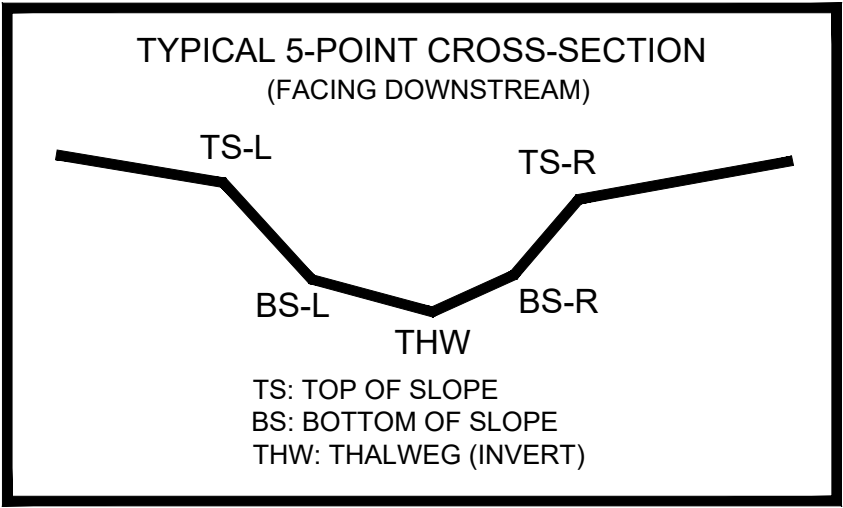
- EASEMENT LINES SHOWN ON PLAN VIEW WERE PROVIDED BY MOUNTAIN VALLEY PIPELINE.
 - SURVEY POINTS FOR CROSS SECTIONS AND THALWEG PROFILES COLLECTED IN 2021 HAVE BEEN USED IN COMBINATION WITH SURVEY POINTS COLLECTED PREVIOUSLY IN 2020 IN ORDER TO GENERATE THE PRE-CROSSING SURFACE SHOWN IN PLAN. DUE TO NATURAL EROSIONAL STREAM PROCESSES THAT CAN OCCUR OVER TIME, MINOR ADJUSTMENTS TO THE PROFILE ALIGNMENTS MAY HAVE BEEN REQUIRED IN ORDER TO GENERATE A CLEAN PRE-CROSSING SURFACE.

- ALL SECTION VIEWS SHOWN LEFT TO RIGHT FACING DOWNSTREAM.
 - POST-CROSSING SURVEY INFORMATION SHOWN IN RED. DATA PENDING.
 - POST-CROSSING SURVEY POINTS FOR CROSS SECTIONS AND THALWEG ARE PROJECTED ONTO PRE-CROSSING SECTION AND PROFILE VIEWS FOR COMPARISON.

AS-BUILT TABLE: S-J44 CROSS SECTION A					
PT. LOC.	PRE-CROSSING			AS-BUILT	
	NORTHING	EASTING	ELEV.	VERT. DIFF.	HORZ. DIFF.
TS-L	14204662.92	1757791.45	1146.83		
BS-L	14204659.76	1757791.04	1144.36		
THW	14204658.40	1757790.94	1144.16		
BS-R	14204654.10	17557790.48	1145.61		
TS-R	14204645.58	1757788.34	1146.83
