# **Baseline Assessment – Stream Attributes**

# Reach S-J58 (Permanent Access Road) Perennial Spread A Wetzel County, West Virginia

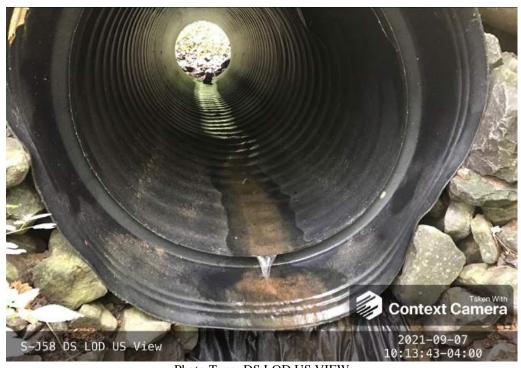
Photo Type: DS LOD US VIEW
Location, Orientation, Photographer Initials: Downstream at ROW/LOD looking S upstream, COC
Lat: 39.462546 Long: -80.505386

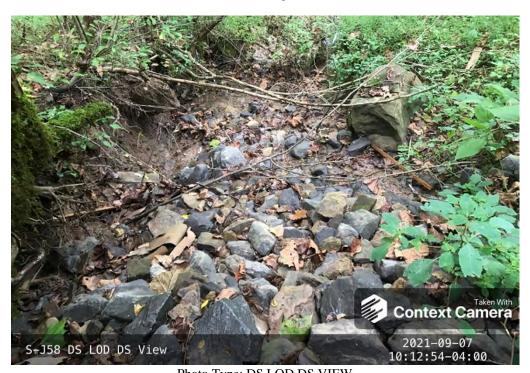
Photo Type: DS LOD DS VIEW
Location, Orientation, Photographer Initials: Downstream at ROW/LOD looking N downstream, COC
Lat: 39.462546 Long: -80.505386

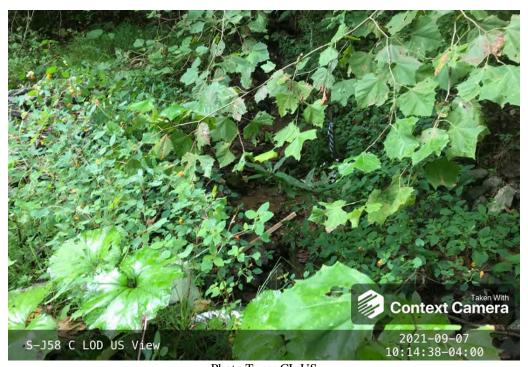
Photo Type: CL US
Location, Orientation, Photographer Initials: On thalweg at ROW/LOD centerline looking SE Upstream, COC
Lat: 39.462546 Long: -80.505386

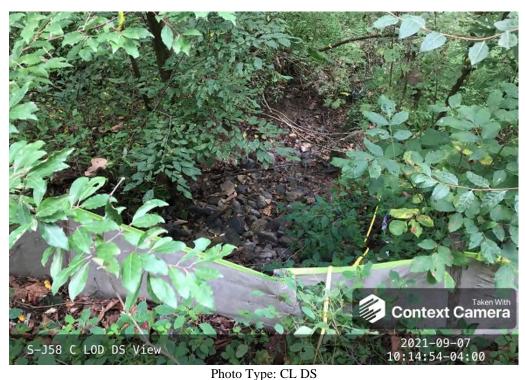
Location, Orientation, Photographer Initials: On thalweg at ROW/LOD centerline looking N Downstream, COC Lat: 39.462546 Long: -80.505386

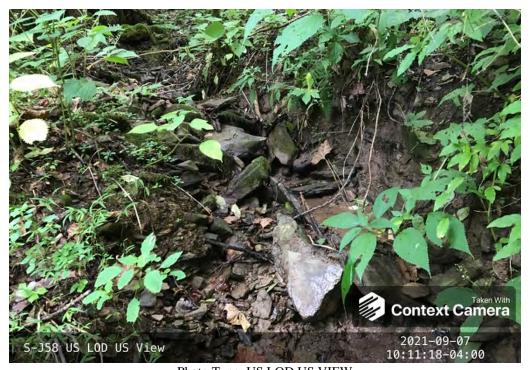
Photo Type: US LOD US VIEW Location, Orientation, Photographer Initials: Upstream at ROW/LOD looking SE upstream, COC Lat: 39.462546 Long: -80.505386

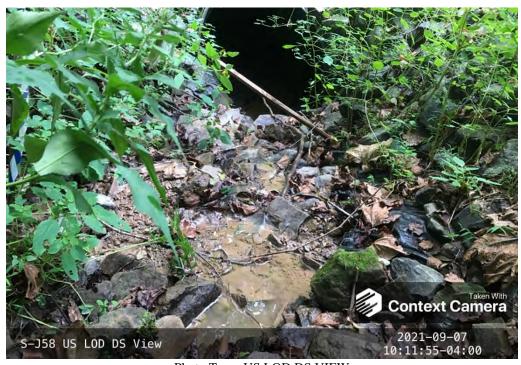
Photo Type: US LOD DS VIEW
Location, Orientation, Photographer Initials: Upstream at ROW/LOD looking NW downstream, COC
Lat: 39.462546 Long: -80.505386

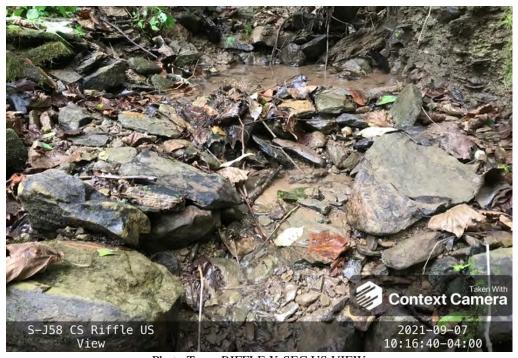
Photo Type: RIFFLE X-SEC US VIEW
Location, Orientation, Photographer Initials: Downstream looking SE upstream at riffle, COC
Lat: 39.462546 Long: -80.505386

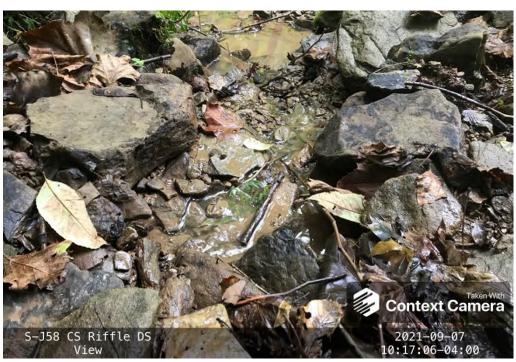
Photo Type: RIFFLE X-SEC DS VIEW
Location, Orientation, Photographer Initials: Upstream looking N downstream at riffle, COC
Lat: 39.462546 Long: -80.505386

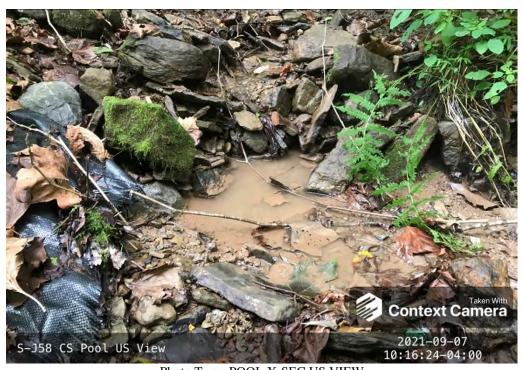
Photo Type: POOL X-SEC US VIEW
Location, Orientation, Photographer Initials: Downstream looking SE upstream at pool, COC
Lat: 39.462546 Long: -80.505386

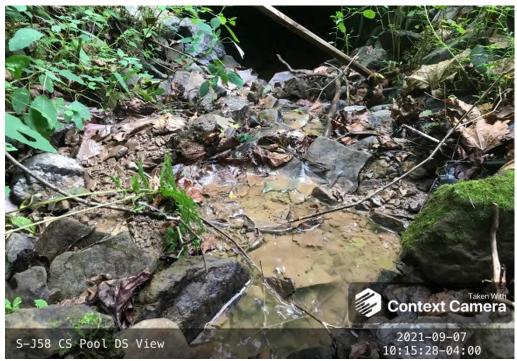
Photo Type: POOL X-SEC DS VIEW
Location, Orientation, Photographer Initials: Upstream looking NW downstream at pool, COC
Lat: 39.462546 Long: -80.505386

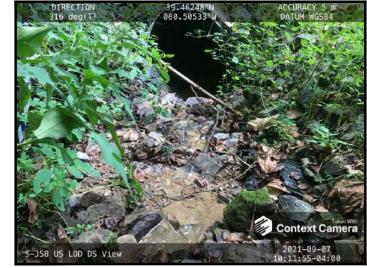
PHOTO TAKEN LOOKING DOWNSTREAM FROM UPSTREAM IMPACT LIMITS

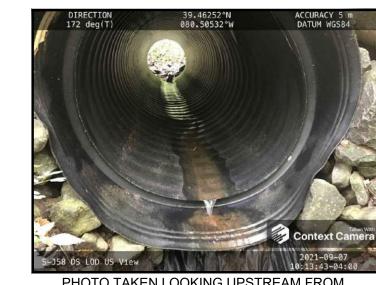
PHOTO TAKEN LOOKING UPSTREAM FROM DOWNSTREAM IMPACT LIMITS
