## **Baseline Assessment – Stream Attributes**

# Reach S-J60 (Timber Mat Crossing) Perennial Spread A Wetzel County, West Virginia

Spread A Stream S-J60 (Timber Mat Crossing) Wetzel County

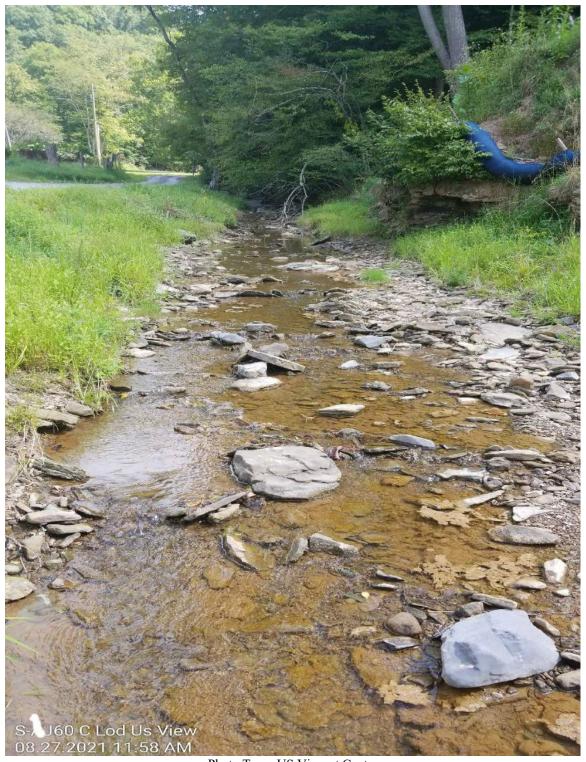
Photo Type: US View at Center Location, Orientation, Photographer Initials: ROW Center, Upstream View, JR/MD Lat: 39.474354 Long: -80.511825

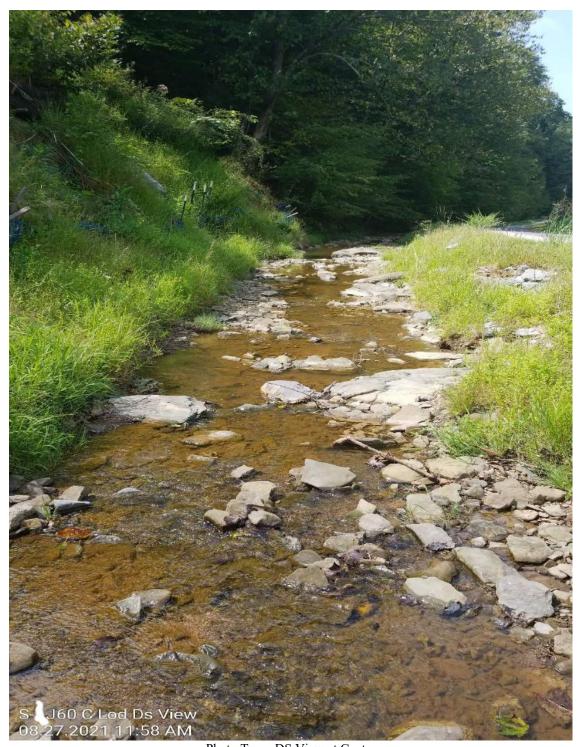
Photo Type: DS View at Center Location, Orientation, Photographer Initials: ROW Center, Downstream View, JR/MB Lat: 39.474354 Lon: -80.511825

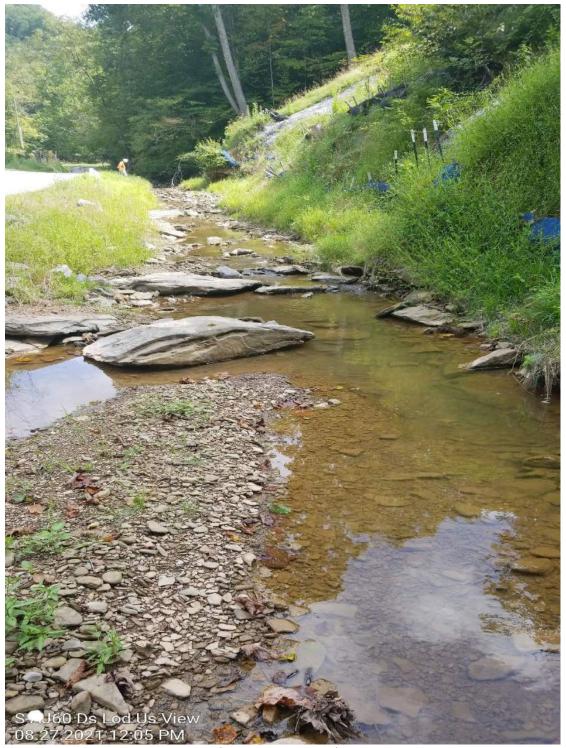
Photo Type: DS, US View Location, Orientation, Photographer Initials: DS Edge of ROW, Upstream View, JR/MB Lat: 39.474354 Long: -80.511825

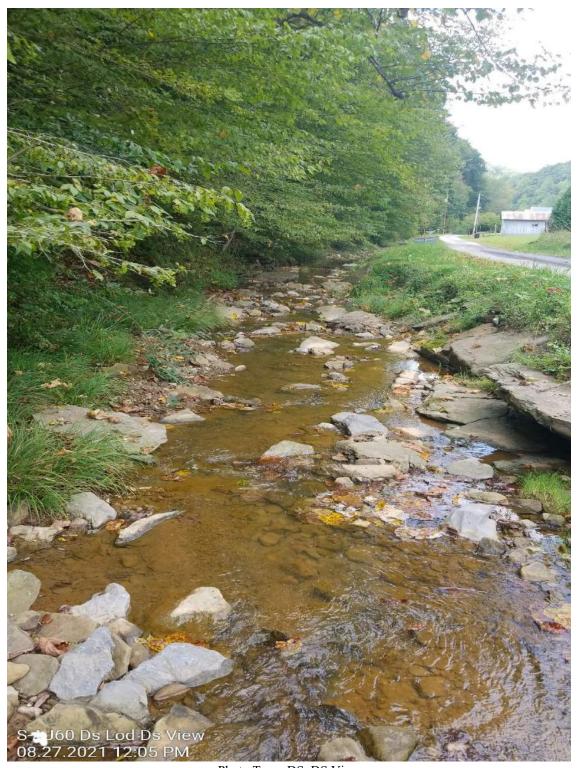
Photo Type: DS, DS View Location, Orientation, Photographer Initials: DS Edge of ROW, Downstream View, JR/MB Lat: 39.474354 Long: -80.511825

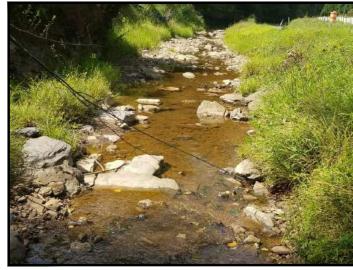
PHOTO TAKEN LOOKING DOWNSTREAM FROM UPSTREAM IMPACT LIMITS
