Baseline Assessment – Stream Attributes

Reach S-J62 (Timber Mat Crossing) Perennial Spread A Harrison County, West Virginia

Title
PROFILE AND CROSS-SECTIONS
BASELINE SURVEY
CROSSING S-J62 - RIGHT FORK BIG ELK
CREEK (MP 11.17)
HARRISON COUNTY, WV

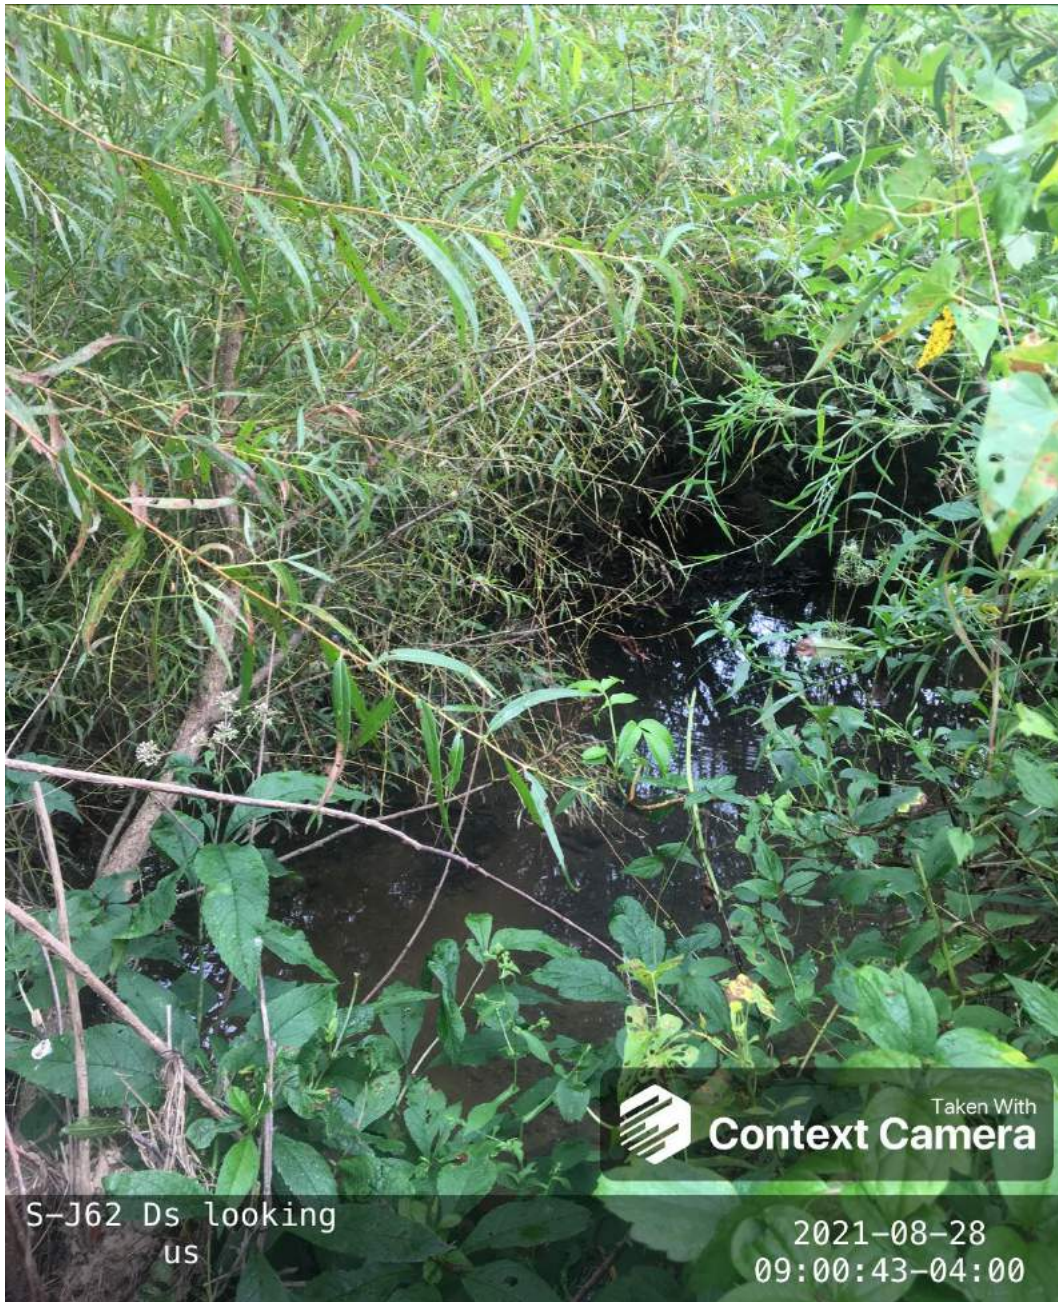
Photo Type: DS, US View

Location, Orientation, Photographer Initials: Downstream Edge of ROW, Upstream View, DP/PL
Lat: 39.445033 Long: -80.482635

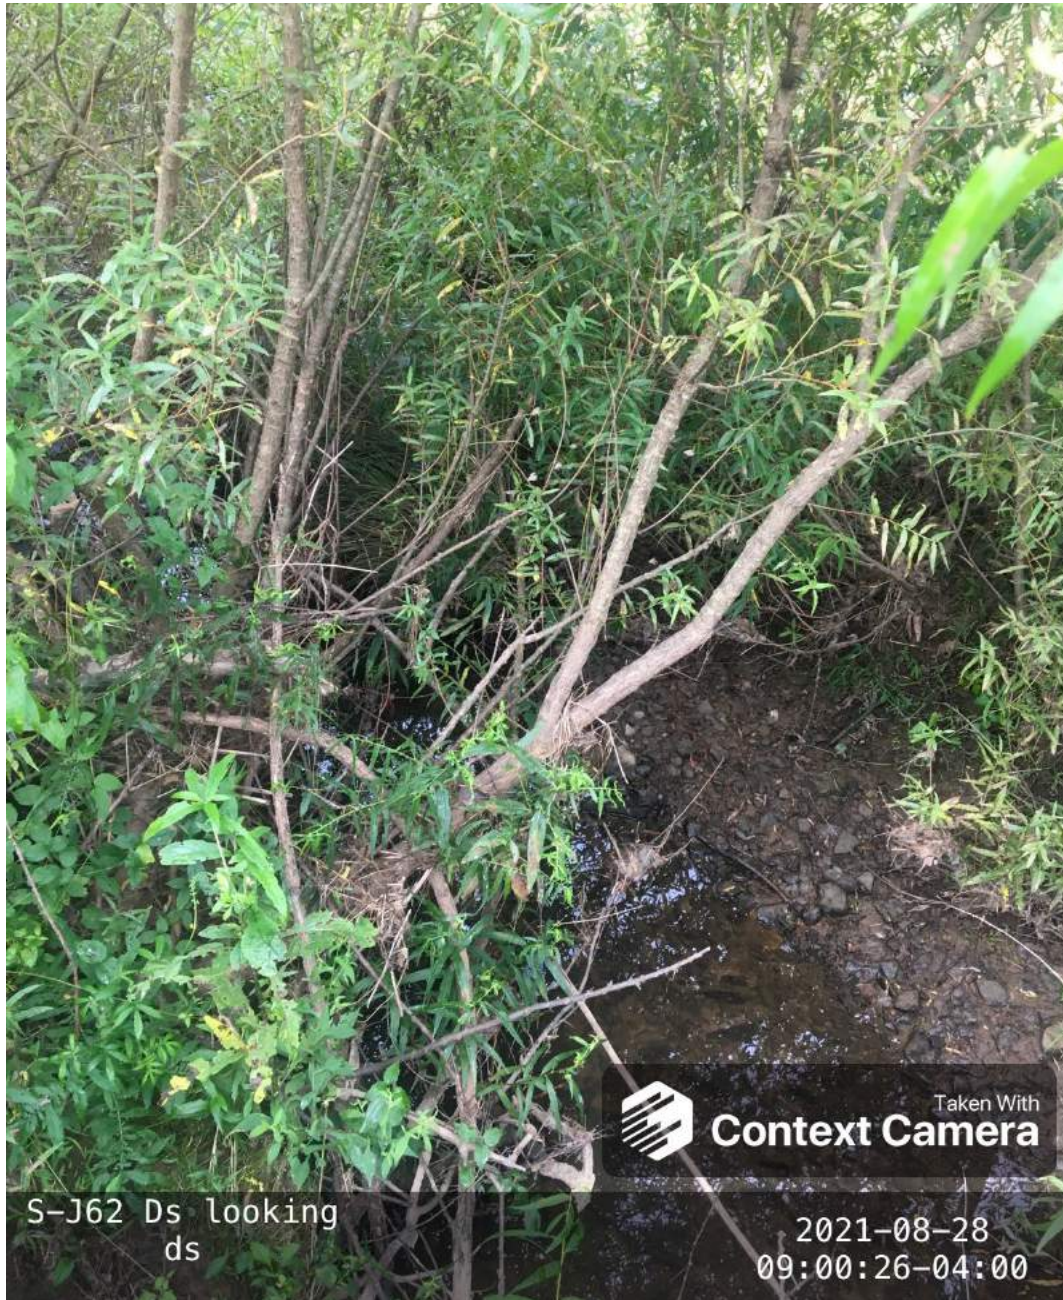
Photo Type: DS, DS View
Location, Orientation, Photographer Initials: Downstream Edge of ROW, Downstream View, DP/PL
Lat: 39.445033 Long: -80.482635

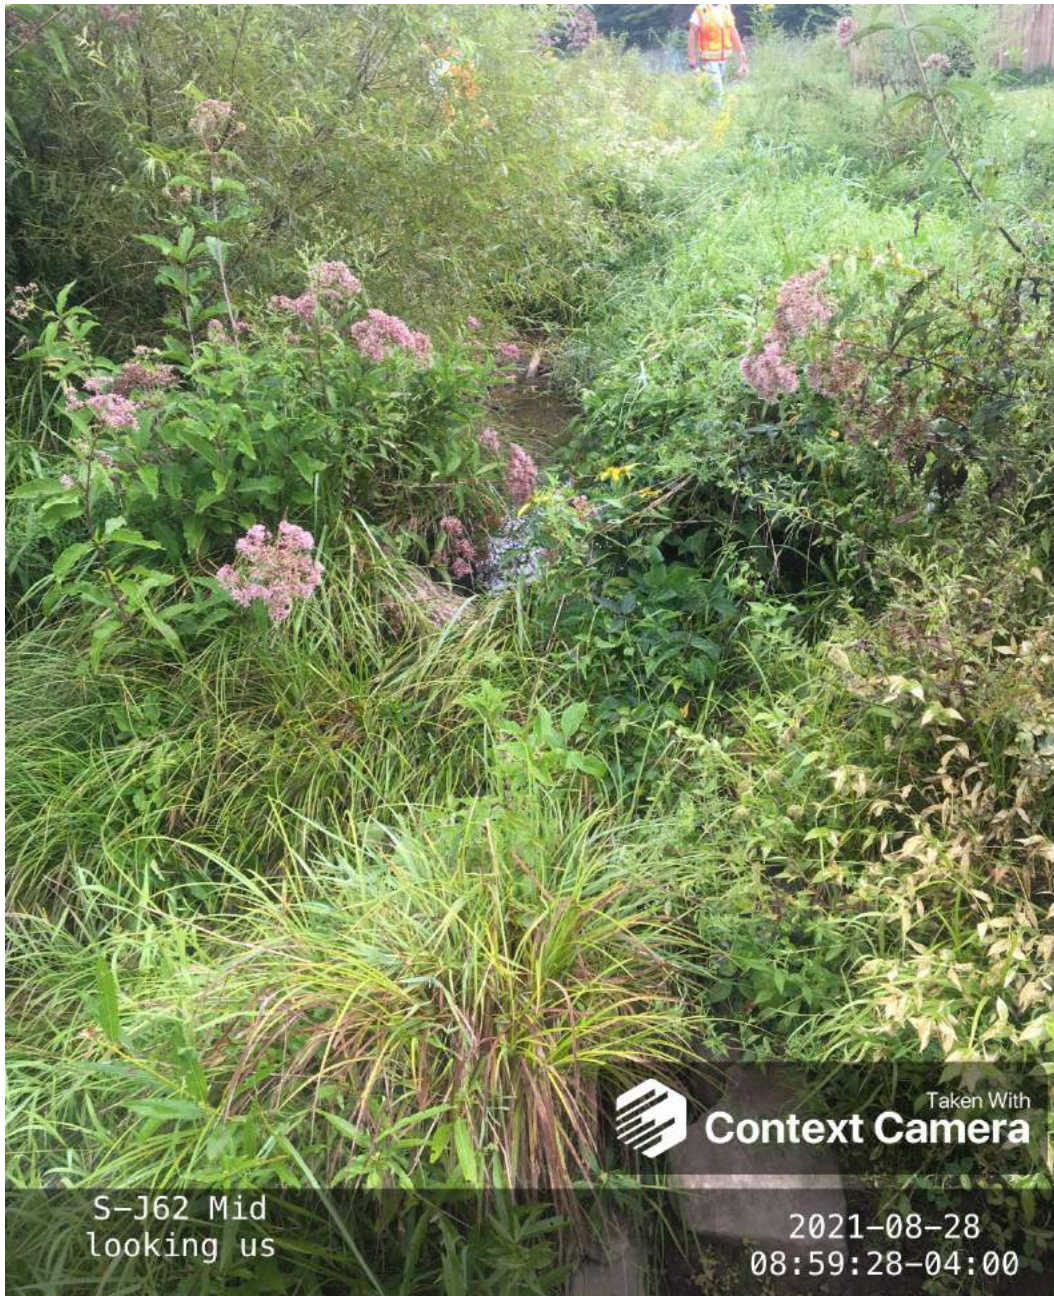
Photo Type: US View at Center
Location, Orientation, Photographer Initials: Center ROW, Upstream View, DP/PL
Lat: 39.445033 Long: -80.482635

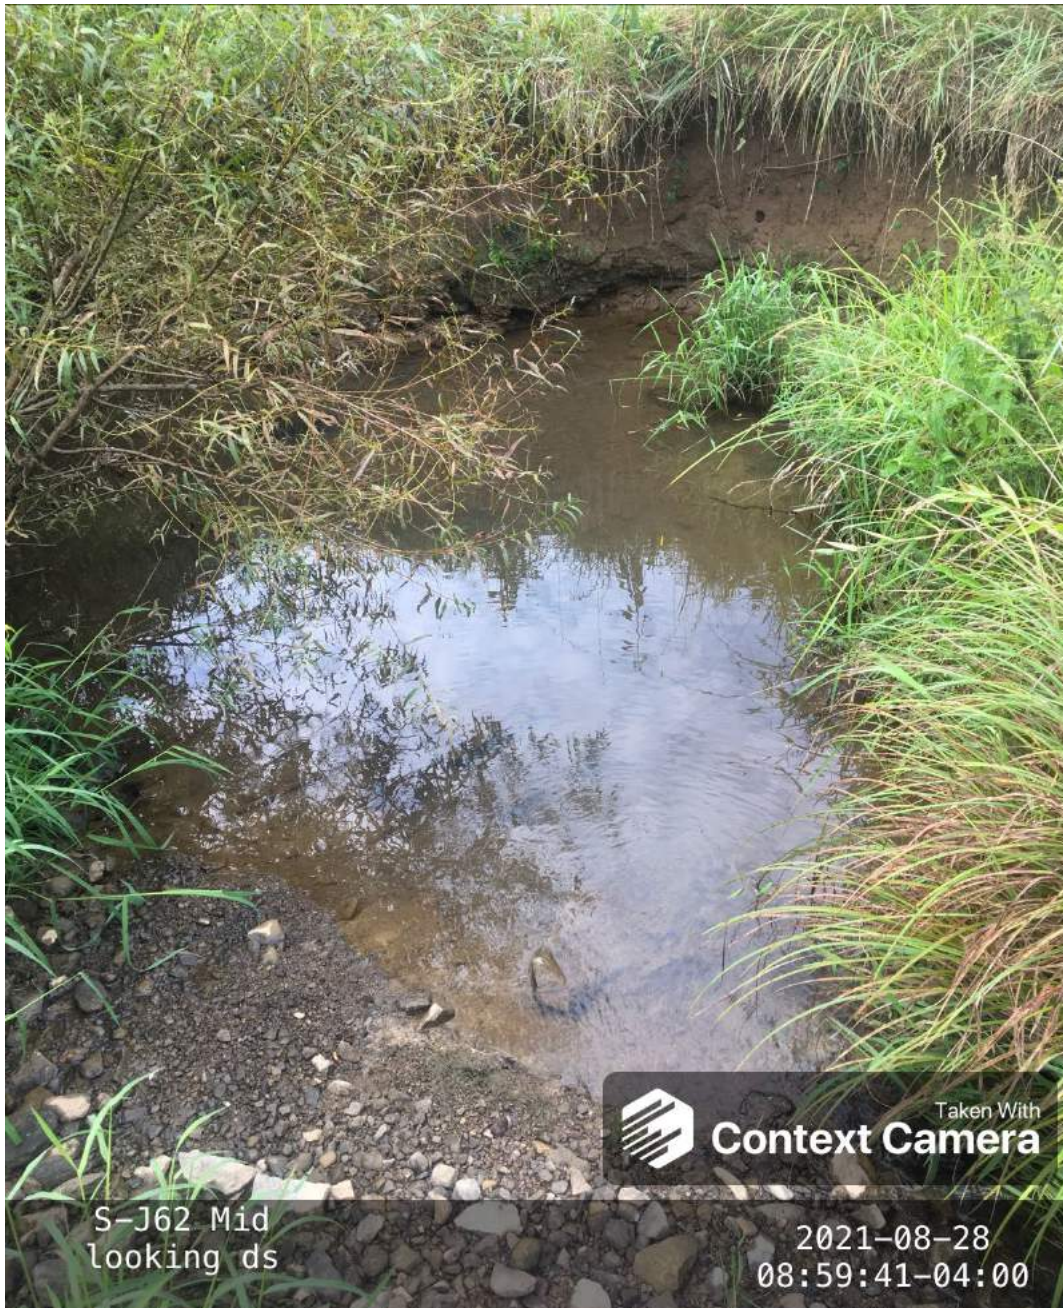
Photo Type: DS View at Center
Location, Orientation, Photographer Initials: ROW Center, Downstream View, DP/PL
Lat: 39.445033 Long: -80.482635

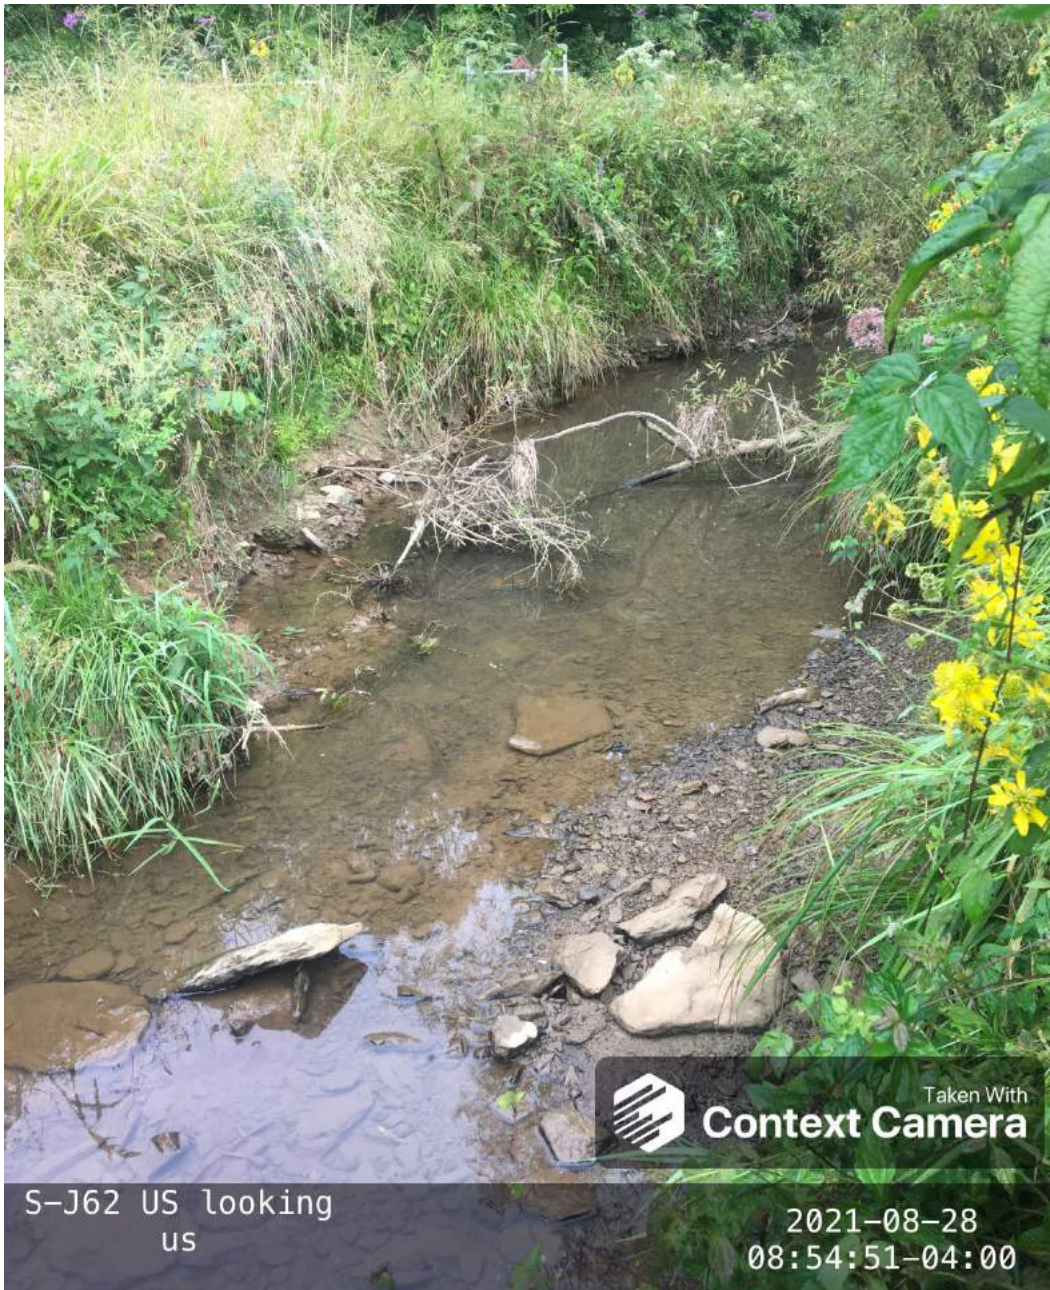
Photo Type: US, US View

S-J62 US looking
us

Location, Orientation, Photographer Initials: Upstream Edge of ROW, Upstream View, DP/PL
Lat: 39.445033 Long: -80.482635

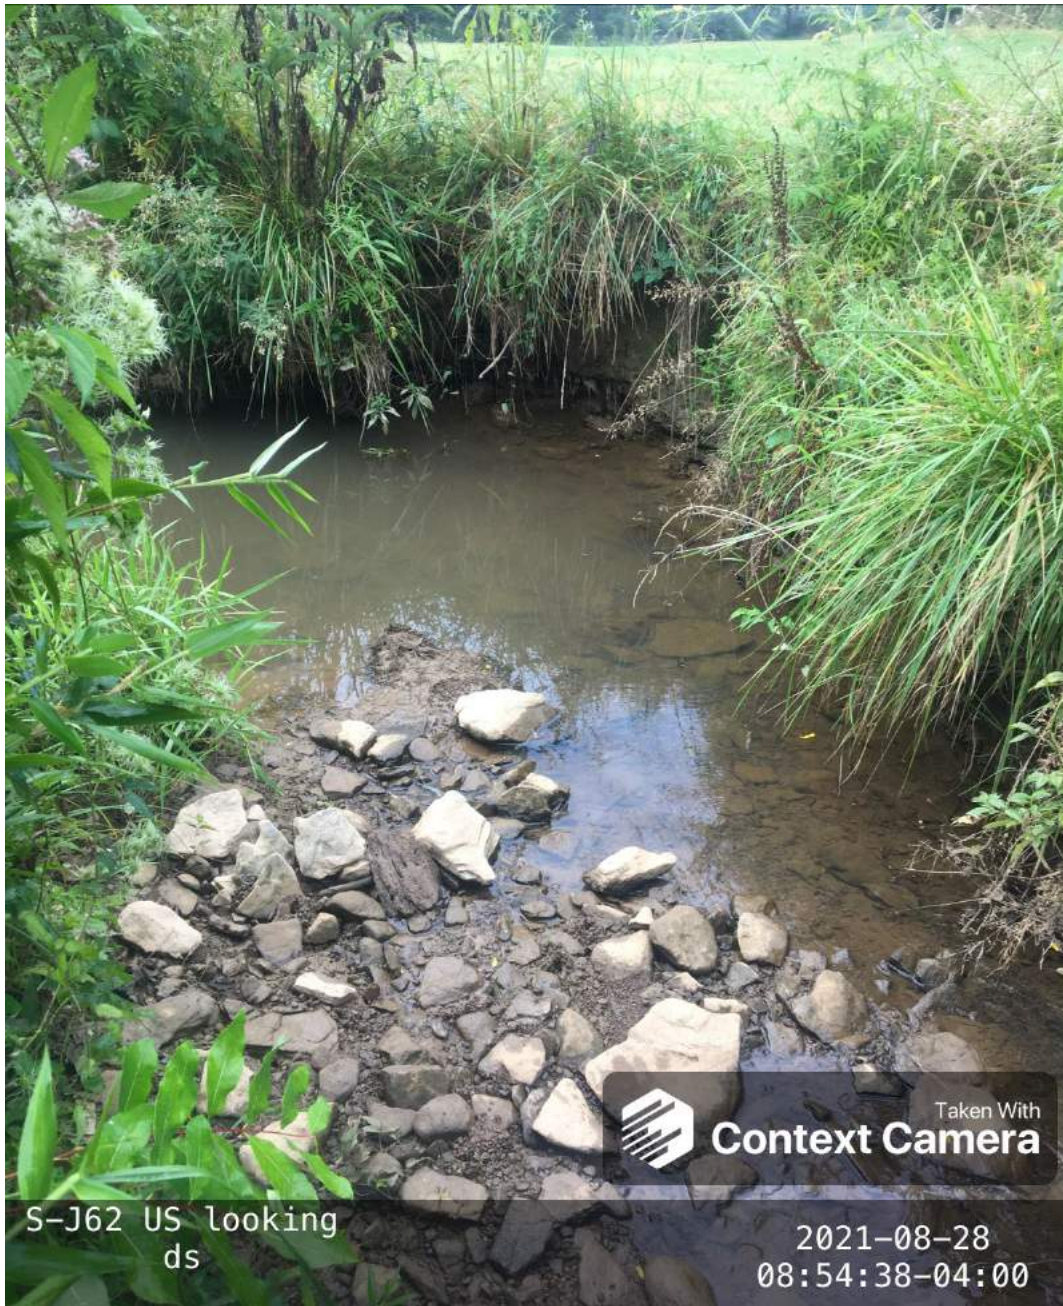
Photo Type: US, DS View
Location, Orientation, Photographer Initials: Upstream Edge of ROW, Downstream View, DP/PL
Lat: 39.445033 Long: -80.482635

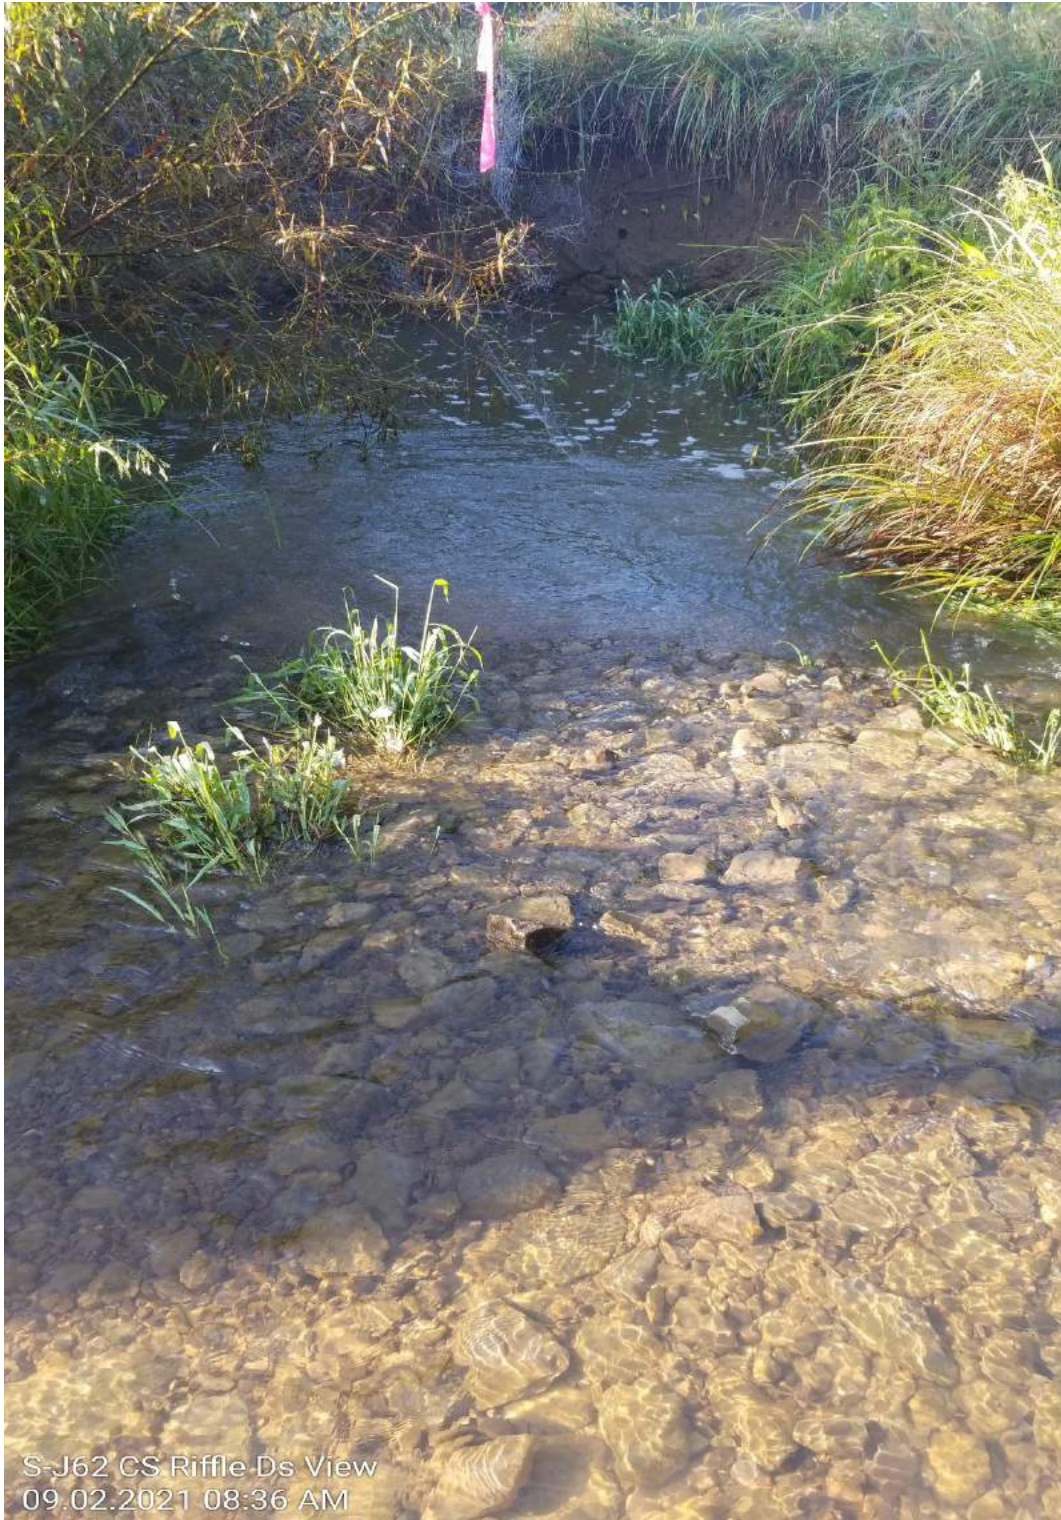
Photo Type: Riffle, DS View

S-J62 CS Riffle Ds View
09.02.2021 08:36 AM

Location, Orientation, Photographer Initials: Upstream of Riffle, Downstream View, DP/PL

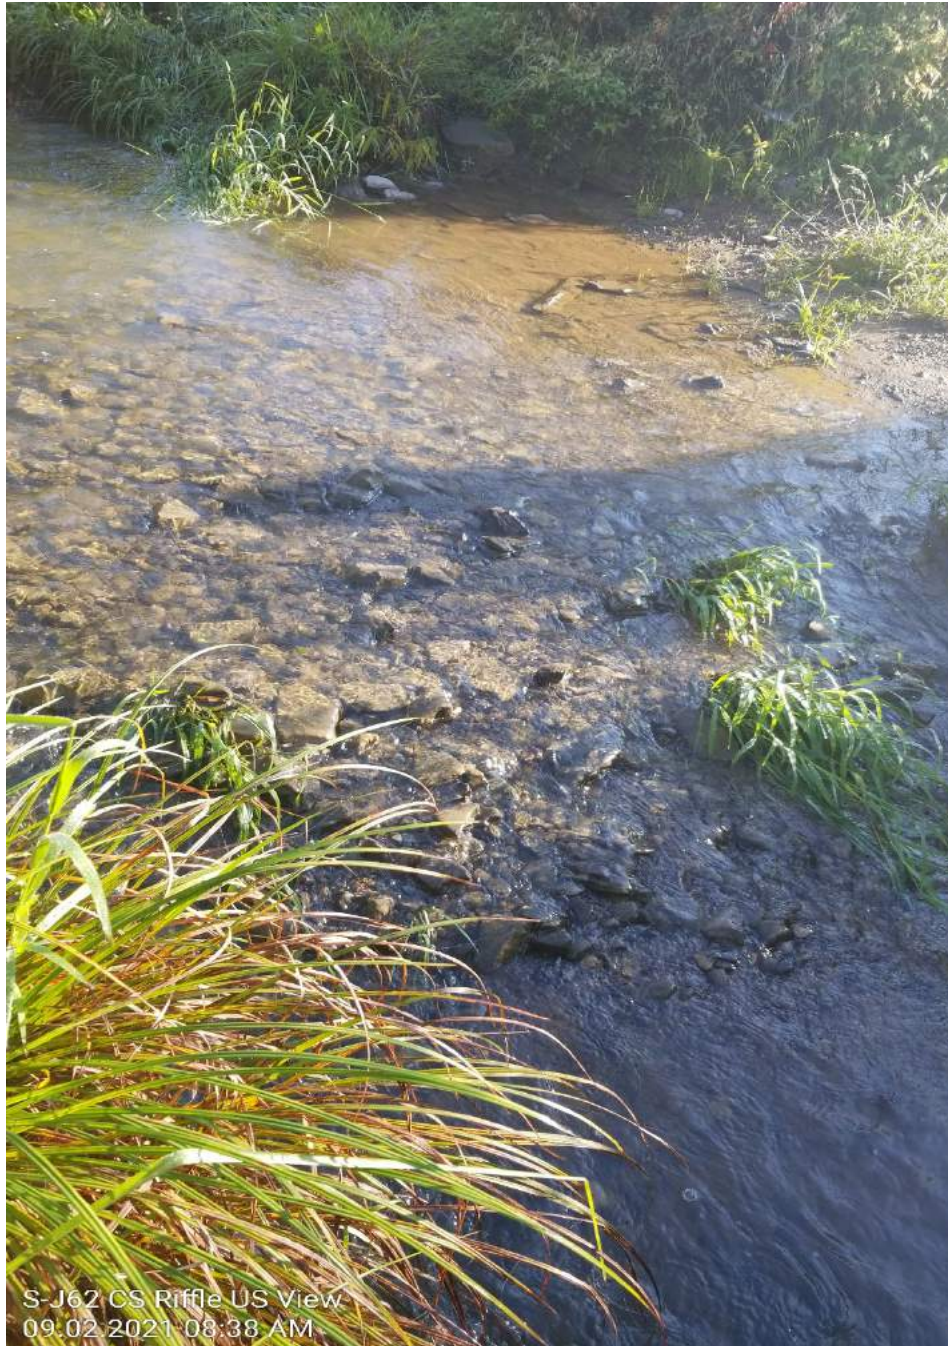
Photo Type: Riffle, US View

S-J62 CS Riffle US View
09.02.2021 08:38 AM

Location, Orientation, Photographer Initials: Downstream of Riffle, Upstream View, DP/PL
Lat: 39.445033 Long: -80.482635

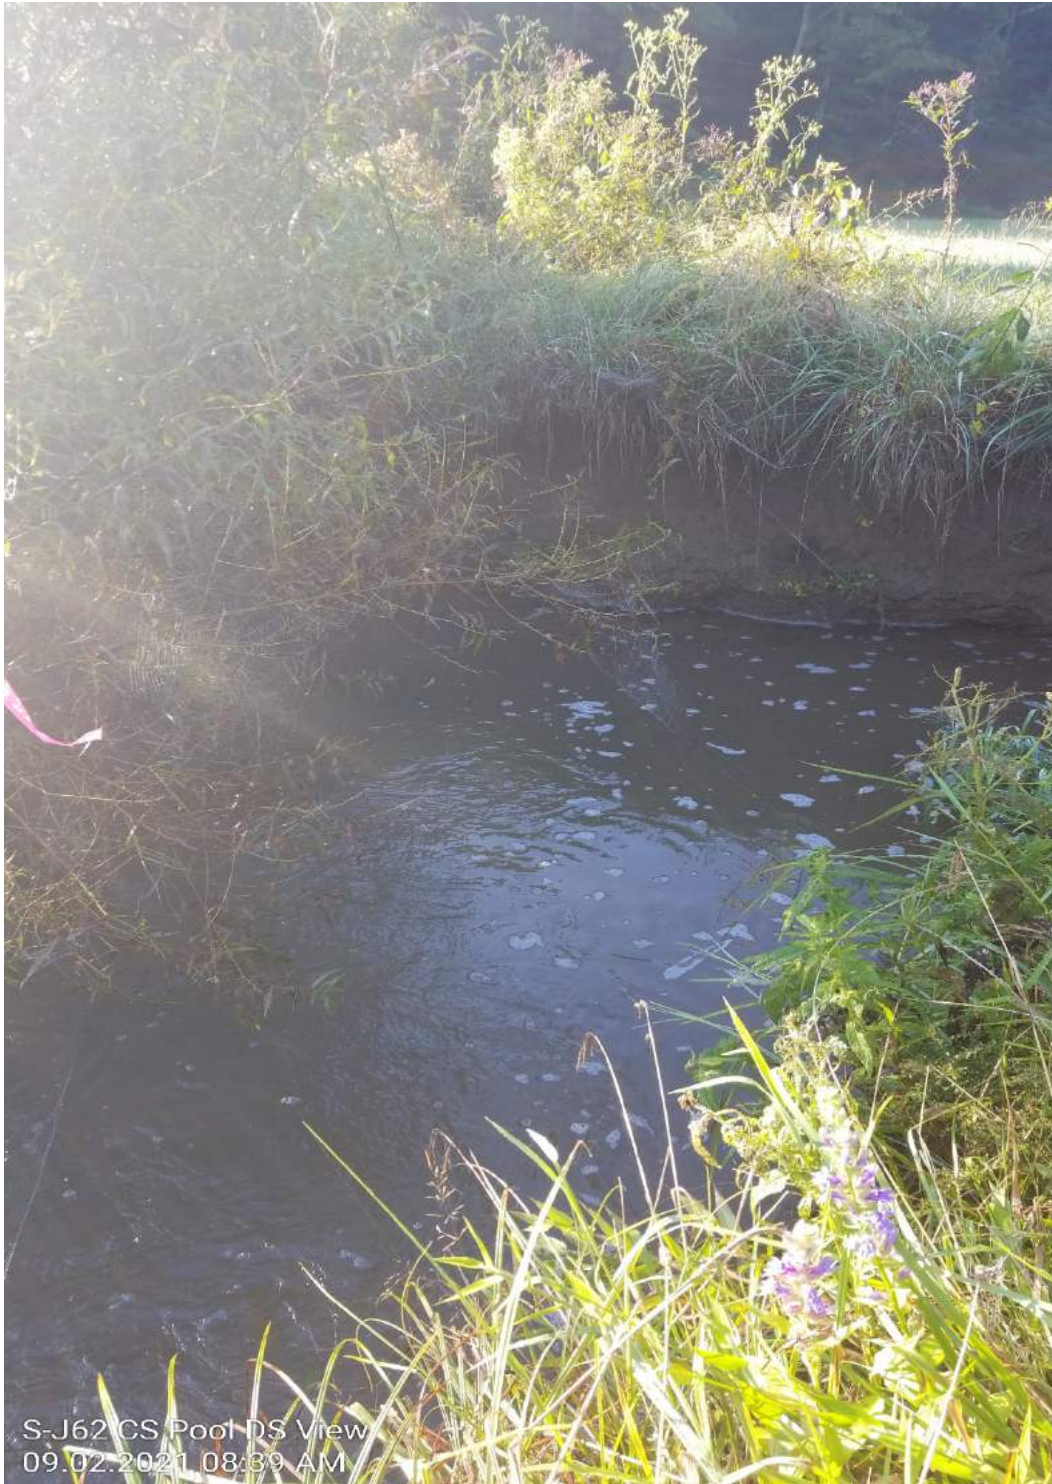
Photo Type: Pool, DS View

S-J62 CS Pool DS View
09.02.2021 08:39 AM

Location, Orientation, Photographer Initials: Upstream of Pool, Downstream View, DP/PL

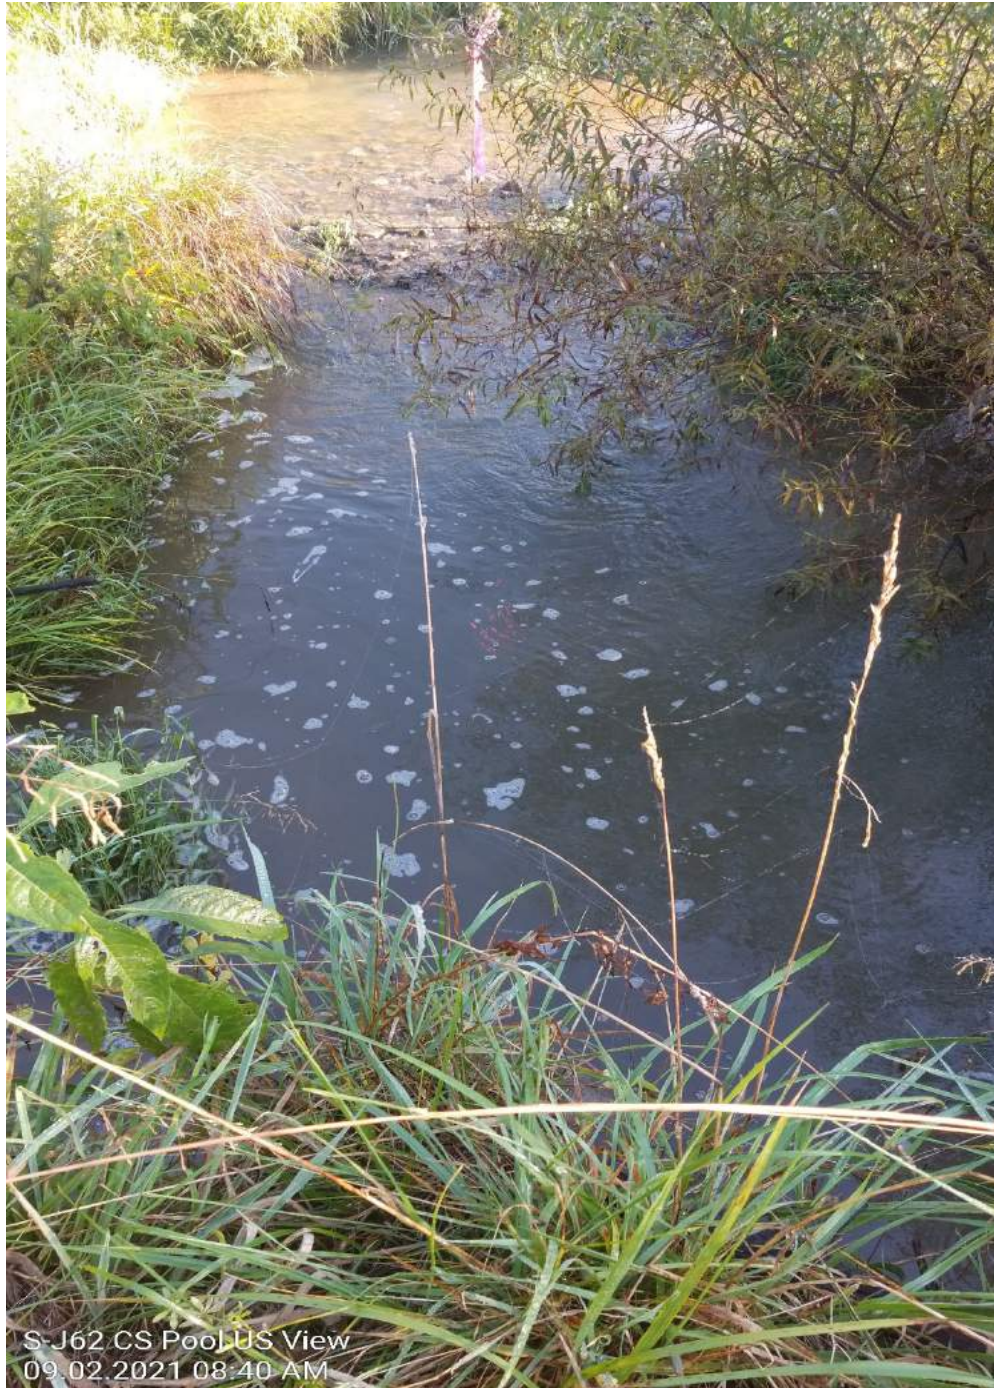
Photo Type: Pool, US View

S-J62 CS Pool US View
09.02.2021 08:40 AM

Location, Orientation, Photographer Initials: Downstream of Pool, Upstream View, DP/PL
Lat: 39.445033 Long: -80.482635

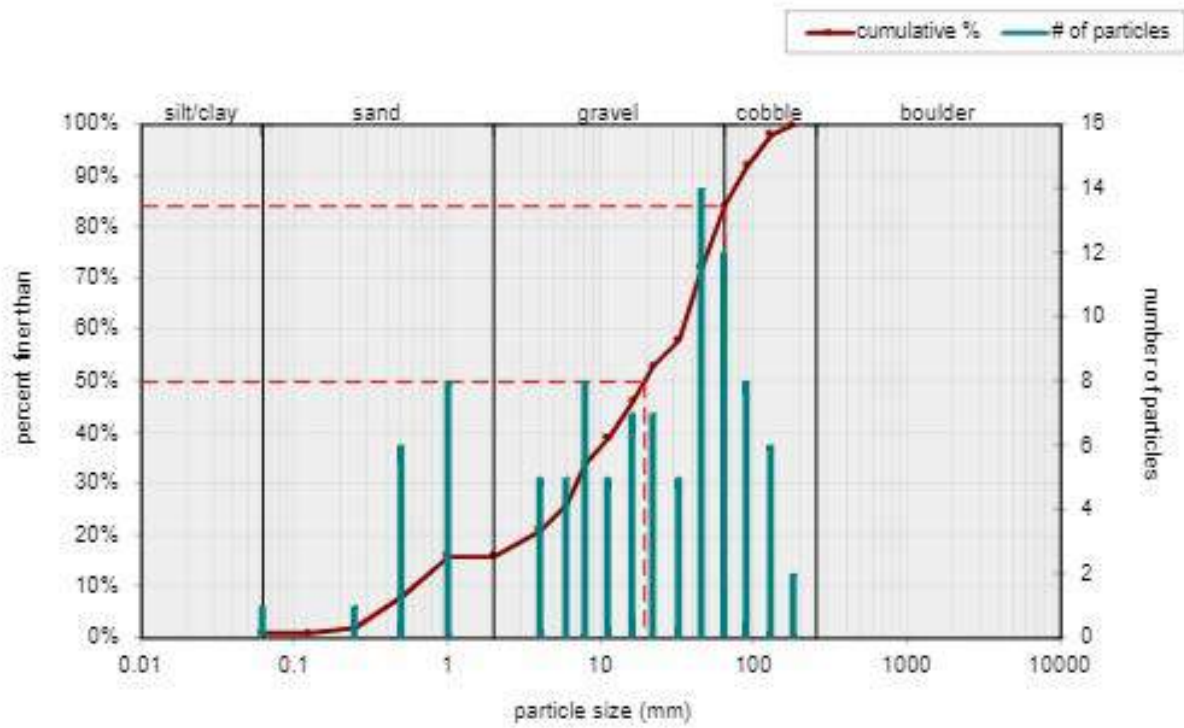
Bankfull Channel Pebble Count, S-J62

Size (mm)		Size Distribution		Type	
D16	2	mean	11.3	silt/clay	1%
D35	8.5	dispersion	6.4	sand	15%
D50	19	skewness	-0.18	gravel	68%
D65	38			cobble	16%
D84	64			boulder	0%
D95	110

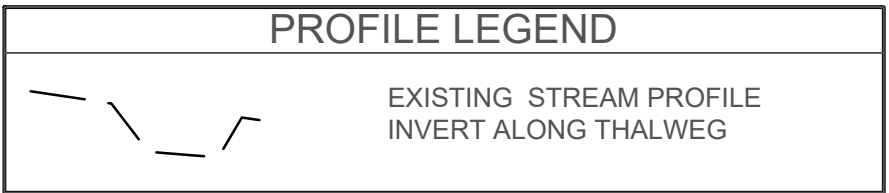
S-J62 BASELINE THALWEG

PROFILE
SCALE: H: 1"=10'
V: 1"=5'

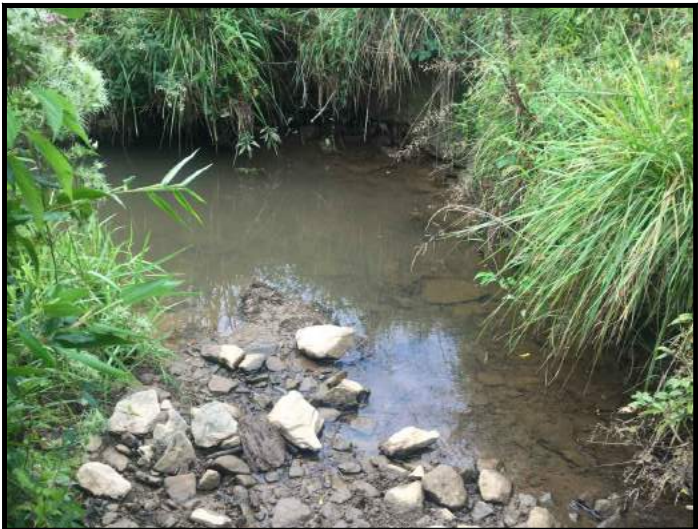
PHOTO TAKEN LOOKING DOWNSTREAM FROM UPSTREAM IMPACT LIMITS

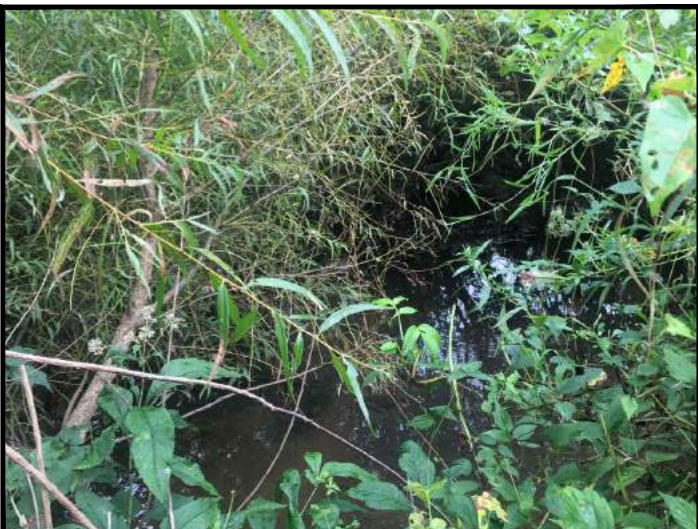
PHOTO TAKEN LOOKING UPSTREAM FROM DOWNSTREAM IMPACT LIMITS
