Baseline Assessment – Stream Attributes

Reach S-J70 (Pipeline ROW) Perennial Spread C Braxton County, West Virginia

E AND CROSS-SECTIONS
BASELINE SURVEY
ING S-J70 - FALLS RUN
(MP 72.43)

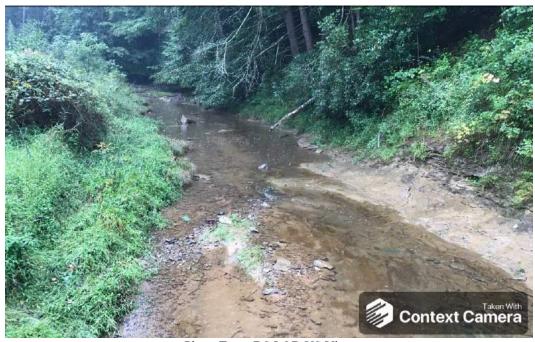
Photo Type: DS LOD US View Location, Orientation, Photographer Initials: Downstream Edge of LOD, Upstream View, PEL/AJE Lat: 38.778955 Long: -80.525862

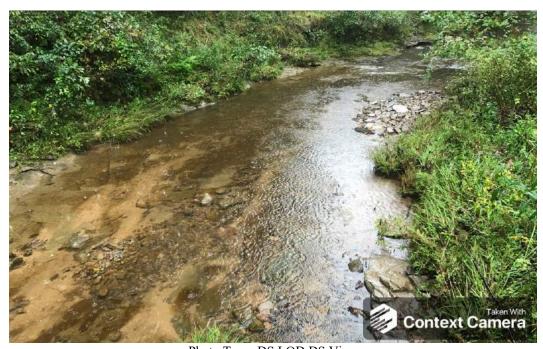
Photo Type: DS LOD DS View Location, Orientation, Photographer Initials: Downstream Edge of LOD, Downstream View, PEL/AJE Lat: 38.778955 Long: -80.525862

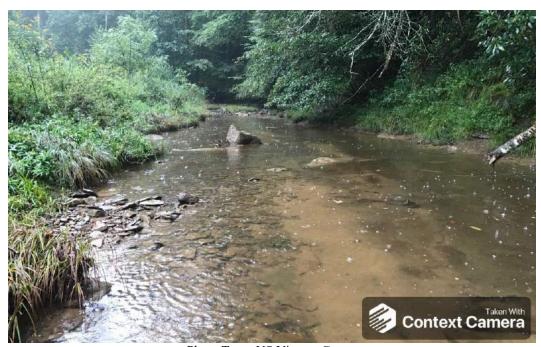
Photo Type: US View at Center Location, Orientation, Photographer Initials: Center LOD, Upstream View, PEL/AJE Lat: 38.778955 Long: -80.525862

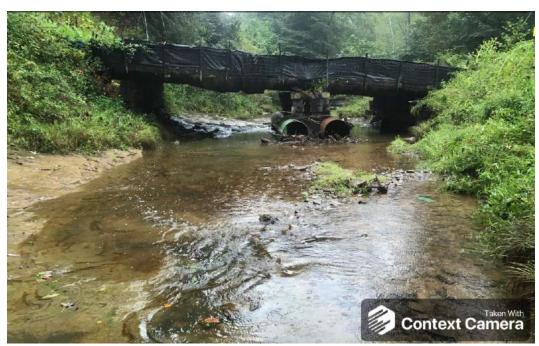
Photo Type: DS View at Center Location, Orientation, Photographer Initials: LOD Center, Downstream View, PEL/AJE Lat: 38.778955 Long: -80.525862

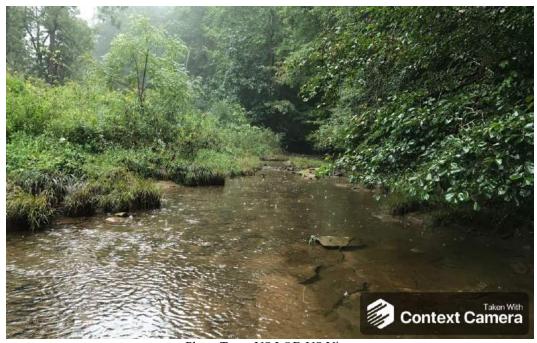
Photo Type: US LOD US View Location, Orientation, Photographer Initials: Upstream Edge of LOD, Upstream View, PEL/AJE Lat: 38.778955 Long: -80.525862

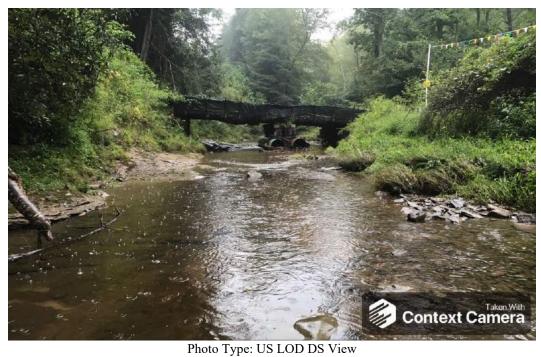
Location, Orientation, Photographer Initials: Upstream Edge of LOD, Downstream View, PEL/AJE
Lat: 38.778955 Long: -80.525862

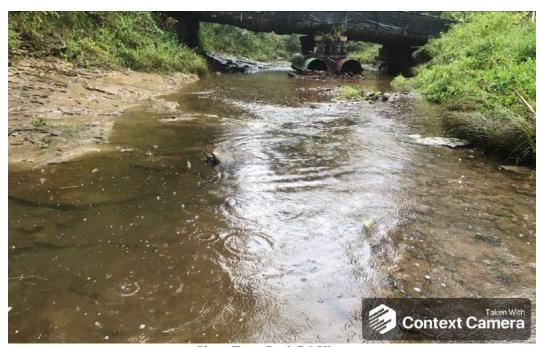
Photo Type: Pool, DS View Location, Orientation, Photographer Initials: Upstream of Pool, Downstream View, PEL/AJE Lat: 38.778955 Long: -80.525862

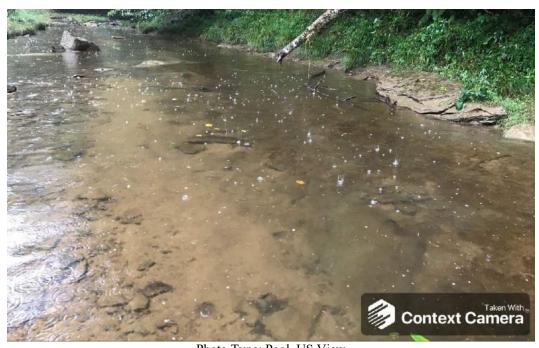
Photo Type: Pool, US View Location, Orientation, Photographer Initials: Downstream of Pool, Upstream View, PEL/AJE Lat: 38.778955 Long: -80.525862

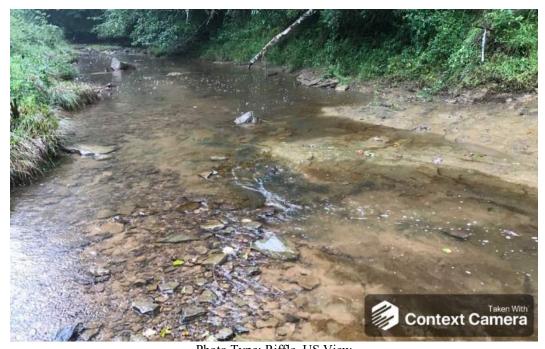
Photo Type: Riffle, US View Location, Orientation, Photographer Initials: Downstream of Riffle, Upstream View, PEL/AJE Lat: 38.778955 Long: -80.525862

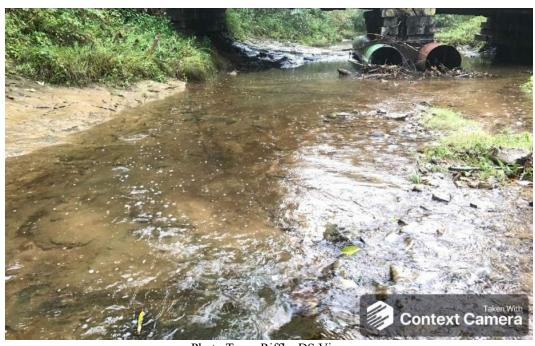
Photo Type: Riffle, DS View Location, Orientation, Photographer Initials: Upstream of Riffle, Downstream View, PEL/AJE Lat: 38.778955 Long: -80.525862

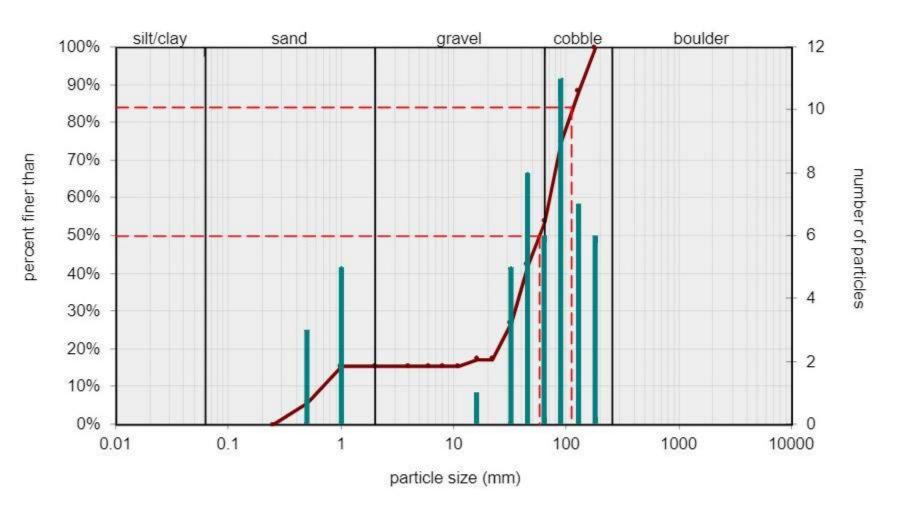
Size (mm)	
W.	D16	12
	D35	38
	D50	57
	D65	77
	D84	110
	D95	160

Size Distribution		
mean	36.3	
dispersion	3.3	
skewness	-0.20

1	Гуре		
silt/clay	0%	bedrock	48%
sand	8%		
gravel	20%		
cobble	24%		
boulder	0%

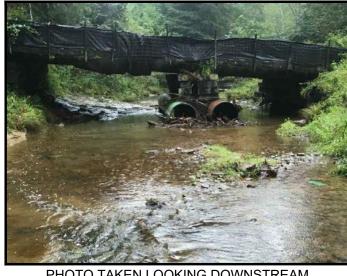
PHOTO TAKEN LOOKING DOWNSTREAM FROM UPSTREAM IMPACT LIMITS

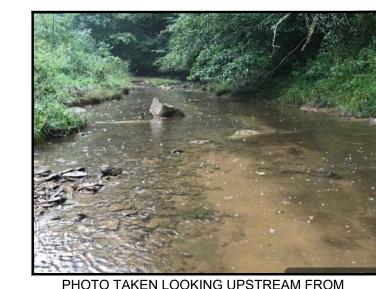
PHOTO TAKEN LOOKING UPSTREAM FROM DOWNSTREAM IMPACT LIMITS
