Baseline Assessment – Stream Attributes

Reach S-JJ1 (Timber Mat Crossing)

Braxton County, West Virginia

Client	Profile and Cross-Sections Baseline Survey
MIC 222	CROSSING S-J1 - UNNAMED TRIB. TO KEITH RUN (MP 71.65) BRAYTON COUNTY, WV

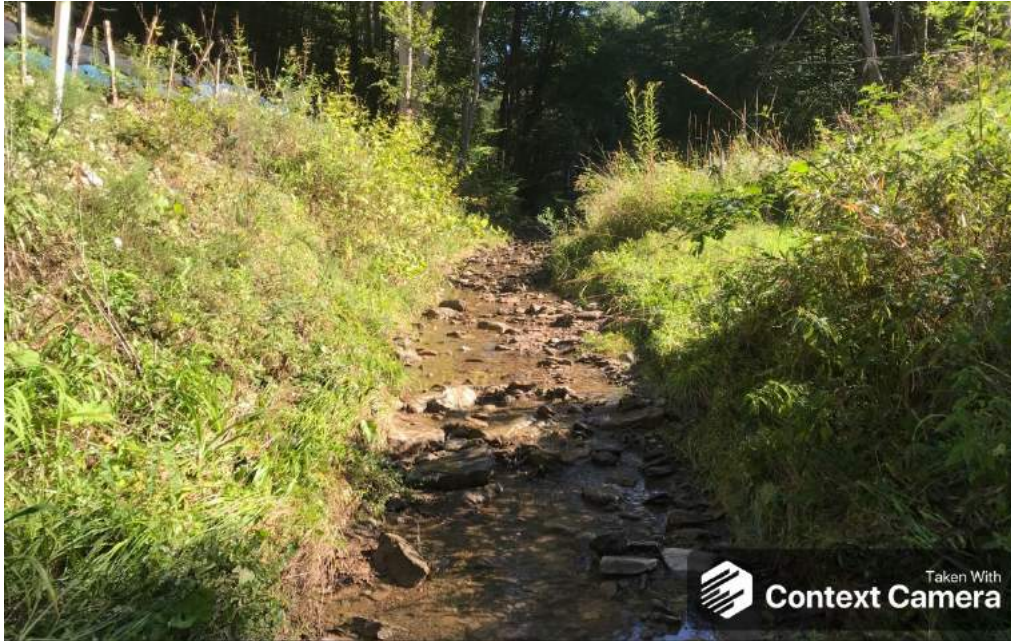
Photo Type: DS, US View

Location, Orientation, Photographer Initials: Downstream Edge of ROW, Upstream View, AE. PI
Lat: 38.78693 Long: -80.530028

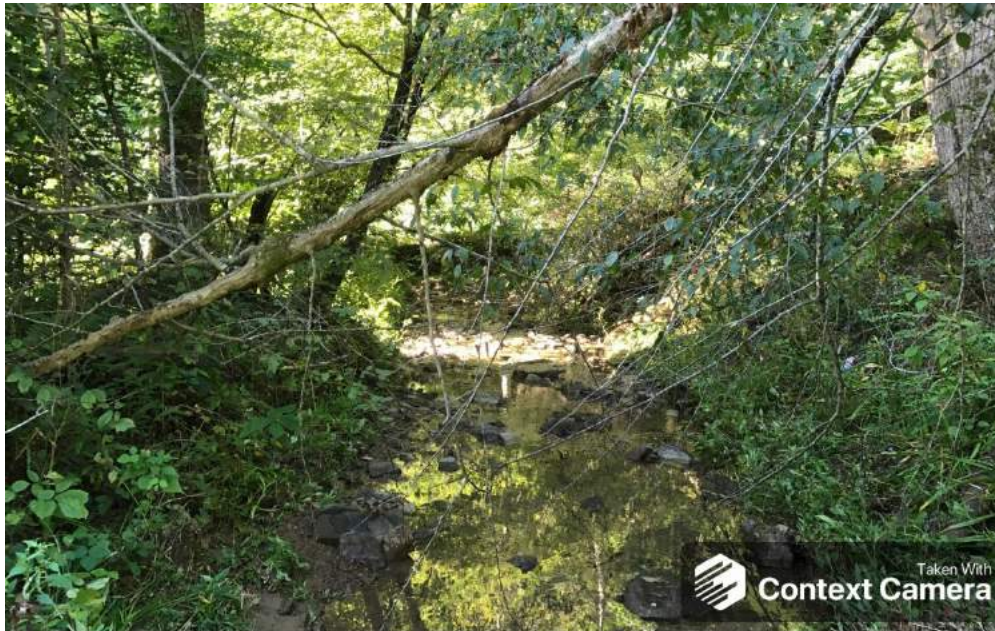
Photo Type: DS, DS View

Location, Orientation, Photographer Initials: Downstream Edge of ROW, Downstream View, AE. PI
Lat: 38.78693 Long: -80.530028

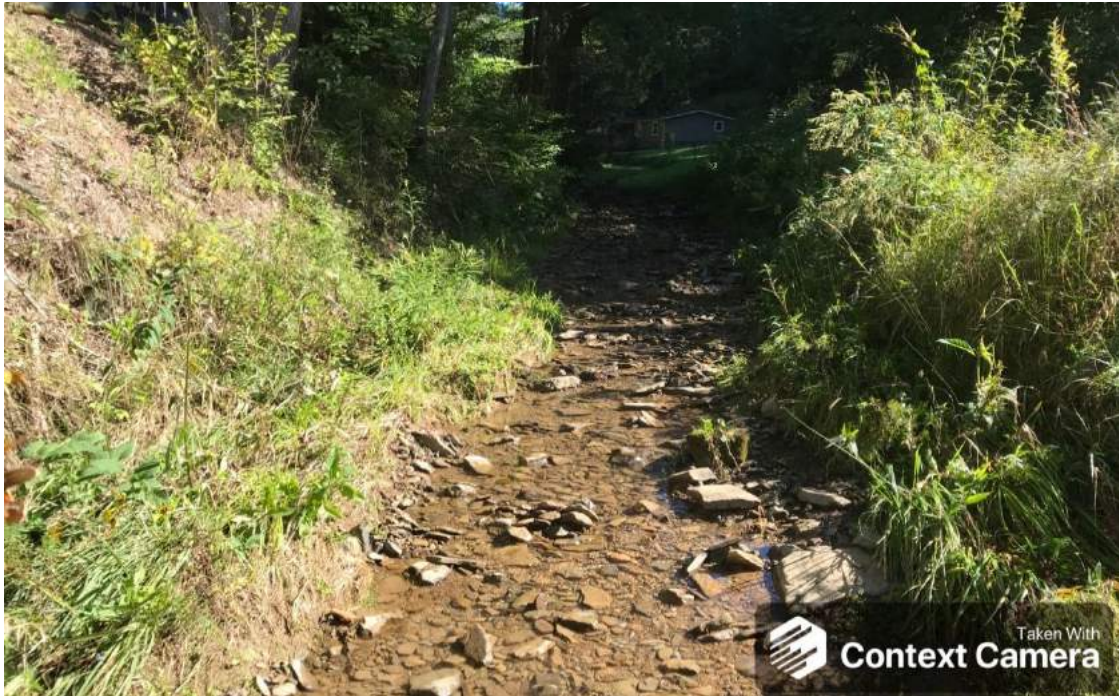
Photo Type: US View at Center
Location, Orientation, Photographer Initials: Center ROW, Upstream View, AE. PI
Lat: 38.78693 Long: -80.530028

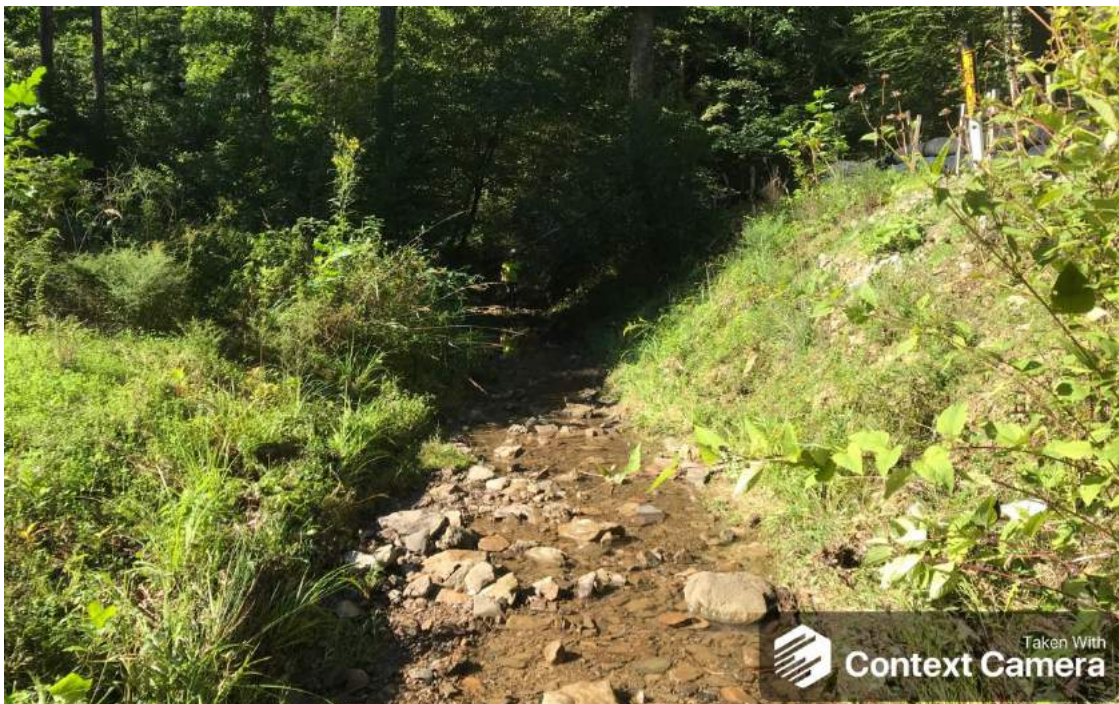
Photo Type: DS View at Center
Location, Orientation, Photographer Initials: ROW Center, Downstream View, AE. PI
Lat: 38.78693 Long: -80.530028

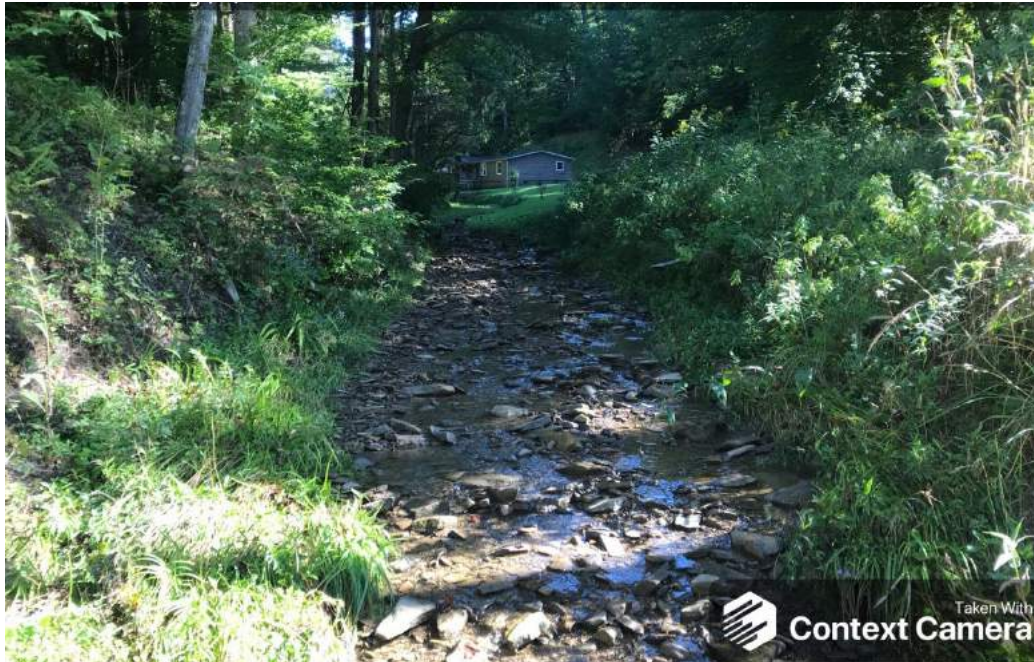
Photo Type: US, US View
Location, Orientation, Photographer Initials: Upstream Edge of ROW, Upstream View, AE. PI
Lat: 38.78693 Long: -80.530028

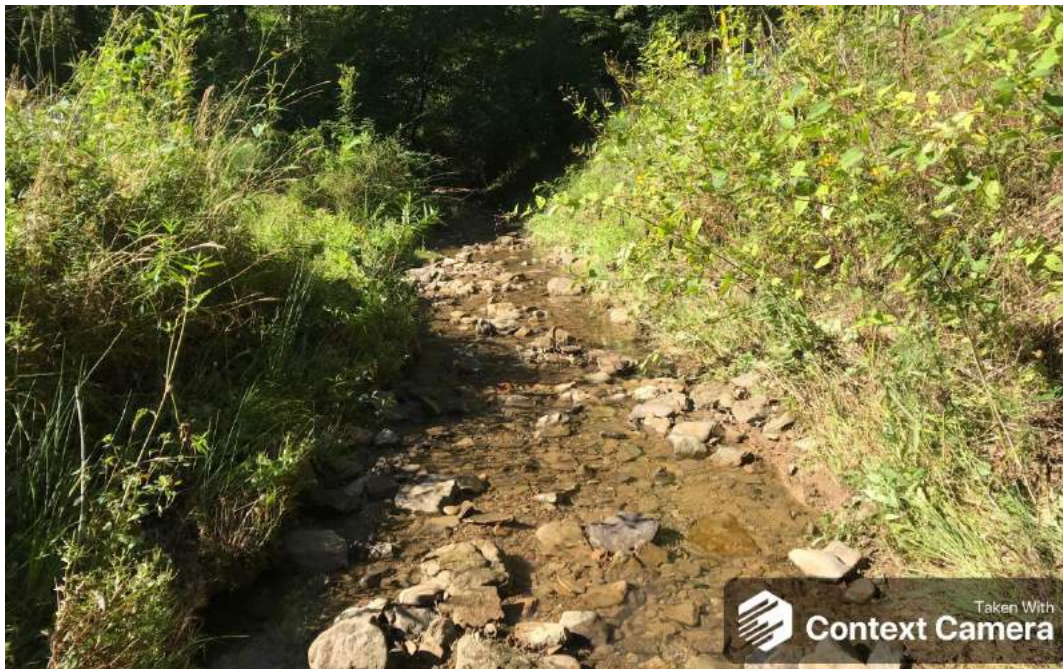
Photo Type: US, DS View
Location, Orientation, Photographer Initials: Upstream Edge of ROW, Downstream View, AE. PI
Lat: 38.78693 Long: -80.530028

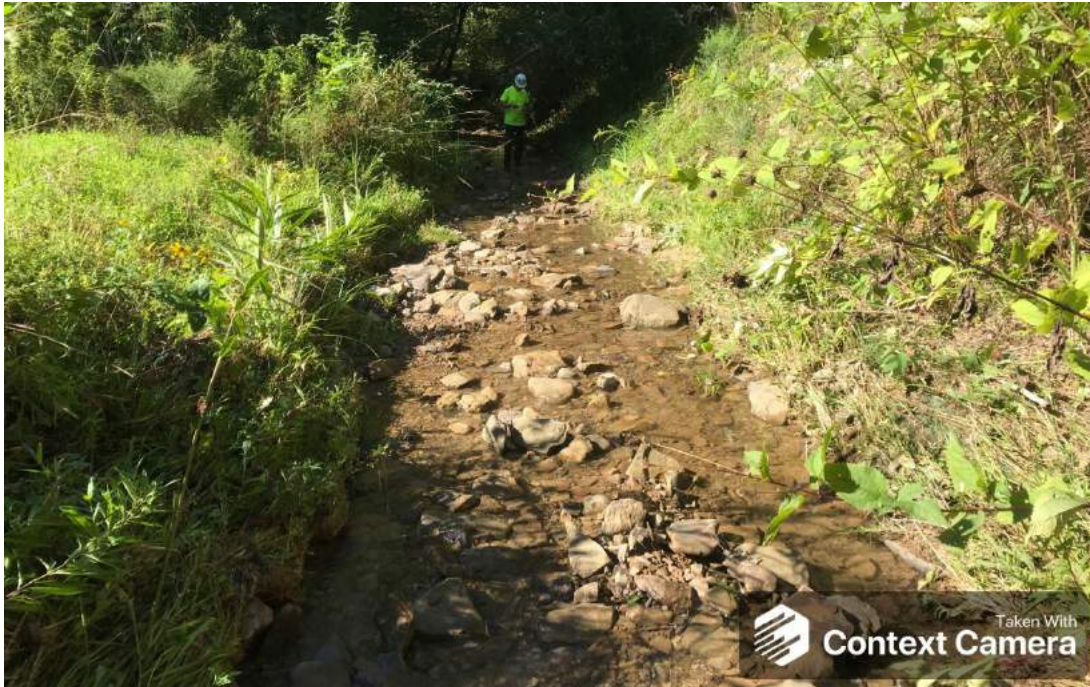
Photo Type: Riffle, DS View
Location, Orientation, Photographer Initials: Upstream of Riffle, Downstream View, AE. PI
Lat: 38.78693 Long: -80.530028

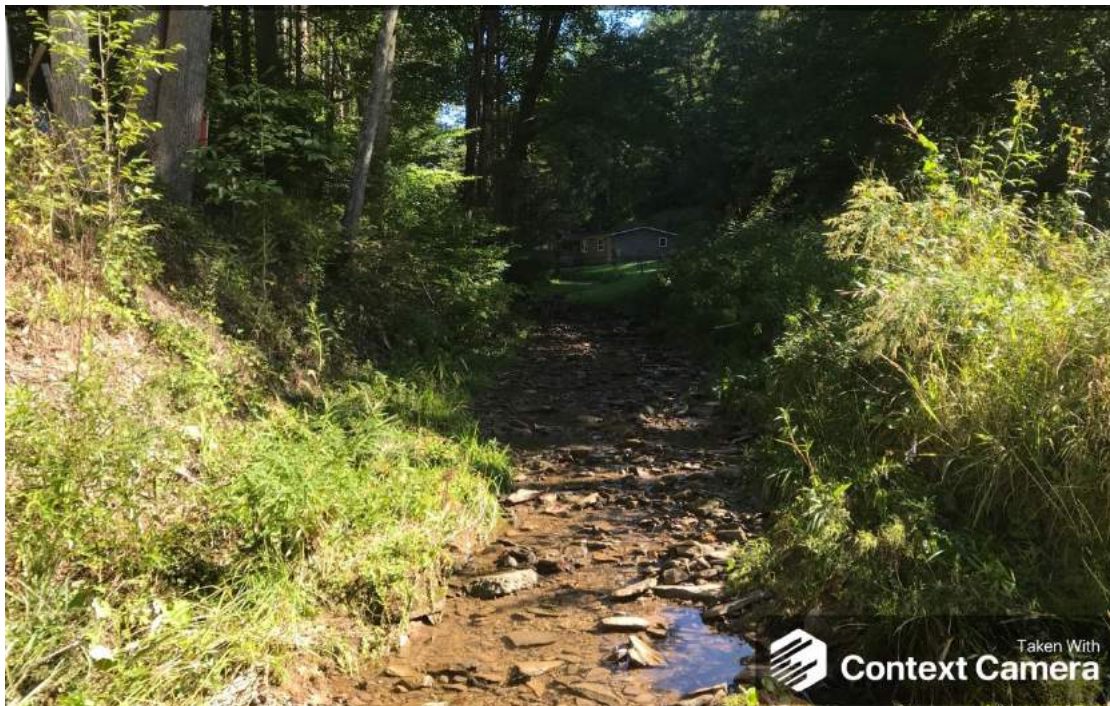
Photo Type: Riffle, US View
Location, Orientation, Photographer Initials: Downstream of Riffle, Upstream View, AE. PI
Lat: 38.78693 Long: -80.530028

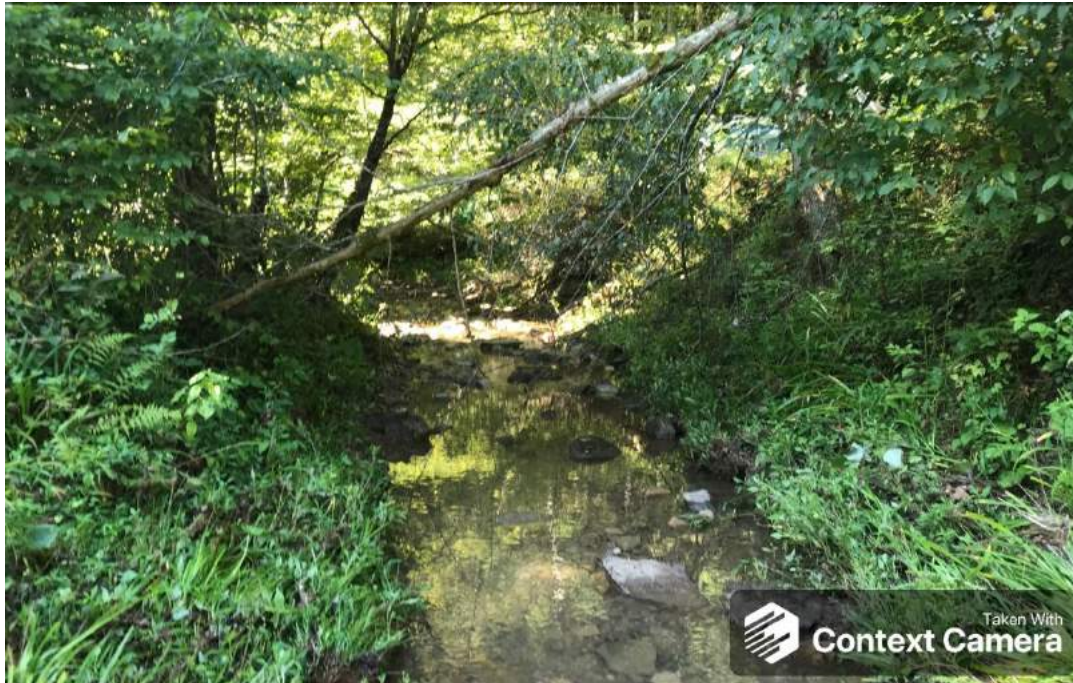
Photo Type: Pool, DS View
Location, Orientation, Photographer Initials: Upstream of Pool, Downstream View, AE. PI
Lat: 38.78693 Long: -80.530028

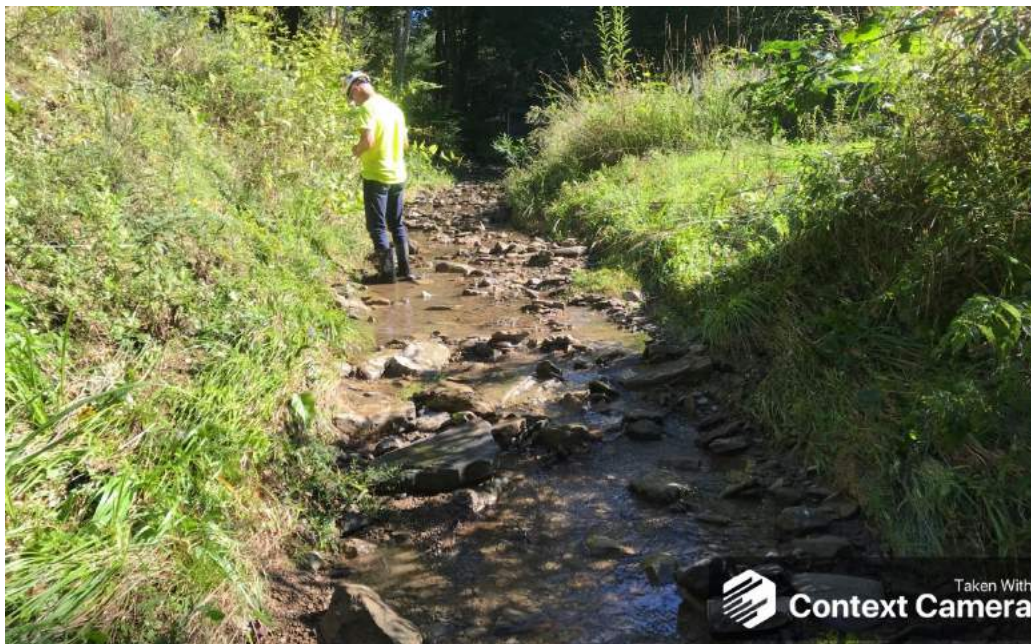
Photo Type: Pool, US View
Location, Orientation, Photographer Initials: Downstream of Pool, Upstream View, AE. PI
Lat: 38.78693 Long: -80.530028

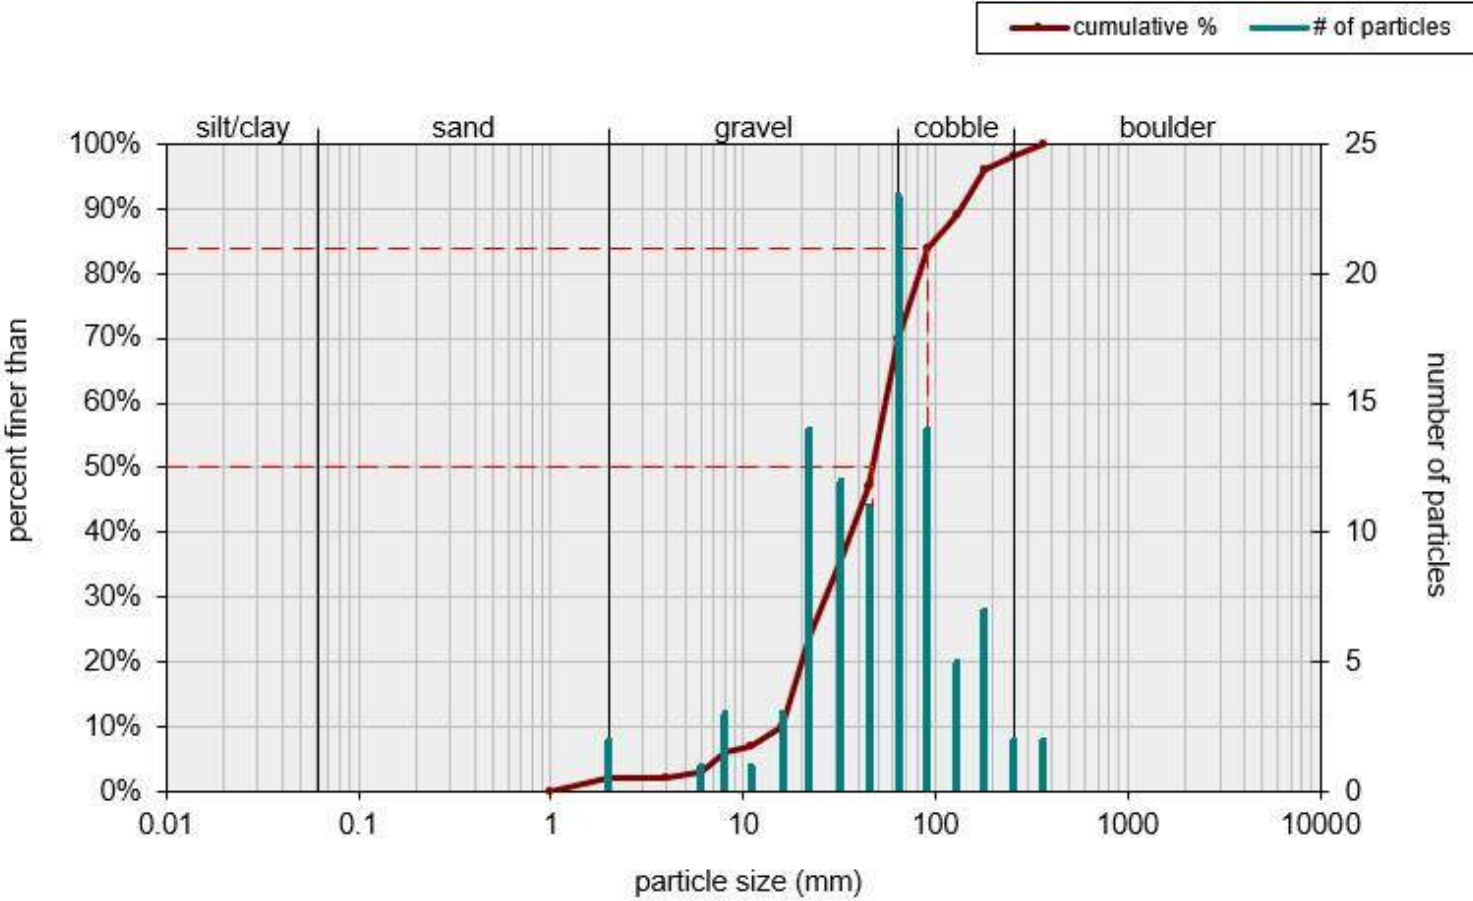
Bankfull Channel Pebble Count, S-JJ1, UNT to Keith Run

Size (mm)		Size Distribution		Type	
D16	18	mean	40.2	silt/clay	0%
D35	31	dispersion	2.3	sand	2%
D50	47	skewness	-0.08	gravel	68%
D65	59			cobble	28%
D84	90			boulder	2%
D95	170

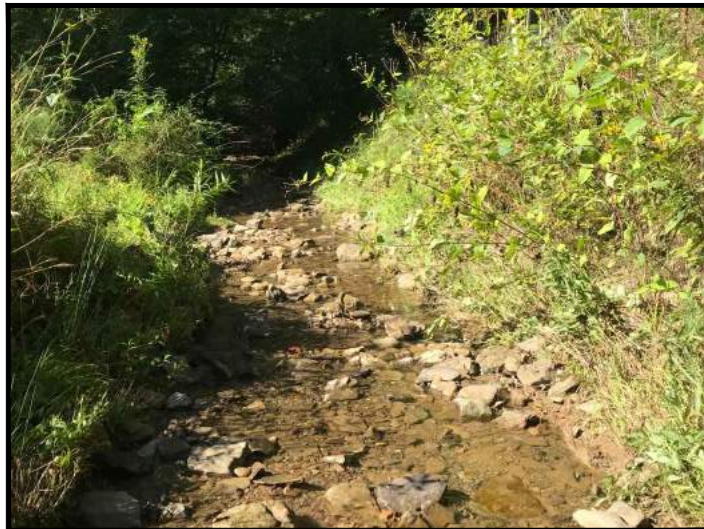
PHOTO TAKEN LOOKING DOWNSTREAM
FROM UPSTREAM IMPACT LIMITS

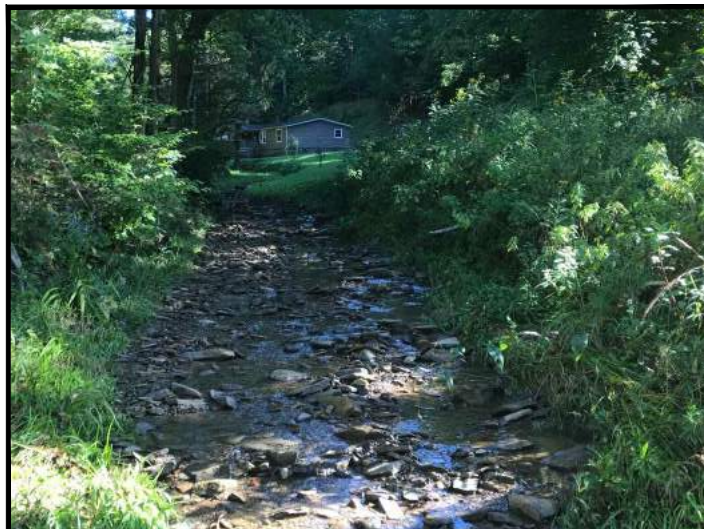
PHOTO TAKEN LOOKING UPSTREAM FROM
DOWNSTREAM IMPACT LIMITS

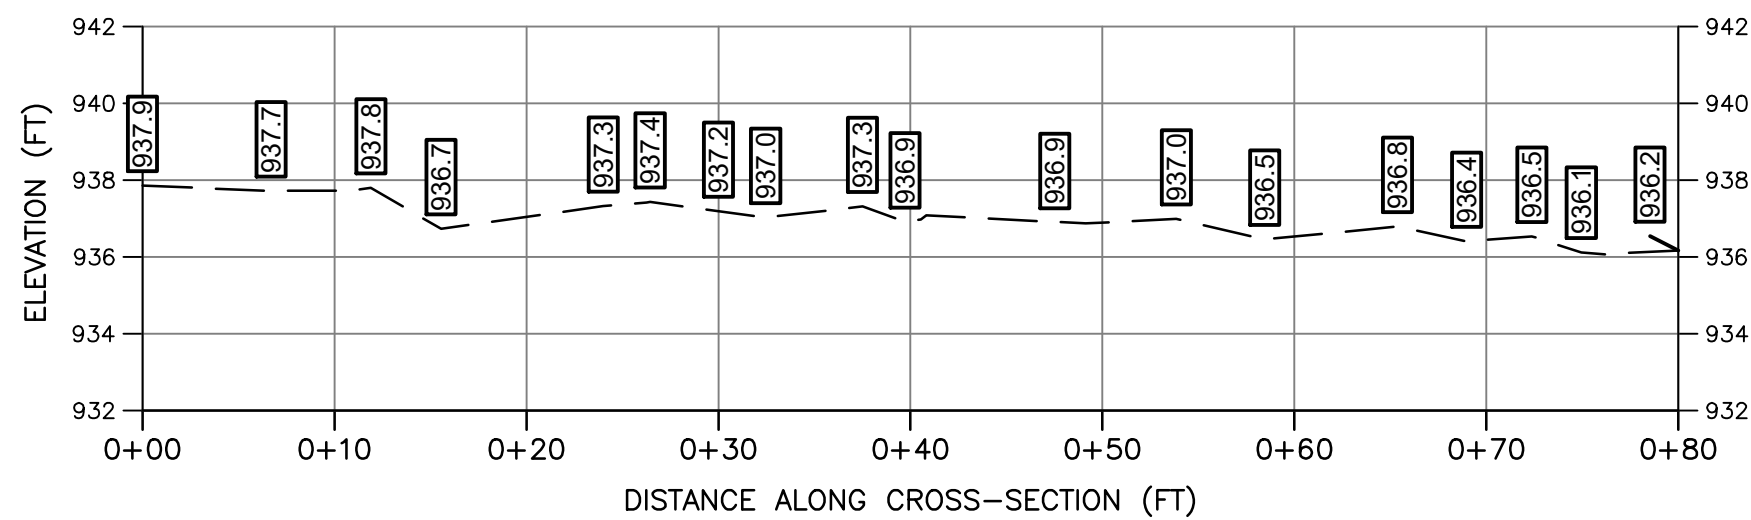
EXISTING STREAM PROFILE
INVERT ALONG THALWEG

TYPICAL 5-POINT CROSS-SECTION
(FACING DOWNSTREAM)

AS-BUILT TABLE: S-J11 CROSS SECTION A					
PRE-CROSSING				AS-BUILT	
PT. LOC.	NORTHING	EASTING	ELEV	VERT. DIFF.	HORZ. DIFF.
TS-L	14085399.6700'	1774324.5540'	939.7211'		
BS-L	14085402.4200'	1774322.7250'	937.1731'		
THW	14085404.1200'	1774313.7660'	937.0851'		
BS-R	14085405.7500'	1774310.6180'	937.5851'		
TS-R	14085410.2600'	1774302.3120'	944.5071'
