Baseline Assessment – Stream Attributes

Reach S-K21 (Pipeline ROW)
Perennial
Spread F
Greenbrier County, West Virginia

Title
PROFILE AND CROSS-SECTIONS
BASELINE SURVEY
CROSSING S-K21 - UNNAMED TRIB. TO
BUFFALO CREEK (MP 155.24)
GREENBRIER COUNTY, WV

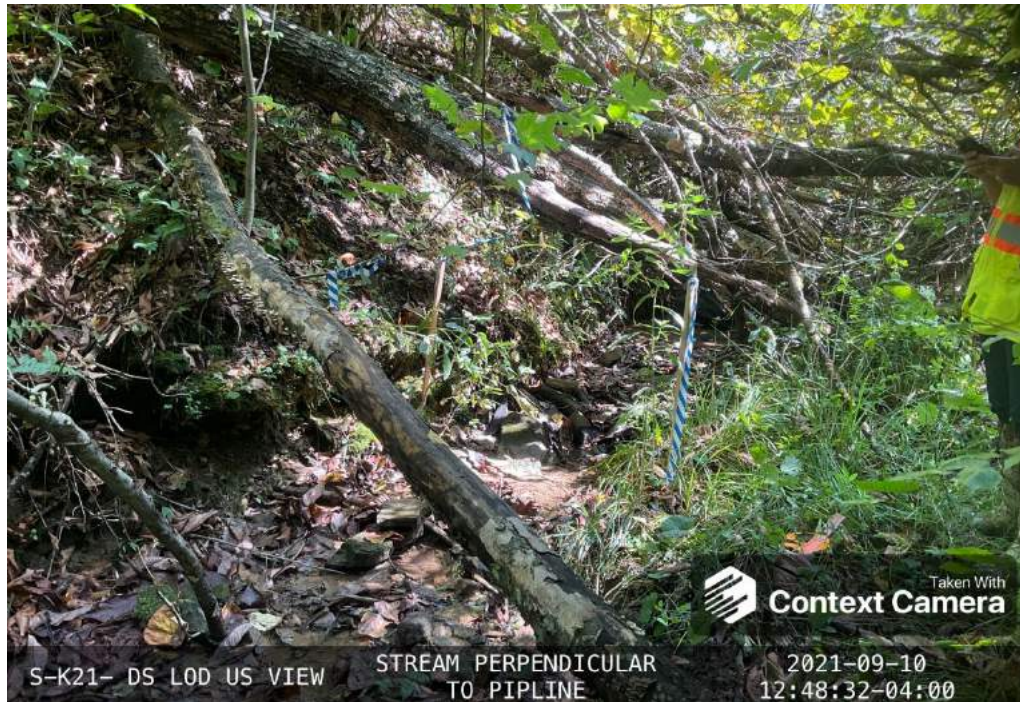
Photo Type: DS, US View
Location, Orientation, Photographer Initials: Downstream Edge of ROW, Upstream View, CNJ
Lat: 37.858566 Long: -80.755584

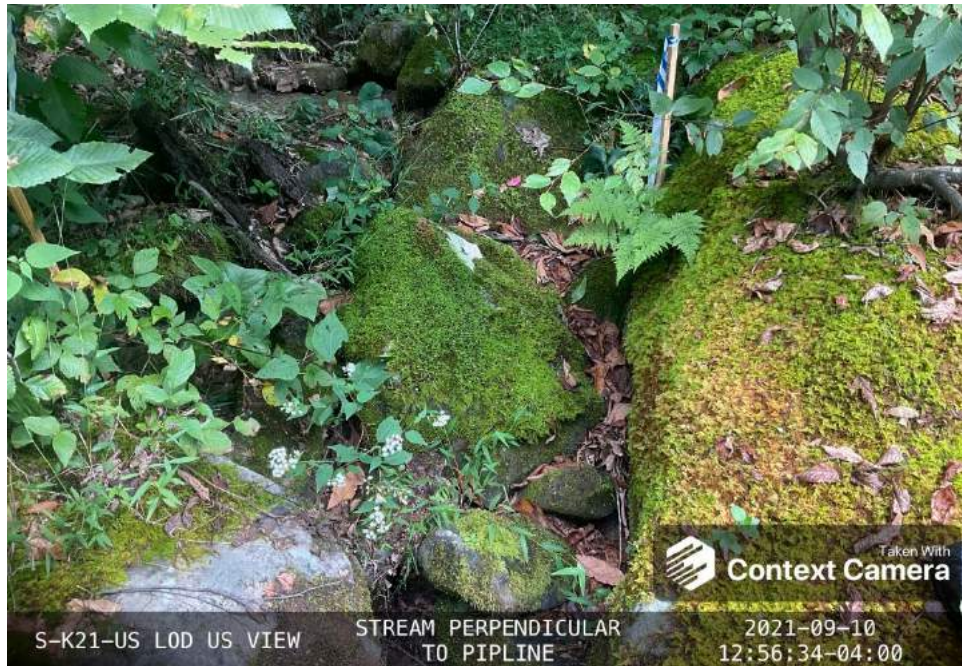
S-K21-US LOD US VIEW

STREAM PERPENDICULAR
TO PIPELINE

Photo Type: US, US View

Location, Orientation, Photographer Initials: Upstream Edge of ROW, Upstream View, CNJ

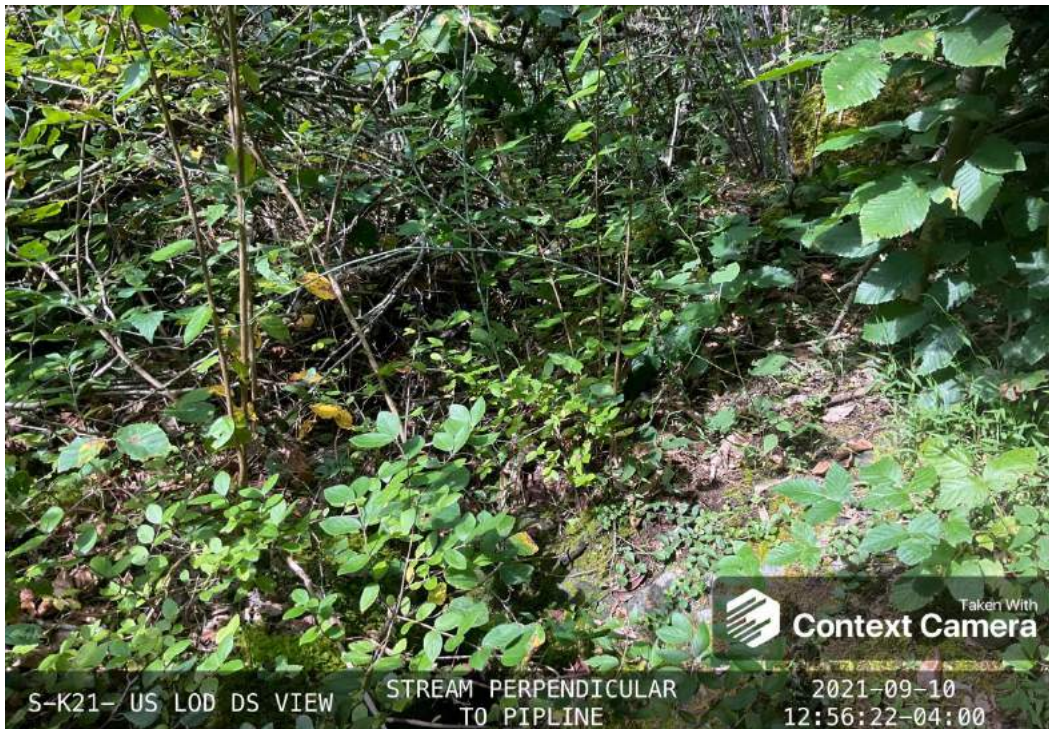
S-K21- US LOD DS VIEW

STREAM PERPENDICULAR
TO PIPELINE

Photo Type: US, DS View

Location, Orientation, Photographer Initials: Upstream Edge of ROW, Downstream View, CNJ

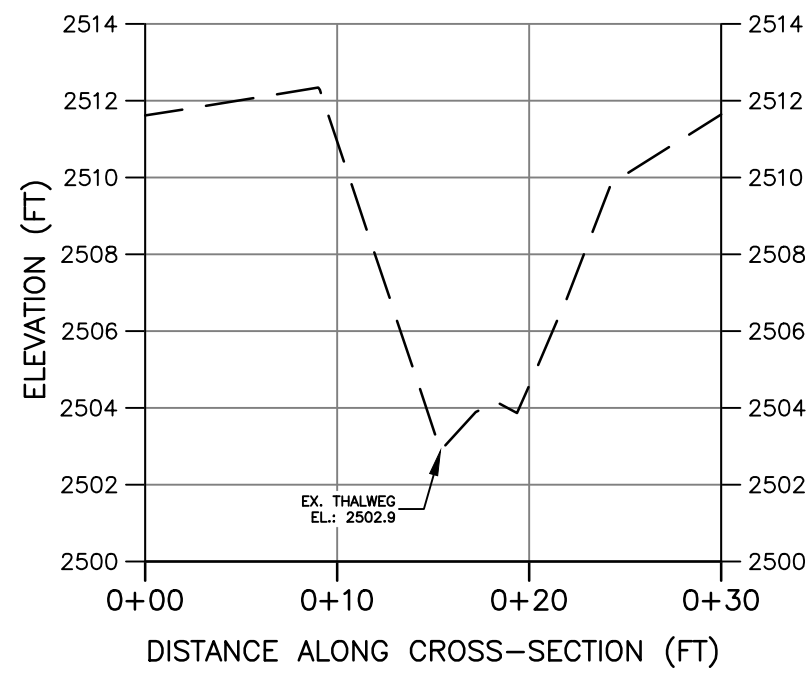
S-K1 BASELINE CROSS-SECTION A

AS-BUILT TABLE: S-K21 CROSS SECTION A					
PT. LOC.	PRE-CROSSING			AS-BUILT	
	NORTHING	EASTING	ELEV.	VERT. DIFF.	HORZ. DIFF.
TS-L	13747181.3200	1710956.3060	2512.346'		
BS-L	13747187.5100	1710955.7280	2502.871'		
THW	13747190.2050	1710949.9770	2503.245'		
BS-R	13747191.6400	1710955.2150	2503.892'		
TS-R	13747196.7500	1710954.1120	2509.899'

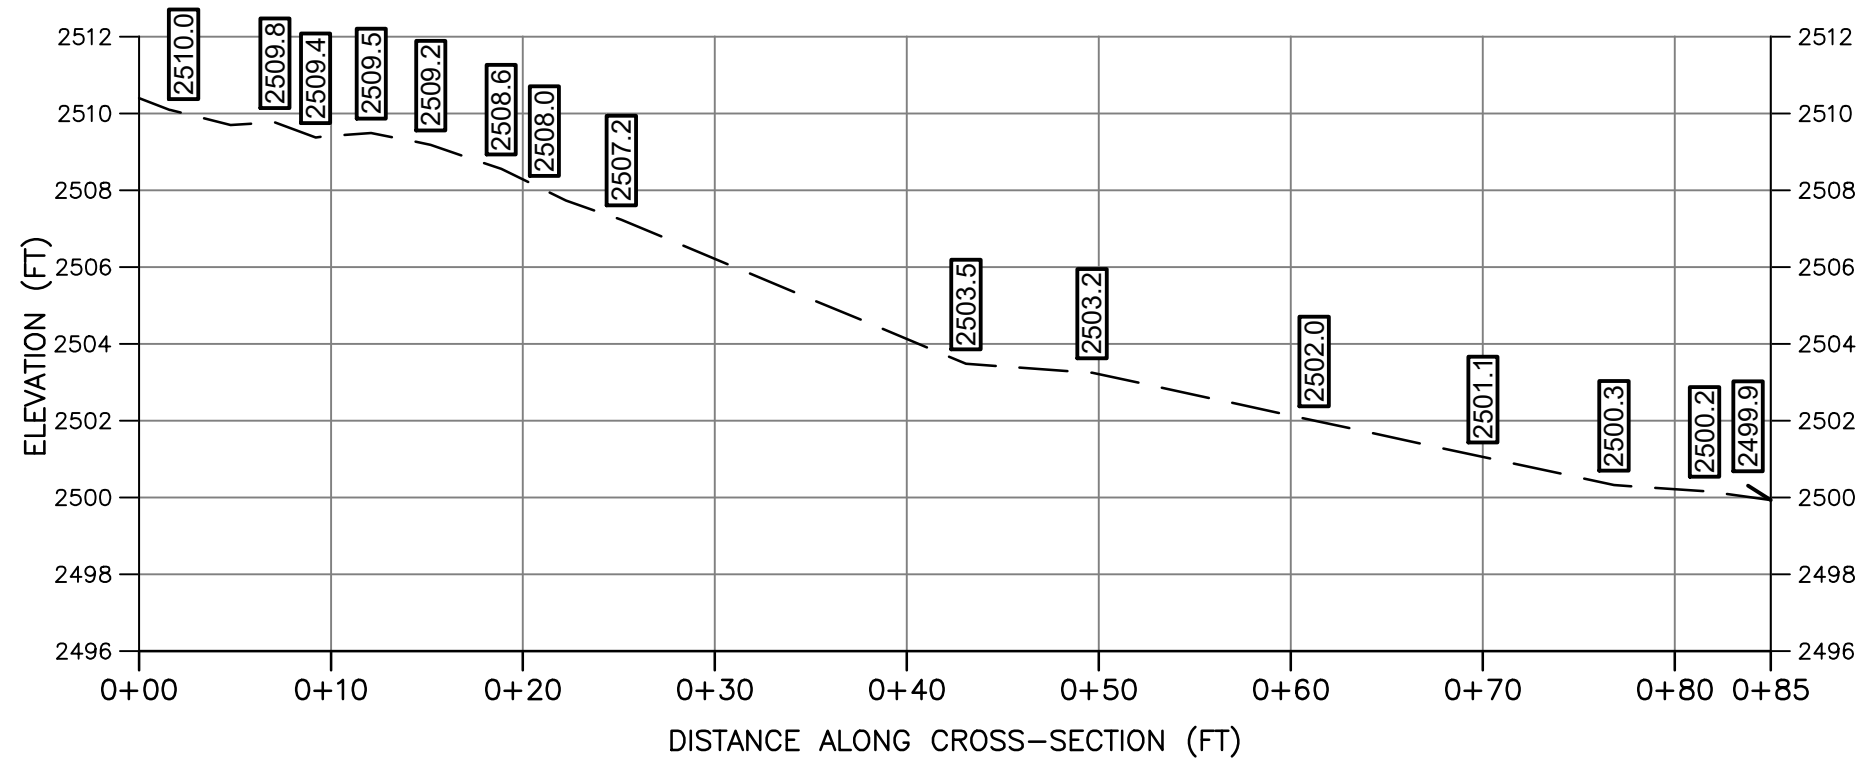
S-K21 BASELINE THALWEG PROFILE

--- EXISTING STREAM PROFILE
- - - INVERT ALONG THALWEG

SCALE: H: 1"=10'
V: 1"=5'

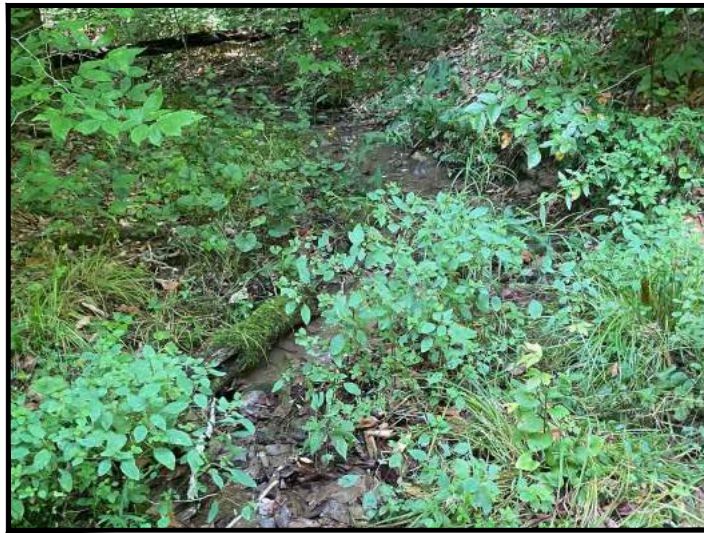
PHOTO TAKEN LOOKING DOWNSTREAM
FROM UPSTREAM IMPACT LIMITS
