Baseline Assessment – Stream Attributes

Reach S-K82 (Pipeline ROW)
Perennial
Spread B
Harrison County, West Virginia

Title PROFILE AND CROSS-SECTIONS
BASELINE SURVEY
CROSSING S-K82 - UNNAMED TRIB.
KINCHELOE CREEK (MP 38.01)
HARRISON COUNTY, WV

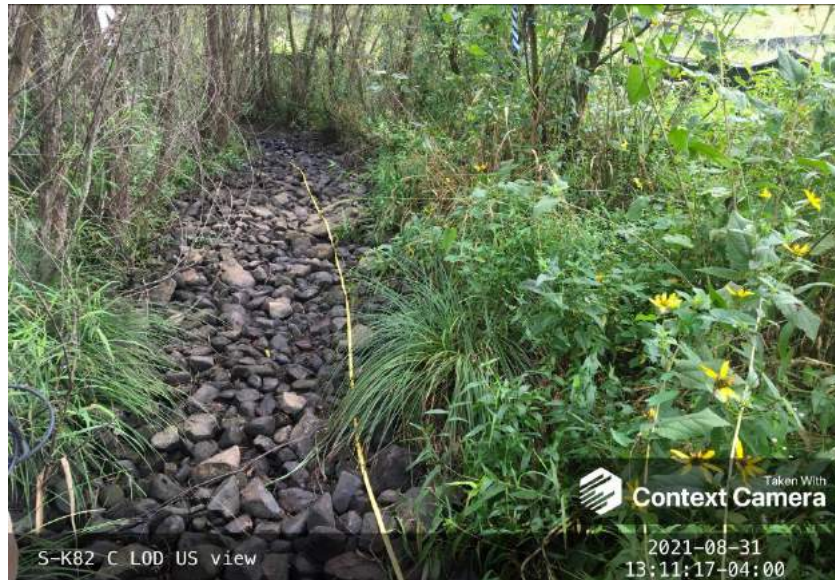
Photo Type: US View at Center
Location, Orientation, Photographer Initials: Center ROW, Upstream View, DP/VM/HK
Lat: 39.167753 Long: -80.578181

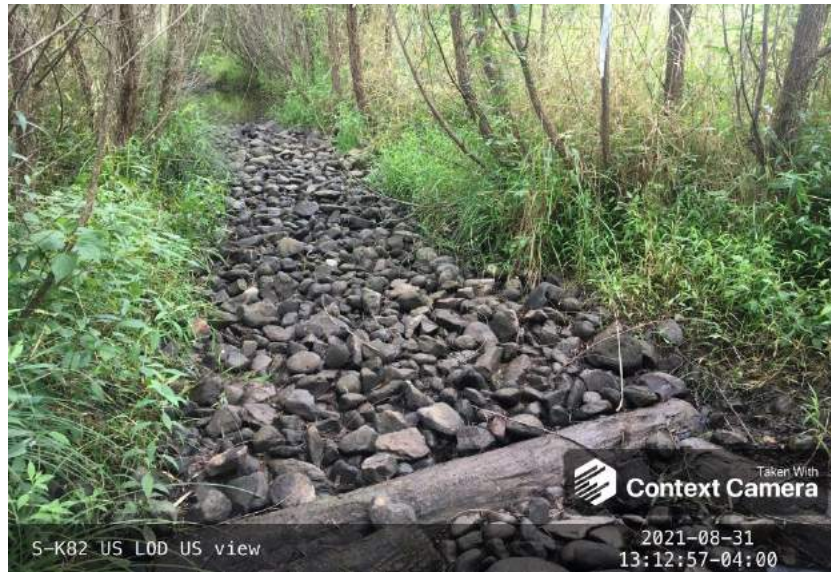
Photo Type: US, US View

Location, Orientation, Photographer Initials: Upstream Edge of ROW, Upstream View, DP/VM/HK
Lat: 39.167753 Long: -80.578181

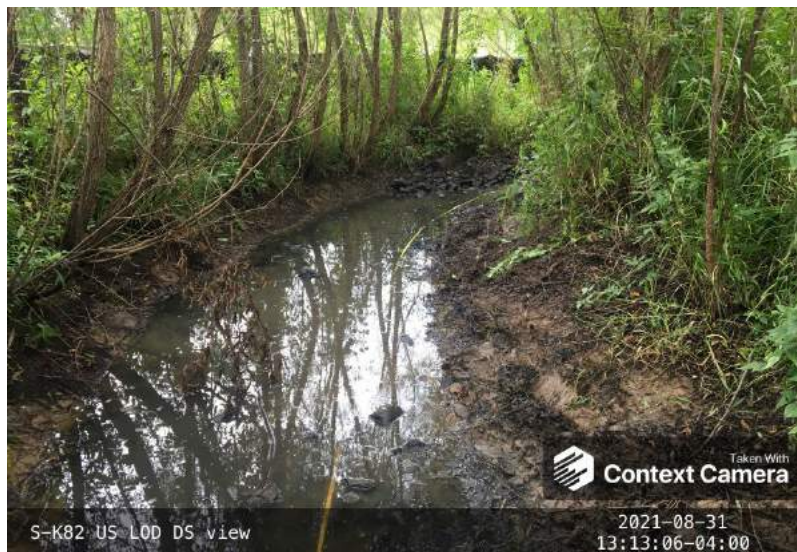
Photo Type: US, DS View

Location, Orientation, Photographer Initials: Upstream Edge of ROW, Downstream View, DP/VM/HK
Lat: 39.167753 Long: -80.578181

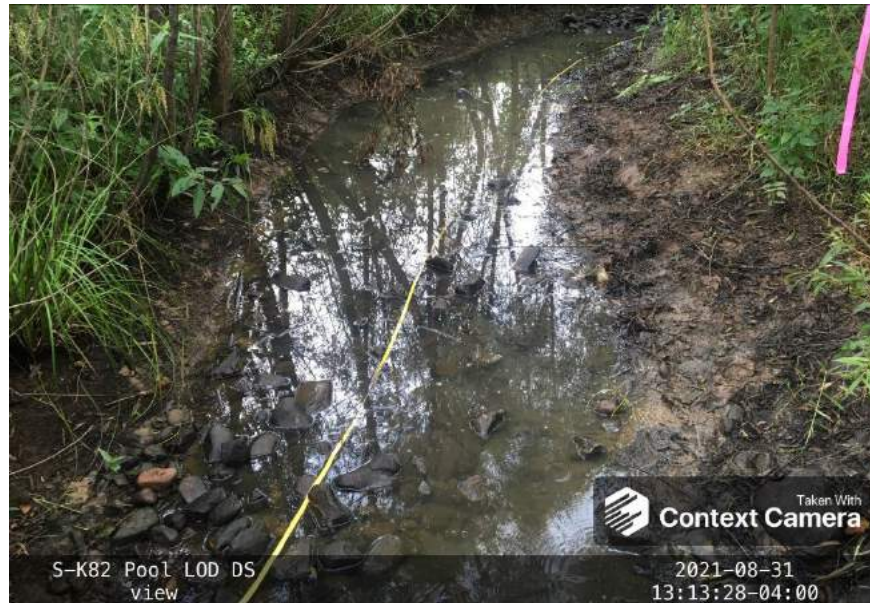
Photo Type: Pool, DS View

Location, Orientation, Photographer Initials: Upstream of Pool, Downstream View, DP/VM/HK
Lat: 39.167753 Long: -80.578181

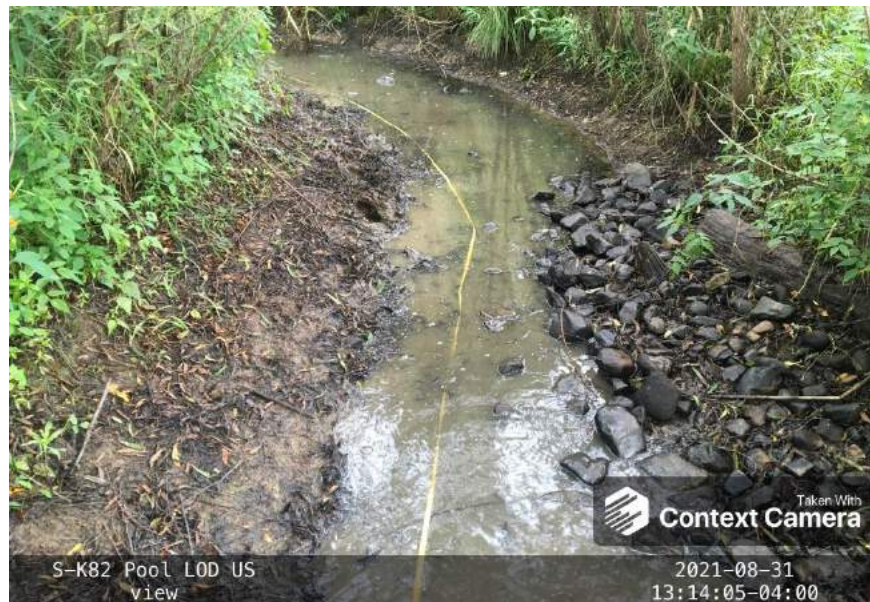
Photo Type: Pool, US View

Location, Orientation, Photographer Initials: Downstream of Pool, Upstream View, DP/VM/HK
Lat: 39.167753 Long: -80.578181

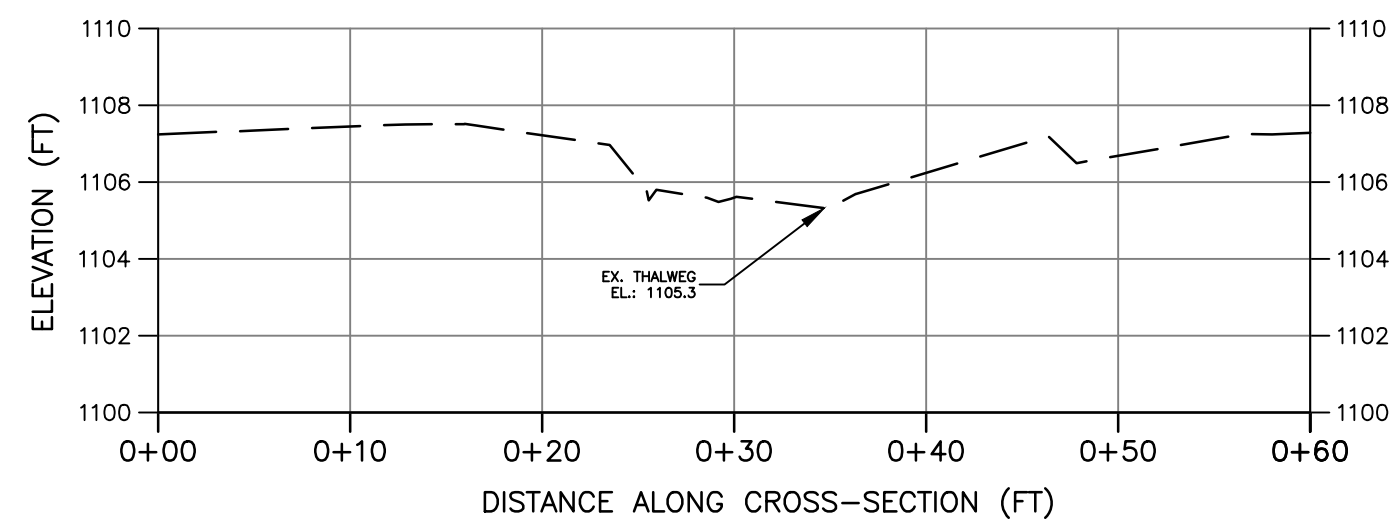
Profile view graph showing ELEVATION (FT) vs. DISTANCE ALONG CROSS-SECTION (FT). The graph displays a cross-section profile with a vertical axis from 1100 to 1110 feet and a horizontal axis from 0+00 to 0+60 feet. A dashed line represents the existing ground surface, and a solid line represents the proposed road profile. A callout indicates "EX. THALWEG EL.: 1104.5" at approximately station 0+28.
