Reach S-L10 (Pipeline ROW) Perennial Spread E Greenbrier County, West Virginia

Data	Included
Photos	✓
SWVM Form	✓
FCI Calculator and HGM Form	N/A – Perennial stream
RBP Physical Characteristics Form	✓
Water Quality Data	✓
RBP Habitat Form	✓
RBP Benthic Form	✓
Benthic Identification Sheet	N/A – Poor Riffle Habitat
Wolman Pebble Count	✓
Reference Reach Software Pebble Count Data	✓
Longitudinal Profile and Cross Sections	✓

County: Greenbrier Stream ID: S-L10

Stream Name: UNT to Boggs Creek

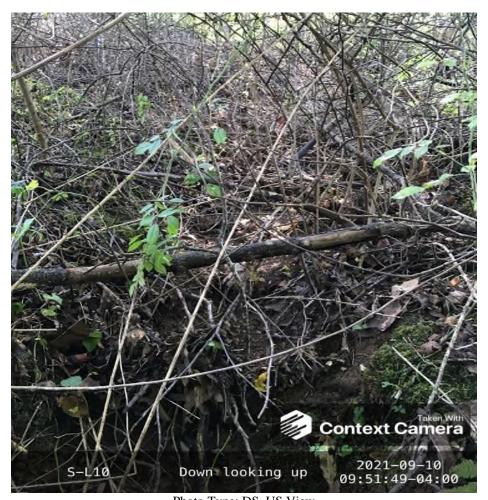
Photo Type: DS, US View Location, Orientation, Photographer Initials: Downstream Edge of ROW, Upstream View, MD Lat: 37.938308 Long: -80.747009

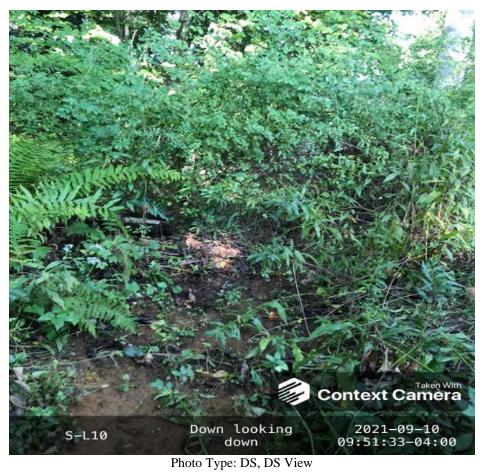
Location, Orientation, Photographer Initials: Downstream Edge of ROW, Downstream View, MD

Lat: 37.938308 Long: -80.747009

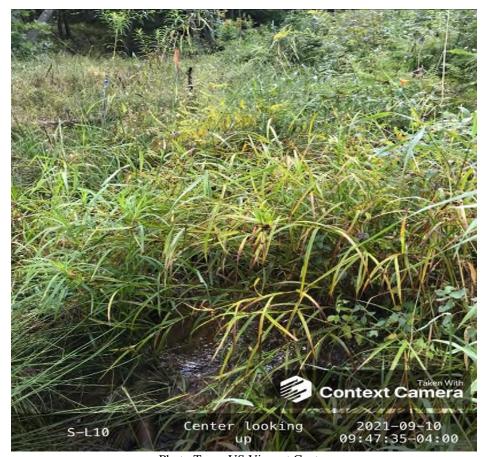
Photo Type: US View at Center Location, Orientation, Photographer Initials: Center ROW, Upstream View, MD Lat: 37.938308 Long: -80.747009

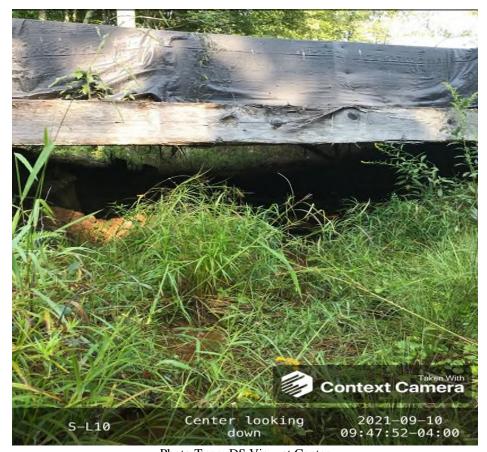
Photo Type: DS View at Center Location, Orientation, Photographer Initials: ROW Center, Downstream View, MD Lat: 37.938308 Long: -80.747009

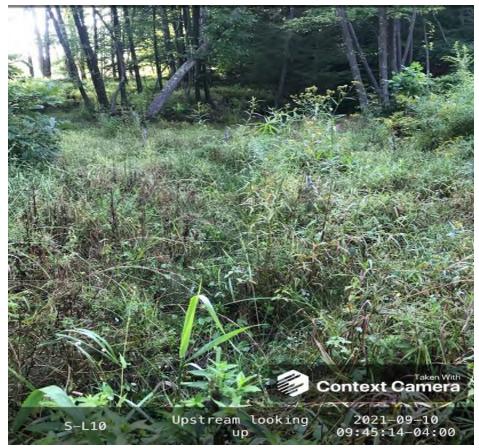
Photo Type: US, US View
Location, Orientation, Photographer Initials: Upstream Edge of ROW, Upstream View, MD
Lat: 37.938308 Long: -80.747009

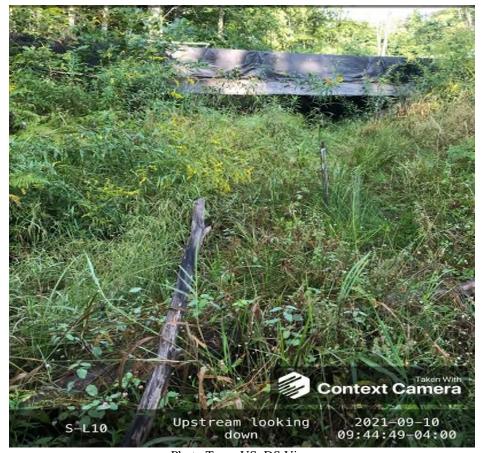
Photo Type: US, DS View
Location, Orientation, Photographer Initials: Upstream Edge of ROW, Downstream View, MD
Lat: 37.938308 Long: -80.747009

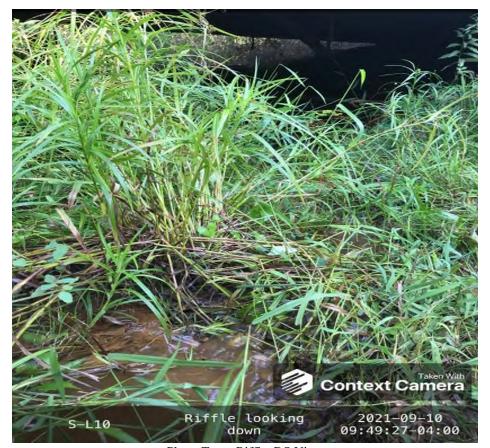
Photo Type: Riffle, DS View
Location, Orientation, Photographer Initials: Upstream of Riffle, Downstream View, MD
Lat: 37.938308 Long: -80.747009

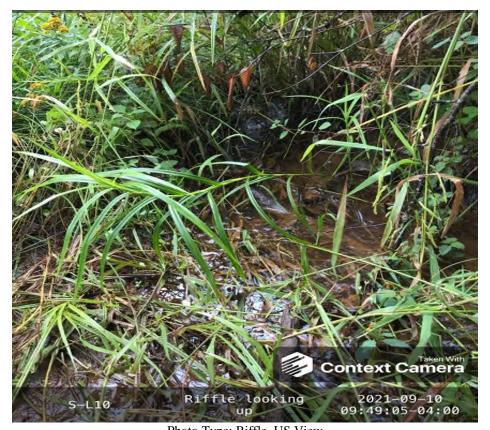
Photo Type: Riffle, US View Location, Orientation, Photographer Initials: Downstream of Riffle, Upstream View, MD Lat: 37.938308 Long: -80.747009

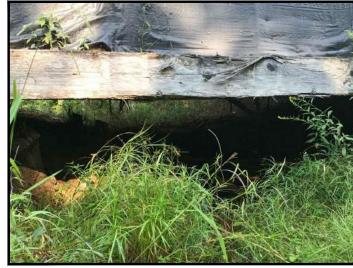
PHOTO TAKEN LOOKING DOWNSTREAM FROM UPSTREAM IMPACT LIMITS

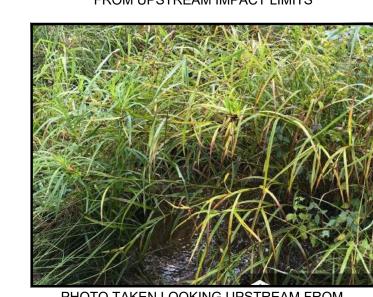
PHOTO TAKEN LOOKING UPSTREAM FROM DOWNSTREAM IMPACT LIMITS
