Baseline Assessment – Stream Attributes

Reach S-L44 (Pipeline ROW)
Perennial
Spread C
Braxton County, West Virginia

Spread C Stream S-L44 (Pipeline ROW) Braxton County

Client	<p>PROFILE AND CROSS-SECTIONS BASELINE SURVEY</p> <p>CROSSING S-L44 – UNNAMED TRIB. TO LAUREL RUN (MP 78.07) BRAXTON COUNTY, WV</p>	<p>222</p> <p>MC</p>
--------	---	----------------------

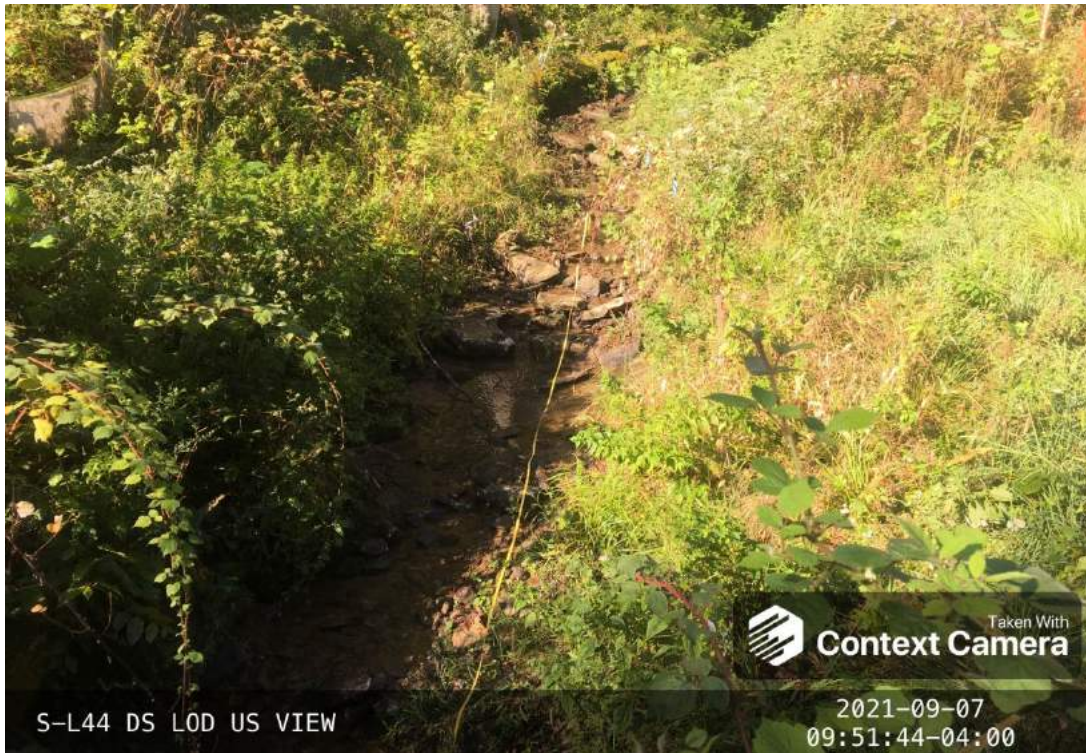
Photo Type: DS, US View

Location, Orientation, Photographer Initials: Downstream Edge of ROW, Upstream View, VM/HK/SK
Lat: 38.716945 Long: -80.494589

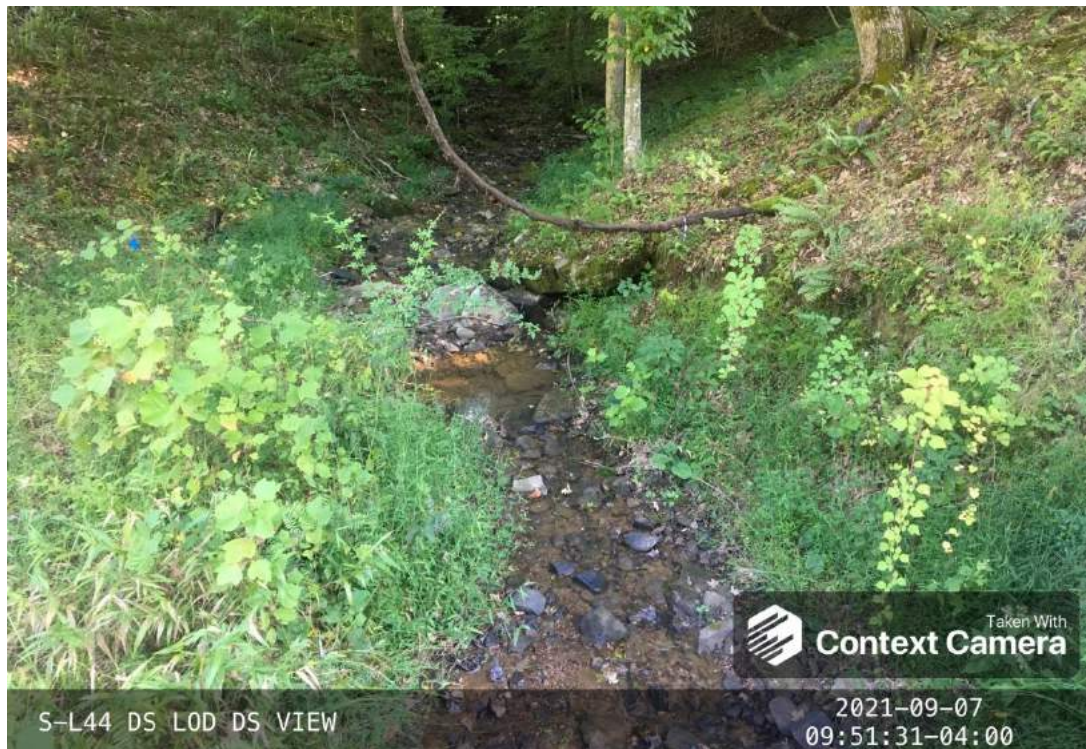
Photo Type: DS, DS View

Location, Orientation, Photographer Initials: Downstream Edge of ROW, Downstream View, VM/HK/SK
Lat: 38.716945 Long: -80.494589

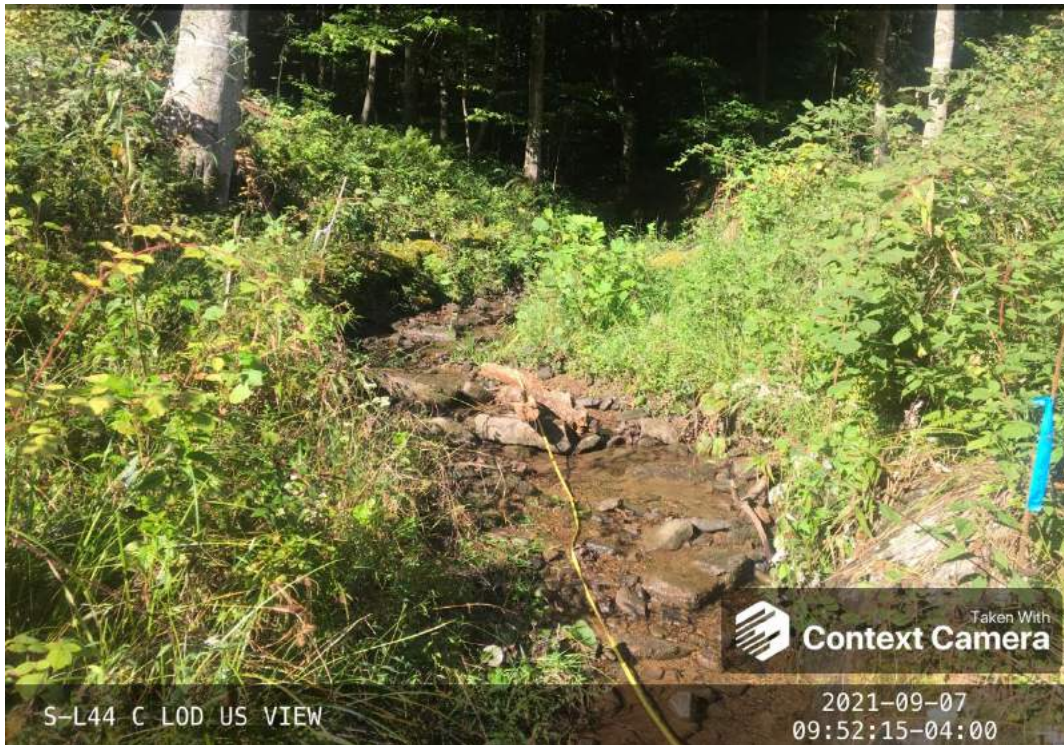
Photo Type: US View at Center
Location, Orientation, Photographer Initials: Center ROW, Upstream View, VM/HK/SK
Lat: 38.716945 Long: -80.494589

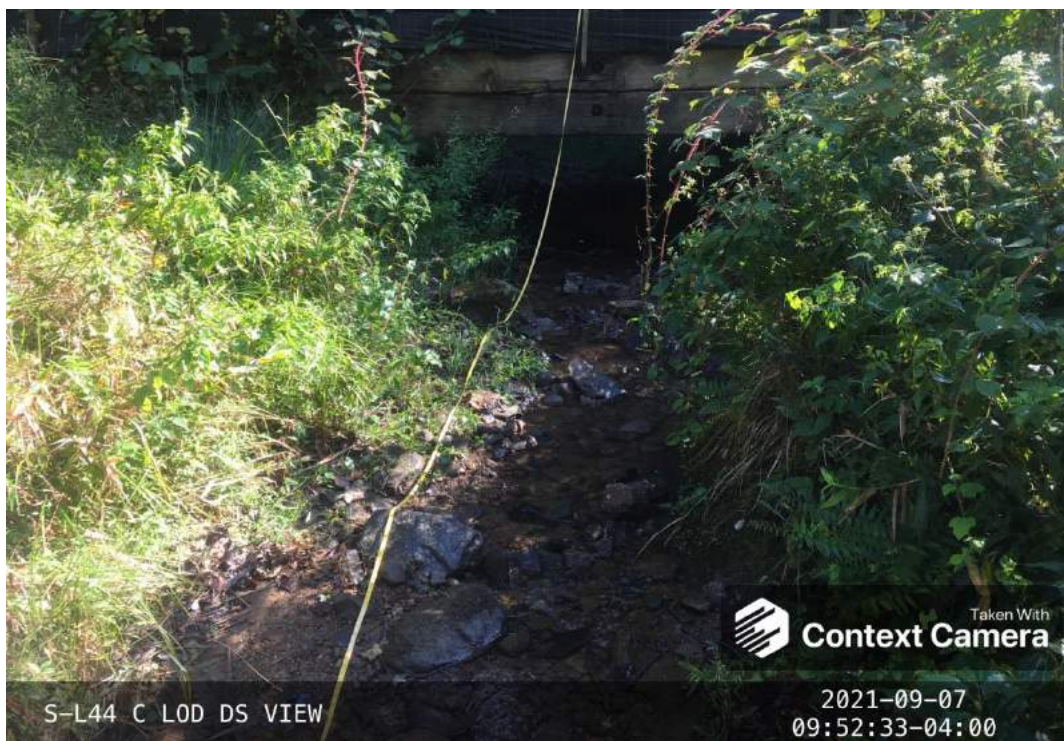
Photo Type: DS View at Center
Location, Orientation, Photographer Initials: ROW Center, Downstream View, VM/HK/SK
Lat: 38.716945 Long: -80.494589

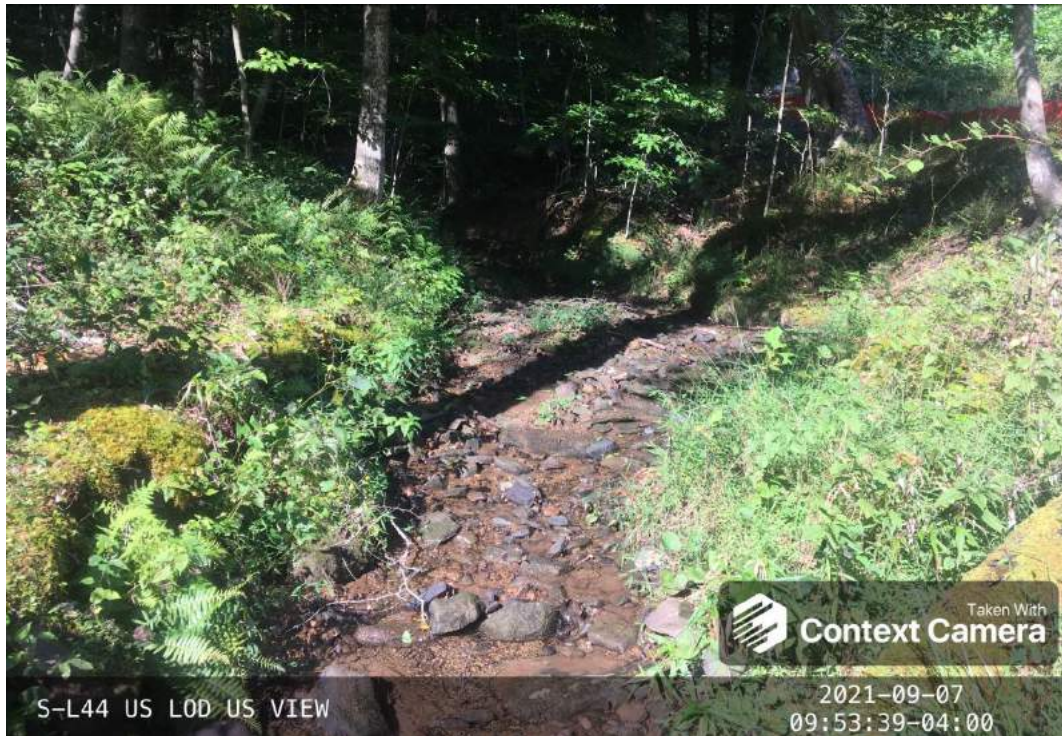
Photo Type: US, US View

Location, Orientation, Photographer Initials: Upstream Edge of ROW, Upstream View, VM/HK/SK
Lat: 38.716945 Long: -80.494589

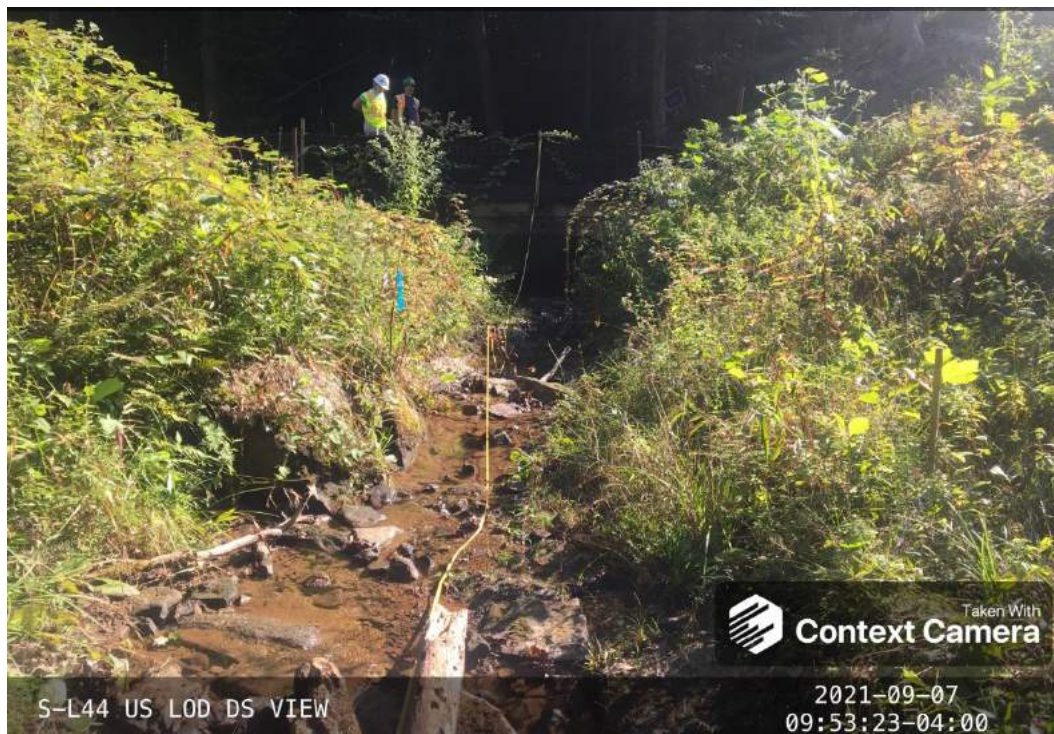
Photo Type: US, DS View

Location, Orientation, Photographer Initials: Upstream Edge of ROW, Downstream View, VM/HK/SK
Lat: 38.716945 Long: -80.494589

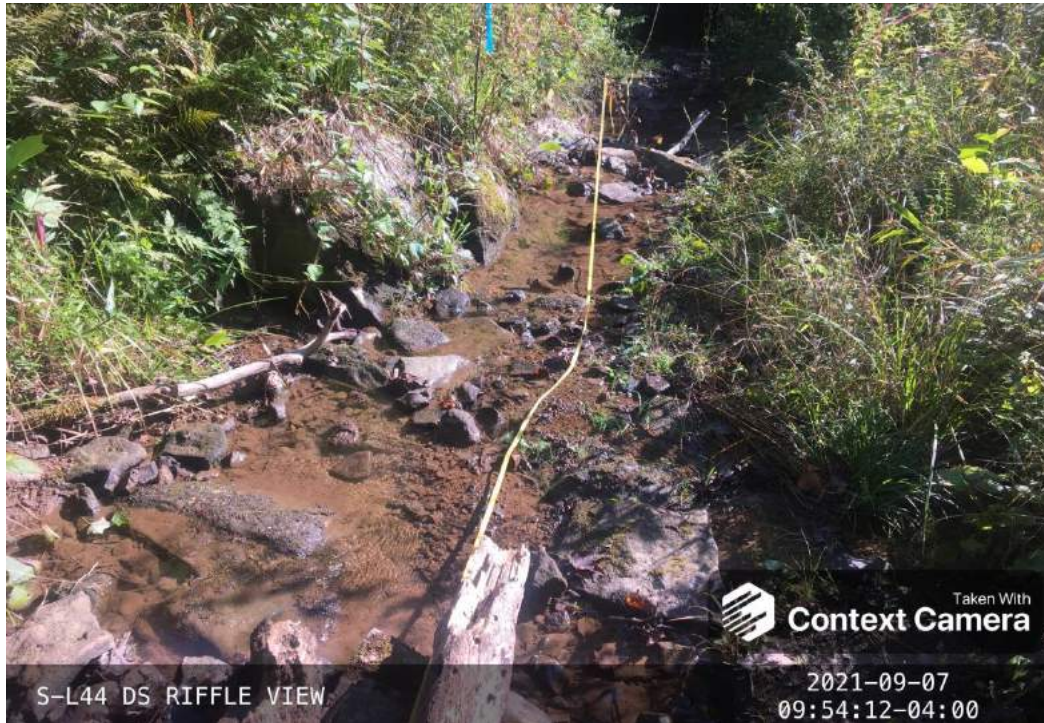
Photo Type: Riffle, DS View

Location, Orientation, Photographer Initials: Upstream of Riffle, Downstream View, VM/HK/SK
Lat: 38.716945 Long: -80.494589

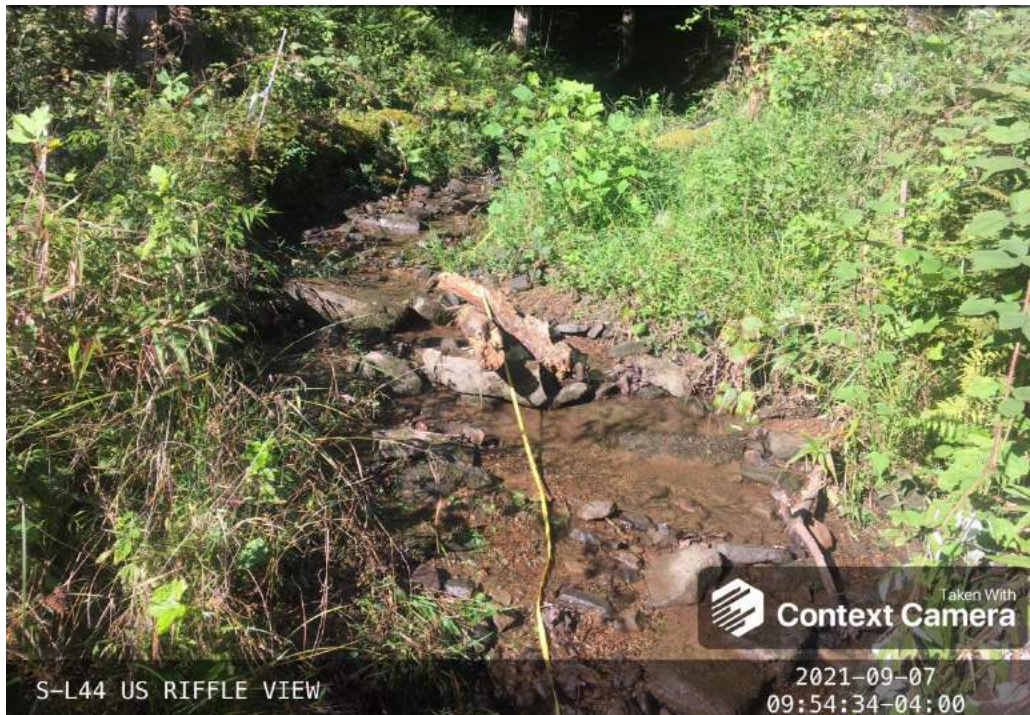
Photo Type: Riffle, US View

Location, Orientation, Photographer Initials: Downstream of Riffle, Upstream View, VM/HK/SK
Lat: 38.716945 Long: -80.494589

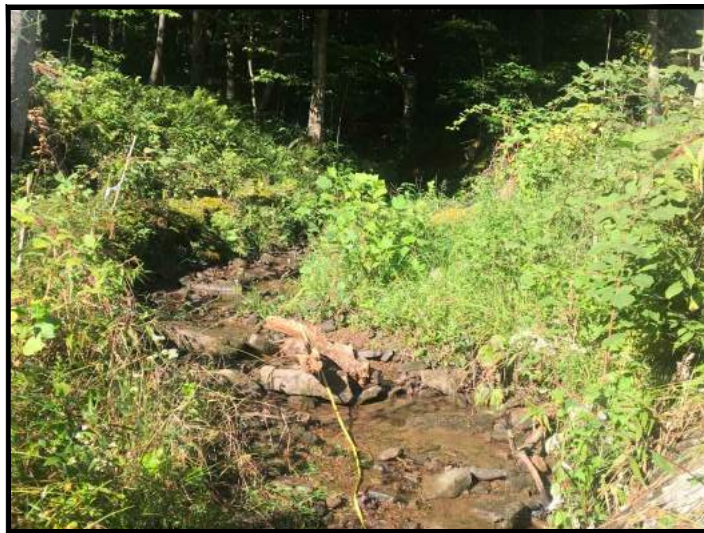
PHOTO TAKEN LOOKING UPSTREAM FROM
DOWNSTREAM IMPACT LIMITS
