Baseline Assessment – Stream Attributes

Reach S-L46 (Pipeline ROW)
Perennial
Spread C
Braxton County, West Virginia

Spread C Stream S-L46 (Pipeline ROW) Braxton County

PROFILE AND CROSS-SECTIONS
BASELINE SURVEY
CROSSING S-L46 - UNT TO LAUREL
RUN (MP 77.63)
BRAXTON COUNTY, WV

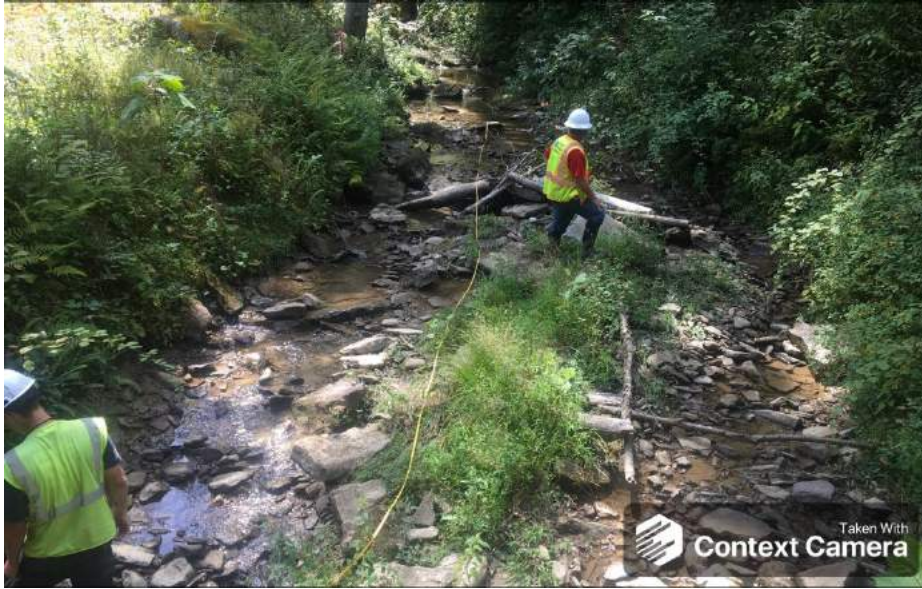
Photo Type: DS, US View
Location, Orientation, Photographer Initials: Downstream Edge of ROW, Upstream View, HK/VM
Lat: 38.72188 Long: -80.499258

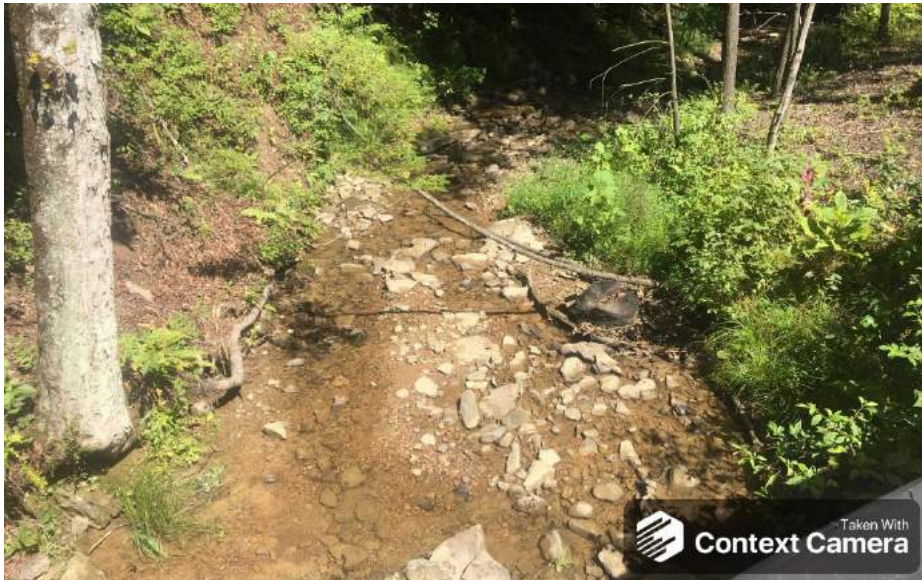
Photo Type: DS, DS View
Location, Orientation, Photographer Initials: Downstream Edge of ROW, Downstream View, HK/VM
Lat: 38.72188 Long: -80.499258

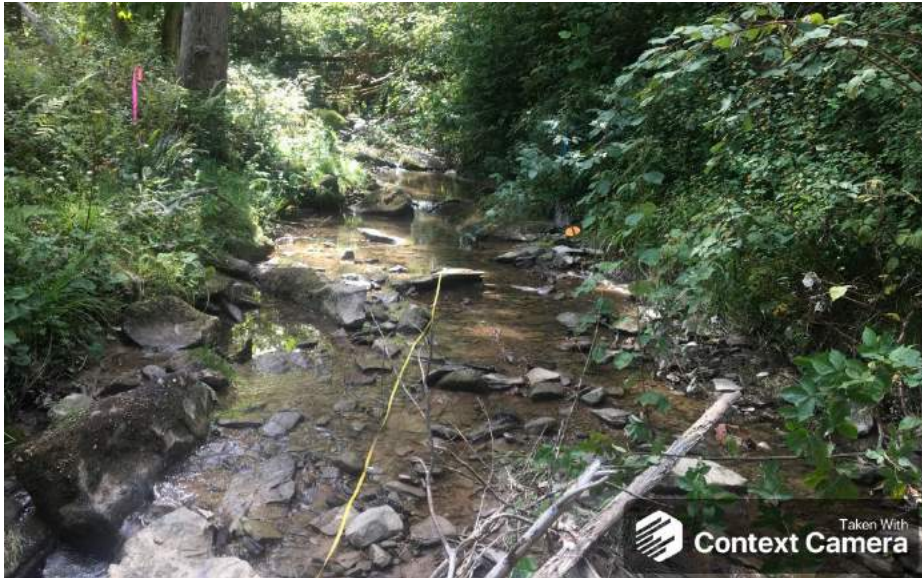
Photo Type: US View at Center
Location, Orientation, Photographer Initials: Center ROW, Upstream View, HK/VM
Lat: 38.72188 Long: -80.499258

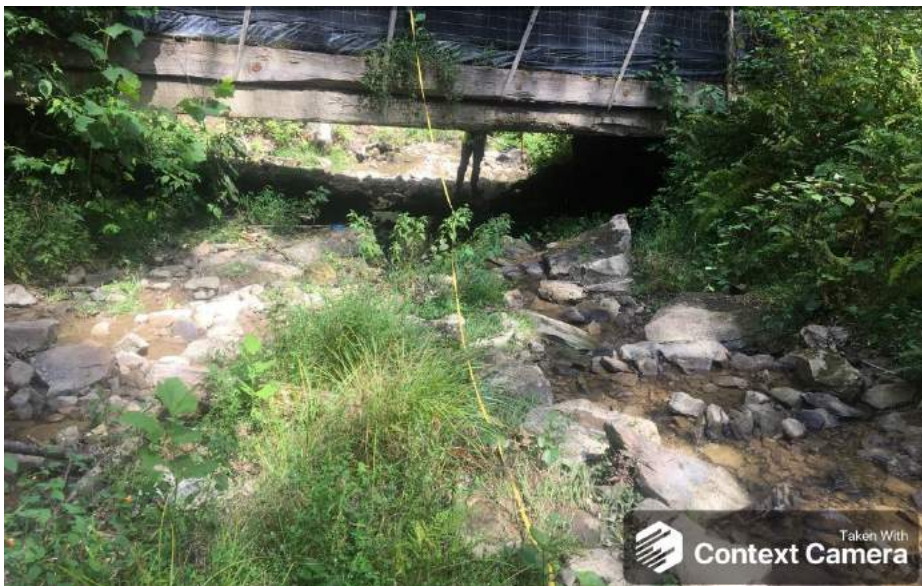
Photo Type: DS View at Center
Location, Orientation, Photographer Initials: ROW Center, Downstream View, HK/VM
Lat: 38.72188 Long: -80.499258

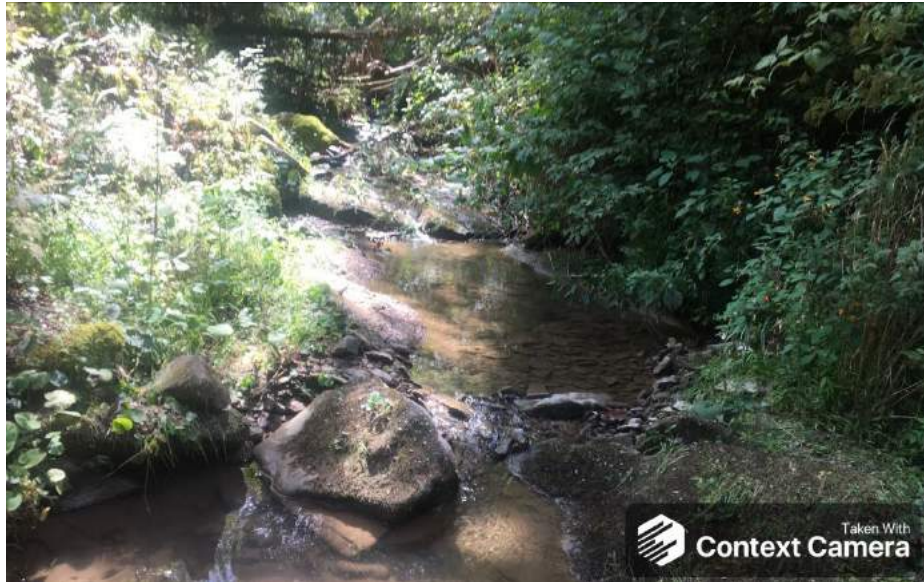
Photo Type: US, US View
Location, Orientation, Photographer Initials: Upstream Edge of ROW, Upstream View, HK/VM
Lat: 38.72188 Long: -80.499258

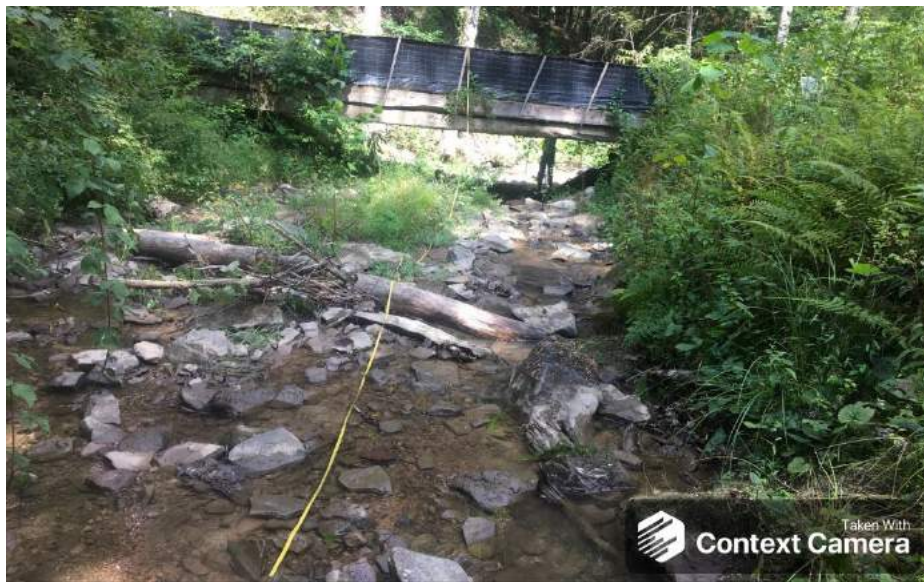
Photo Type: US, DS View
Location, Orientation, Photographer Initials: Upstream Edge of ROW, Downstream View, HK/VM
Lat: 38.72188 Long: -80.499258

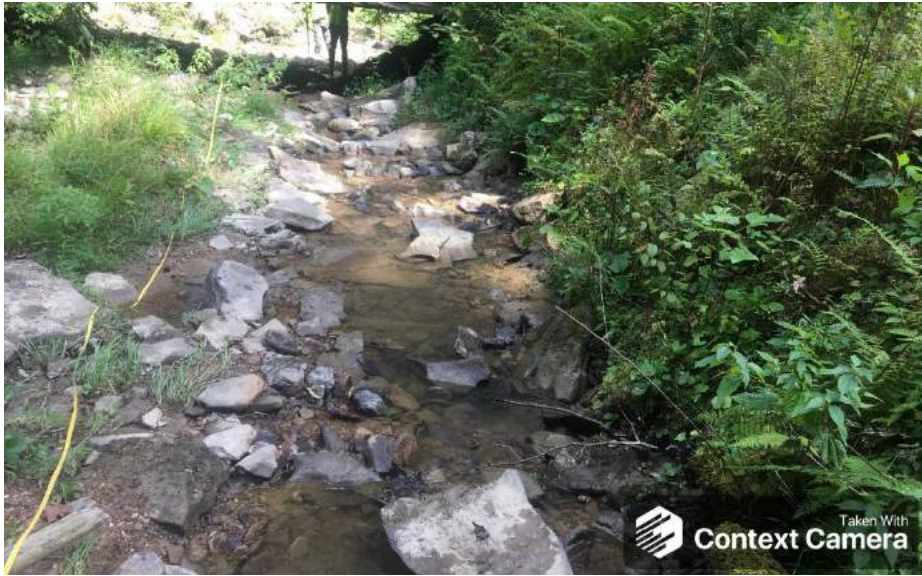
Photo Type: Riffle, DS View
Location, Orientation, Photographer Initials: Upstream of Riffle, Downstream View, HK/VM
Lat: 38.72188 Long: -80.499258

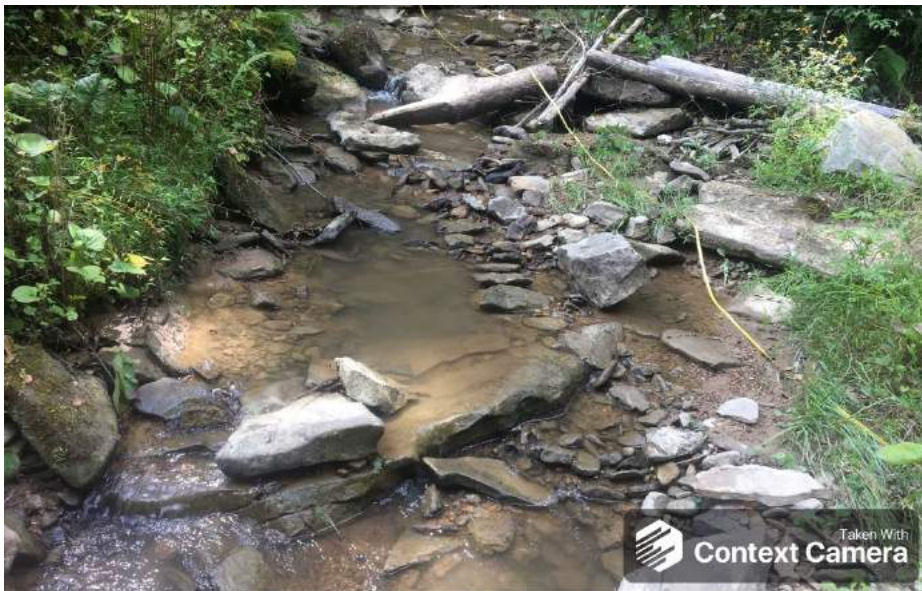
Photo Type: Riffle, US View
Location, Orientation, Photographer Initials: Downstream of Riffle, Upstream View, HK/VM
Lat: 38.72188 Long: -80.499258

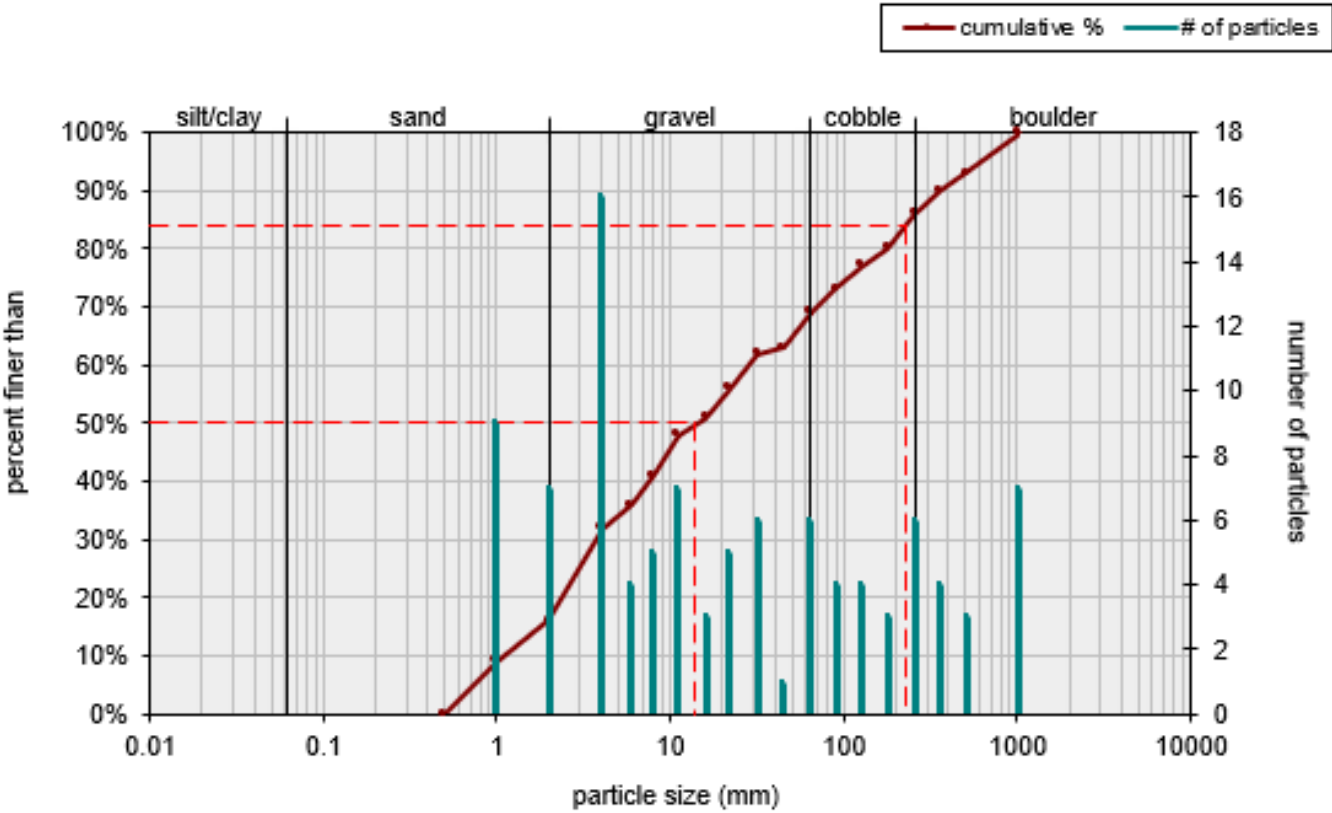
Bankfull Channel Pebble Count, S-L46

Size (mm)	
D16	2
D35	5.4
D50	14
D65	51
D84	230
D95	620

Size Distribution	
mean	21.4
dispersion	11.7
skewness	0.13

Type	
silt/clay	0%
sand	16%
gravel	53%
cobble	17%
boulder	14%

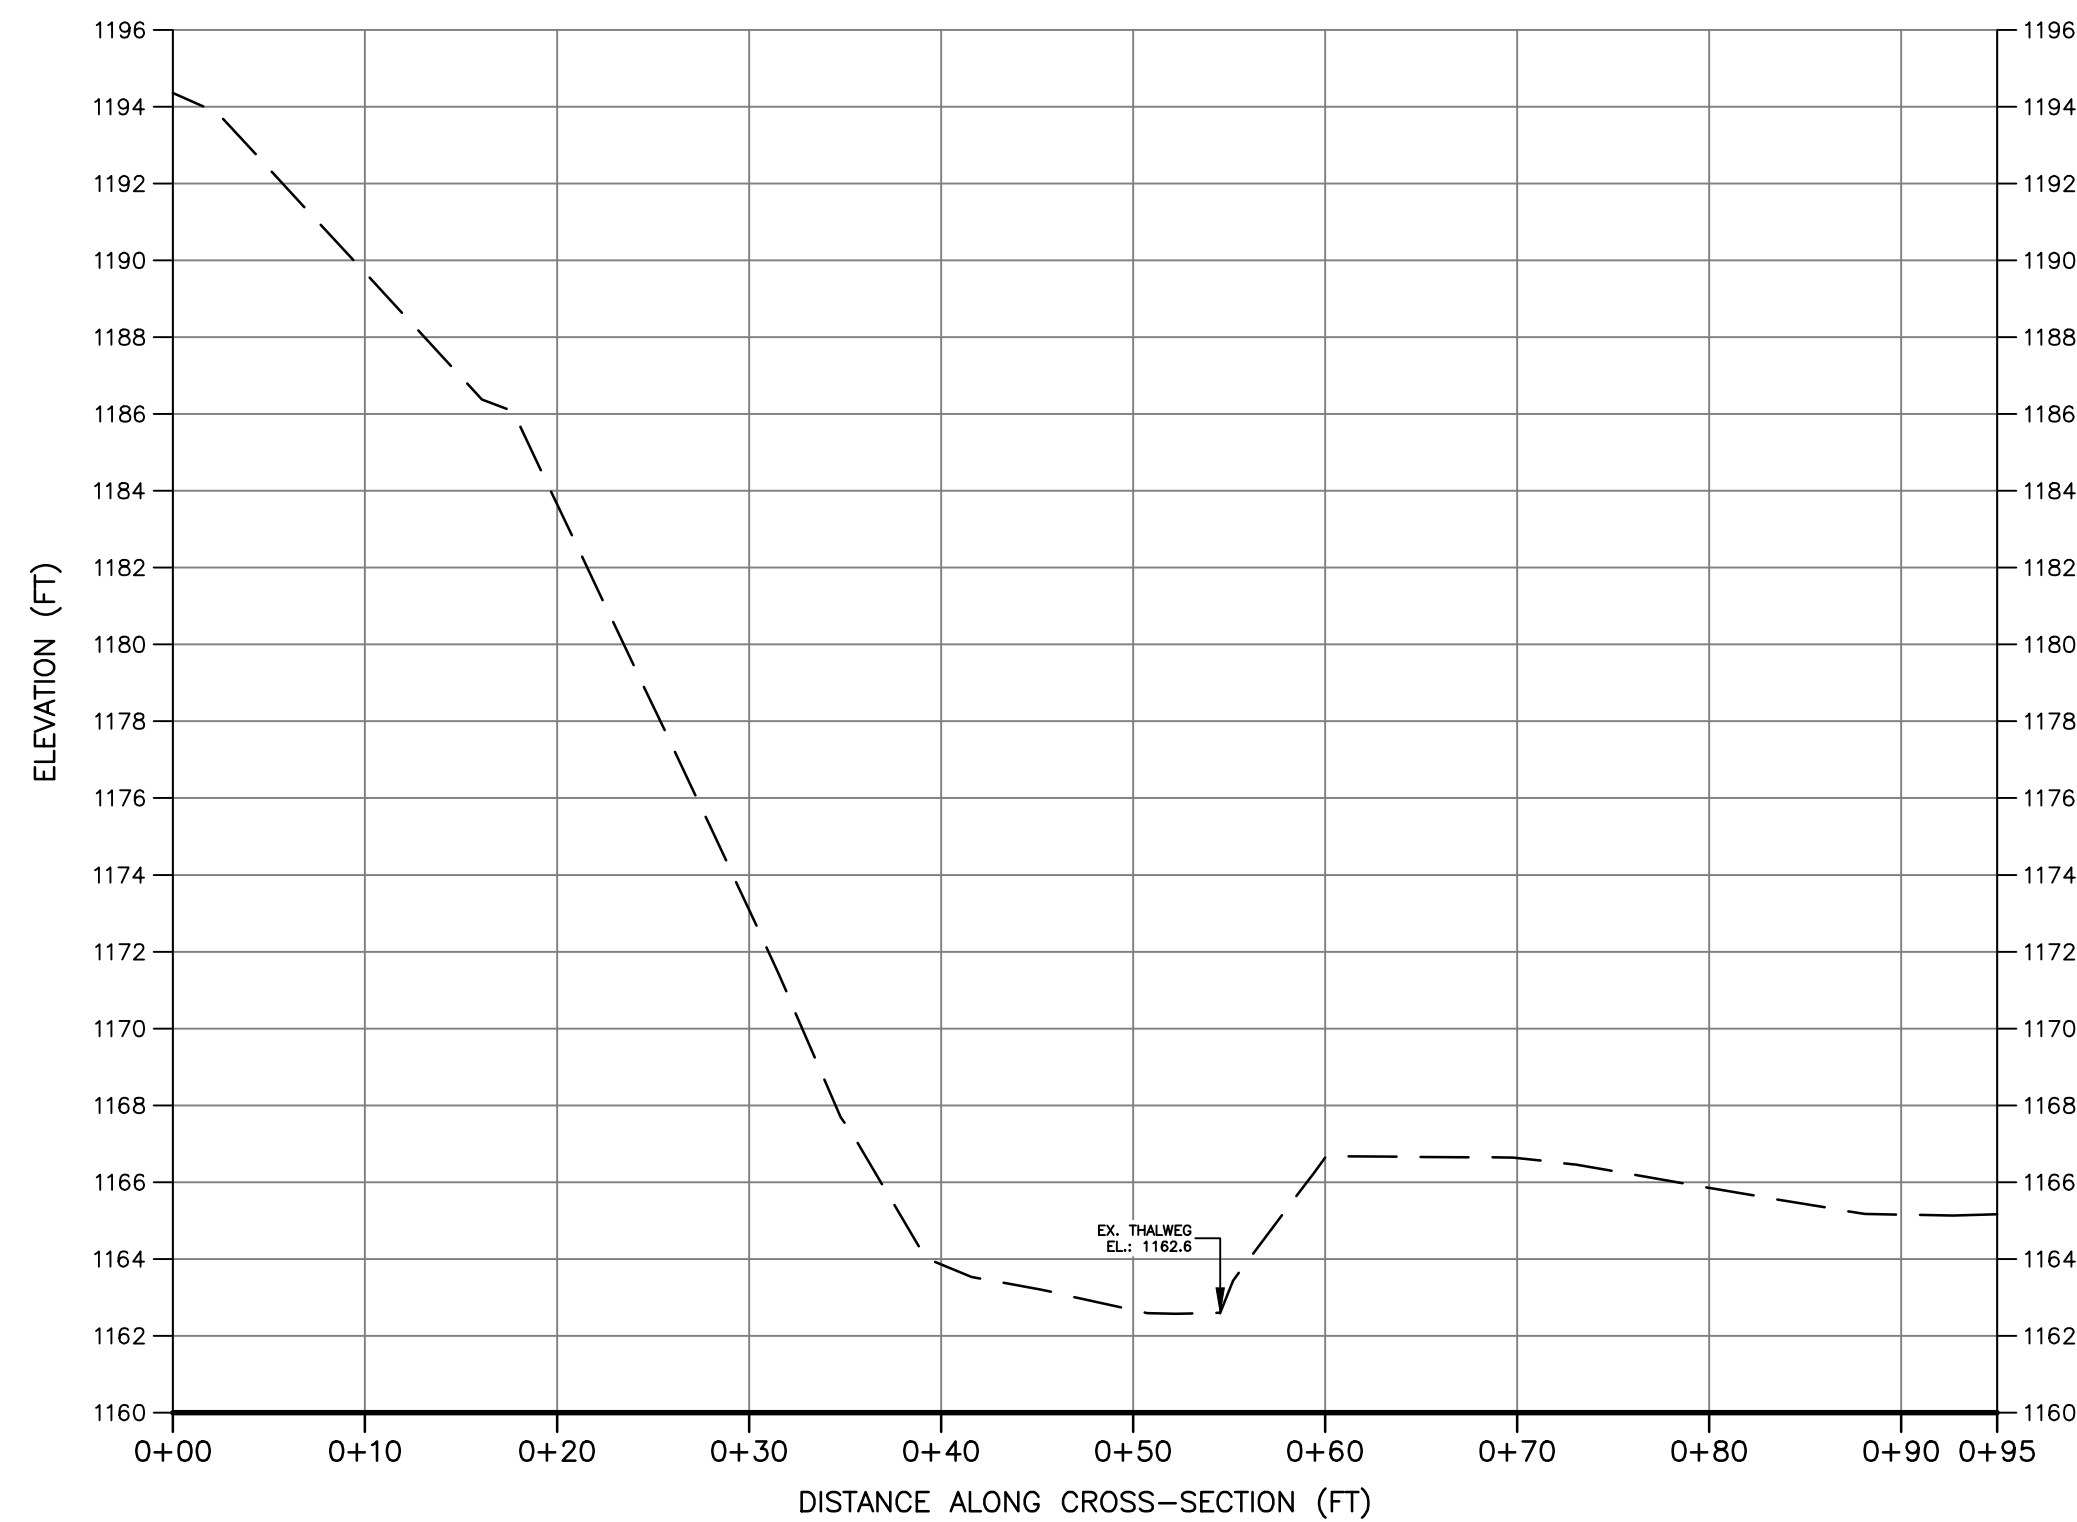
EXISTING STREAM PROFILE
INVERT ALONG THALWEG

PROFILE
SCALE: H: 1"=10'
V: 1"=5'

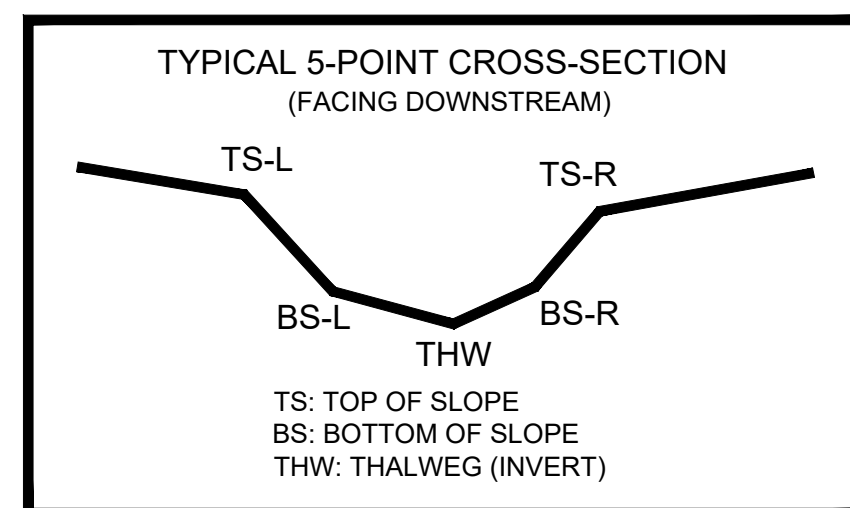
AS-BUILT TABLE: S-L46 CROSS SECTION A					
PT. LOC.	PRE-CROSSING			AS-BUILT	
	NORTHING	EASTING	ELEV	VERT. DIFF.	HORZ. DIFF.
TS-L	14061763.8200	1783188.8350	1186.087		
BS-L	14061746.7800	1783203.5840	1164.047		
THW	14061740.9300	1783214.7020	1162.452		
BS-R	14061738.3800	1783217.2070	1166.394		
TS-R	14061735.7800	1783221.2760	1166.588

— — EXISTING GRADE

SCALE: H: 1"=10'
V: 1"=5'
