## Baseline Assessment – Stream Attributes

**Reach S-L51 (Timber Mat Crossing)**

**Braxton County, West Virginia**

**Profile and Cross-Sections**  
**Baseline Survey**  
**Crossing S-L51 - Barbecue Run**  
**67.4)**  
**Dravton County, WV**

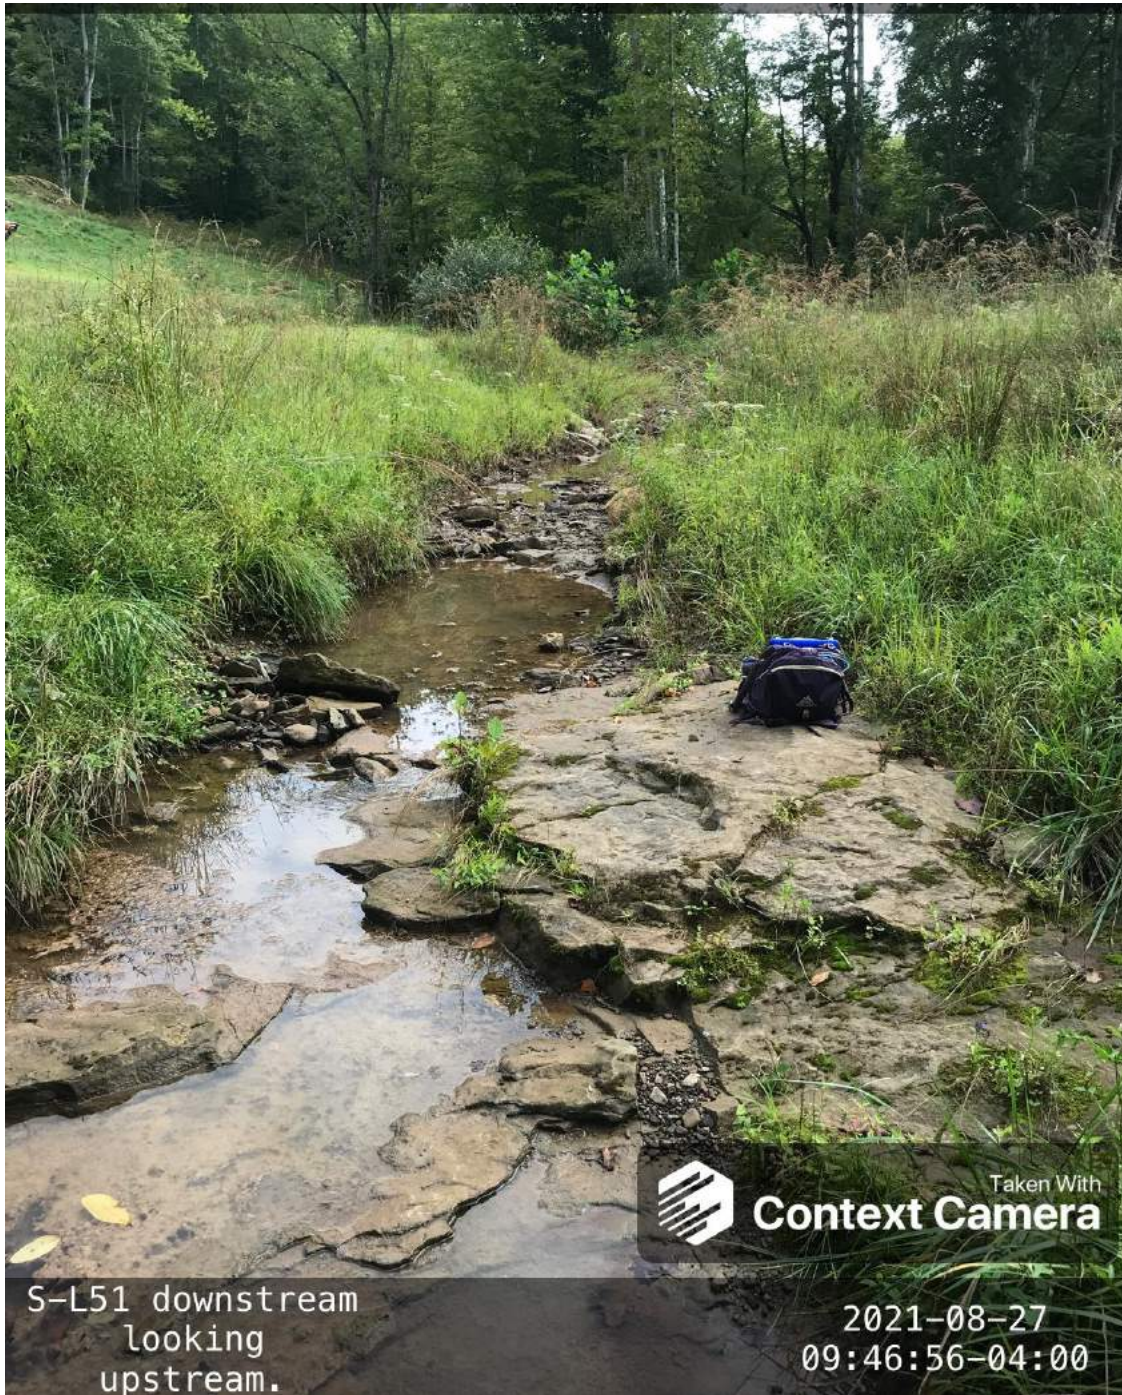
Photo Type: DS, US View  
Location, Orientation, Photographer Initials: Downstream Edge of ROW, Upstream View, KP, LC, DD  
Lat: 38.839355 Long: -80.519693

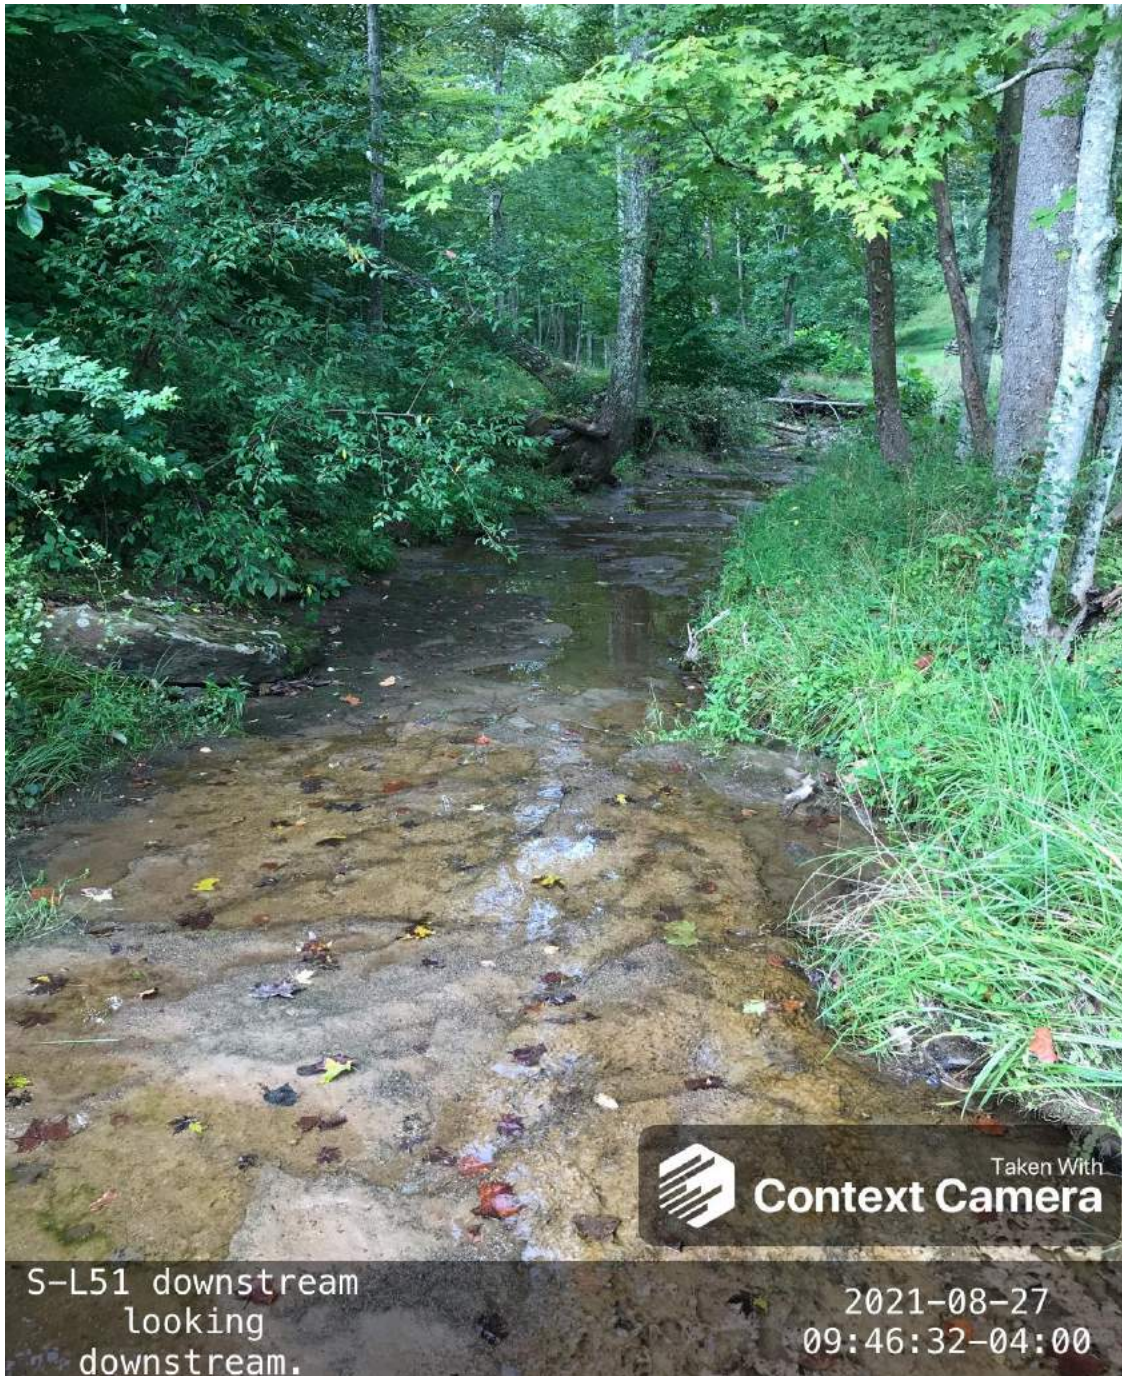
Photo Type: DS, DS View

Location, Orientation, Photographer Initials: Downstream Edge of ROW, Downstream View, KP, LC, DD  
Lat: 38.839355 Long: -80.519693

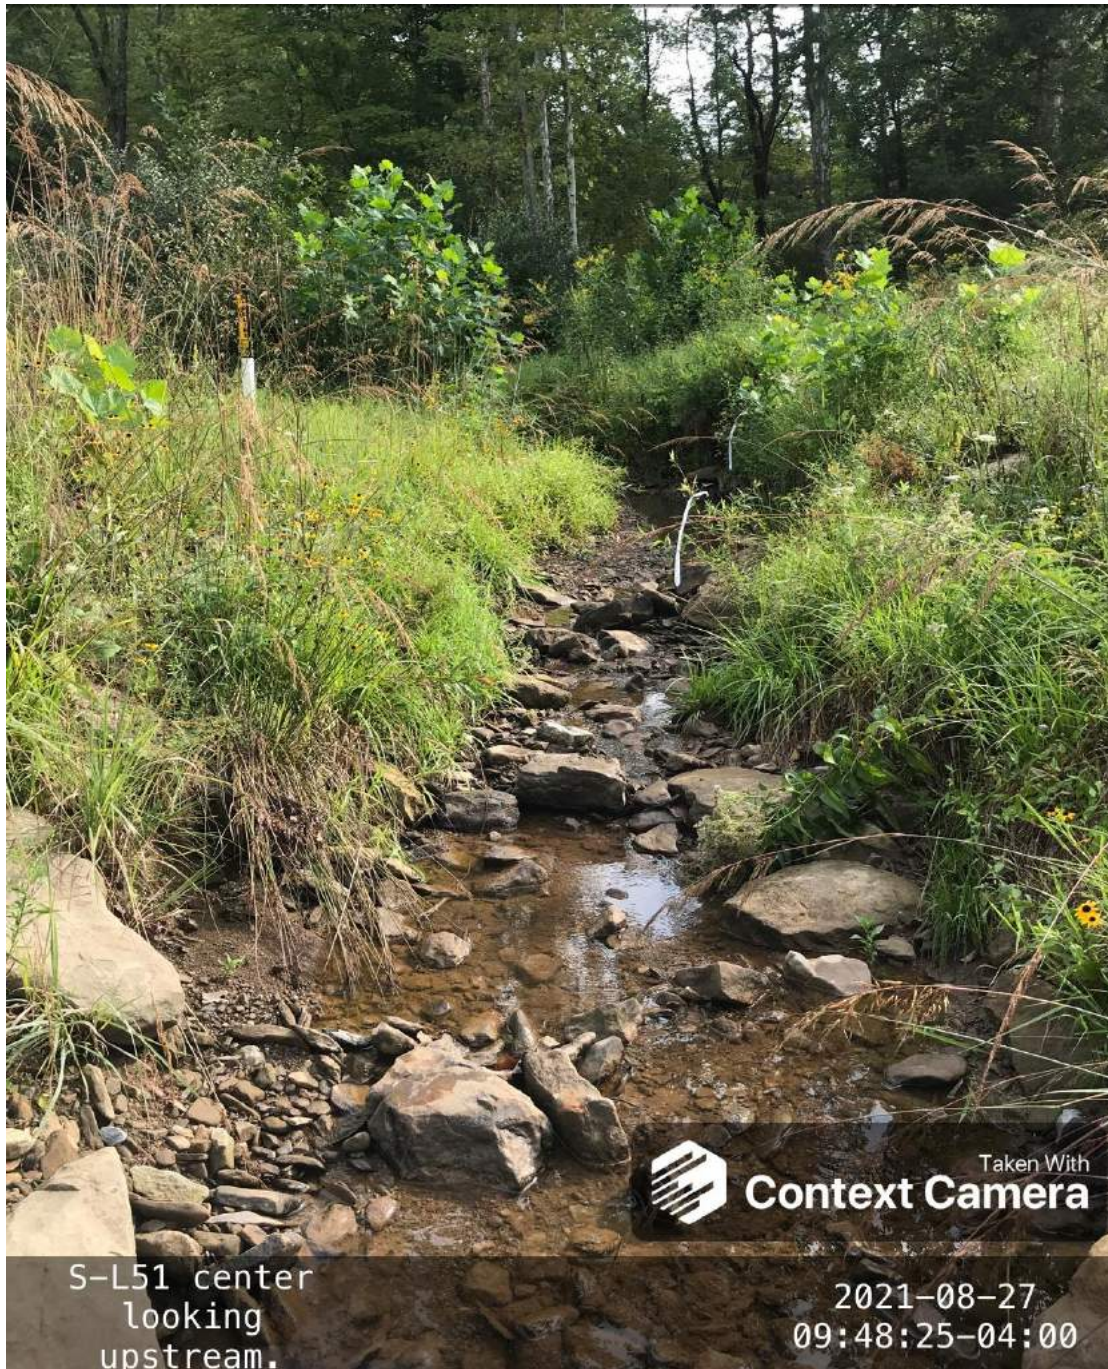
Photo Type: US View at Center  
Location, Orientation, Photographer Initials: Center ROW, Upstream View, KP, LC, DD  
Lat: 38.839355 Long: -80.519693

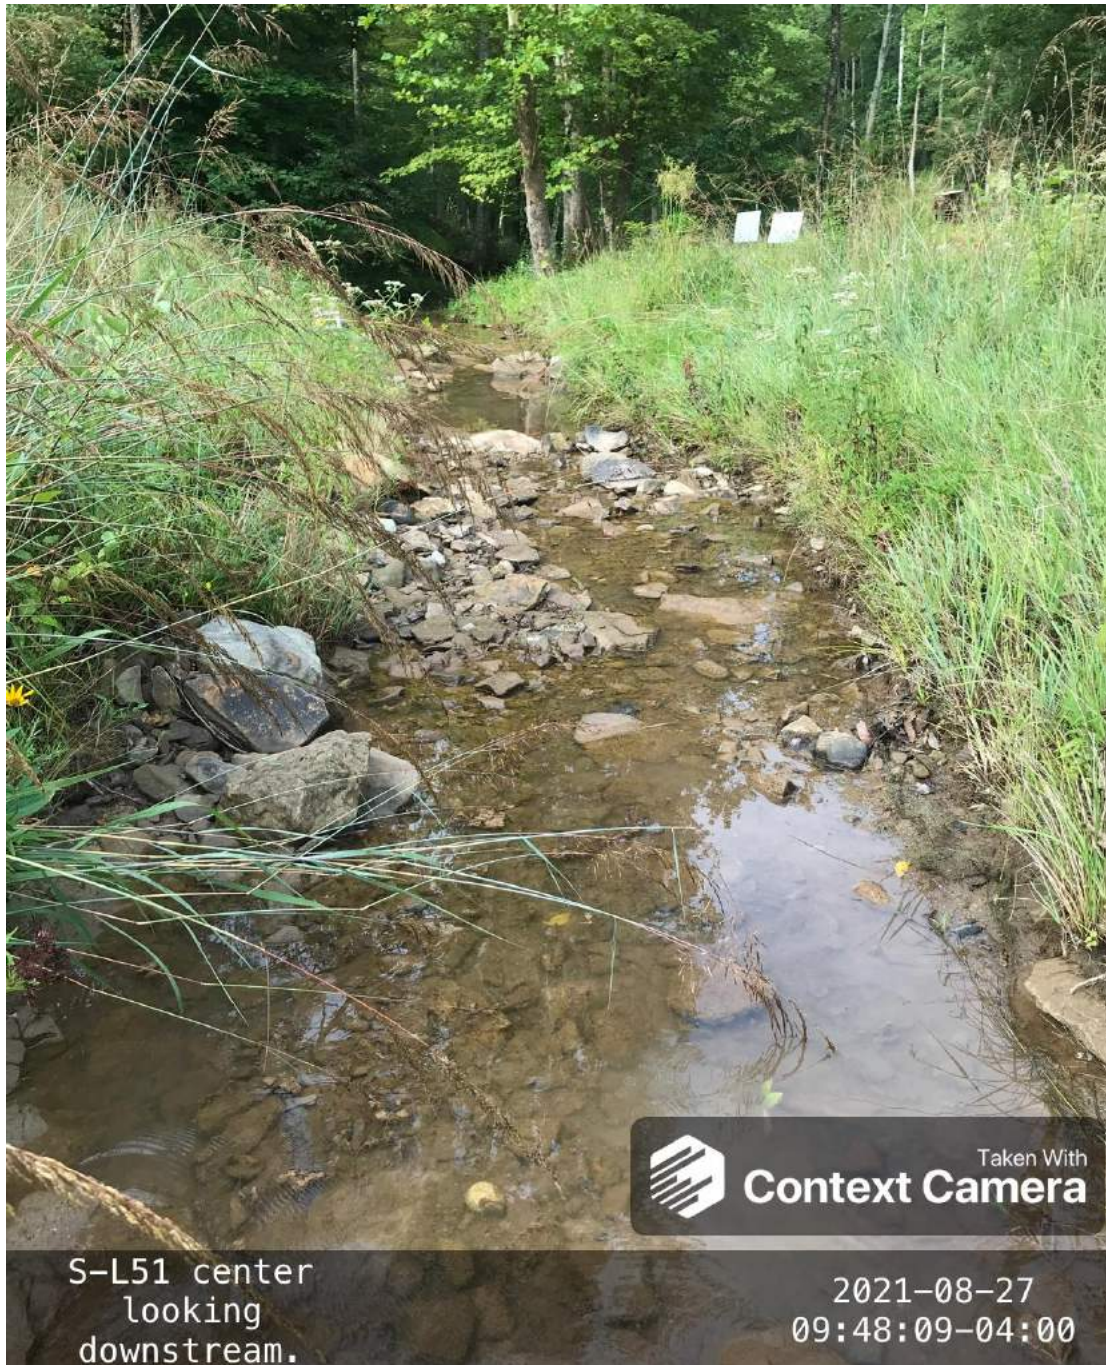
S-L51 center  
looking  
downstream.

Photo Type: DS View at Center  
Location, Orientation, Photographer Initials: ROW Center, Downstream View, KP, LC, DD  
Lat: 38.839355 Long: -80.519693

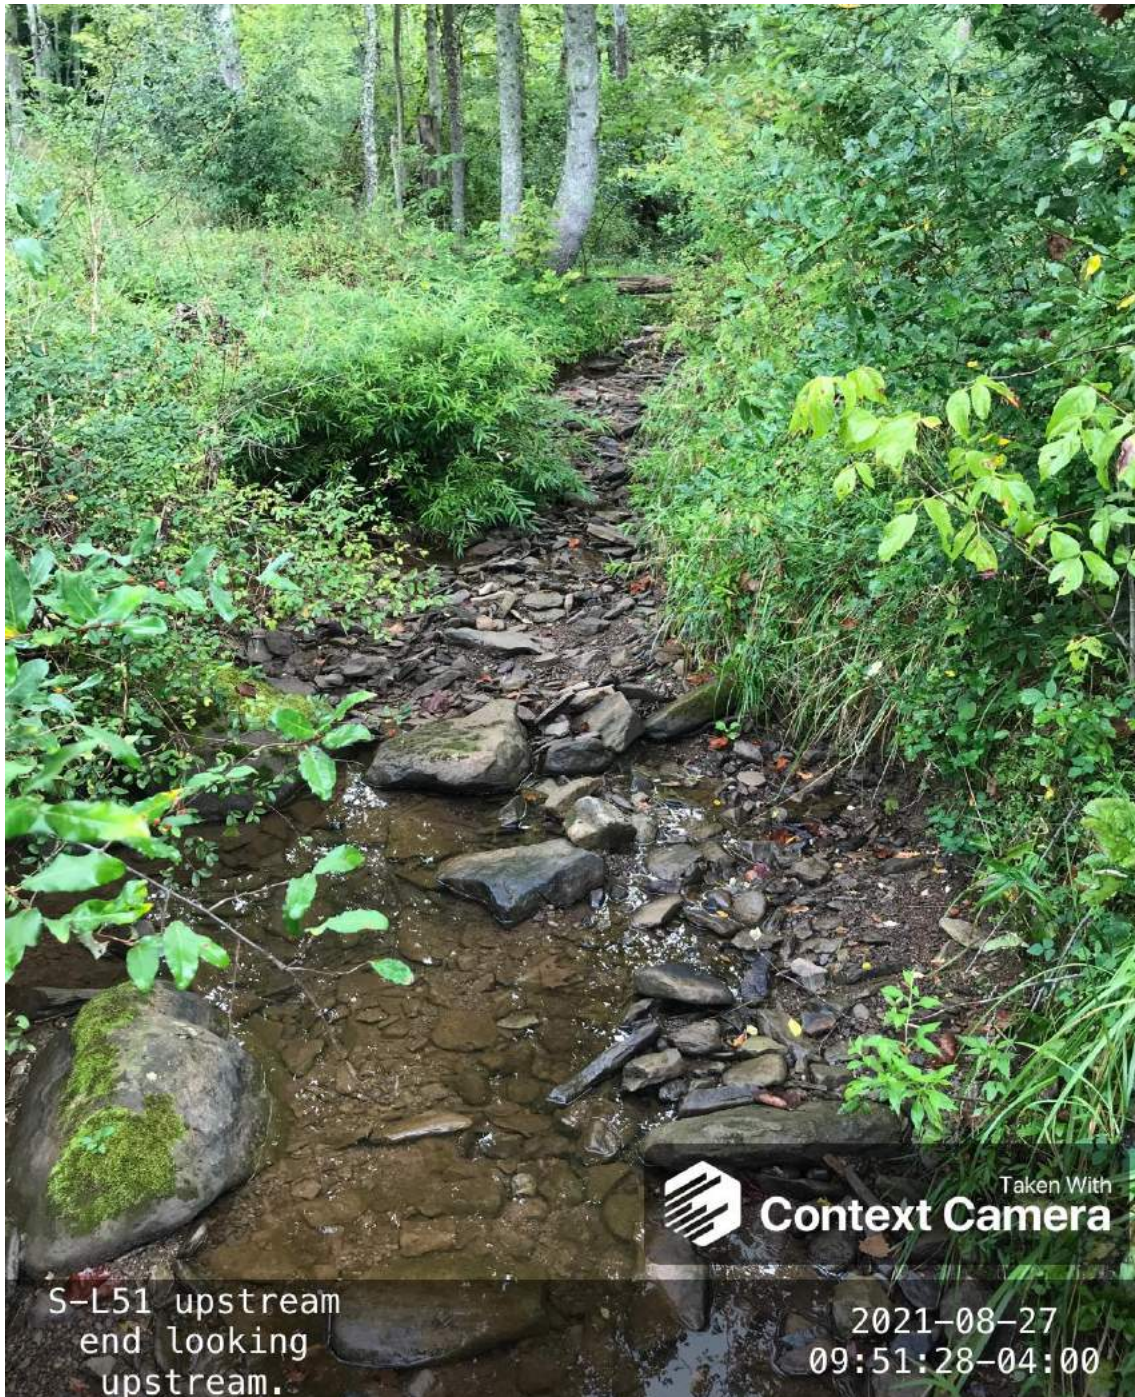
Photo Type: US, US View  
Location, Orientation, Photographer Initials: Upstream Edge of ROW, Upstream View, KP, LC, DD  
Lat: 38.839355 Long: -80.519693

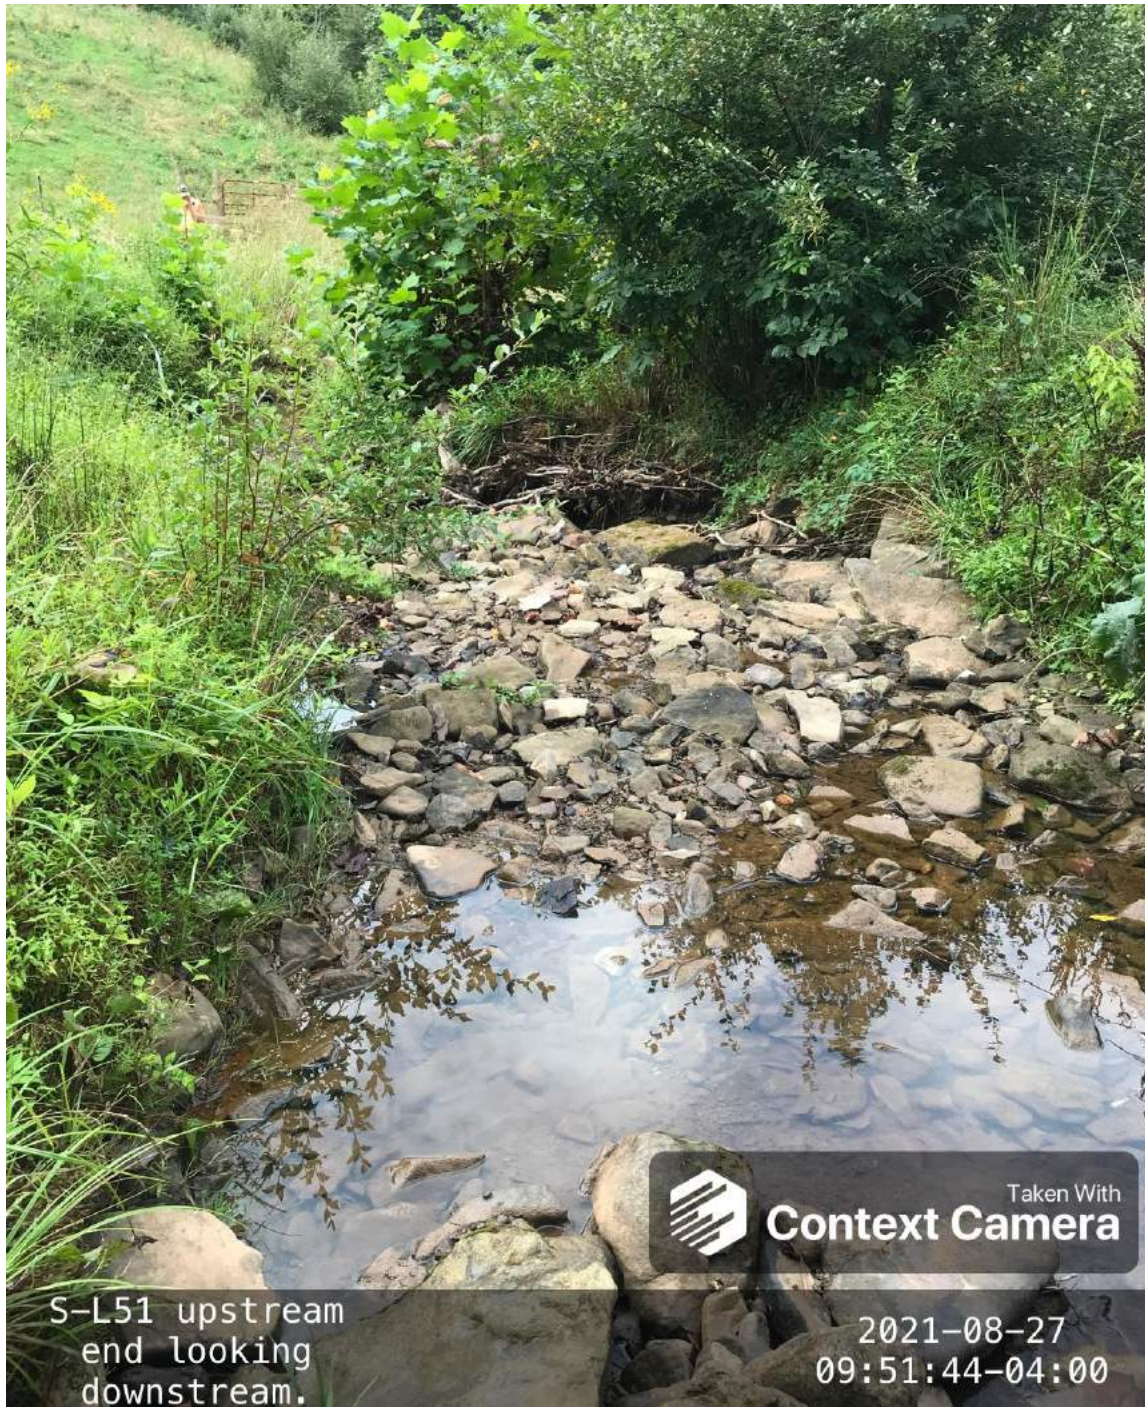
Photo Type: US, DS View

Location, Orientation, Photographer Initials: Upstream Edge of ROW, Downstream View, KP, LC, DD  
Lat: 38.839355 Long: -80.519693

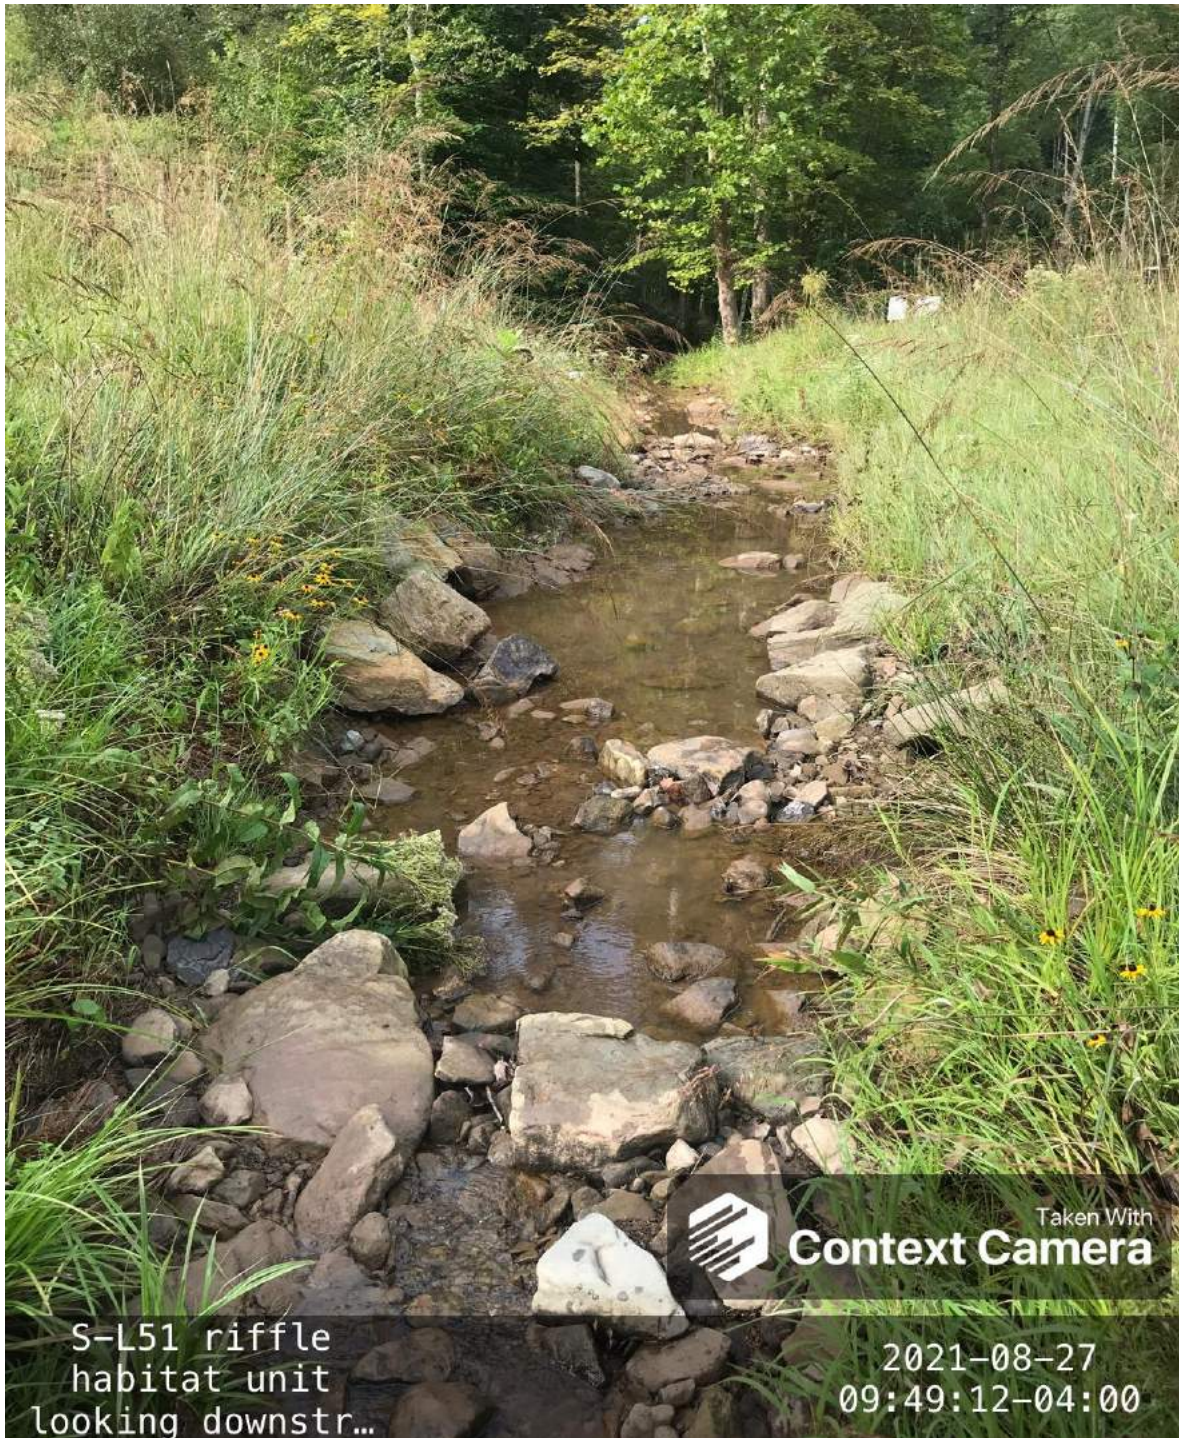
Photo Type: Riffle, DS View  
Location, Orientation, Photographer Initials: Upstream of Riffle, Downstream View, KP, LC, DD  
Lat: 38.839355 Long: -80.519693

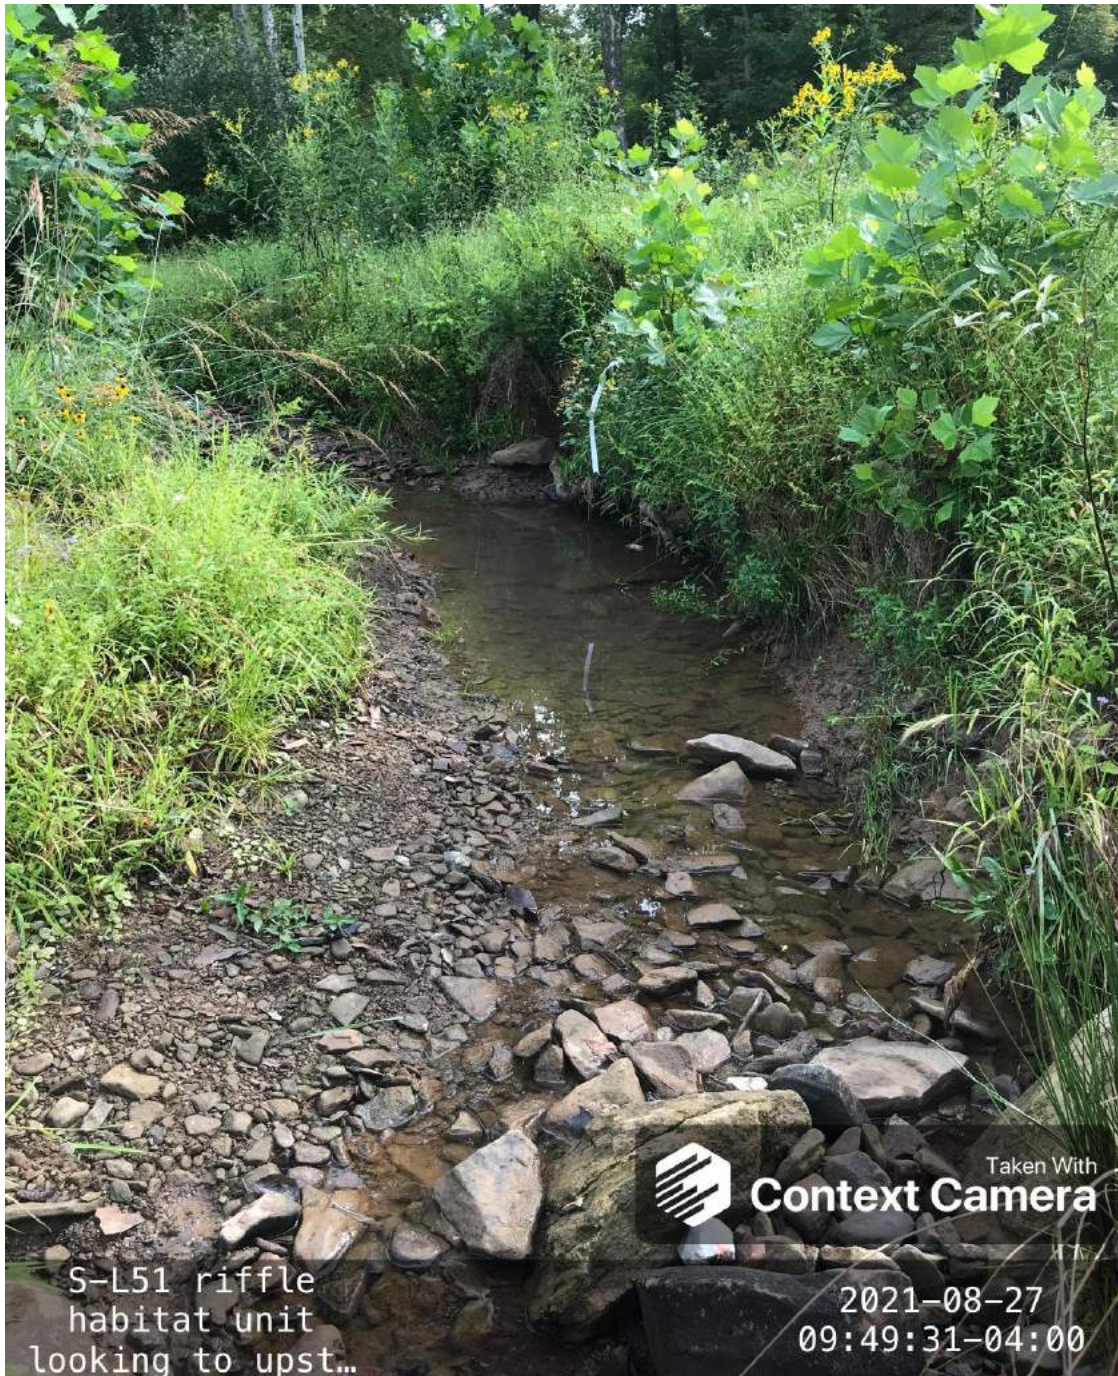
Photo Type: Riffle, US View

Location, Orientation, Photographer Initials: Downstream of Riffle, Upstream View, KP, LC, DD  
Lat: 38.839355 Long: -80.519693

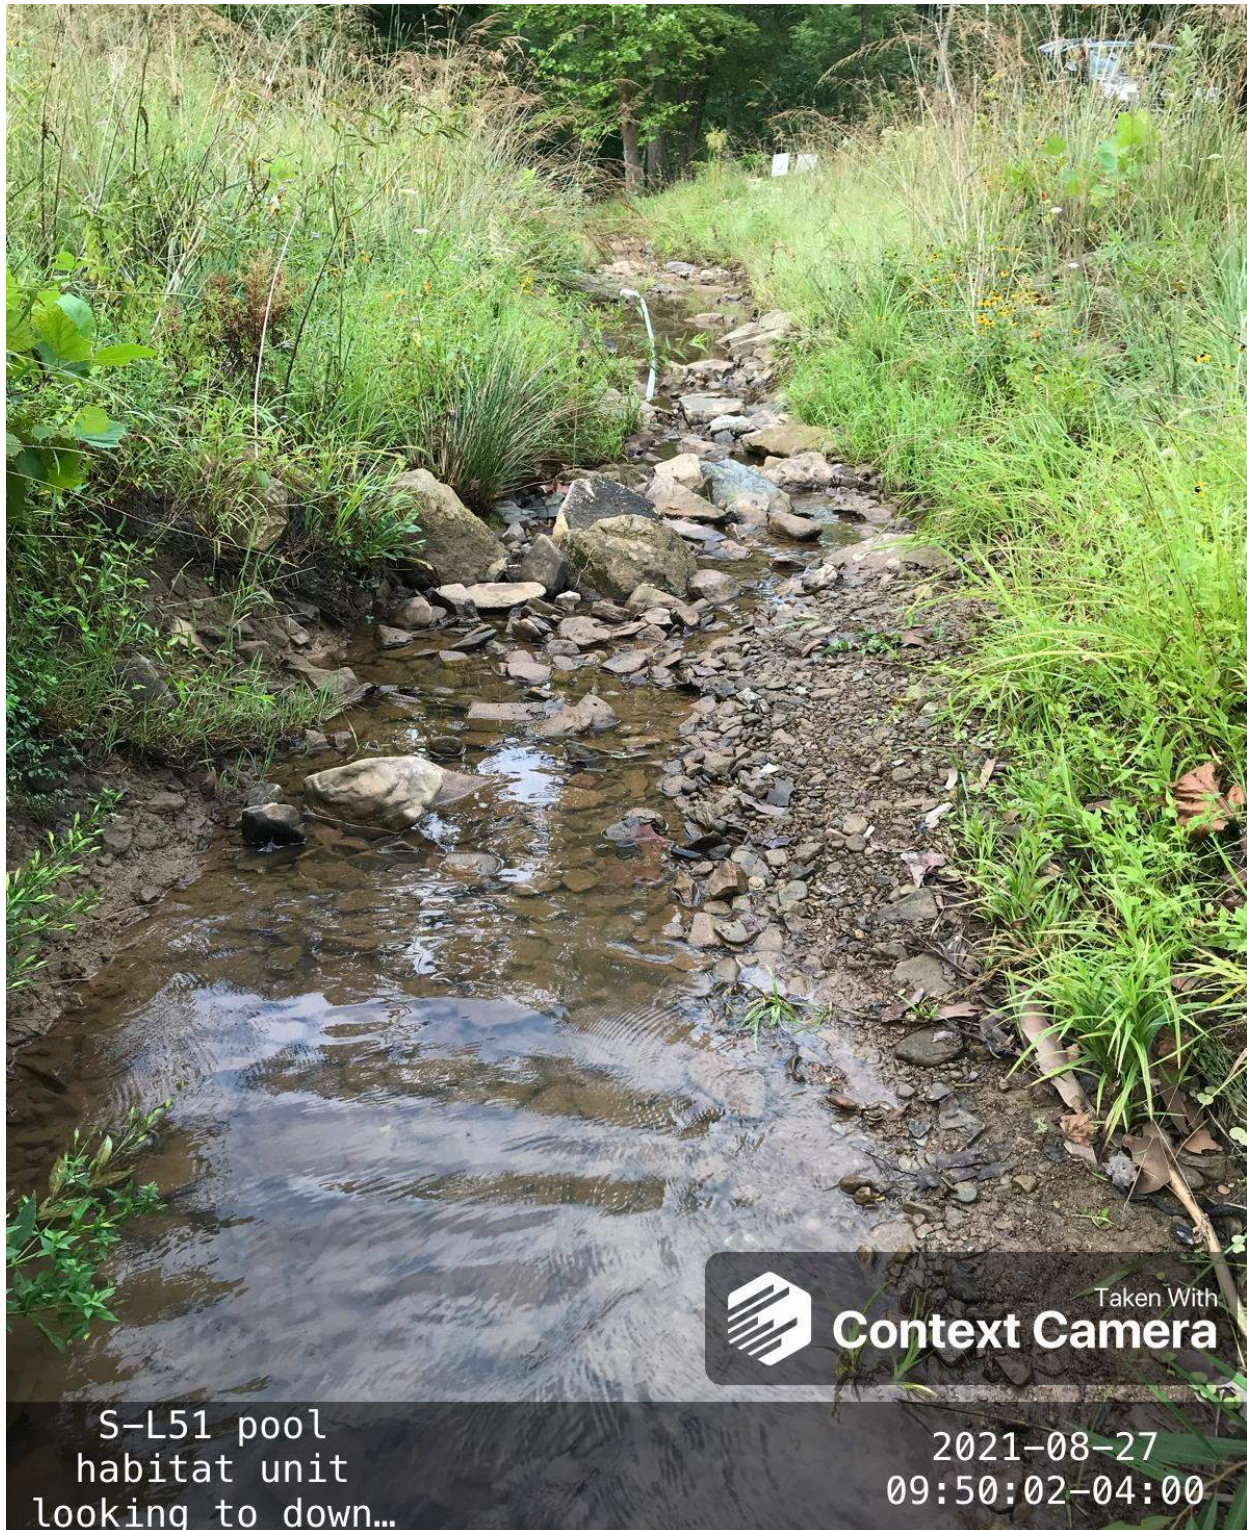
Photo Type: Pool, DS View  
Location, Orientation, Photographer Initials: Upstream of Pool, Downstream View, KP, LC, DD  
Lat: 38.839355 Long: -80.519693

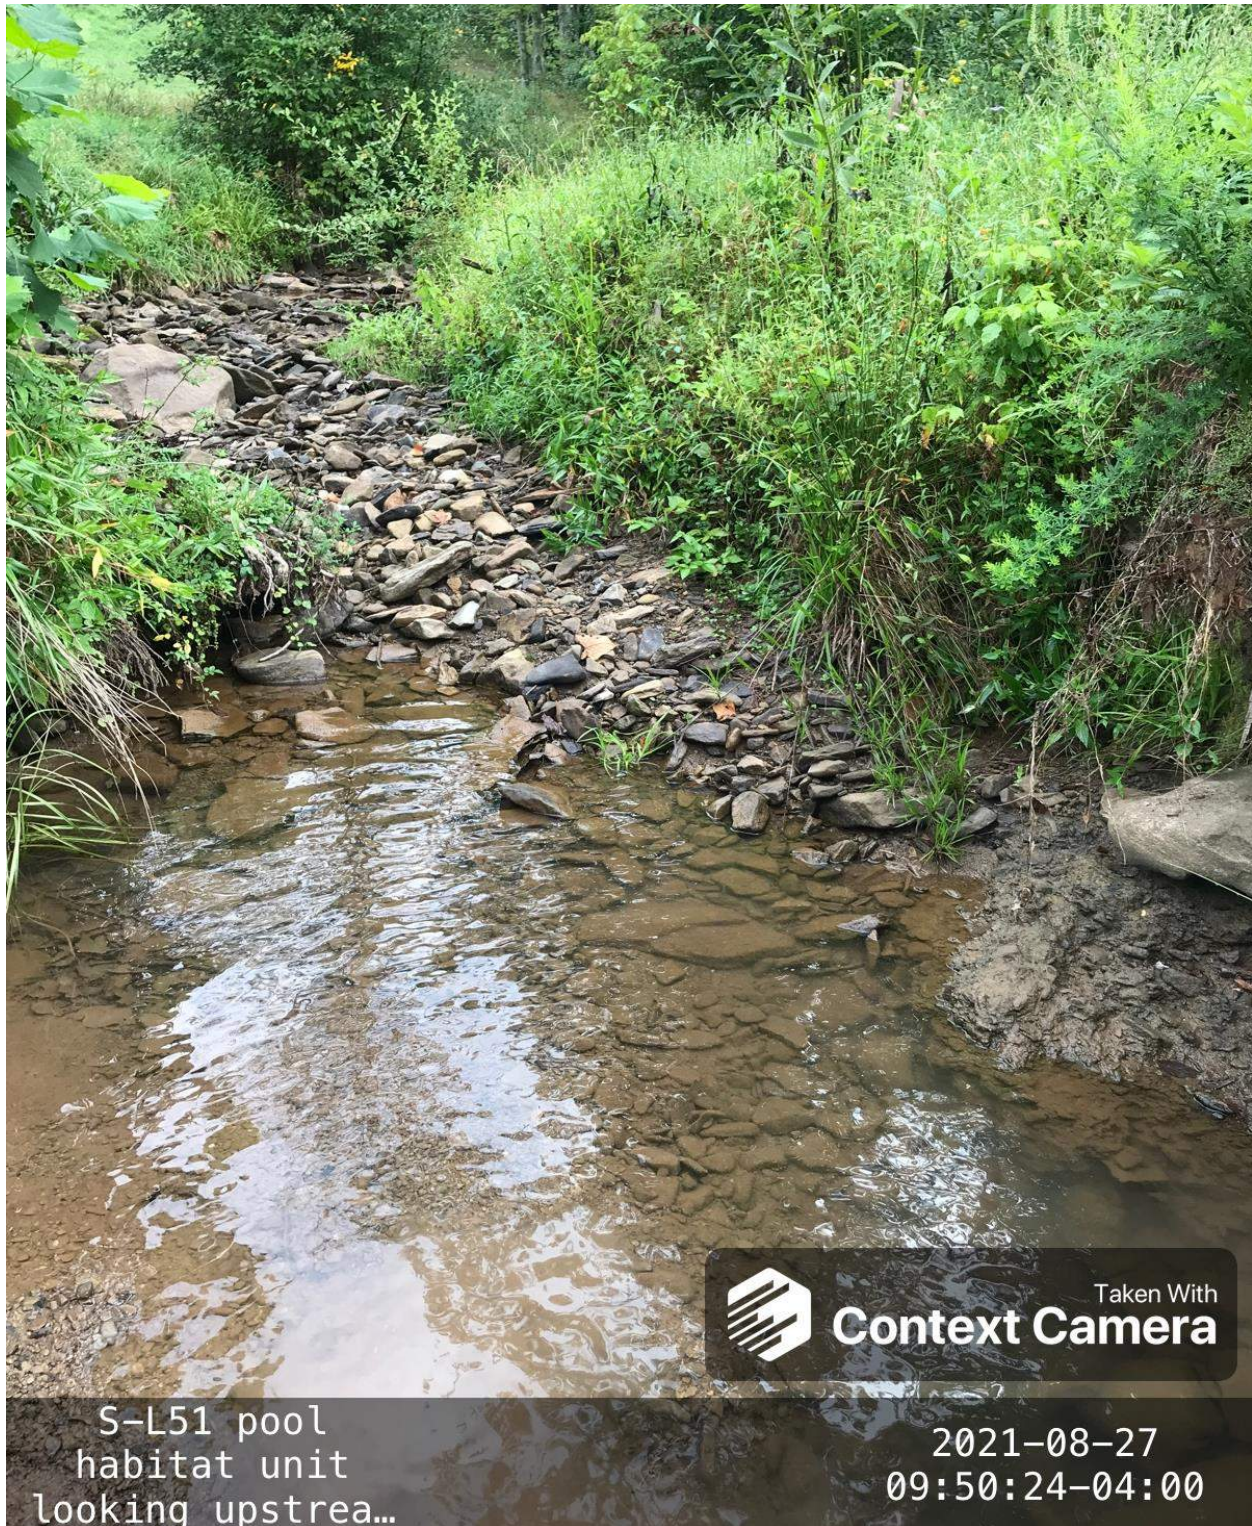
Photo Type: Pool, US View  
Location, Orientation, Photographer Initials: Downstream of Pool, Upstream View, KP, LC, DD  
Lat: 38.839355 Long: -80.519693

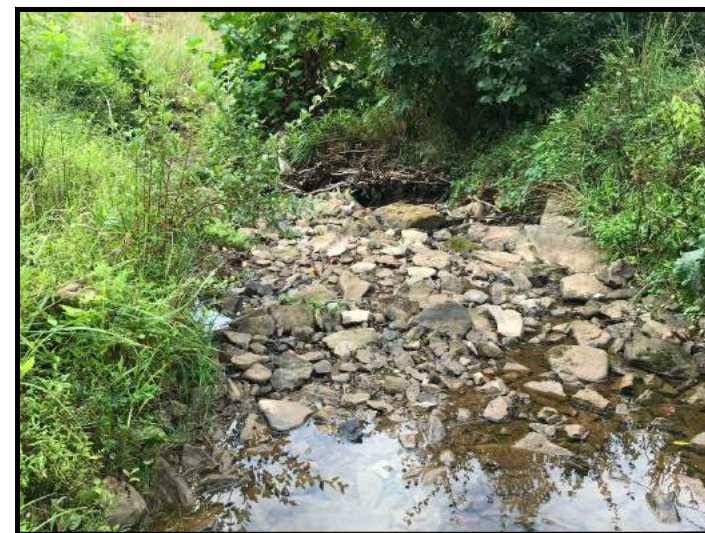
PHOTO TAKEN LOOKING DOWNSTREAM  
FROM UPSTREAM IMPACT LIMITS

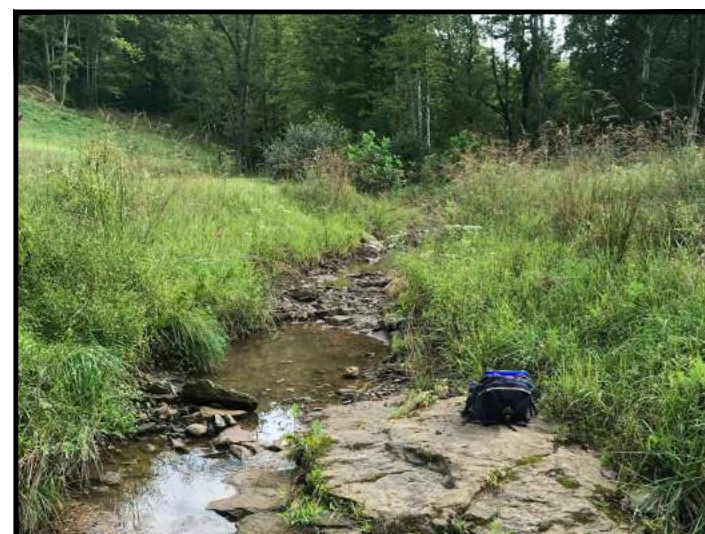
PHOTO TAKEN LOOKING UPSTREAM FROM  
DOWNSTREAM IMPACT LIMITS
