Baseline Assessment – Stream Attributes

Reach S-L76 (Permanent Access Road) Perennial Spread B Lewis County, West Virginia

Spread B S-L76 (Permanent Access Road) Lewis County

LE AND CROSS-SECTIONS
BASELINE SURVEY
CROSSING S-L76 -
DIAN FORK (MP 58.90)
LEWIS COUNTY, WV

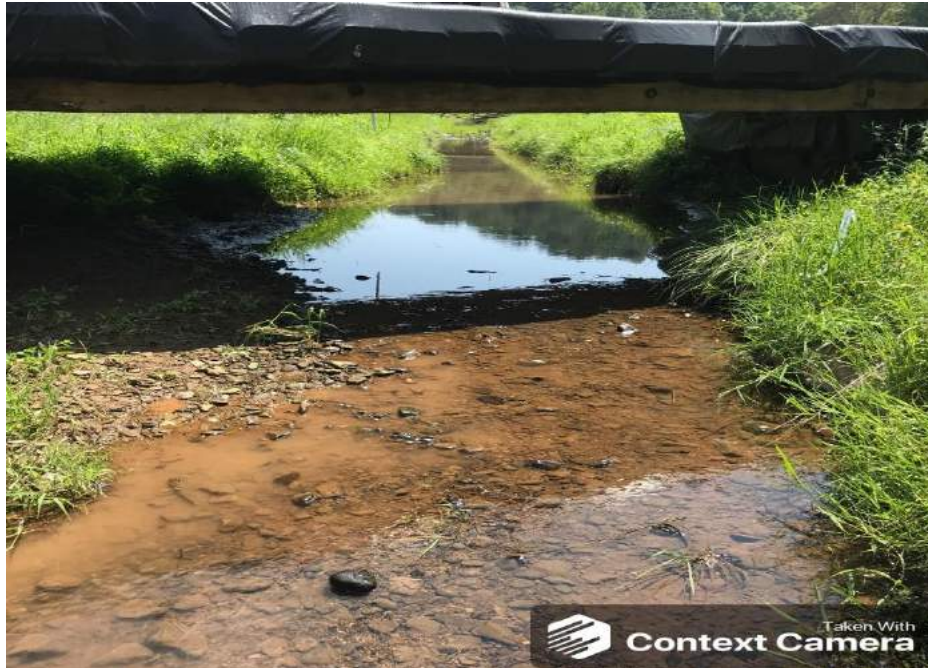
Photo Type: DS, US View

Location, Orientation, Photographer Initials: Downstream Edge of ROW, Upstream View, LC, KP, PL, DD
Lat: 38.929761 Long: -80.575251

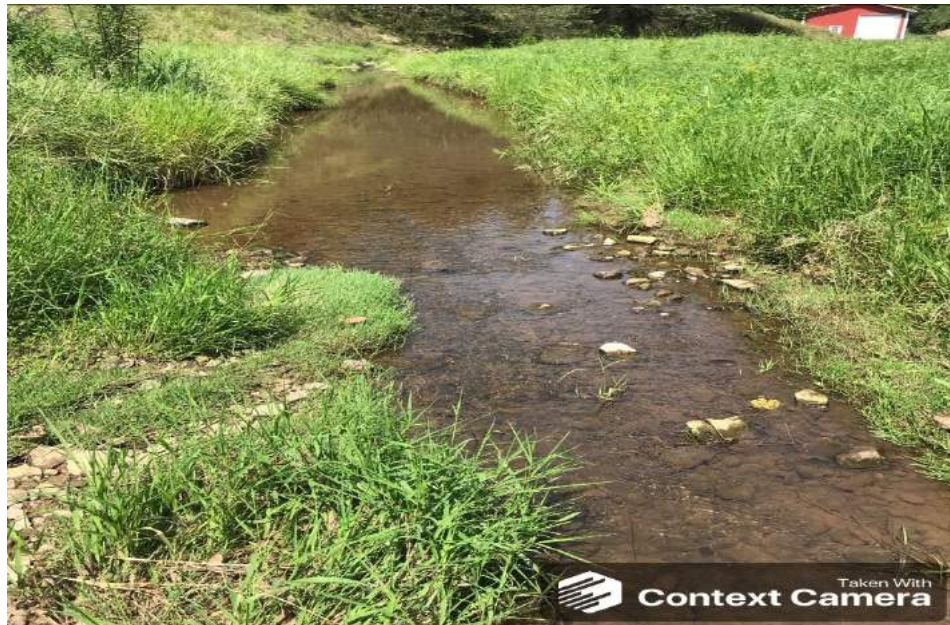
Photo Type: DS, DS View

Location, Orientation, Photographer Initials: Downstream Edge of ROW, Downstream View, LC, KP, PL, DD
Lat: 38.929761 Long: -80.575251

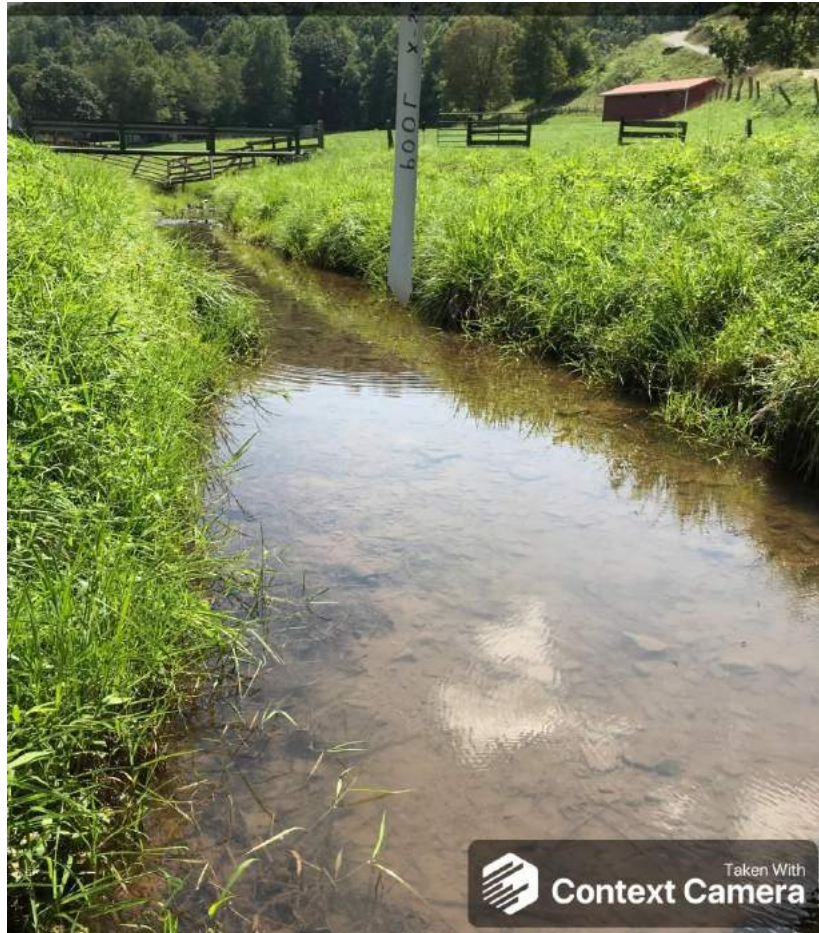
Photo Type: US View at Center

Location, Orientation, Photographer Initials: Center ROW, Upstream View, LC, KP, PL, DD
Lat: 38.929761 Long: -80.575251

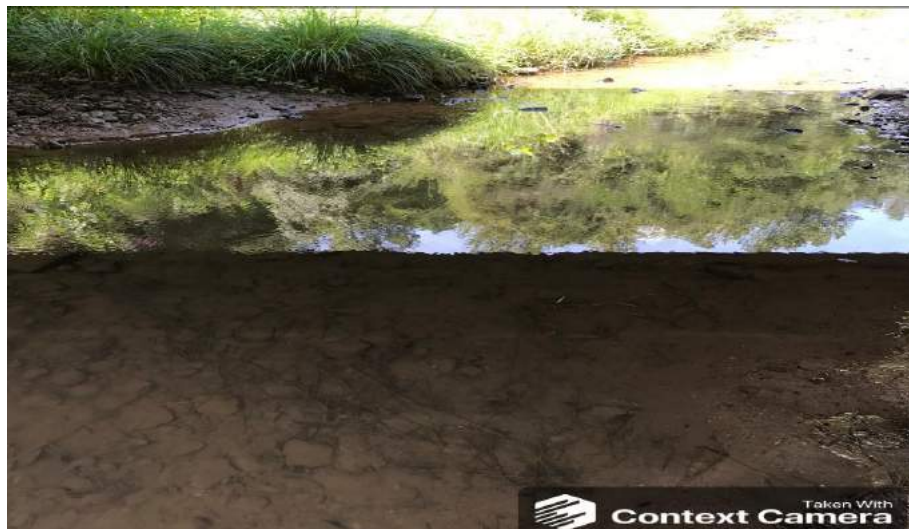
Photo Type: DS View at Center

Location, Orientation, Photographer Initials: ROW Center, Downstream View, LC, KP, PL, DD
Lat: 38.929761 Long: -80.575251

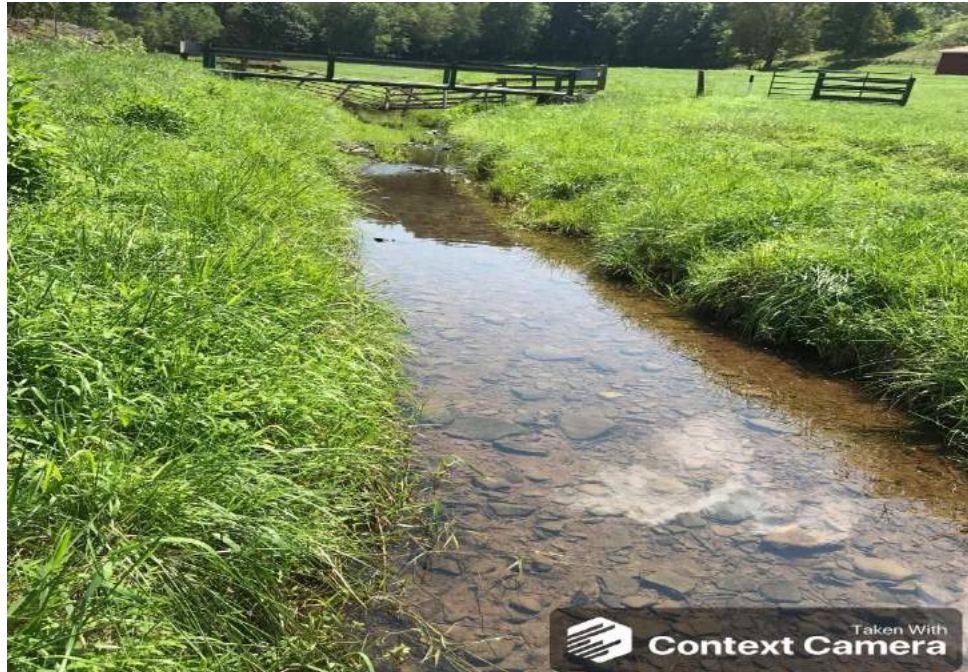
Photo Type: US, US View

Location, Orientation, Photographer Initials: Upstream Edge of ROW, Upstream View, LC, KP, PL, DD
Lat: 38.929761 Long: -80.575251

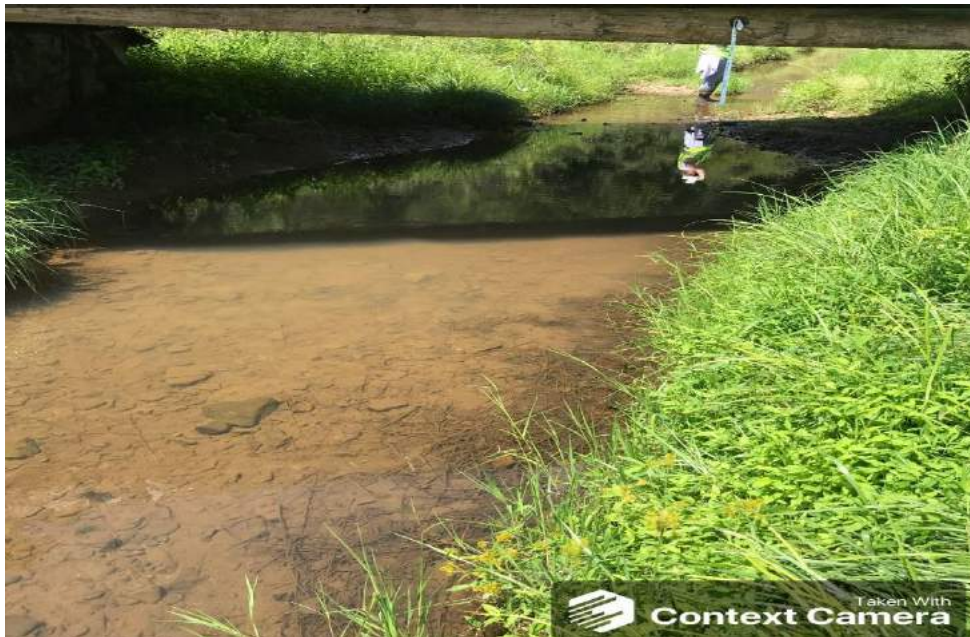
Photo Type: US, DS View

Location, Orientation, Photographer Initials: Upstream Edge of ROW, Downstream View, LC, KP, PL, DD
Lat: 38.929761 Long: -80.575251

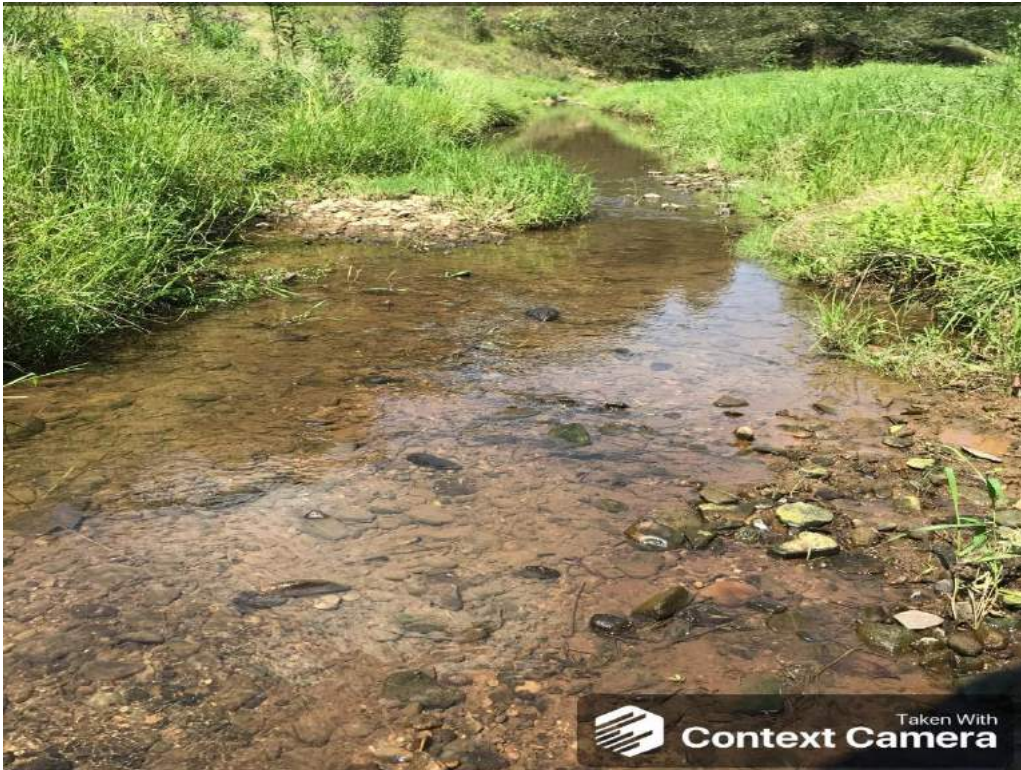
Photo Type: Riffle, DS View

Location, Orientation, Photographer Initials: Upstream of Riffle, Downstream View, LC, KP, PL, DD
Lat: 38.929761 Long: -80.575251

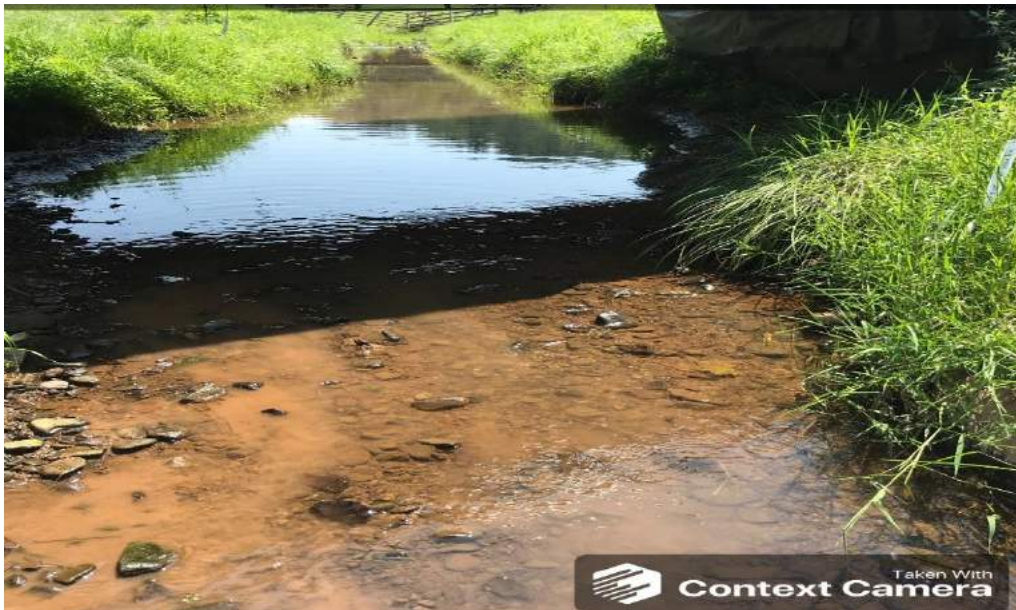
Photo Type: Riffle, US View

Location, Orientation, Photographer Initials: Downstream of Riffle, Upstream View, LC, KP, PL, DD
Lat: 38.929761 Long: -80.575251

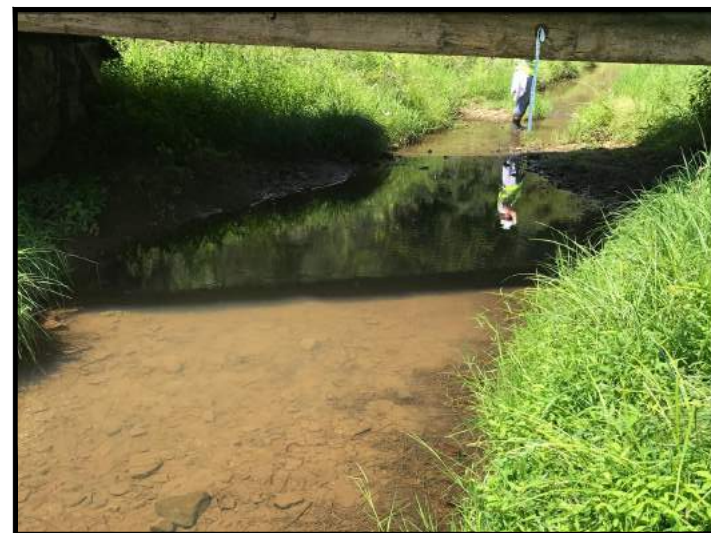
PHOTO TAKEN LOOKING DOWNSTREAM
FROM UPSTREAM IMPACT LIMITS

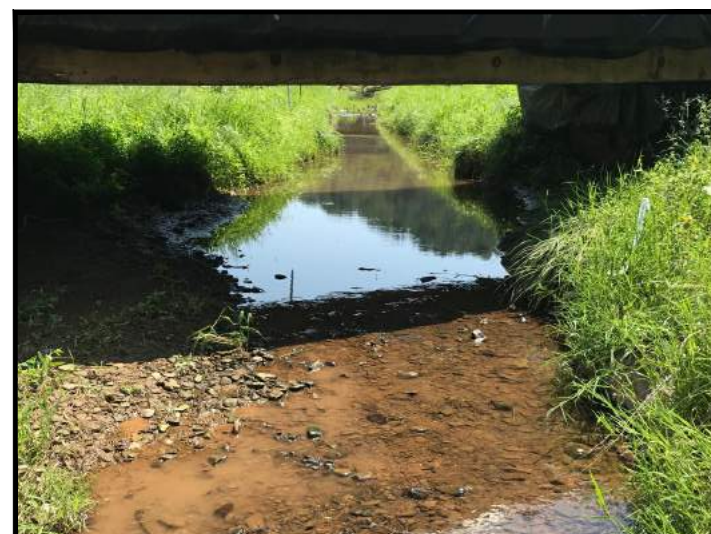
PHOTO TAKEN LOOKING UPSTREAM FROM
DOWNSTREAM IMPACT LIMITS
