Baseline Assessment – Stream Attributes

Reach S-N15 (Timber Mat Crossing) Intermittent Spread D Nicholas County, West Virginia

Spread D Stream S-N15 (Timber Mat Crossing) Nicholas County

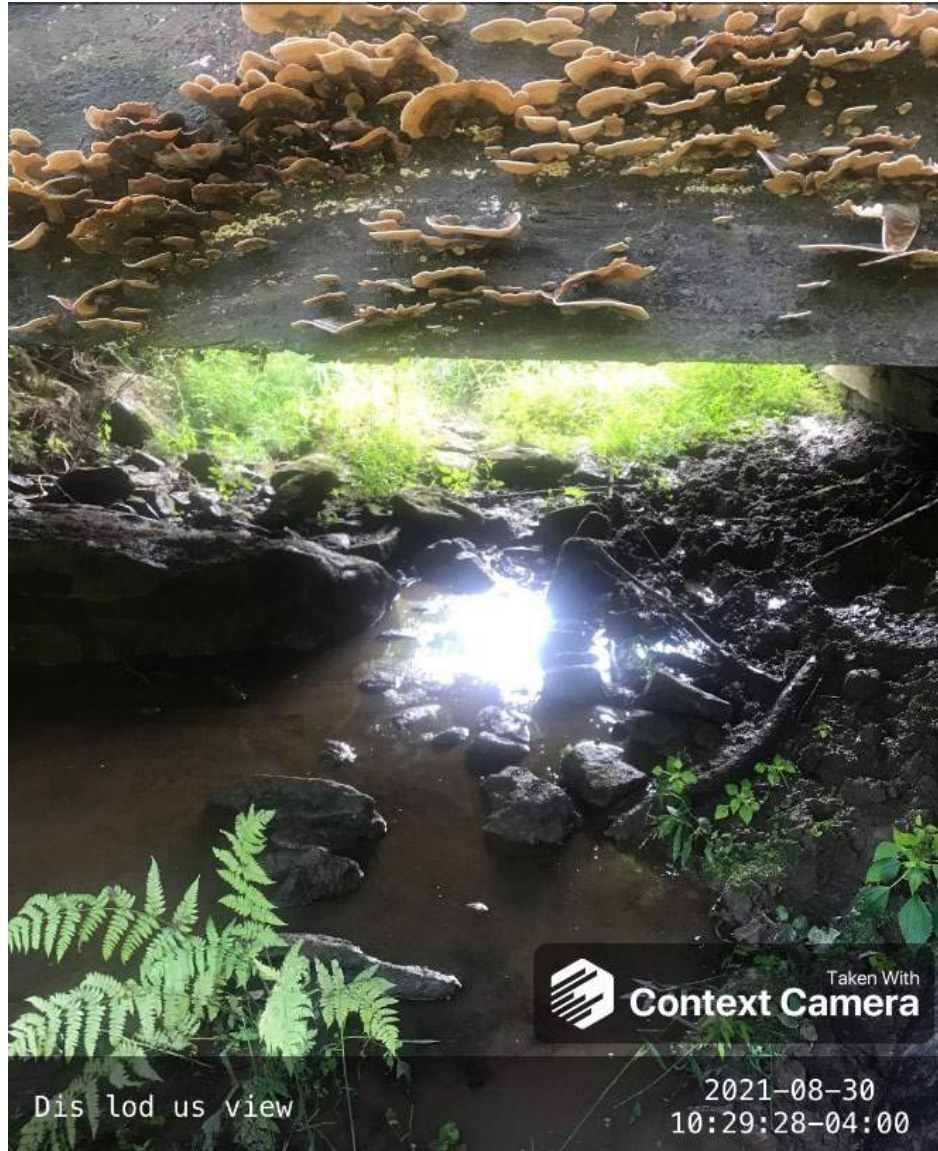
Photo Type: DS, US View

Location, Orientation, Photographer Initials: Downstream Edge of ROW, Upstream View, JM/SM
Lat: 38.301571 Long: -80.674776

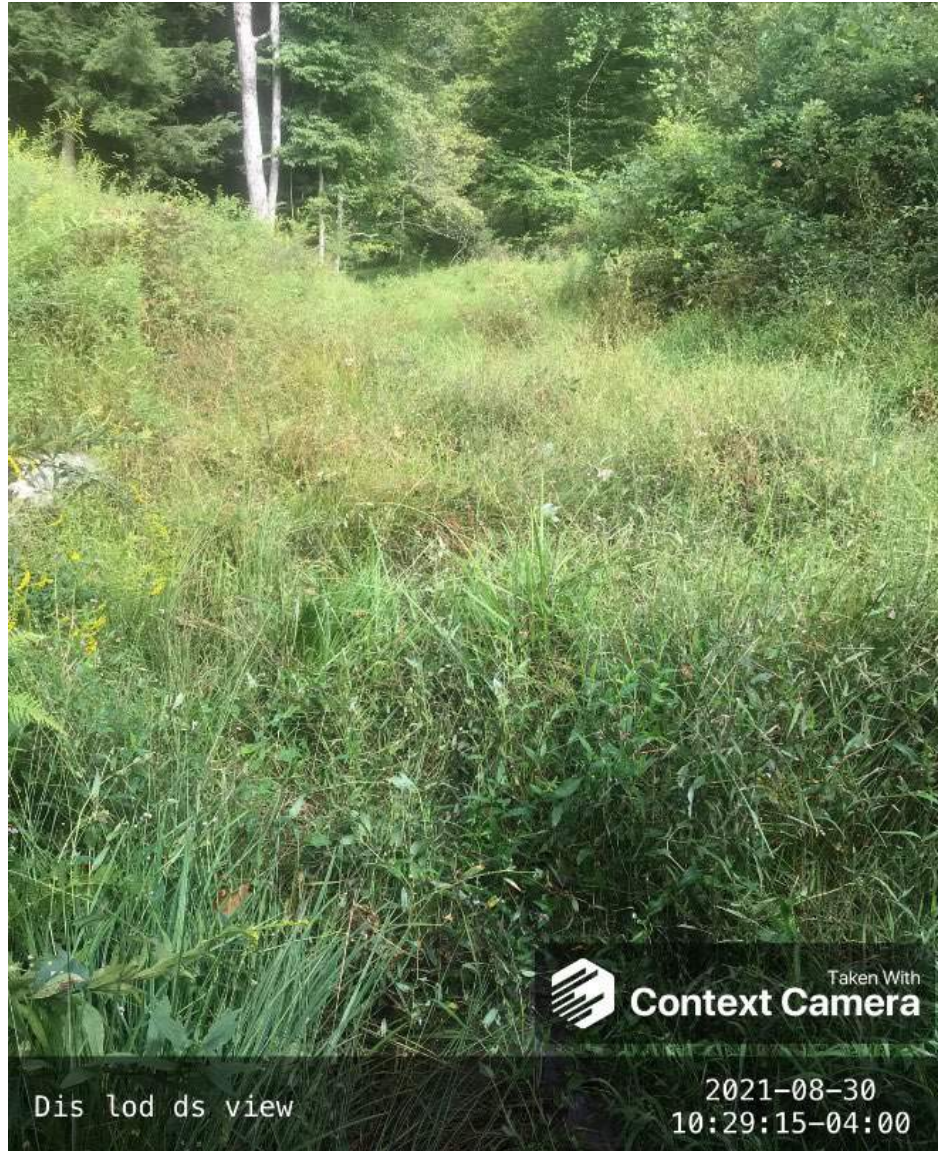
Photo Type: DS, DS View

Location, Orientation, Photographer Initials: Downstream Edge of ROW, Downstream View, JM/SM

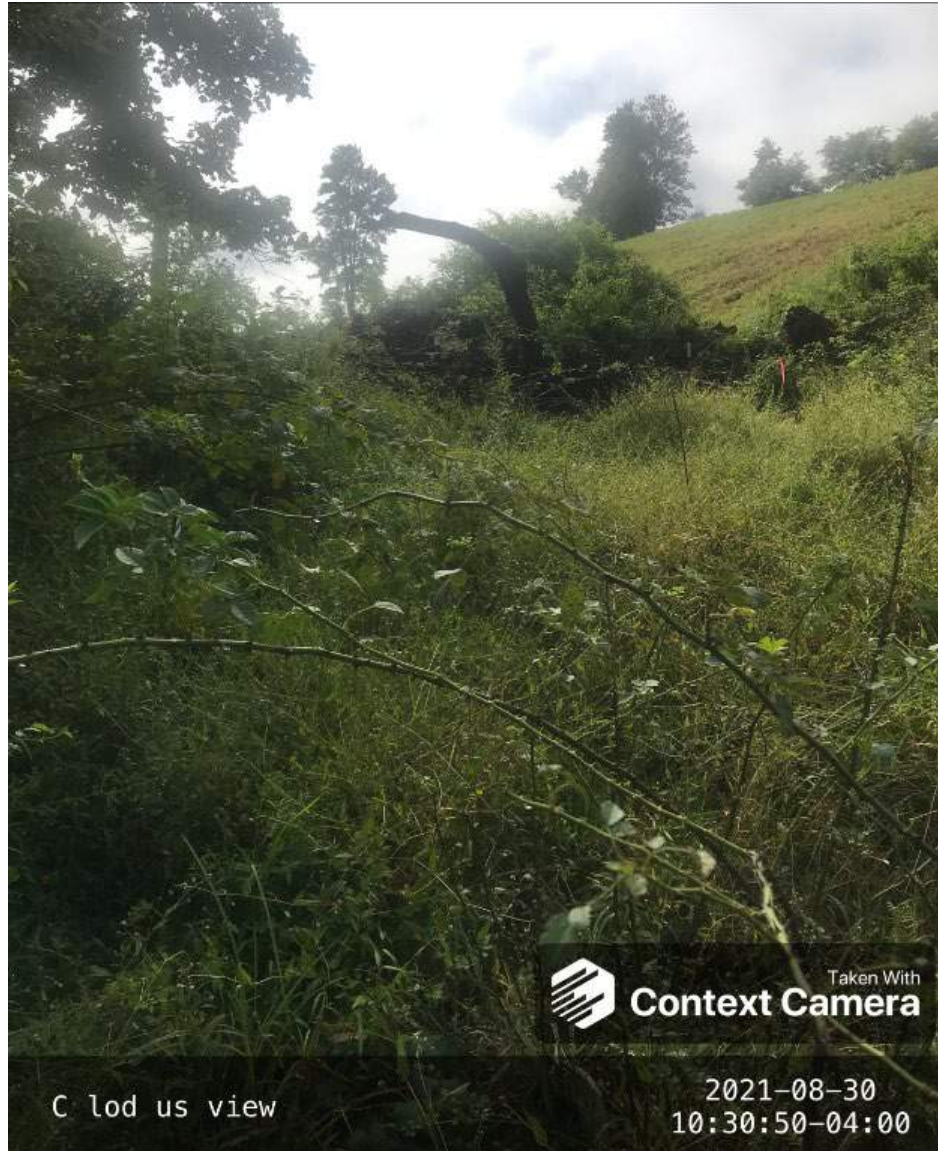
Photo Type: US View at Center
Location, Orientation, Photographer Initials: Center ROW, Upstream View, JM/SM
Lat: 38.301571 Long: -80.674776

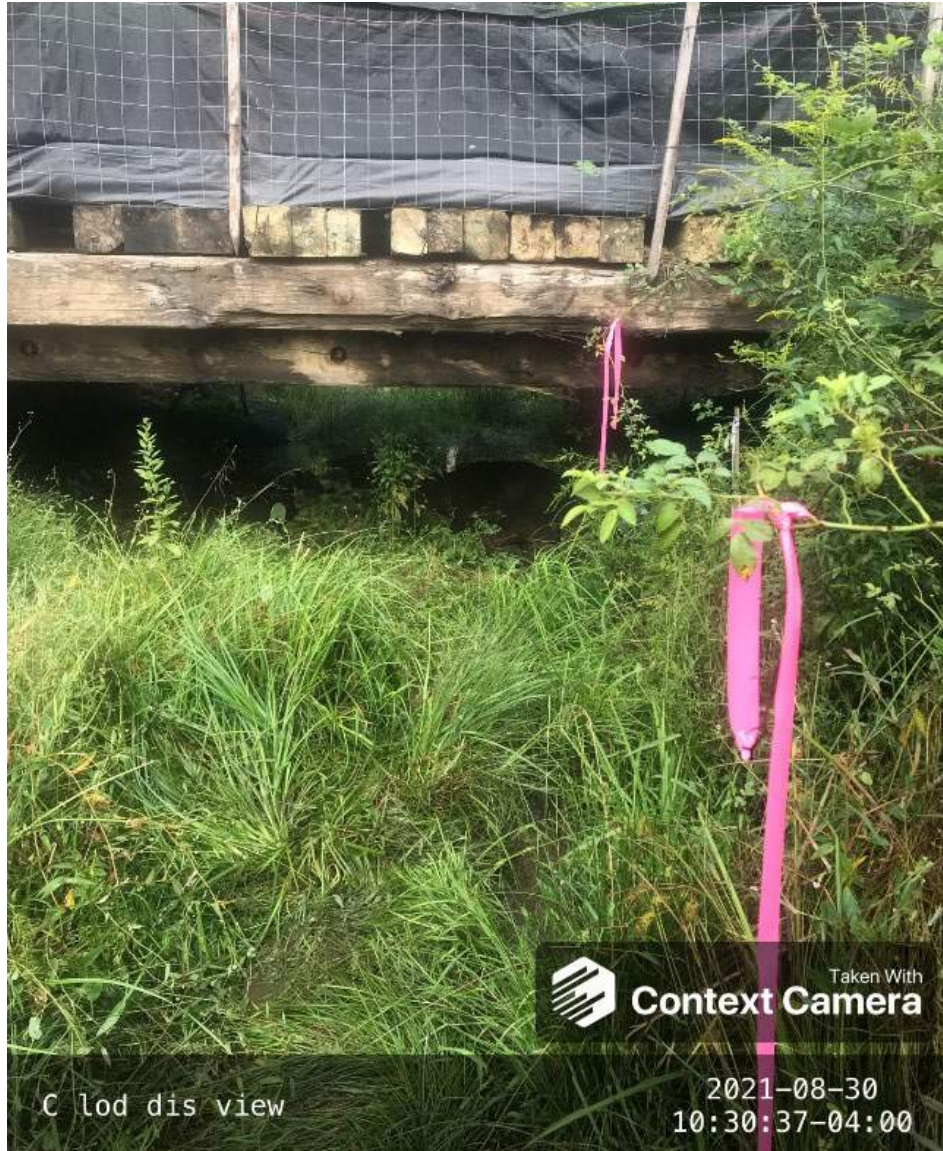
Photo Type: DS View at Center
Location, Orientation, Photographer Initials: ROW Center, Downstream View, JM/SM
Lat: 38.301571 Long: -80.674776

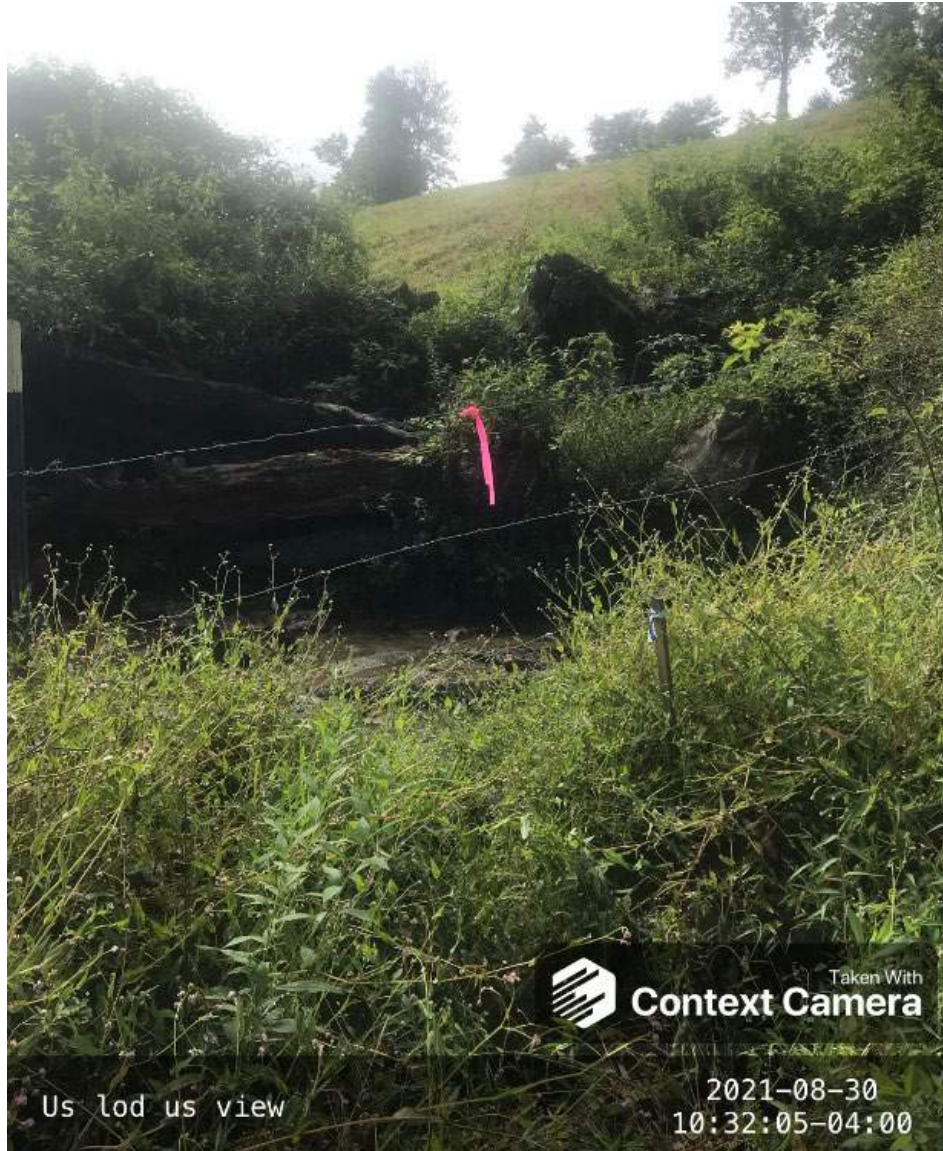
Photo Type: US, US View
Location, Orientation, Photographer Initials: Upstream Edge of ROW, Upstream View, JM/SM
Lat: 38.301571 Long: -80.674776

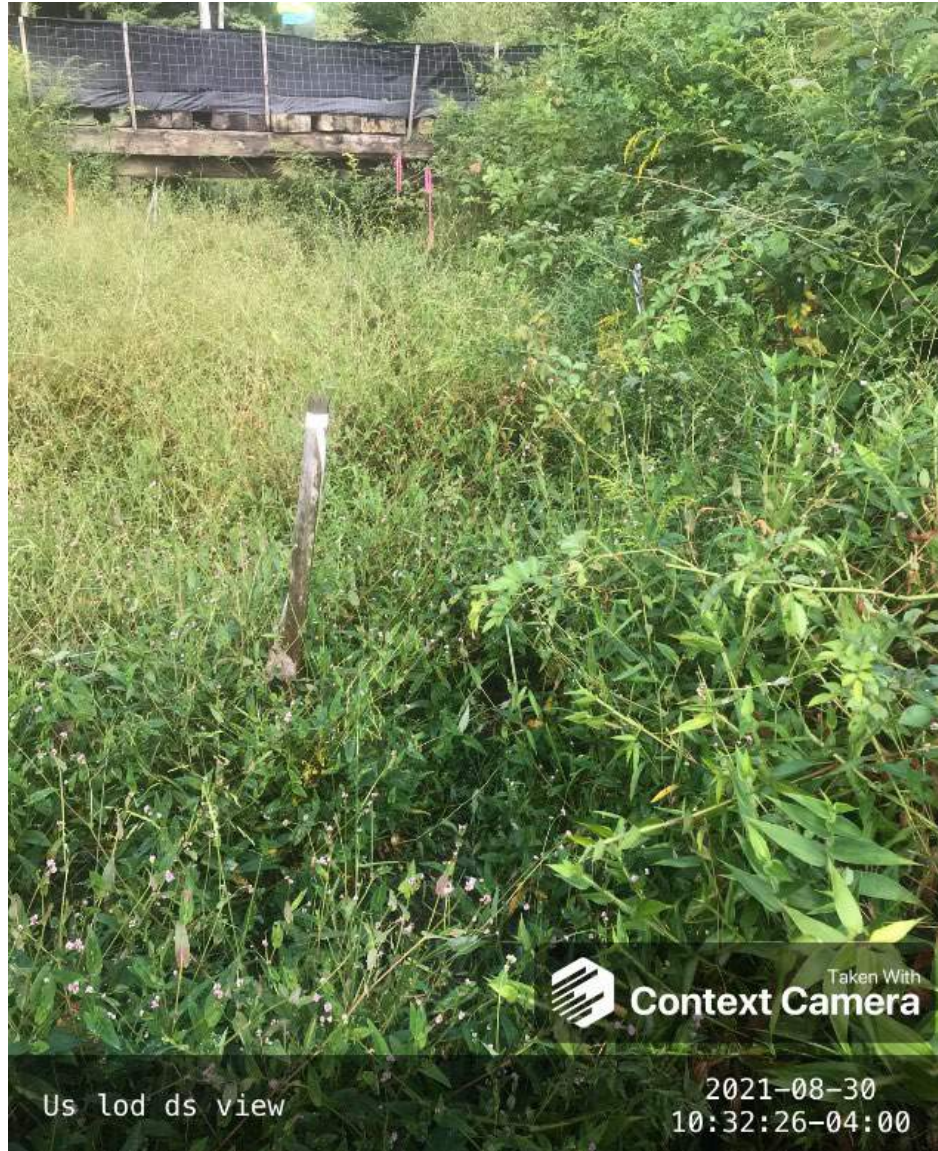
Photo Type: US, DS View

Location, Orientation, Photographer Initials: Upstream Edge of ROW, Downstream View, JM/SM
Lat: 38.301571 Long: -80.674776

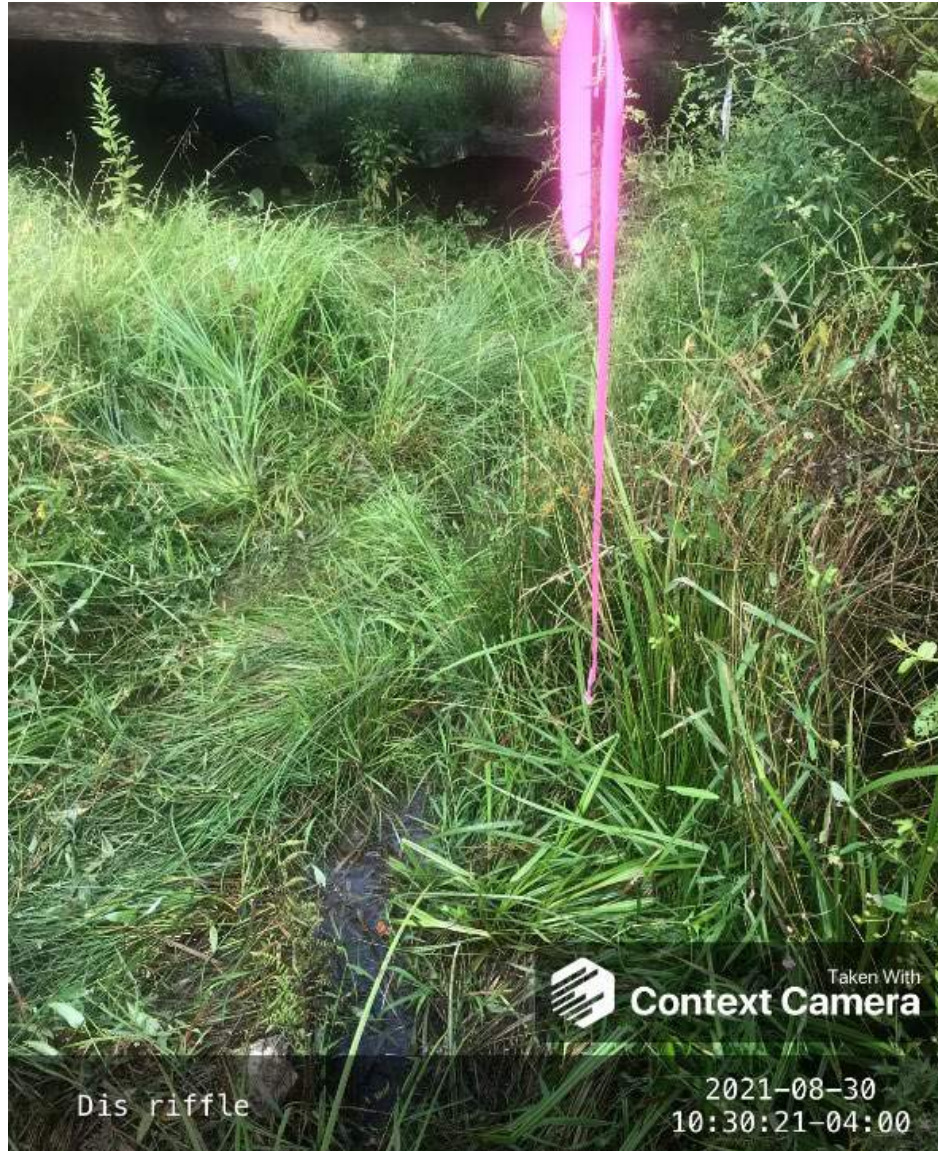
Photo Type: Riffle, DS View
Location, Orientation, Photographer Initials: Upstream of Pool, Downstream View, JM/SM
Lat: 38.301571 Long: -80.674776

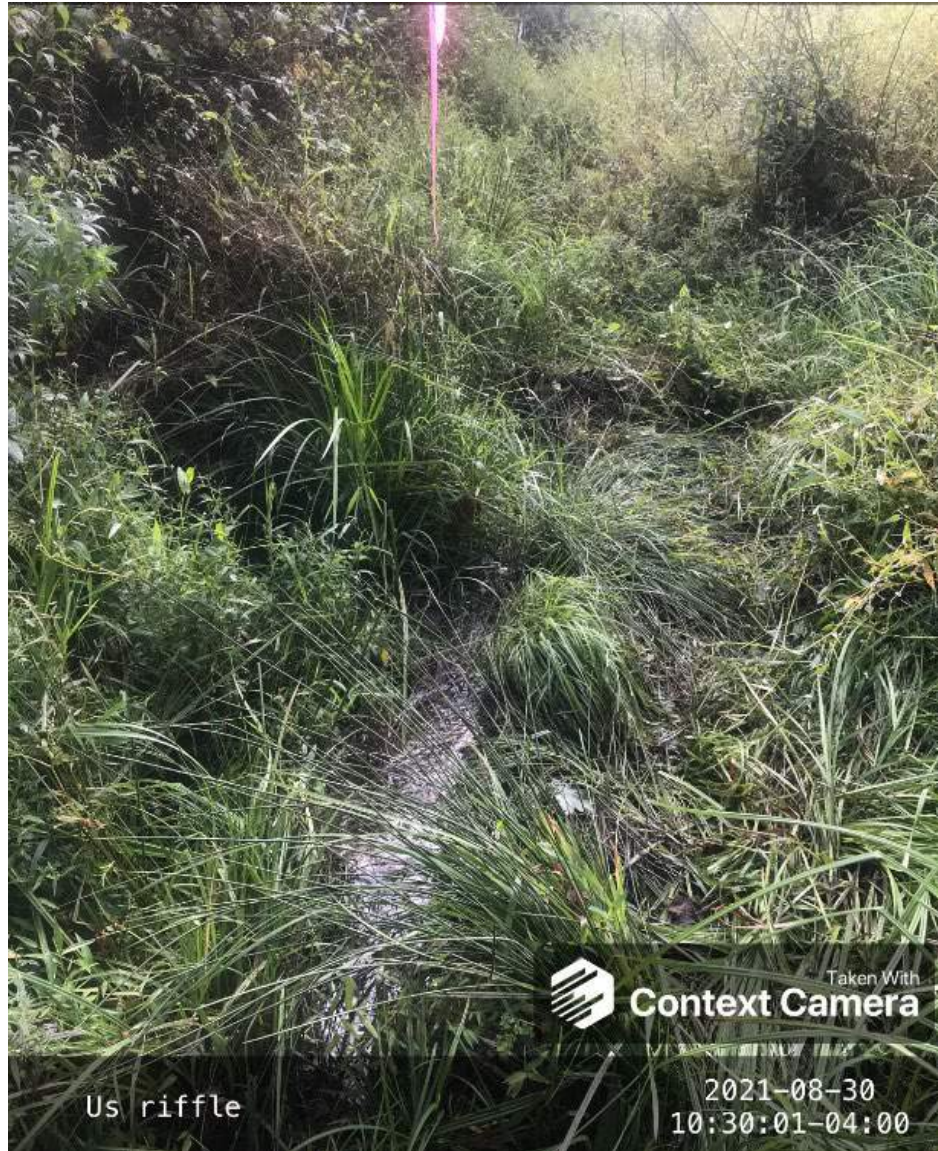
Photo Type: Riffle, US View
Location, Orientation, Photographer Initials: Downstream of Pool, Upstream View, JM/SM
Lat: 38.301571 Long: -80.674776
