Baseline Assessment – Stream Attributes

Reach S-N3 (Timber Mat Crossing) Ephemeral Spread F Summers County, West Virginia

Client
MOUNTAIN VALLEY PIPELINE, LLC
2200 ENERGY DRIVE, 2ND FLOOR
CANONSBURG, PA 15317
Title
PROFILE AND CROSS-SECTIONS
BASELINE SURVEY
CROSSING S-N3 - UNNAMED TRIBUTARY
TO HUNGARD CREEK (MP 169.76)
SUMMERS COUNTY, WV

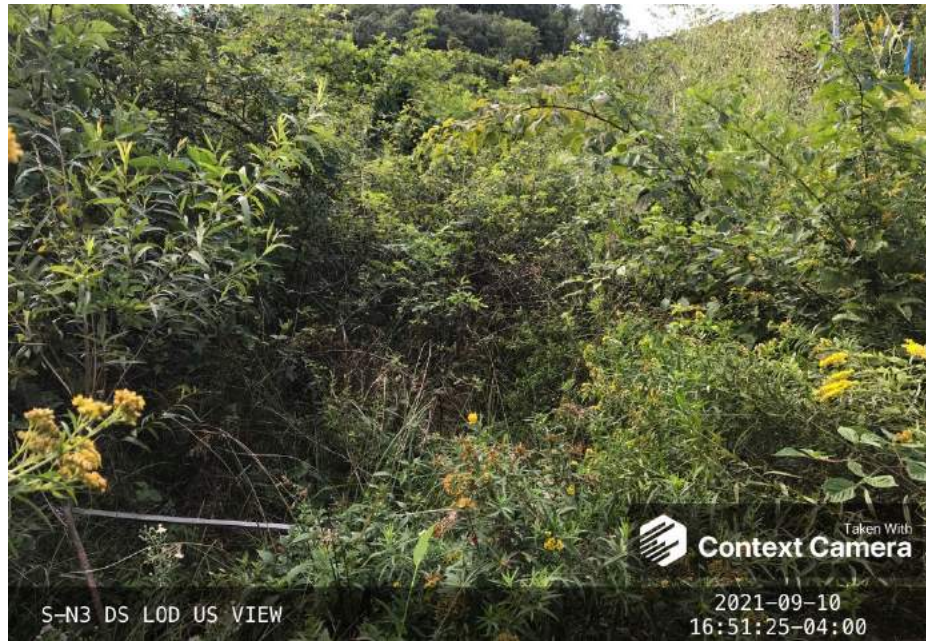
Photo Type: DS, US View

Location, Orientation, Photographer Initials: Downstream Edge of ROW, Upstream View, RH/AR
Lat: 37.694776 Long: -80.736952

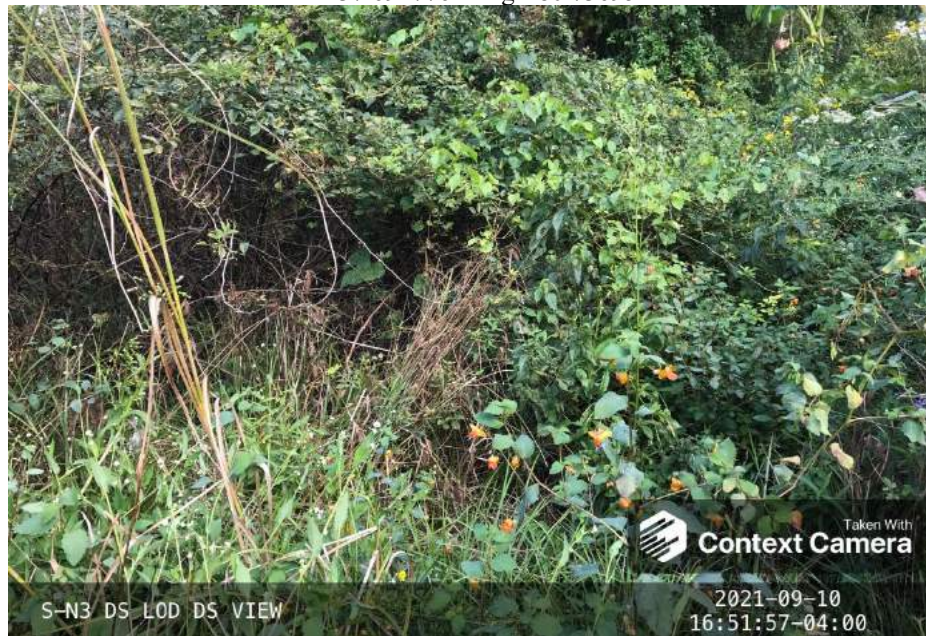
Photo Type: DS, DS View

Location, Orientation, Photographer Initials: Downstream Edge of ROW, Downstream View, RH/AR
Lat: 37.694776 Long: -80.736952

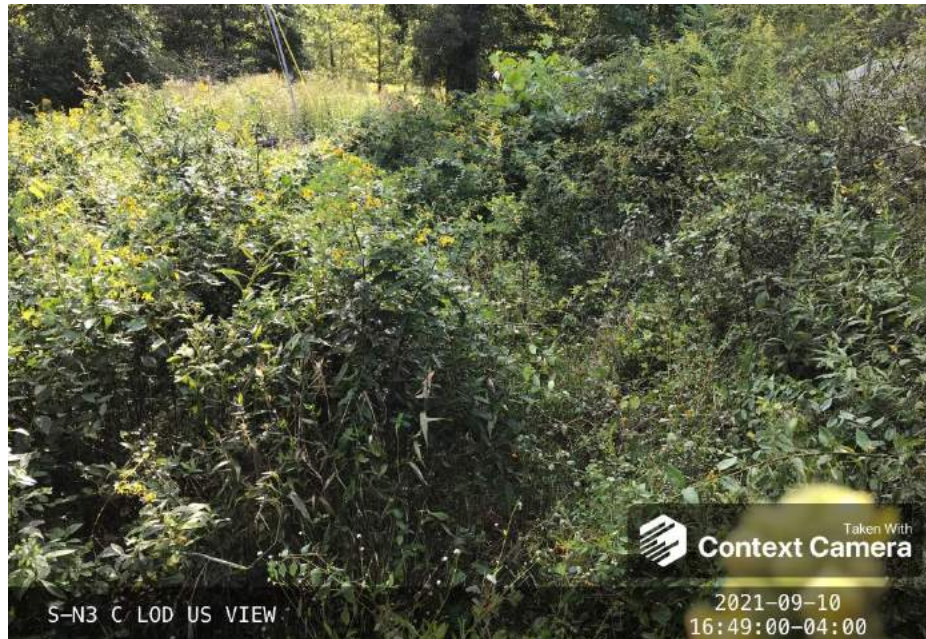
Photo Type: US View at Center
Location, Orientation, Photographer Initials: Center ROW, Upstream View, RH/AR
Lat: 37.694776 Long: -80.736952

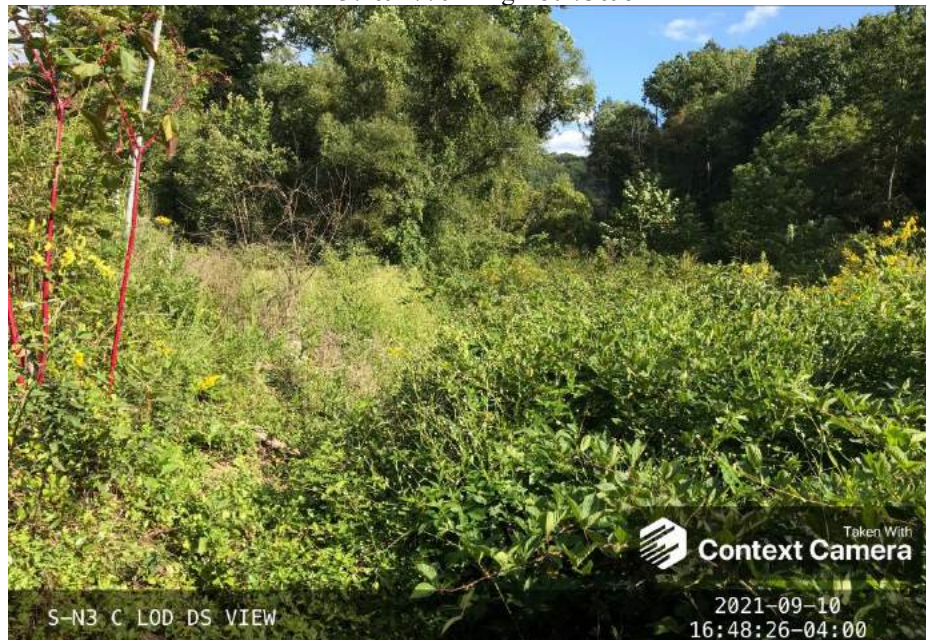
Photo Type: DS View at Center
Location, Orientation, Photographer Initials: ROW Center, Downstream View, RH/AR
Lat: 37.694776 Long: -80.736952

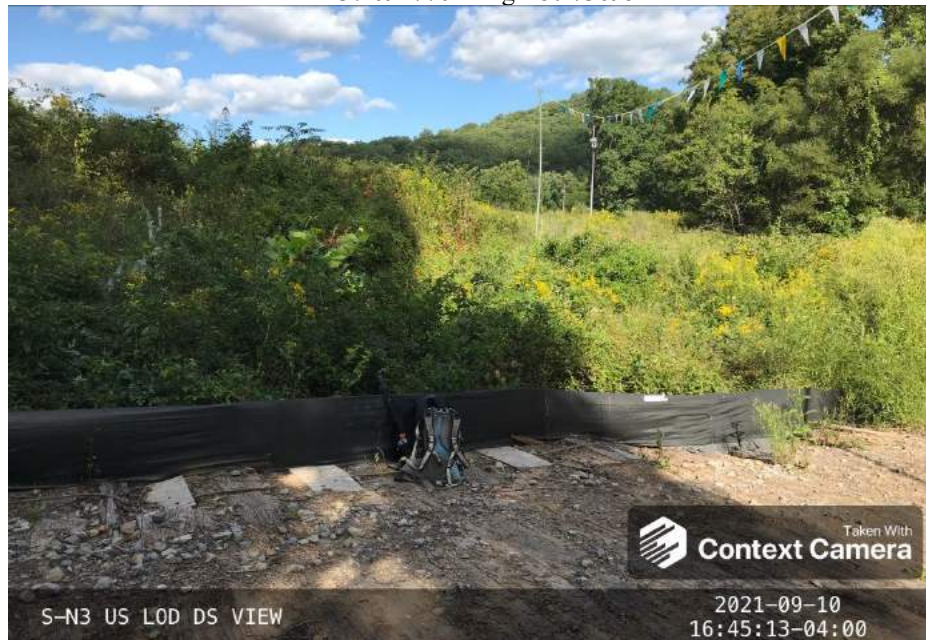
Photo Type: US, DS View

Location, Orientation, Photographer Initials: Upstream Edge of ROW, Downstream View, RH/AR
Lat: 37.694776 Long: -80.736952

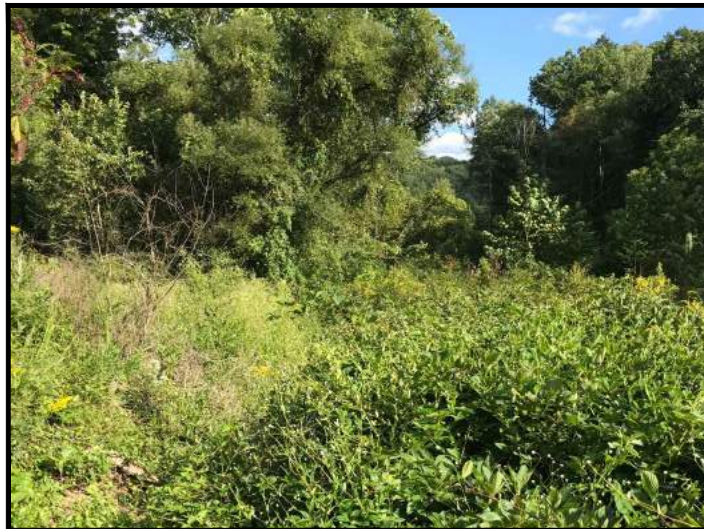
PHOTO TAKEN LOOKING DOWNSTREAM FROM UPSTREAM IMPACT LIMITS

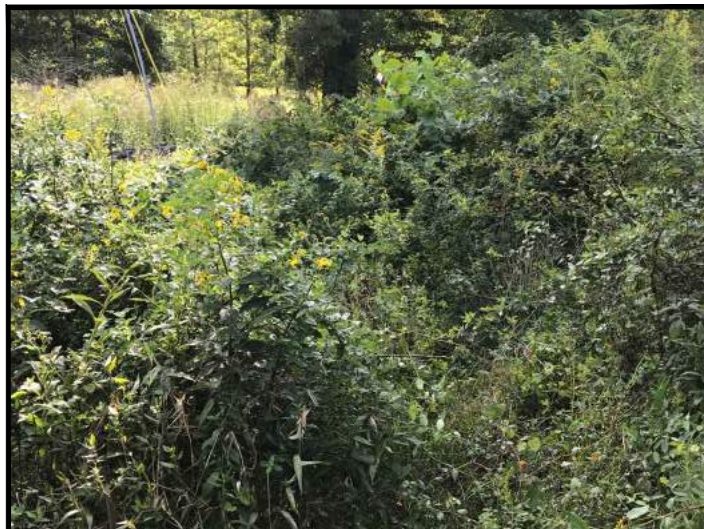
PHOTO TAKEN LOOKING UPSTREAM FROM DOWNSTREAM IMPACT LIMITS
