Baseline Assessment – Stream Attributes

Reach S-RR22 (Timber Mat Crossing) Perennial Spread A Harrison County, West Virginia

Spread A Stream S-RR22 (Timber Mat Crossing) Harrison County

Client	MC 222
Profile and Cross-Sections	
Baseline Survey	
Crossing S-R22 - Unnamed Trib. to	
Grass Run (MP 20.8)	
Harrison County, WV

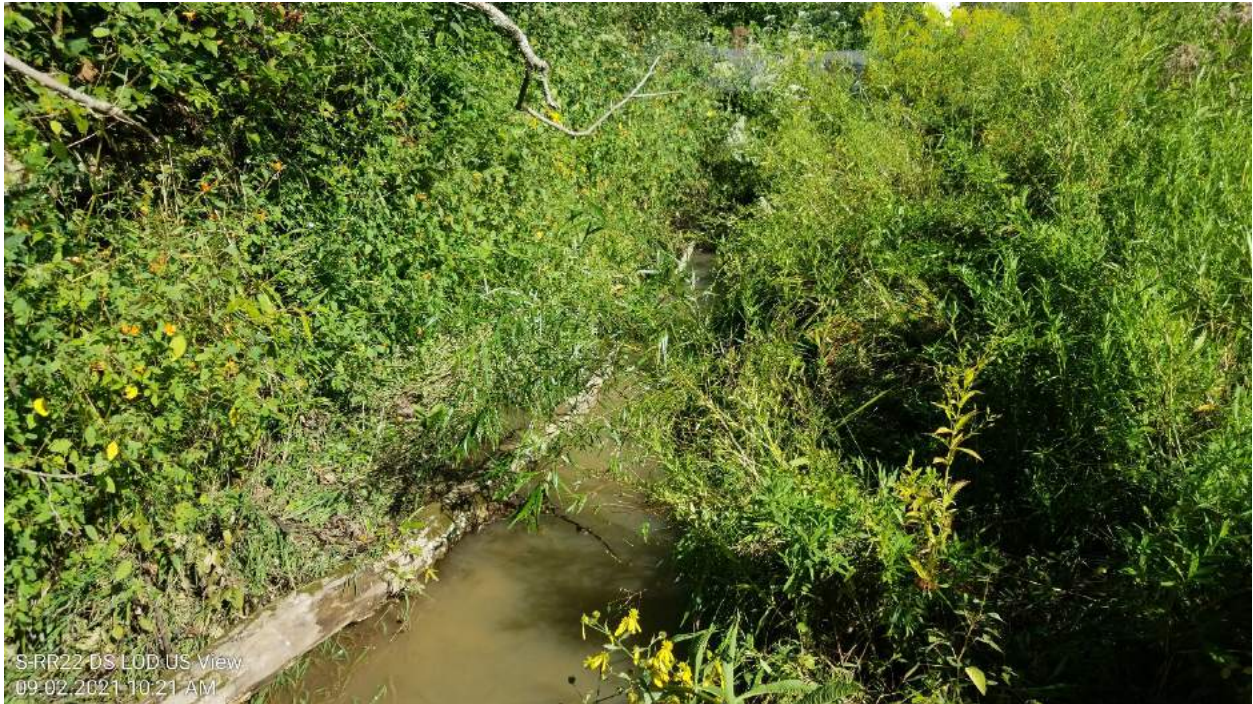
S-RR22 DS LOD US View
09.02.2021 10:21 AM

Photo Type: DS, US View

Location, Orientation, Photographer Initials: Downstream Edge of ROW, Upstream View, JM/CC/SM

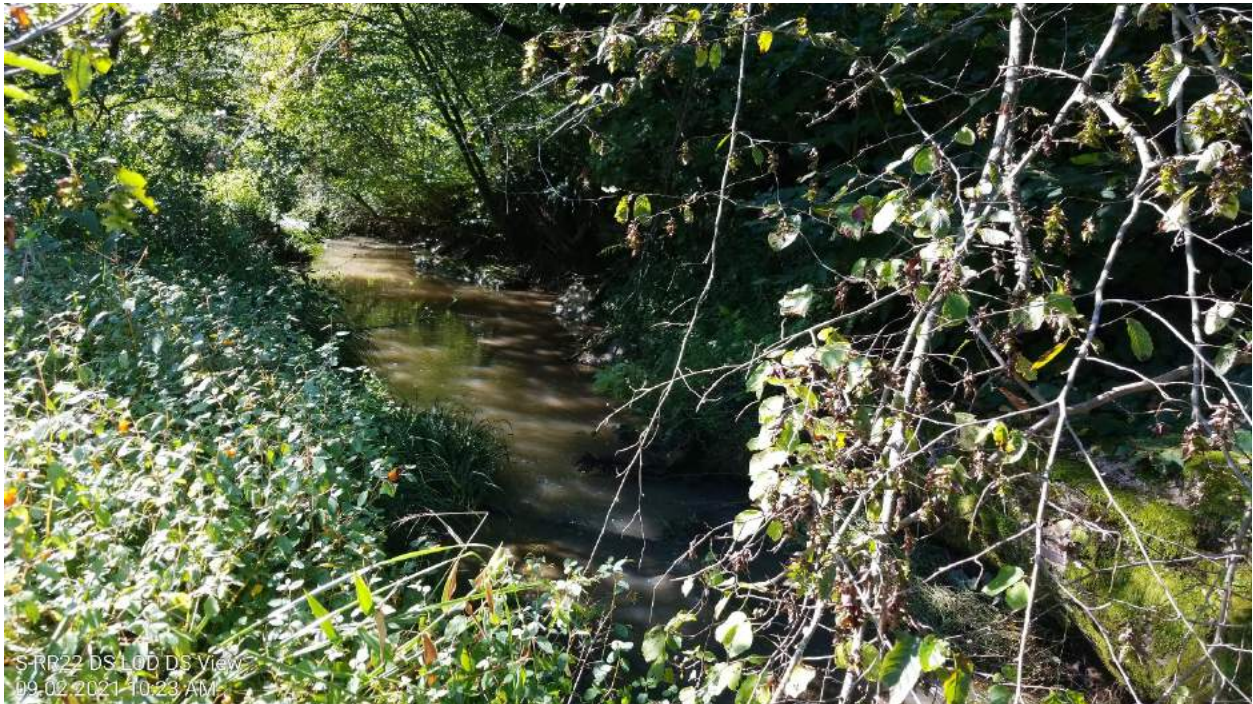
S-RR22 DS LOD DS View
09.02.2021 10:23 AM

Photo Type: DS, DS View

Location, Orientation, Photographer Initials: Downstream Edge of ROW, Downstream View, JM/CC/SM

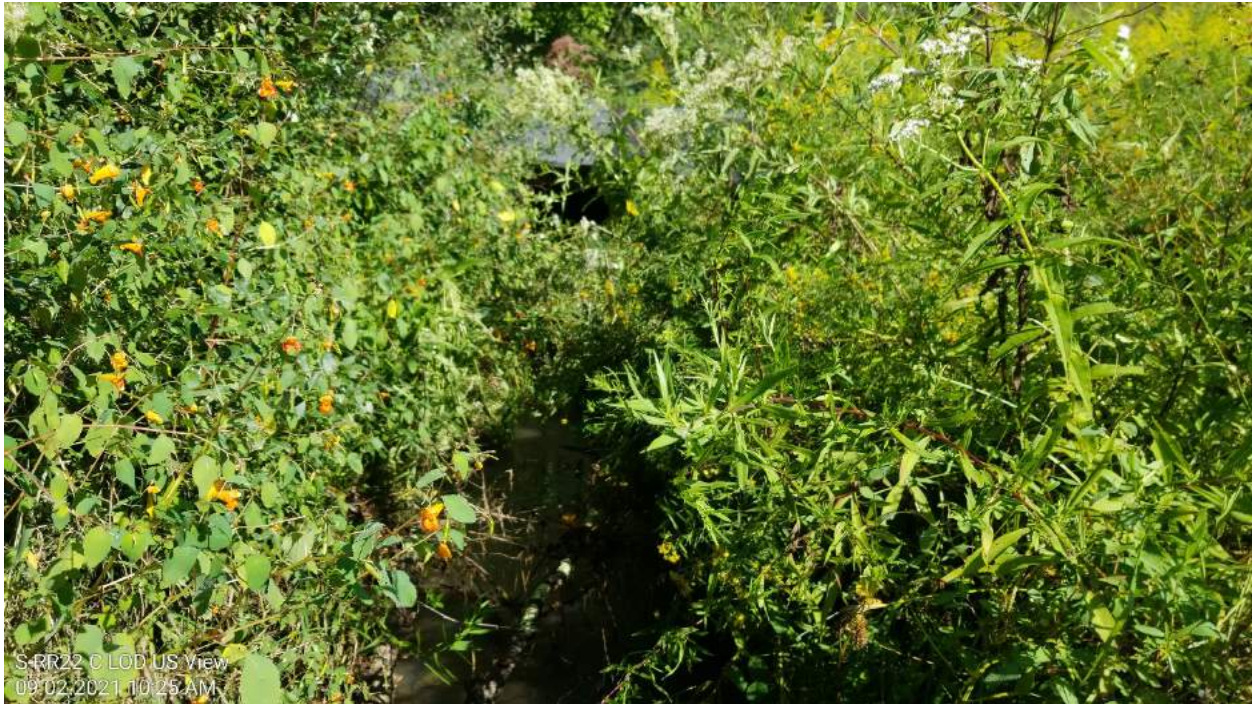
Photo Type: US View at Center
Location, Orientation, Photographer Initials: Center ROW, Upstream View, JM/CC/SM
Lat: 39.342166 Long: -80.512422

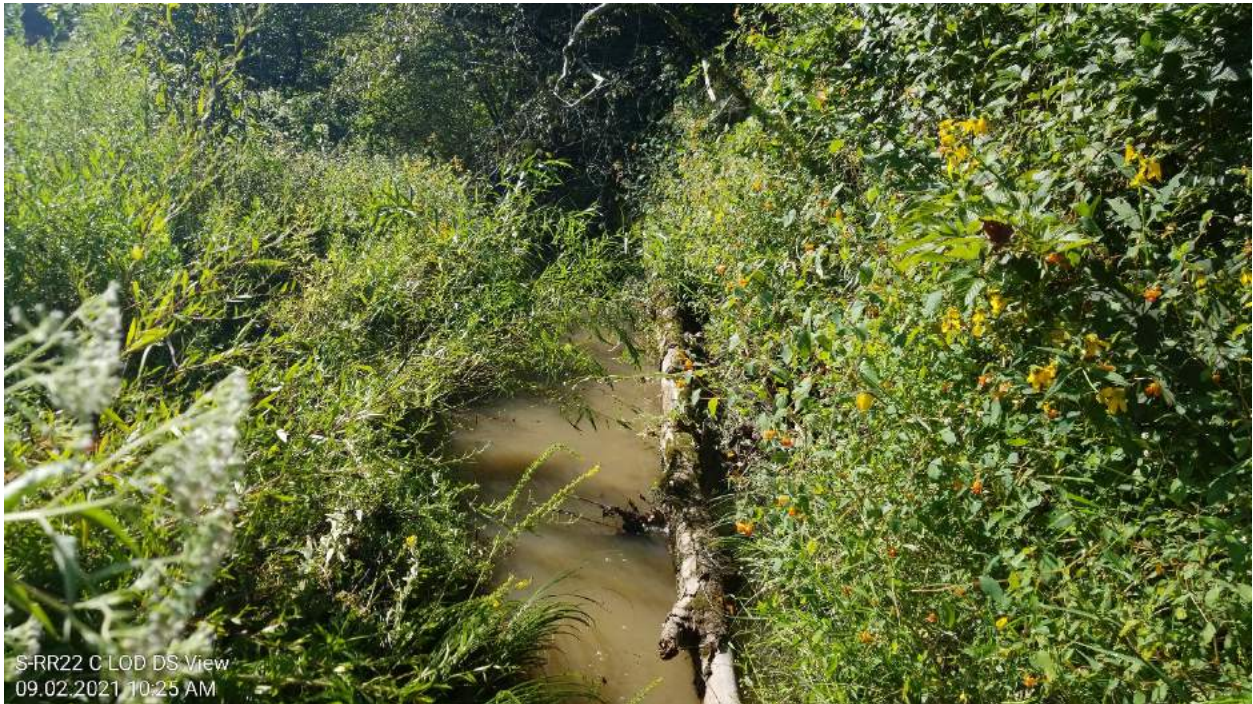
Photo Type: DS View at Center
Location, Orientation, Photographer Initials: ROW Center, Downstream View, JM/CC/SM
Lat: 39.342166 Long: -80.512422

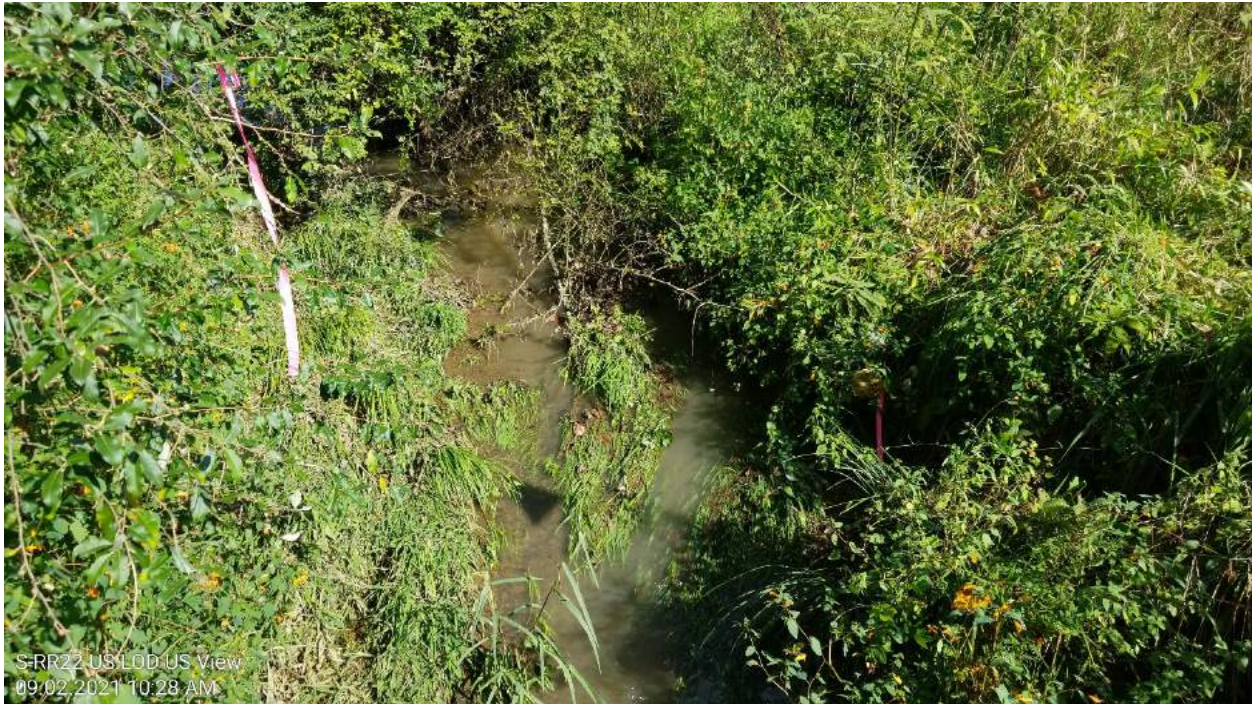
S-RR22 US LOD US View
09.02.2021 10:28 AM

Photo Type: US, US View

Location, Orientation, Photographer Initials: Upstream Edge of ROW, Upstream View, JM/CC/SM

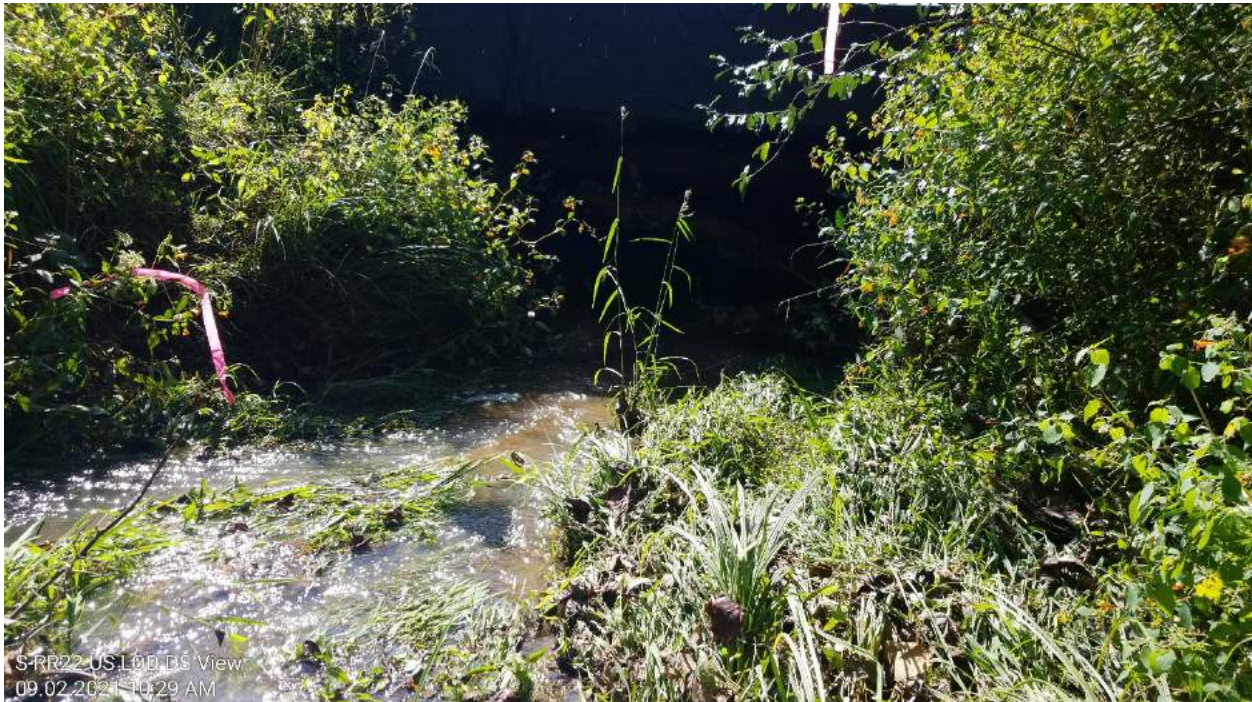
S-RR22 US LOD DS View
09.02.2021 10:29 AM

Photo Type: US, DS View

Location, Orientation, Photographer Initials: Upstream Edge of ROW, Downstream View, JM/CC/SM

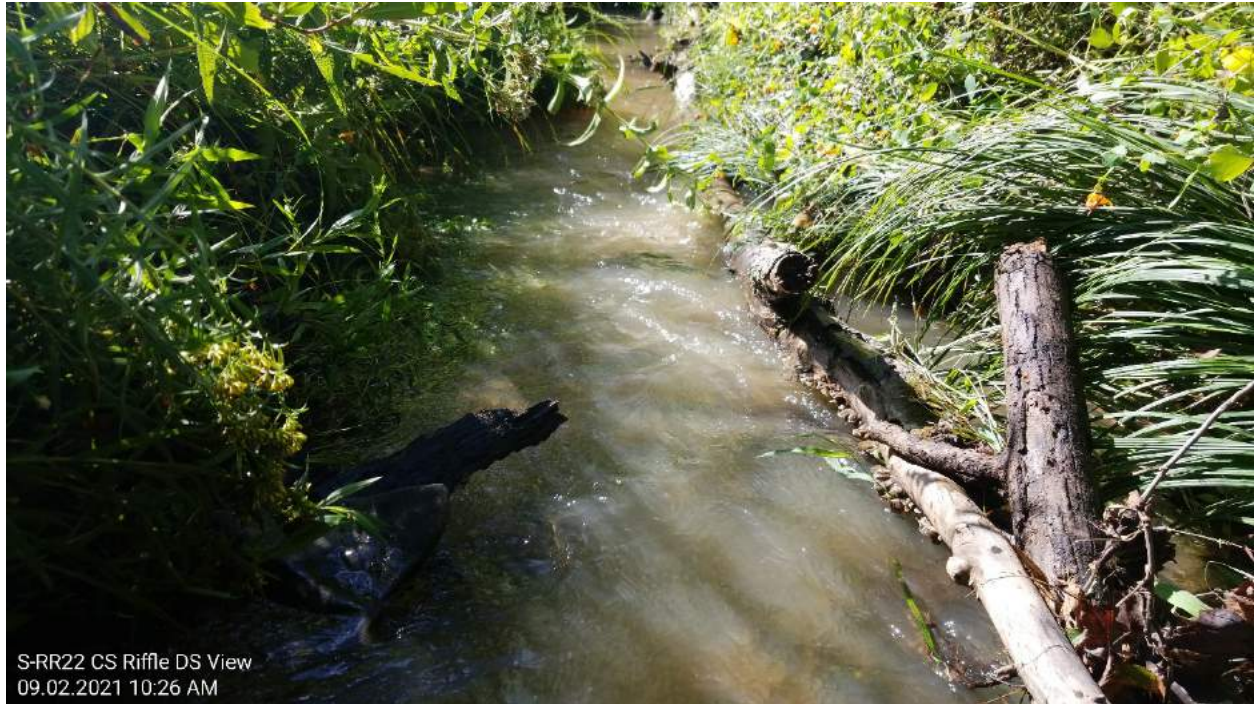
S-RR22 CS Riffle DS View
09.02.2021 10:26 AM

Photo Type: Riffle, DS View
Location, Orientation, Photographer Initials: Upstream of Riffle, Downstream View, JM/CC/SM
Lat: 39.342166 Long: -80.512422

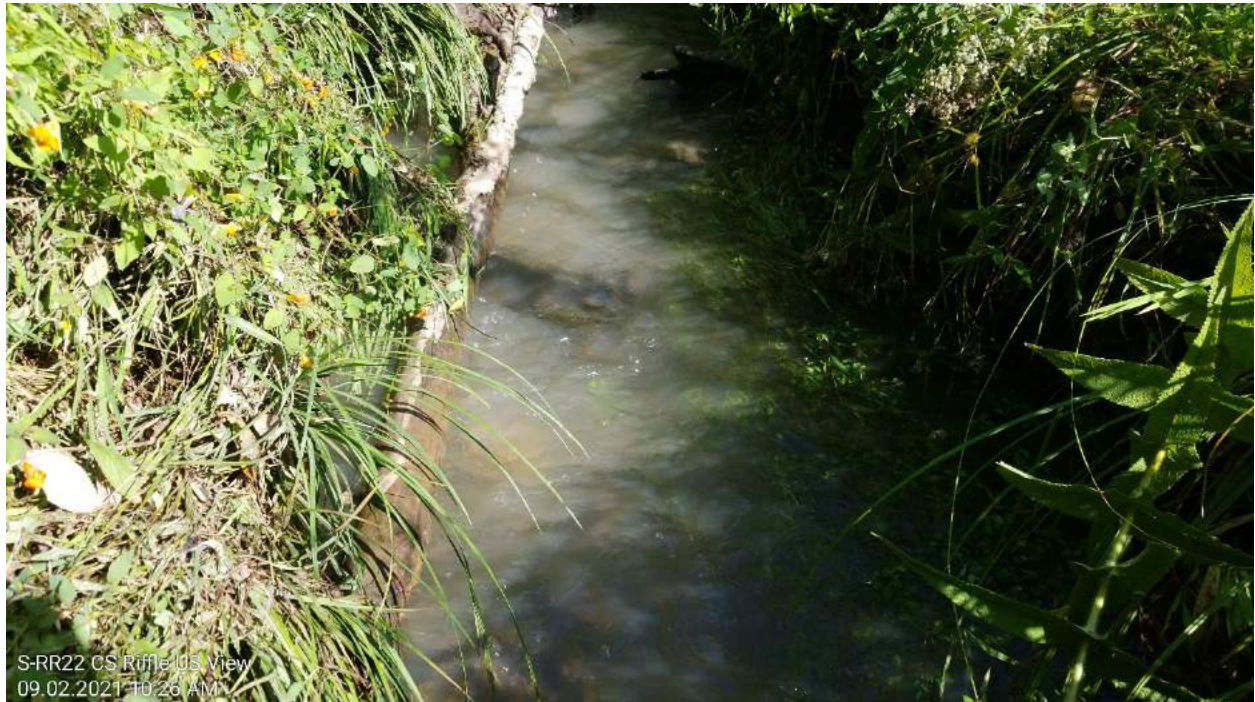
S-RR22 CS Riffle US View
09.02.2021 10:26 AM

Photo Type: Riffle, US View
Location, Orientation, Photographer Initials: Downstream of Riffle, Upstream View, JM/CC/SM
Lat: 39.342166 Long: -80.512422

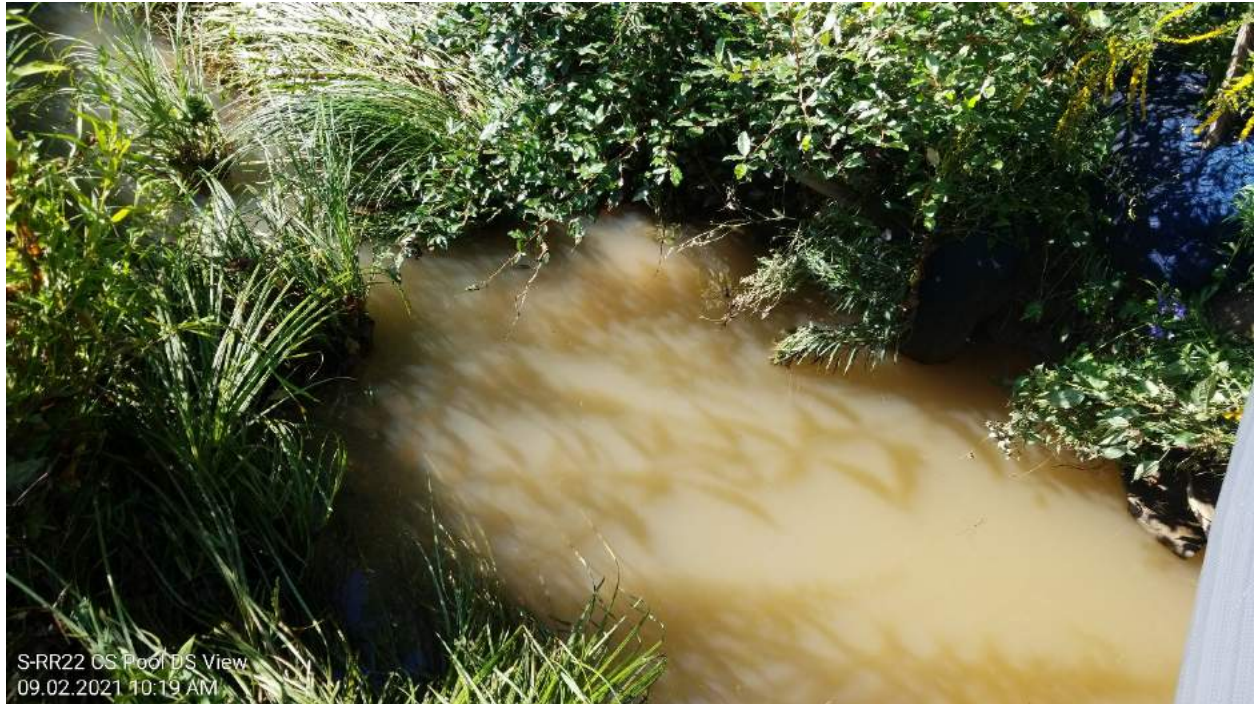
Photo Type: Pool, DS View
Location, Orientation, Photographer Initials: Upstream of Pool, Downstream View, JM/CC/SM
Lat: 39.342166 Long: -80.512422

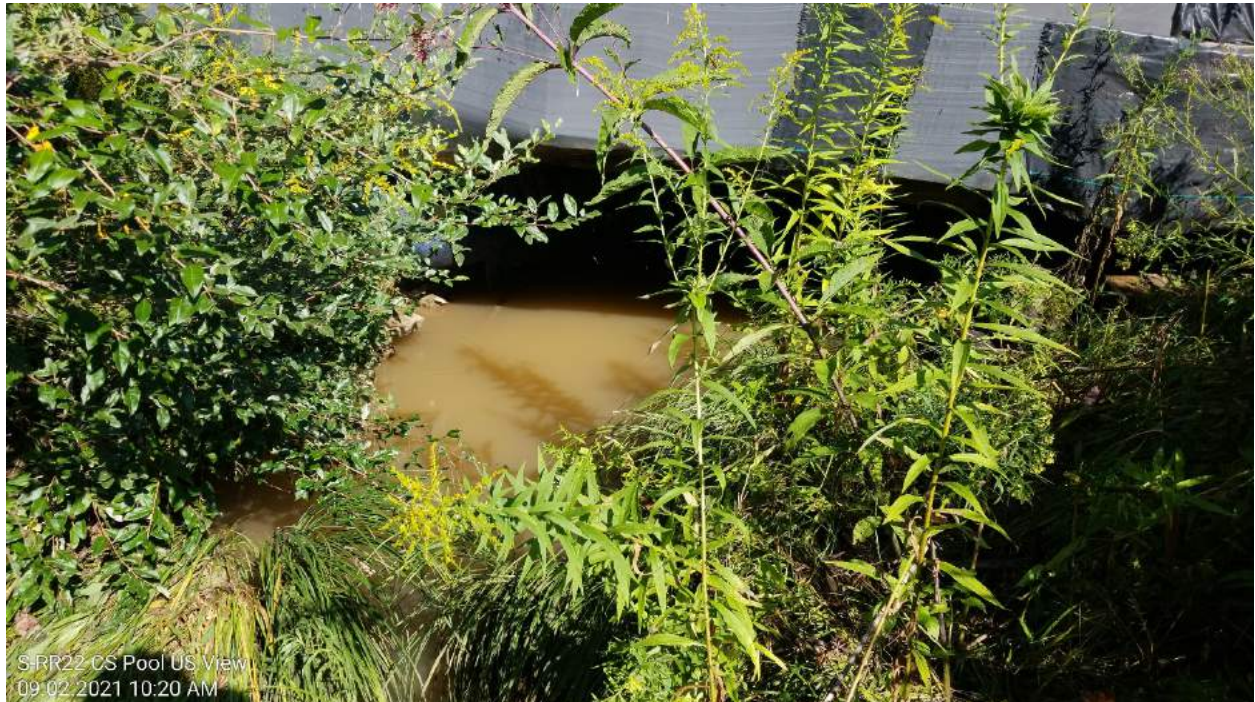
Photo Type: Pool, US View
Location, Orientation, Photographer Initials: Downstream of Pool, Upstream View, JM/CC/SM
Lat: 39.342166 Long: -80.512422

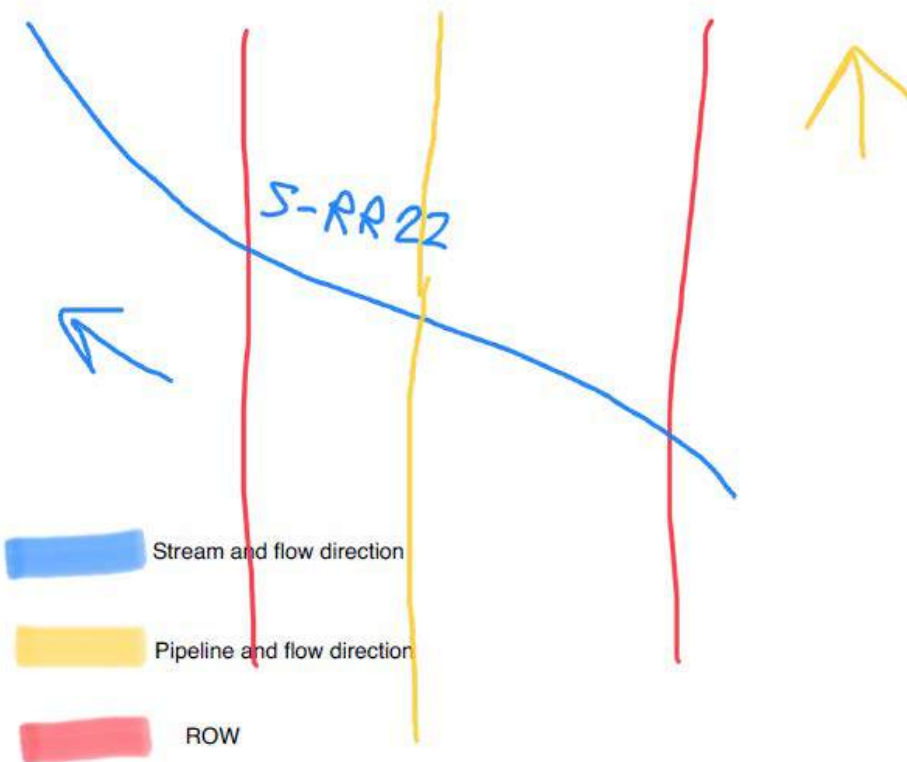
<p> Stream and flow direction Pipeline and flow direction ROW </p>
