Reach S-T29 (Pipeline ROW) Perennial Spread C Webster County, West Virginia

West Virginia Stream and Wetland Valuation Metric (SWVM) Version 2.1, September 2017

WOLMAN PEBBLE COUNT FORM

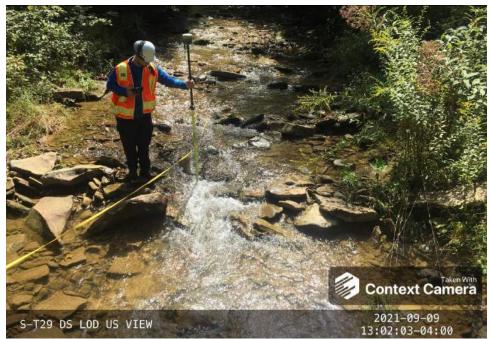
Photo Type: DS, US View

Location, Orientation, Photographer Initials: Downstream at ROW Upstream View, VM, HK, DPF, VM Latitude, Longitude: 38.579092, -80.5262

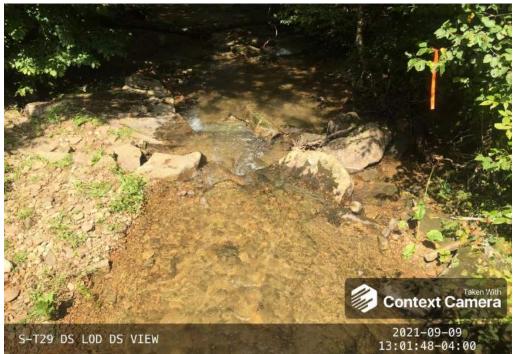
Photo Type: DS, DS View Location, Orientation, Photographer Initials: Downstream at ROW Downstream View, VM, HK, DPF, VM Latitude, Longitude: 38.579092, -80.5262

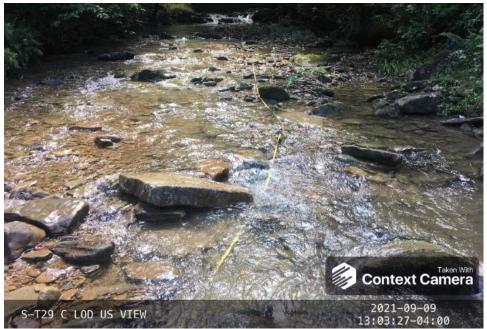
Photo Type: CL US Location, Orientation, Photographer Initials: On thalweg at pipe centerline Upstream View, VM, HK, DPF, VM Latitude, Longitude: 38.579092, -80.5262

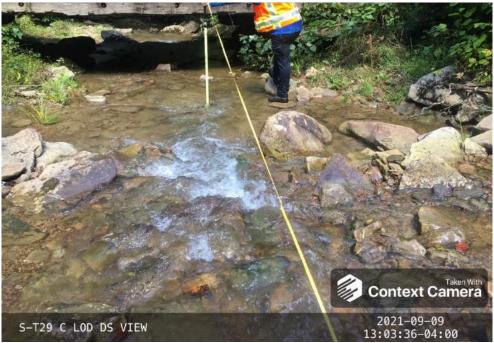
Photo Type: DS View from Center

Location, Orientation, Photographer Initials: On thalweg at pipe centerline Downstream View, VM, HK, DPF, VM Latitude, Longitude: 38.579092, -80.5262

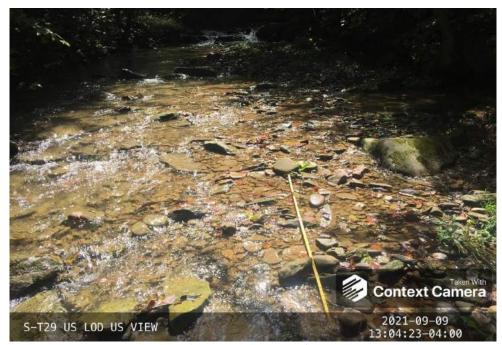
Photo Type: US, US View Location, Orientation, Photographer Initials: Upstream at ROW Upstream, VM, HK, DPF, VM Latitude, Longitude: 38.579092, -80.5262

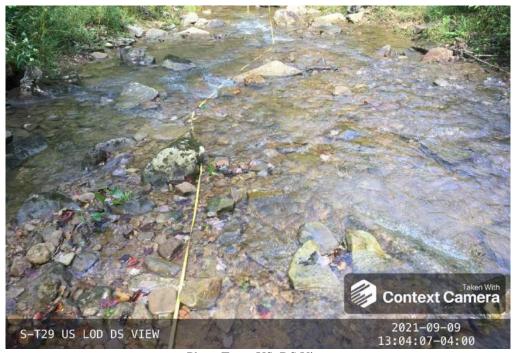
Photo Type: US, DS View Location, Orientation, Photographer Initials: Upstream at ROW Downstream, VM, HK, DPF, VM Latitude, Longitude: 38.579092, -80.5262

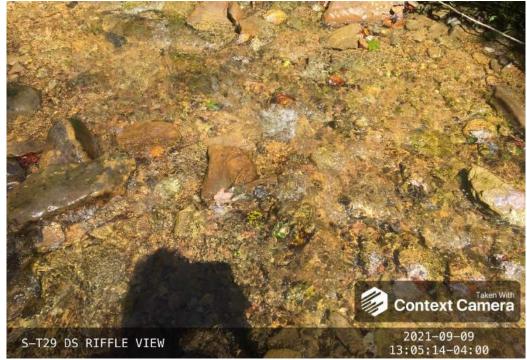
Photo Type: Riffle, DS View

Location, Orientation, Photographer Initials: Upstream at ROW looking downstream, VM, HK, DPF, VM Latitude, Longitude: 38.579092, -80.5262

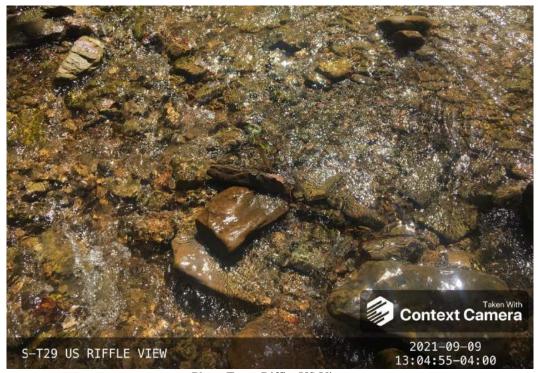
Photo Type: Riffle, US View Location, Orientation, Photographer Initials: Upstream at ROW looking downstream, VM, HK, DPF, VM Latitude, Longitude: 38.579092, -80.5262
