Baseline Assessment – Stream Attributes

Reach S-UV11 ROW (Pipeline ROW)

Lewis County, West Virginia

Client	222
Title	PROFILE AND CROSS-SECTIONS BASELINE SURVEY CROSSING S-UV11 - UNNAMED TRIB. TO OIL CREEK (MP 62.18) LEWIS COUNTY, WV

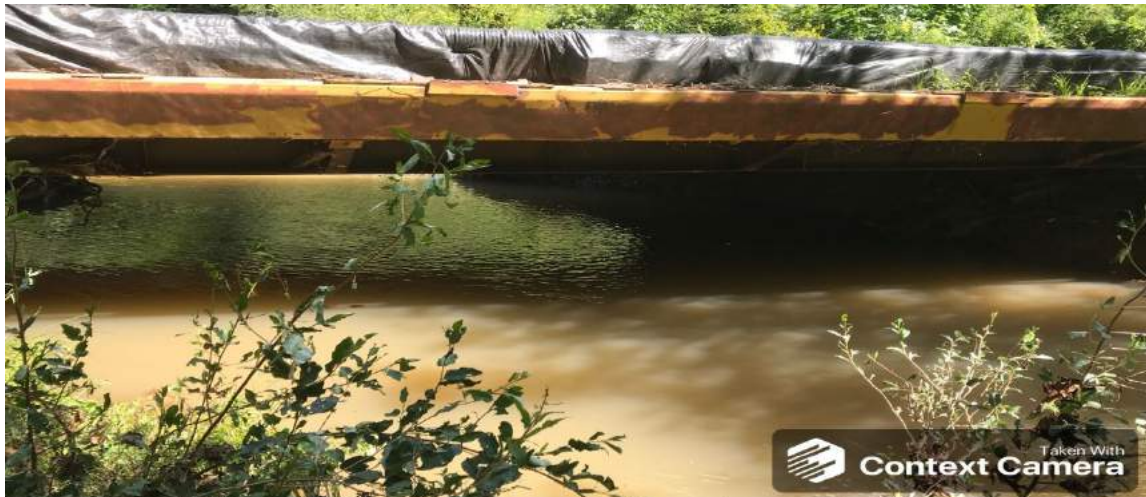
Photo Type: DS, US View

Location, Orientation, Photographer Initials: Downstream Edge of ROW, Upstream View, AJE, PEI
Lat: 38.893014 Long: -80.556192

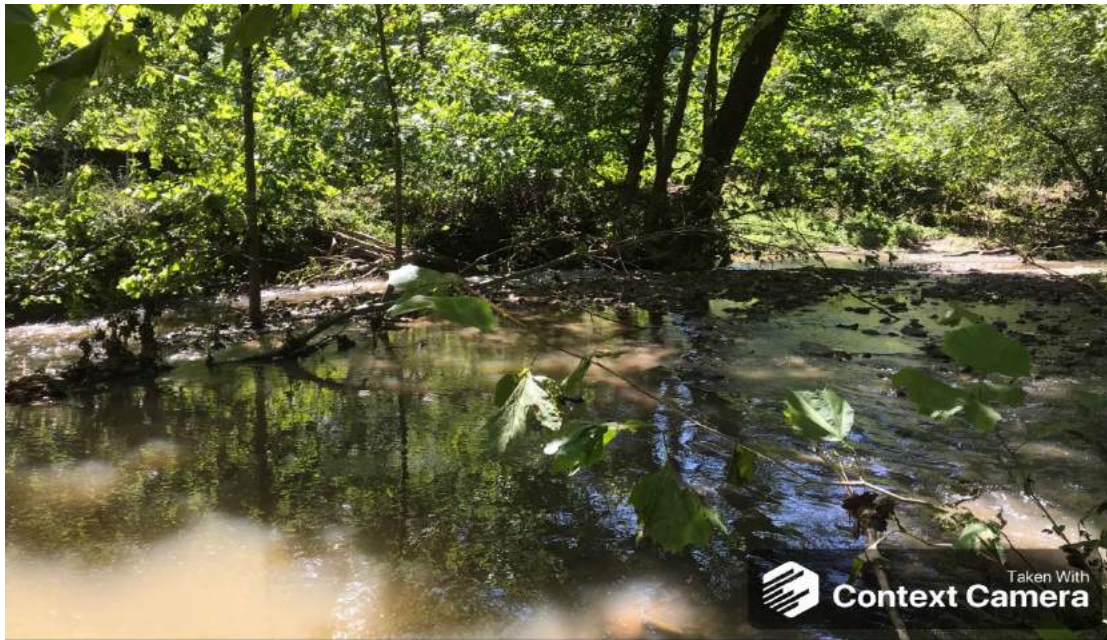
Photo Type: DS, DS View

Location, Orientation, Photographer Initials: Downstream Edge of ROW, Downstream View, AJE, PEI
Lat: 38.893014 Long: -80.556192

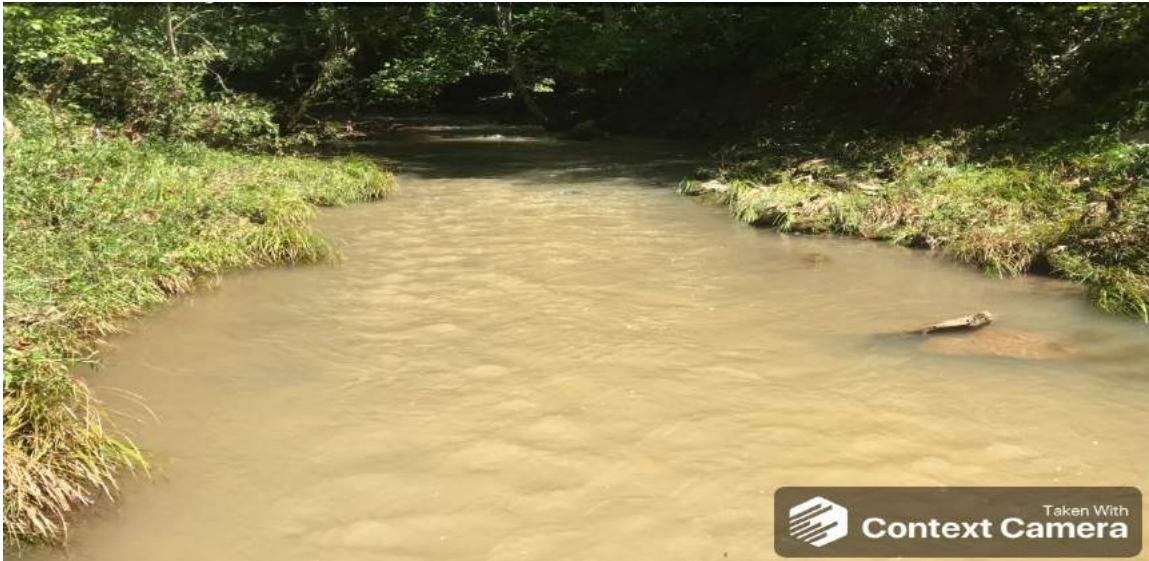
Photo Type: US View at Center
Location, Orientation, Photographer Initials: Center ROW, Upstream View, AJE, PEI
Lat: 38.893014 Long: -80.556192

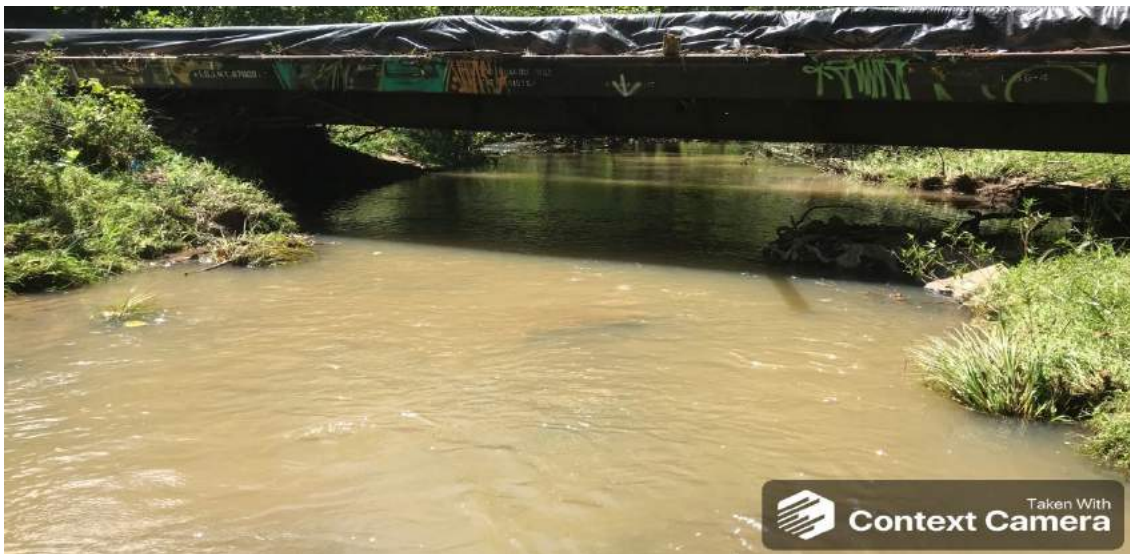
Photo Type: DS View at Center
Location, Orientation, Photographer Initials: ROW Center, Downstream View, AJE, PEI
Lat: 38.893014 Long: -80.556192

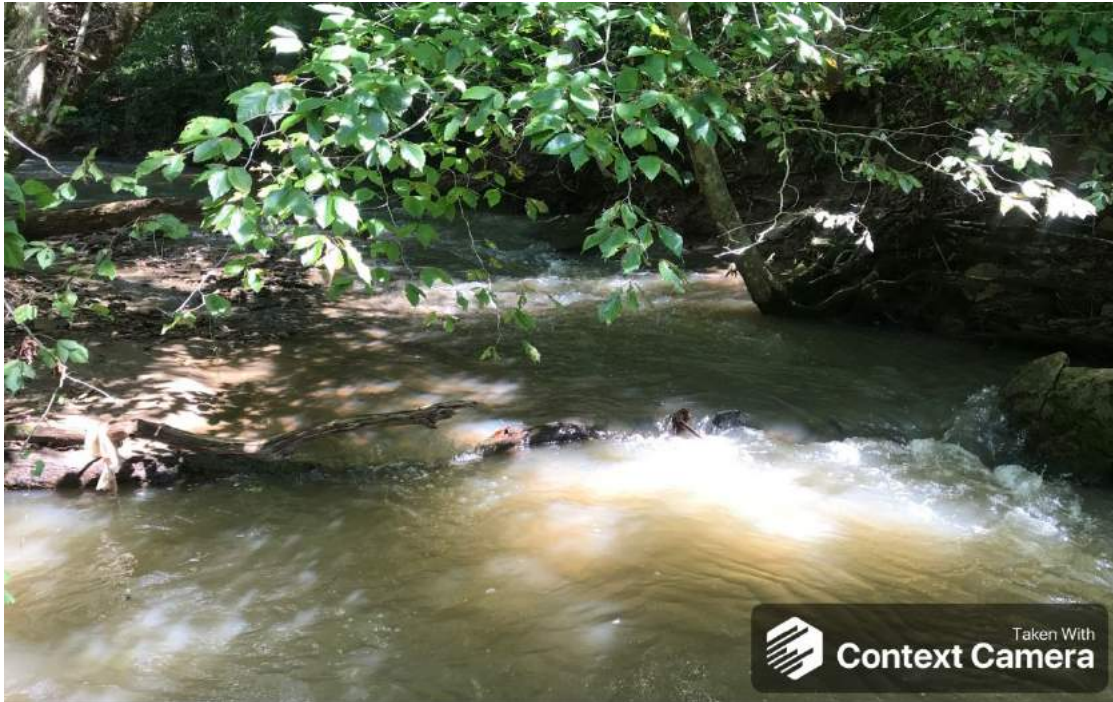
Photo Type: US, US View
Location, Orientation, Photographer Initials: Upstream Edge of ROW, Upstream View, AJE, PEI
Lat: 38.893014 Long: -80.556192

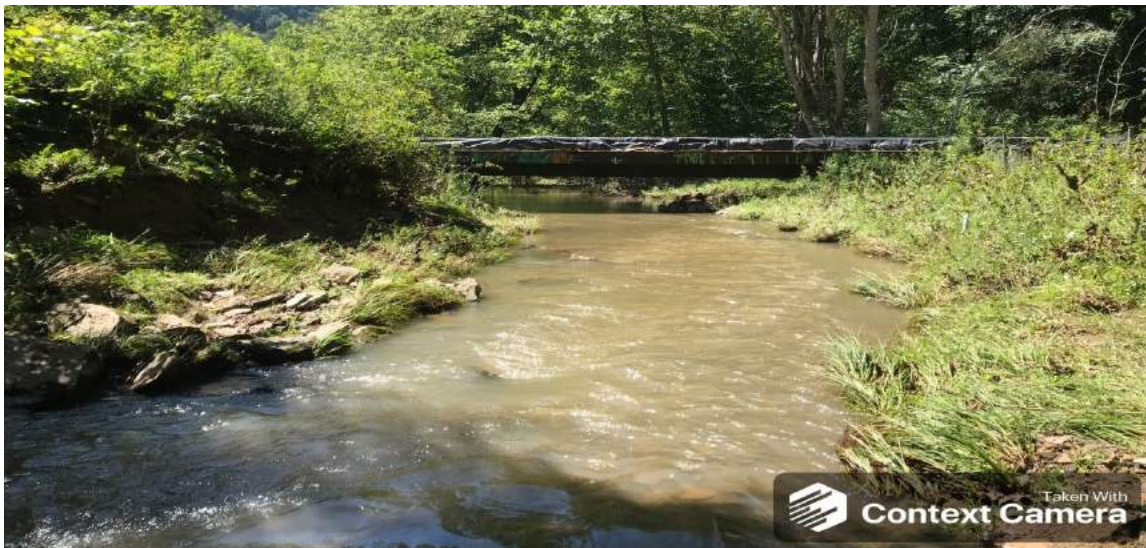
Photo Type: US, DS View
Location, Orientation, Photographer Initials: Upstream Edge of ROW, Downstream View, AJE, PEI
Lat: 38.893014 Long: -80.556192

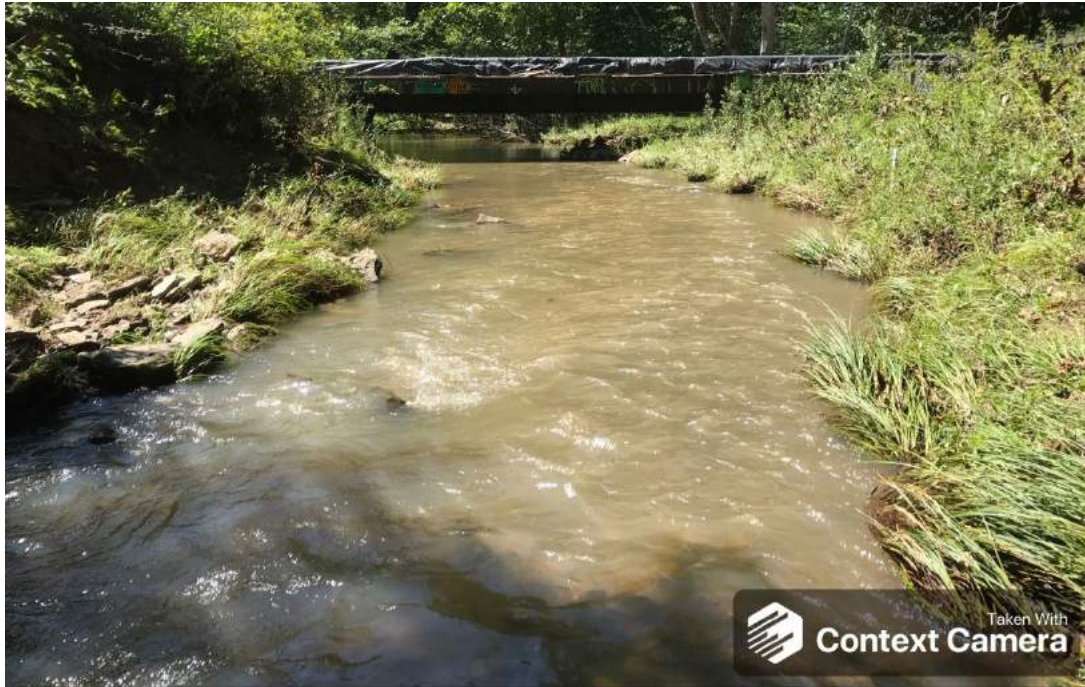
Photo Type: Riffle, DS View
Location, Orientation, Photographer Initials: Upstream of Riffle, Downstream View, AJE, PEI
Lat: 38.893014 Long: -80.556192

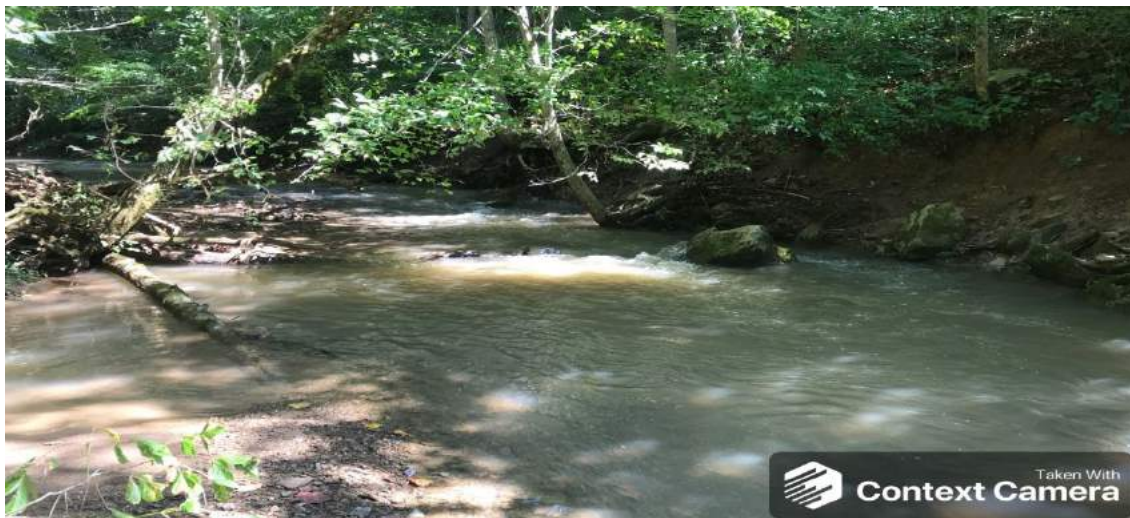
Photo Type: Riffle, US View
Location, Orientation, Photographer Initials: Downstream of Riffle, Upstream View, AJE, PEI
Lat: 38.893014 Long: -80.556192

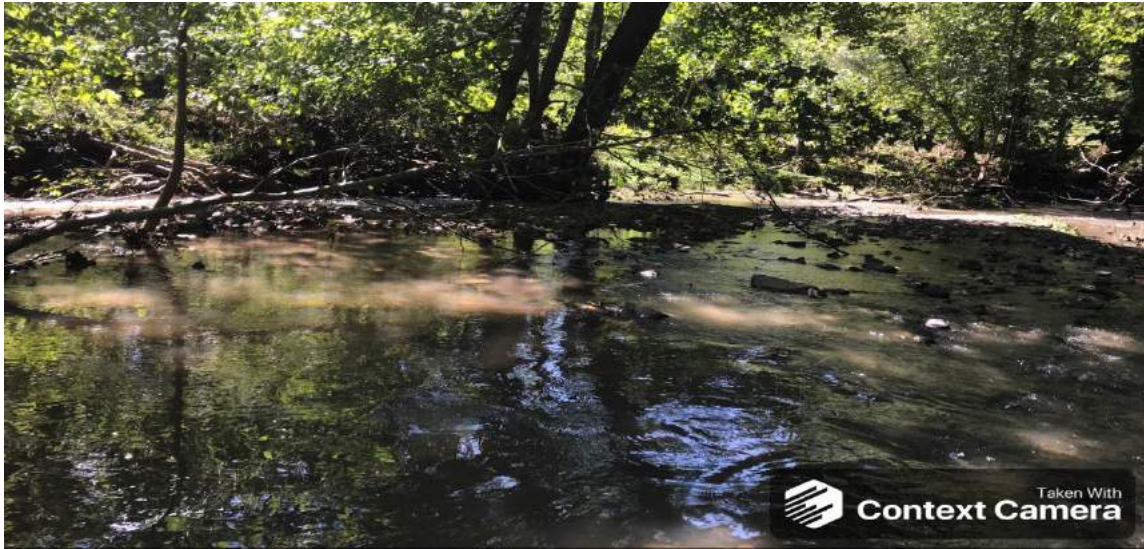
Photo Type: Pool, DS View
Location, Orientation, Photographer Initials: Upstream of Pool, Downstream View, AJE, PEI
Lat: 38.893014 Long: -80.556192

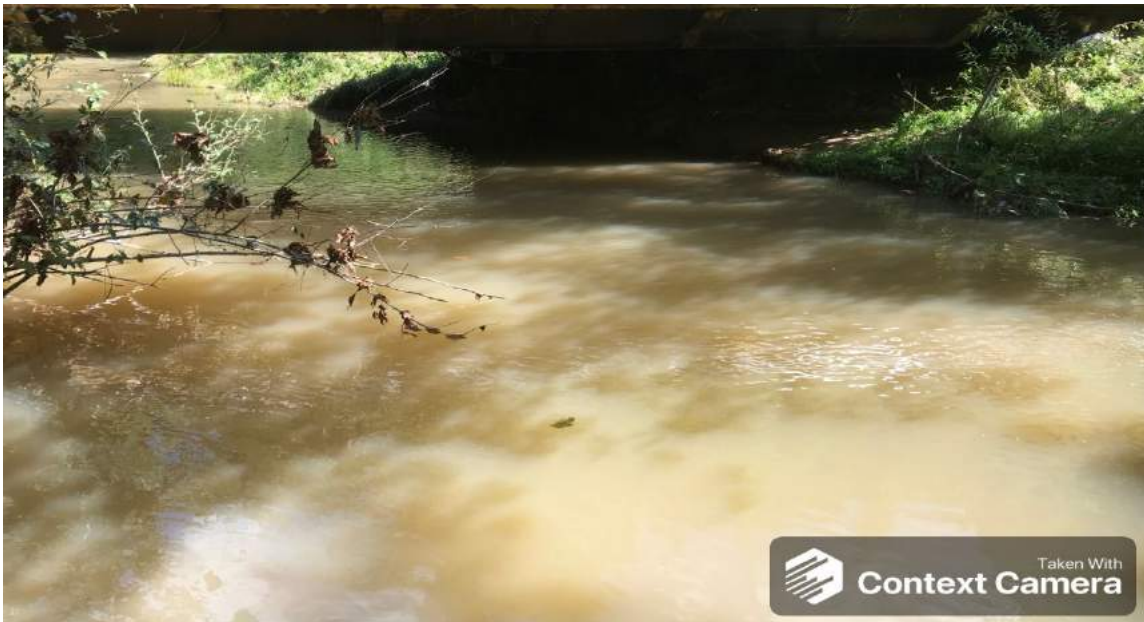
Photo Type: Pool, US View
Location, Orientation, Photographer Initials: Downstream of Pool, Upstream View, AJE, PEI
Lat: 38.893014 Long: -80.556192

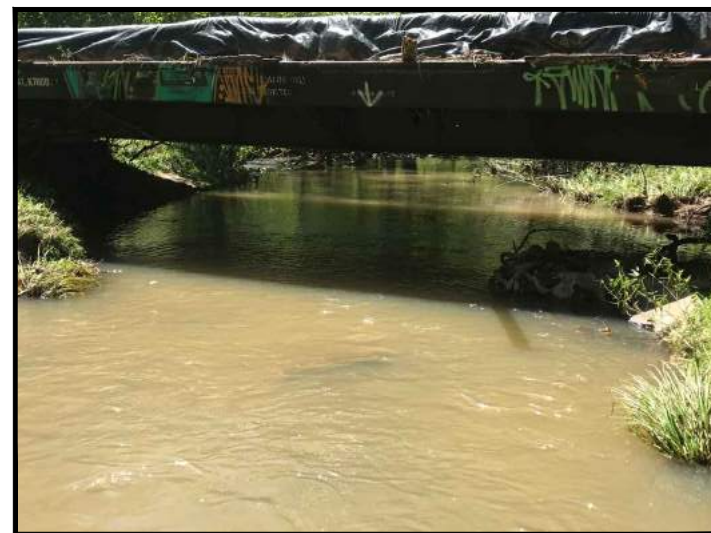
PHOTO TAKEN LOOKING DOWNSTREAM
FROM UPSTREAM IMPACT LIMITS

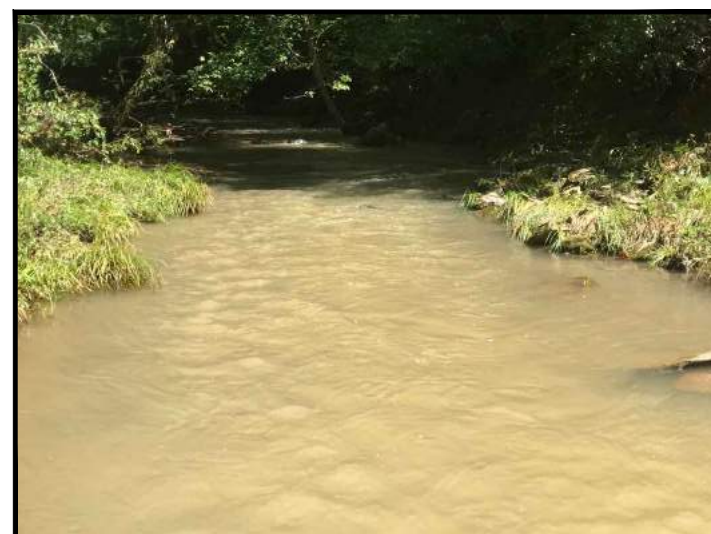
PHOTO TAKEN LOOKING UPSTREAM FROM
DOWNSTREAM IMPACT LIMITS
