Baseline Assessment – Stream Attributes

Reach S-UV6 (Pipeline ROW) Perennial Spread F Greenbrier County, West Virginia

Spread F Stream S-UV6 (Pipeline ROW) Greenbrier County

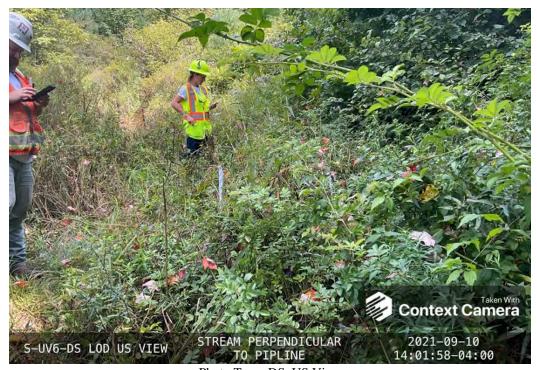
Photo Type: DS, US View Location, Orientation, Photographer Initials: Downstream Edge of ROW, Upstream View, CNJ Lat: 37.854386 Long: -80.754981

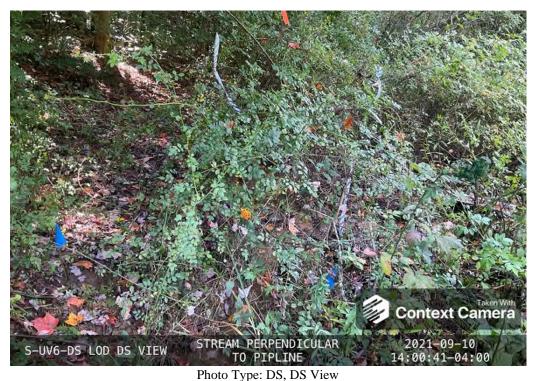
Location, Orientation, Photographer Initials: Downstream Edge of ROW, Downstream View, CNJ
Lat: 37.854386 Long: -80.754981

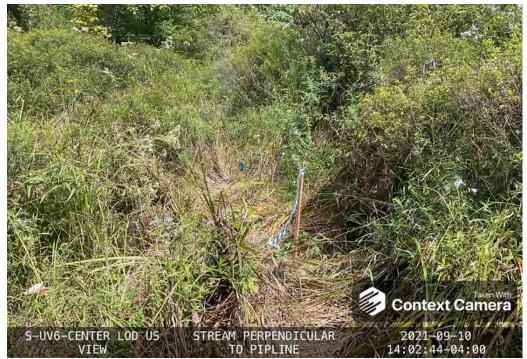
Photo Type: US View at Center Location, Orientation, Photographer Initials: Center ROW, Upstream View, CNJ Lat: 37.854386 Long: -80.754981

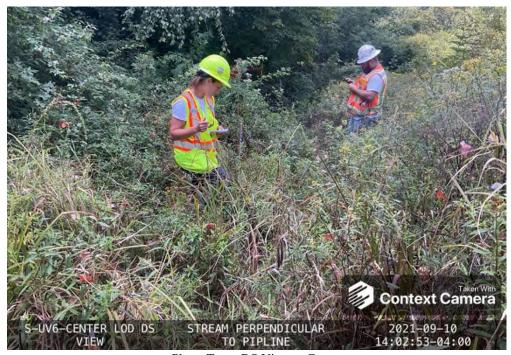
Photo Type: DS View at Center Location, Orientation, Photographer Initials: ROW Center, Downstream View, CNJ Lat: 37.854386 Long: -80.754981

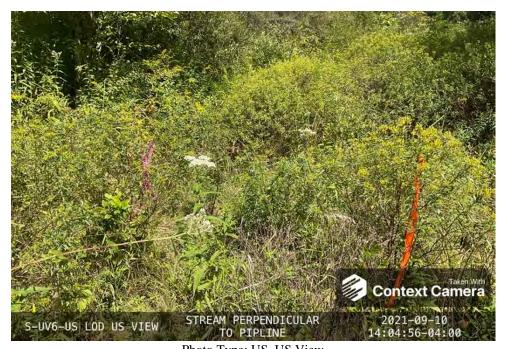
Photo Type: US, US View Location, Orientation, Photographer Initials: Upstream Edge of ROW, Upstream View, CNJ Lat: 37.854386 Long: -80.754981

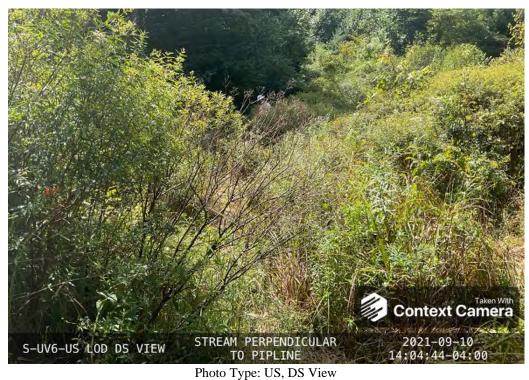
Location, Orientation, Photographer Initials: Upstream Edge of ROW, Downstream View, CNJ Lat: 37.854386 Long: -80.754981

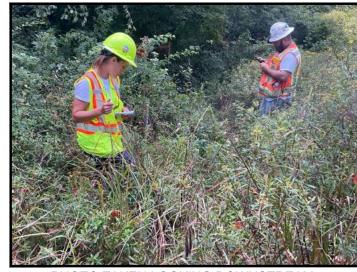
PHOTO TAKEN LOOKING DOWNSTREAM FROM UPSTREAM IMPACT LIMITS

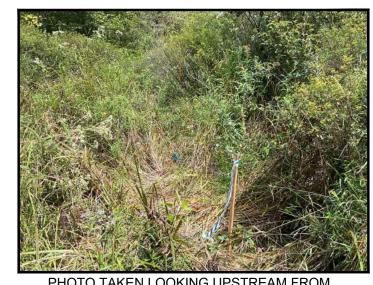
PHOTO TAKEN LOOKING UPSTREAM FROM DOWNSTREAM IMPACT LIMITS
