Baseline Assessment – Stream Attributes

Reach S-VV11 (Pipeline ROW) Ephemeral Spread B Lewis County, West Virginia

PROFILE AND CROSS-SECTIONS
BASELINE SURVEY
SING S-VV'1 - UNNAMED TRIBU
TO SECOND BIG RUN (MP 61.26)
LEWIS COUNTY, WV

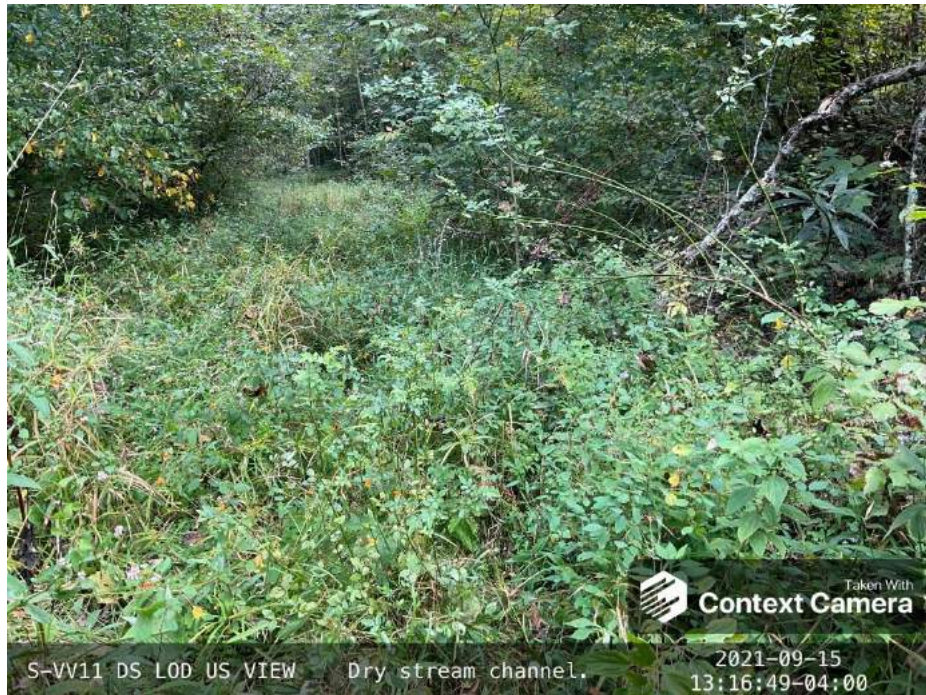
Photo Type: DS, US View

Location, Orientation, Photographer Initials: Downstream Edge of ROW, Upstream View, KY/ZS
Lat: 38.90361, Long: -80.563186

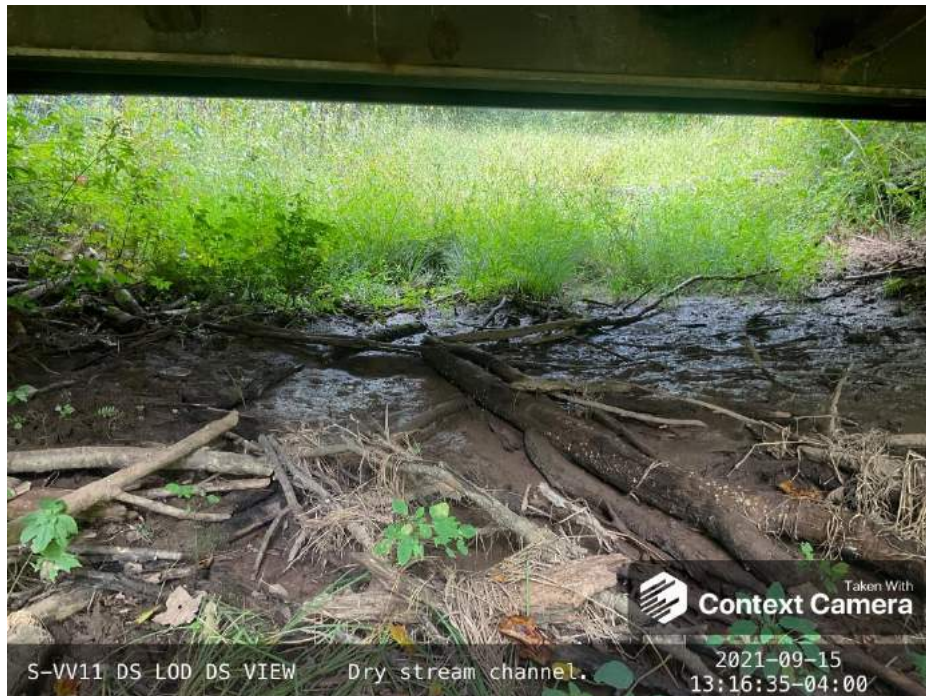
Photo Type: DS, DS View

Location, Orientation, Photographer Initials: Downstream Edge of ROW, Downstream View, KY/ZS
Lat: 38.90361, Long: -80.563186

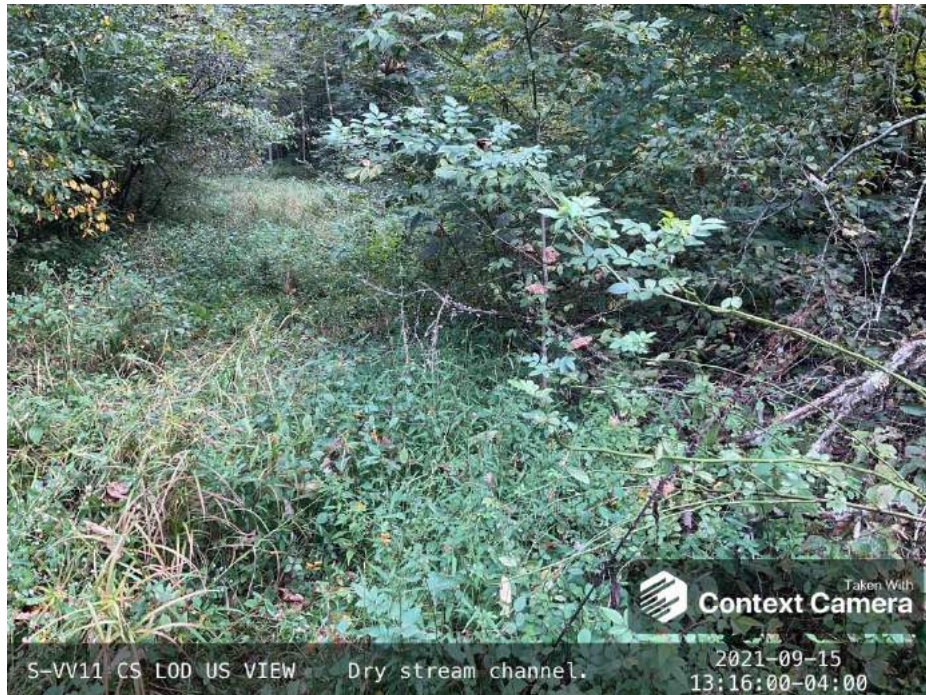
Photo Type: US View at Center
Location, Orientation, Photographer Initials: Center ROW, Upstream View, KY/ZS
Lat: 38.90361, Long: -80.563186

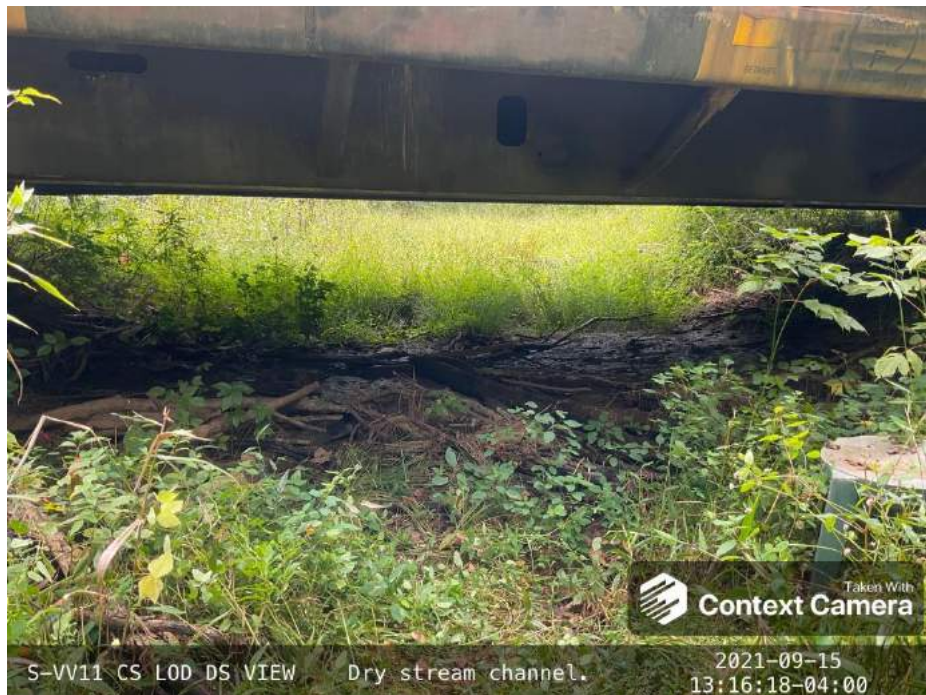
Photo Type: DS View at Center
Location, Orientation, Photographer Initials: ROW Center, Downstream View, KY/ZS
Lat: 38.90361, Long: -80.563186

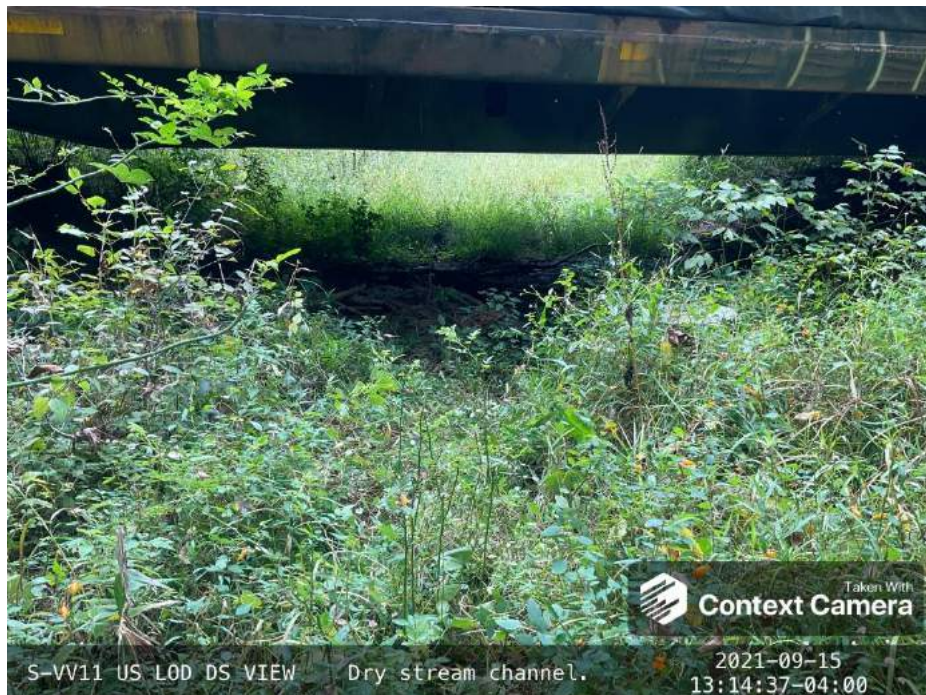
S-VV11 US LOD DS VIEW

Dry stream channel.

Photo Type: US, DS View

Location, Orientation, Photographer Initials: Upstream Edge of ROW, Downstream View, KY/ZS
Lat: 38.90361, Long: -80.563186

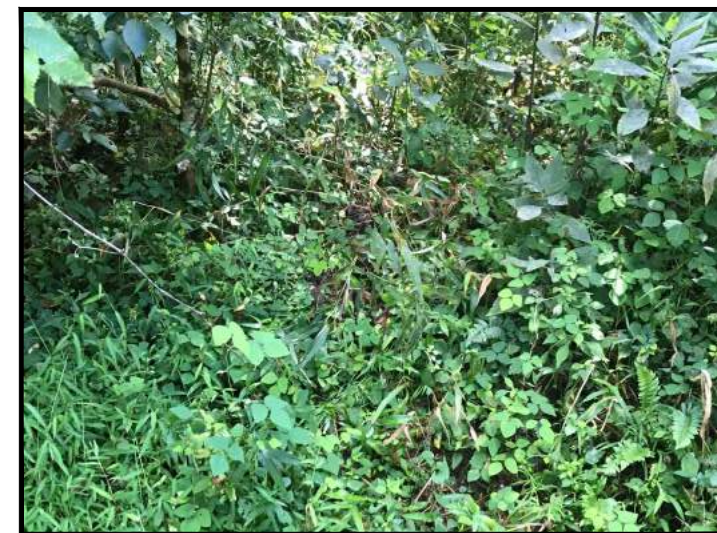
PHOTO TAKEN LOOKING DOWNSTREAM
FROM UPSTREAM IMPACT LIMITS

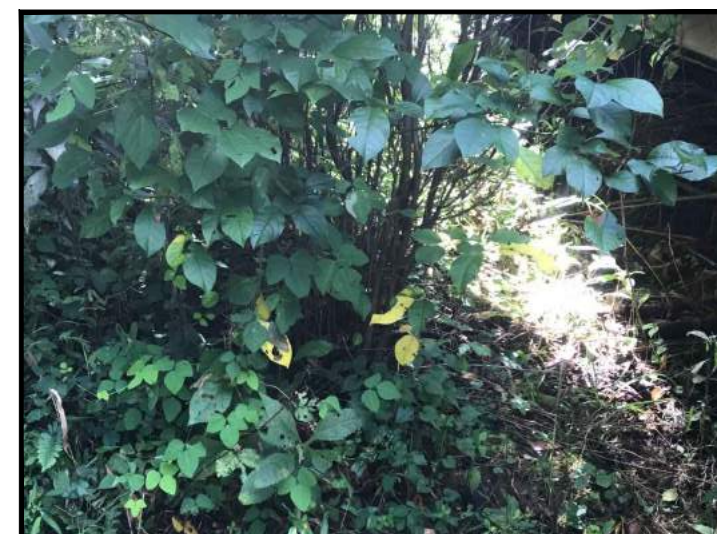
PHOTO TAKEN LOOKING UPSTREAM FROM
DOWNSTREAM IMPACT LIMITS
