Baseline Assessment – Stream Attributes

Reach S-VV13 (Timber Mat Crossing) Perennial Spread B Lewis County, West Virginia

Spread B Stream S-VV13 (Timber Mat Crossing) Lewis County

Title
PROFILE AND CROSS-SECTIONS
BASELINE SURVEY
CROSSING S-VV13 - SECOND BIG RUN
(MP 61.2)
LEWIS COUNTY, WV

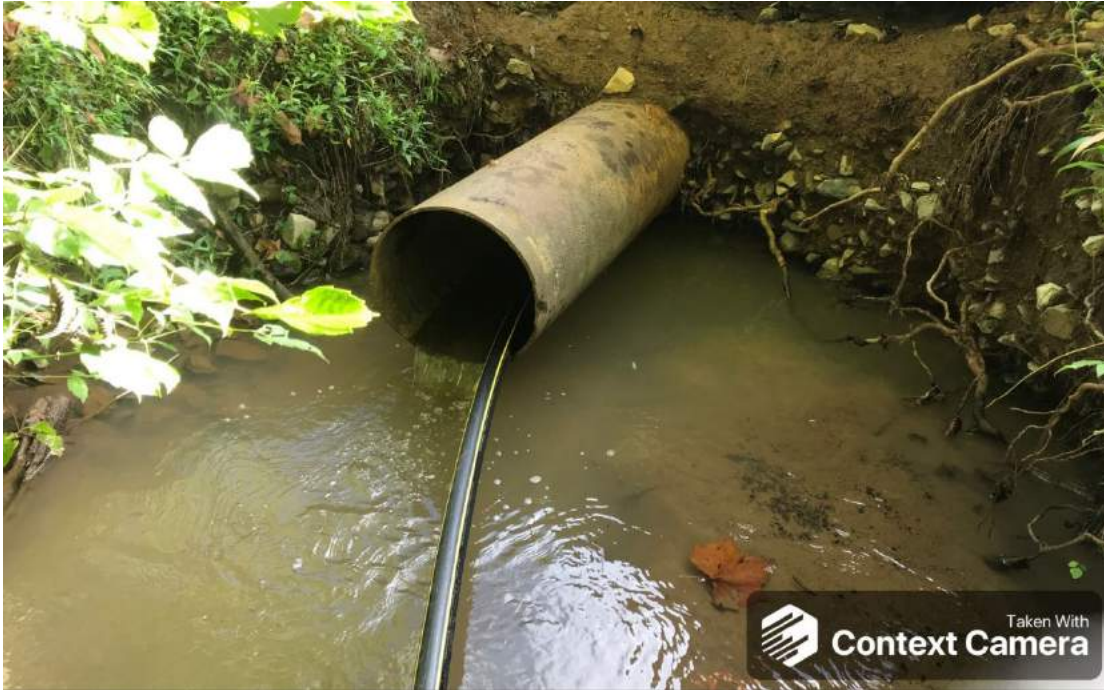
Photo Type: DS, US View

Location, Orientation, Photographer Initials: Downstream Edge of ROW, Upstream View, HK, DH

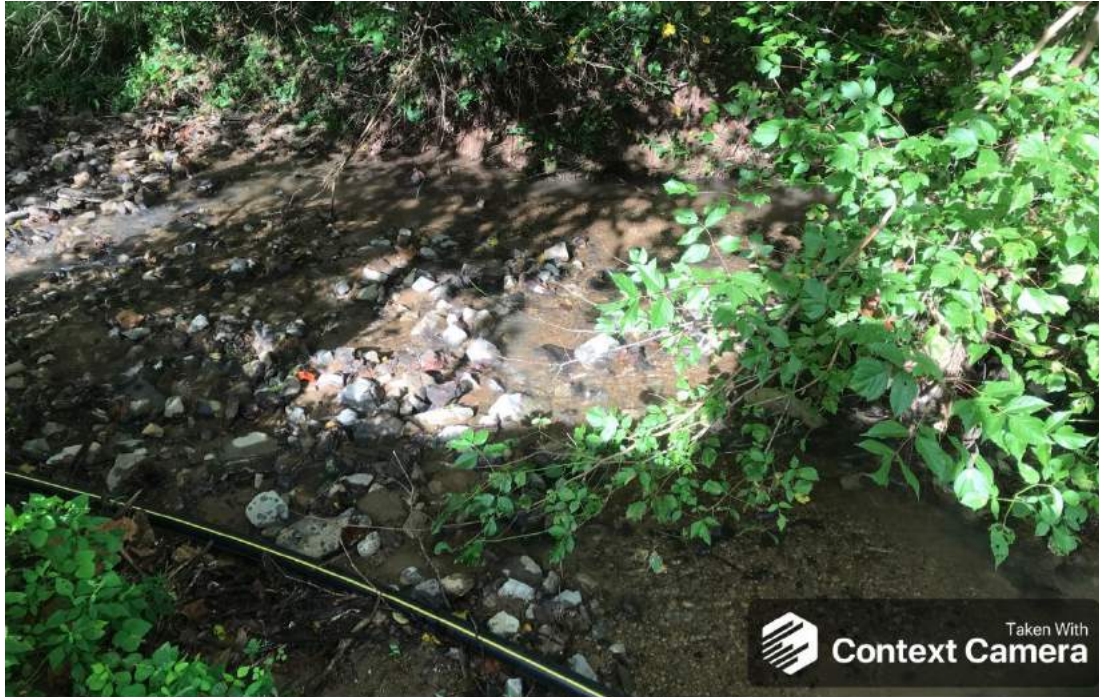
Photo Type: DS, DS View

Location, Orientation, Photographer Initials: Downstream Edge of ROW, Downstream View, HK, DH

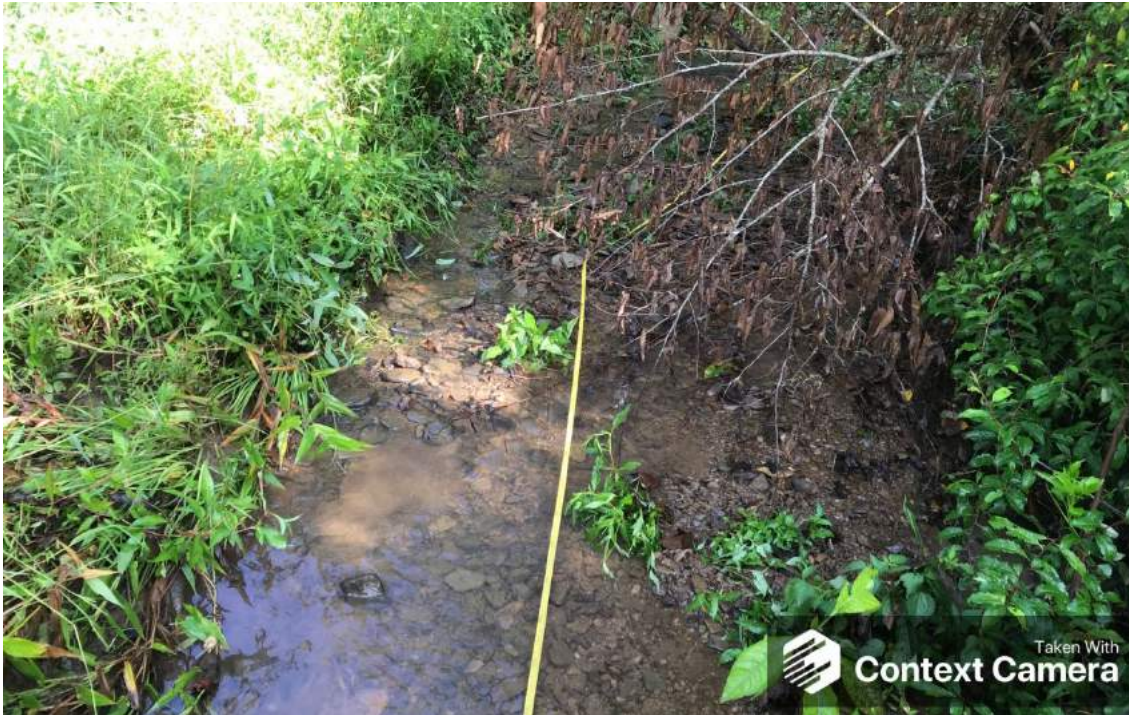
Photo Type: US View at Center

Location, Orientation, Photographer Initials: Center ROW, Upstream View, HK, DH

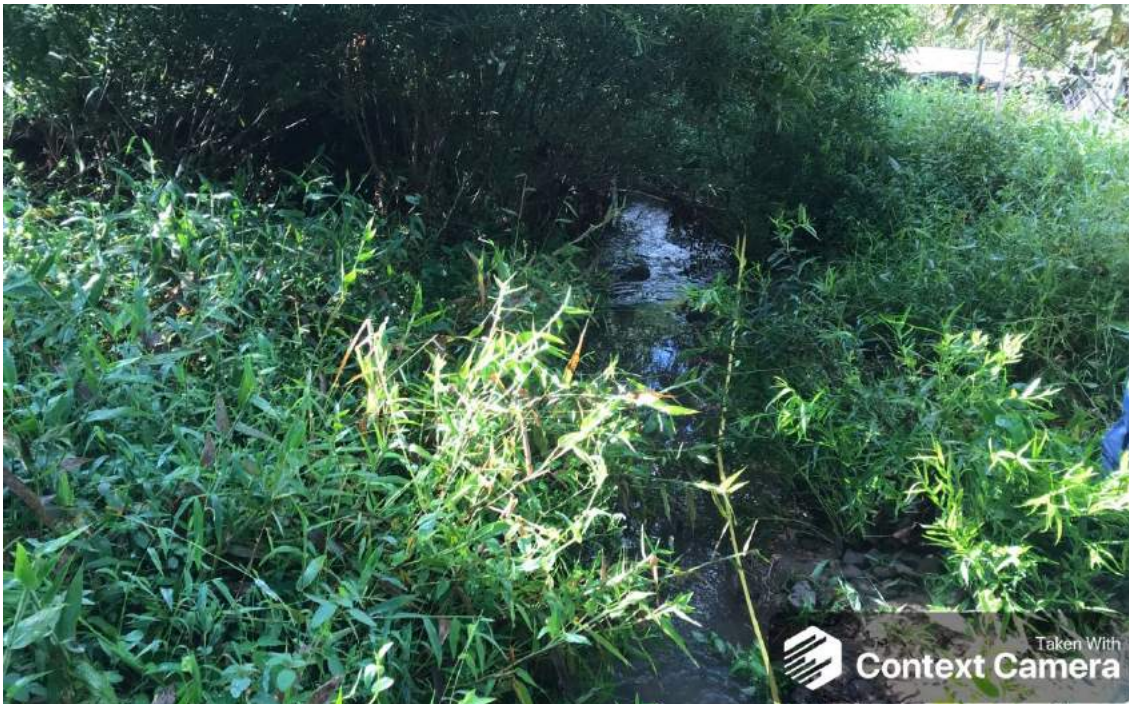
Photo Type: DS View at Center

Location, Orientation, Photographer Initials: ROW Center, Downstream View, HK, DH

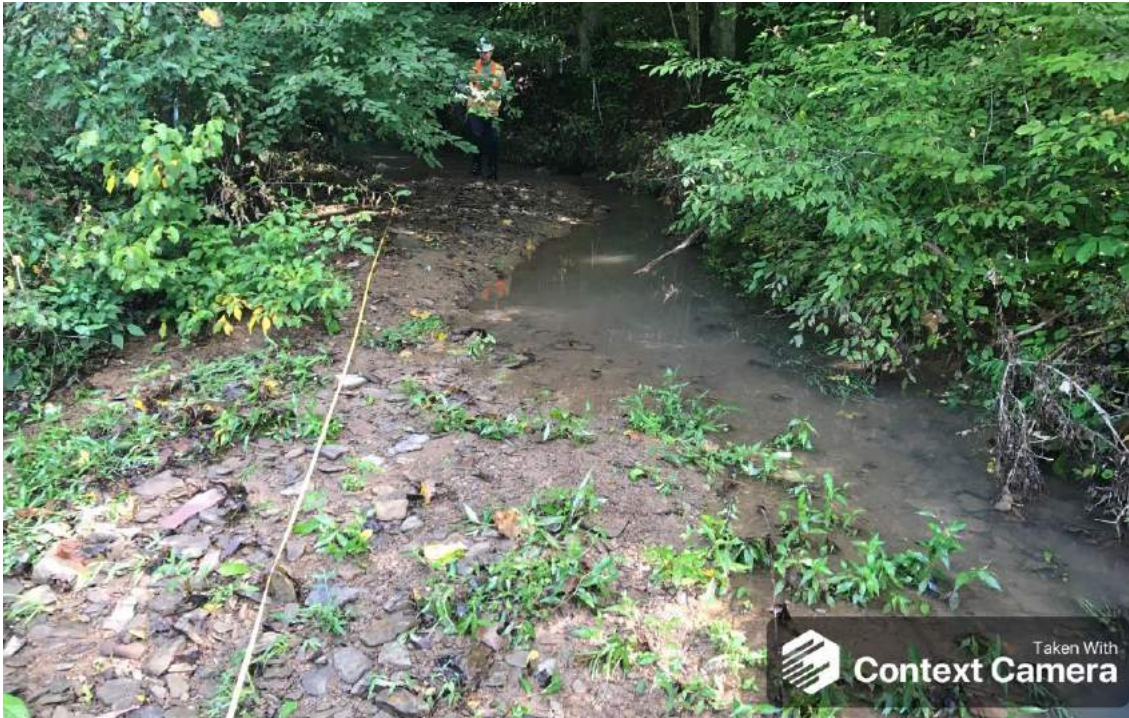
Photo Type: US, US View

Location, Orientation, Photographer Initials: Upstream Edge of ROW, Upstream View, HK, DH
Lat: 38.90393 Long: -80.563537

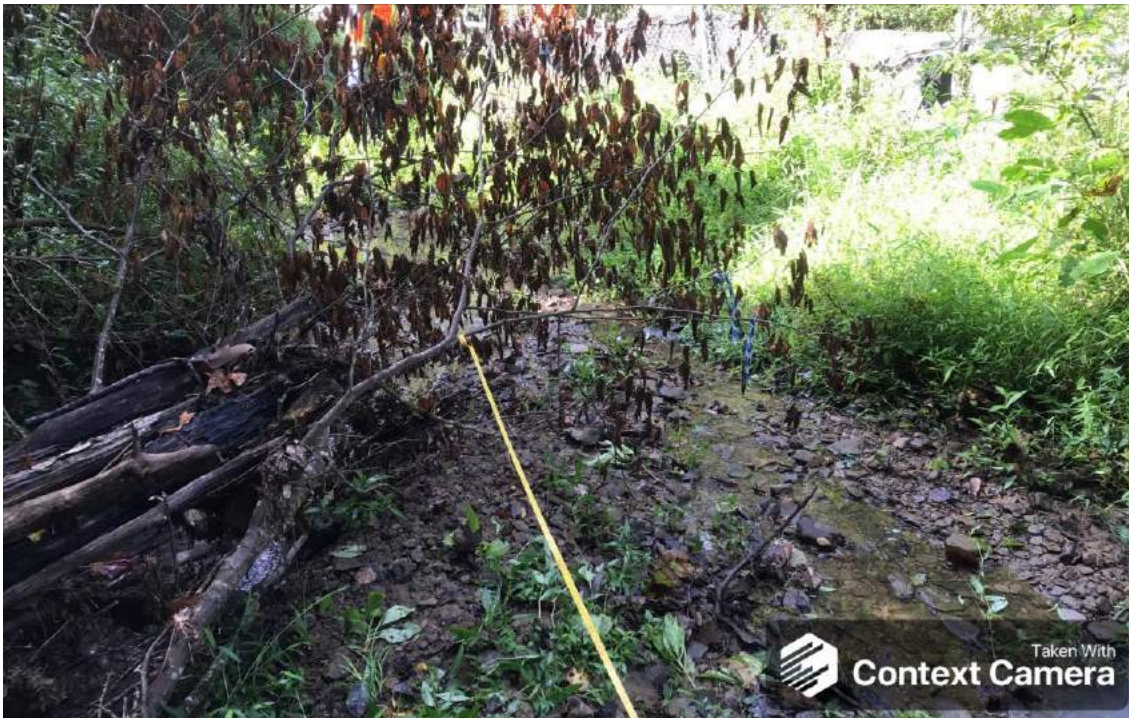
Photo Type: US, DS View

Location, Orientation, Photographer Initials: Upstream Edge of ROW, Downstream View, HK, DH
Lat: 38.90393 Long: -80.563537

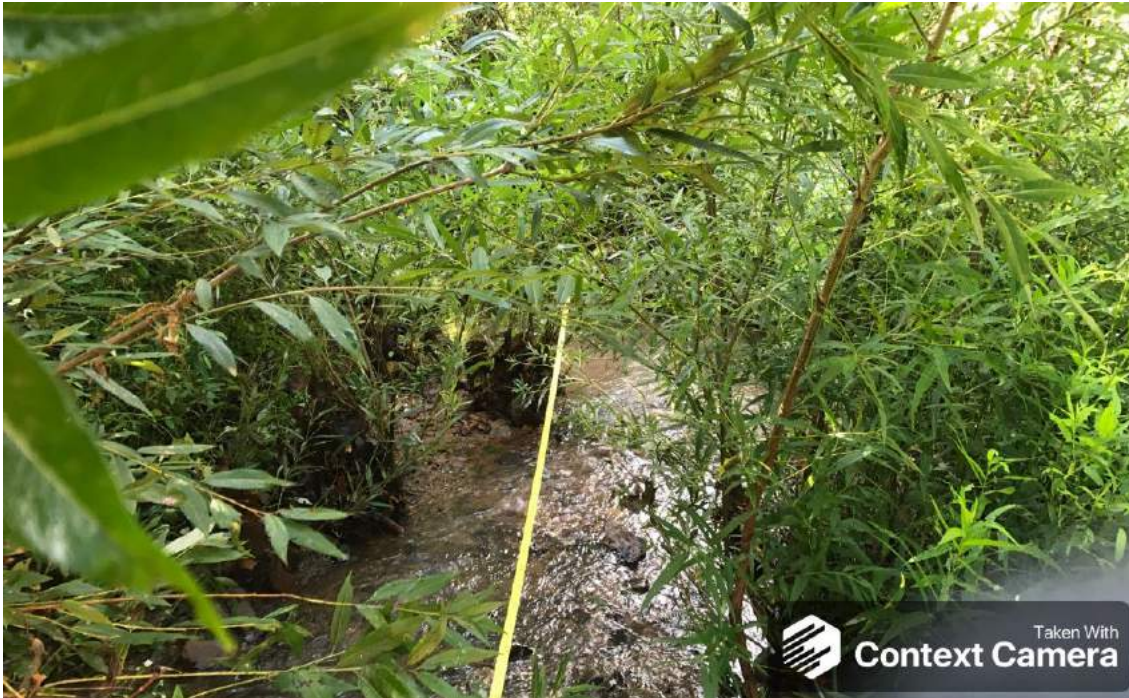
Photo Type: Pool, DS View
Location, Orientation, Photographer Initials: Upstream of Pool, Downstream View, HK, DH
Lat: 38.90393 Long: -80.563537

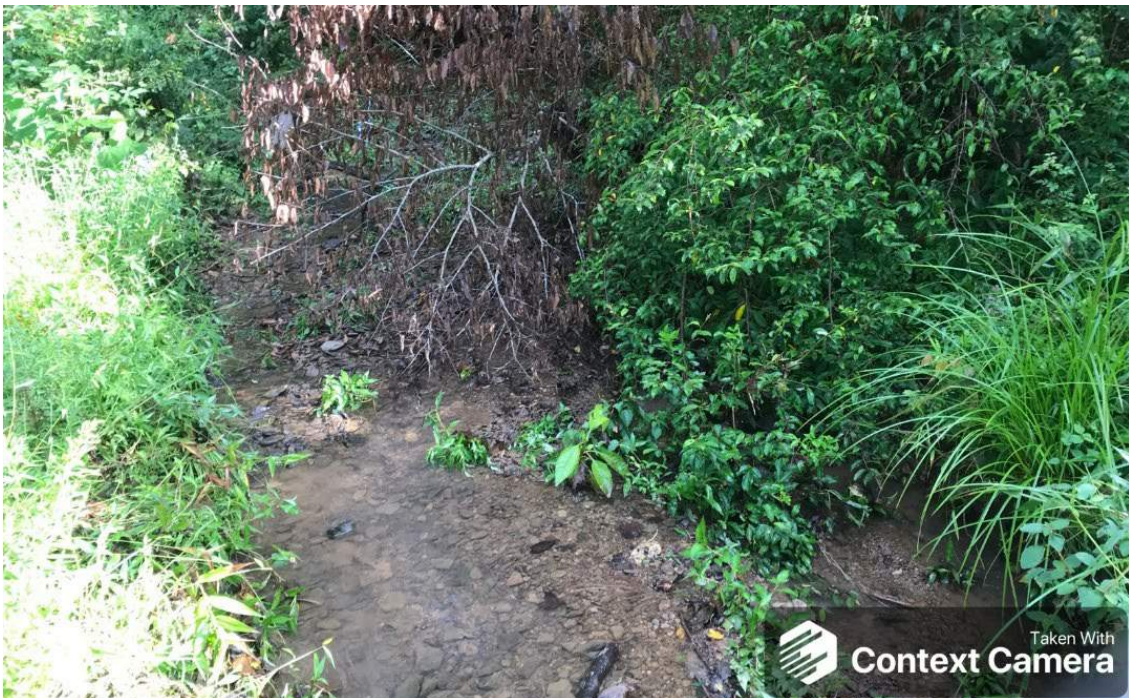
Photo Type: Pool, US View
Location, Orientation, Photographer Initials: Downstream of Pool, Upstream View, HK, DH
Lat: 38.90393 Long: -80.563537

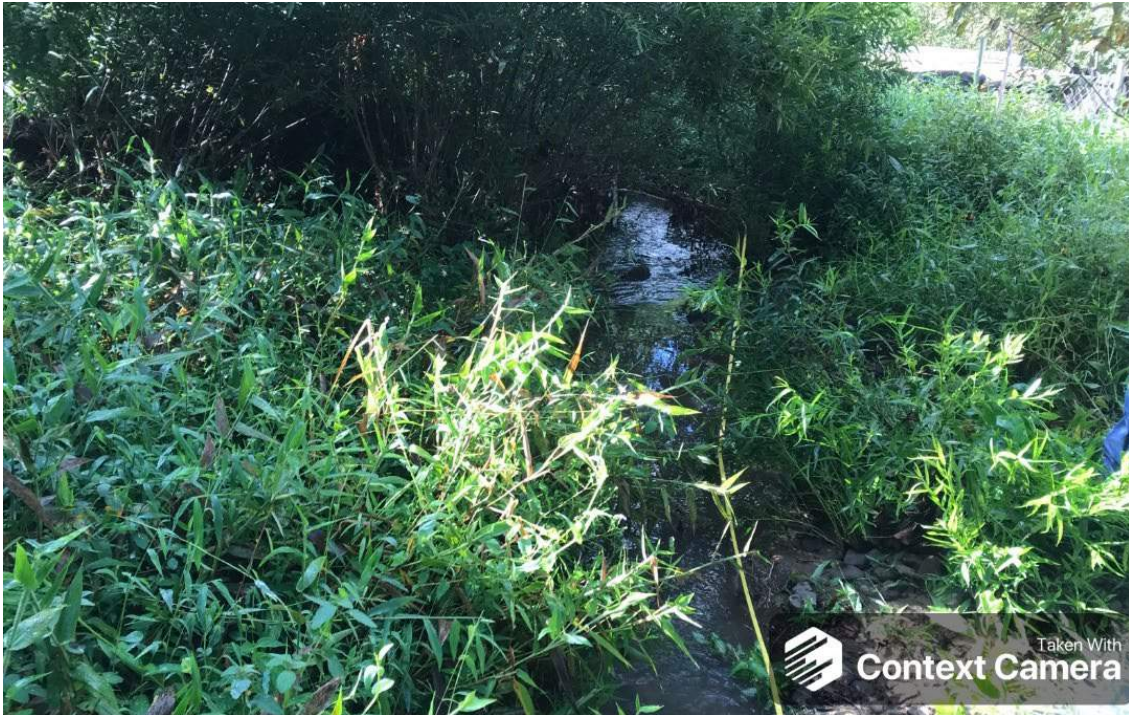
Photo Type: Riffle DS View
Location, Orientation, Photographer Initials: Upstream at ROW looking downstream, HK, DH
Lat: 38.90393 Long: -80.563537

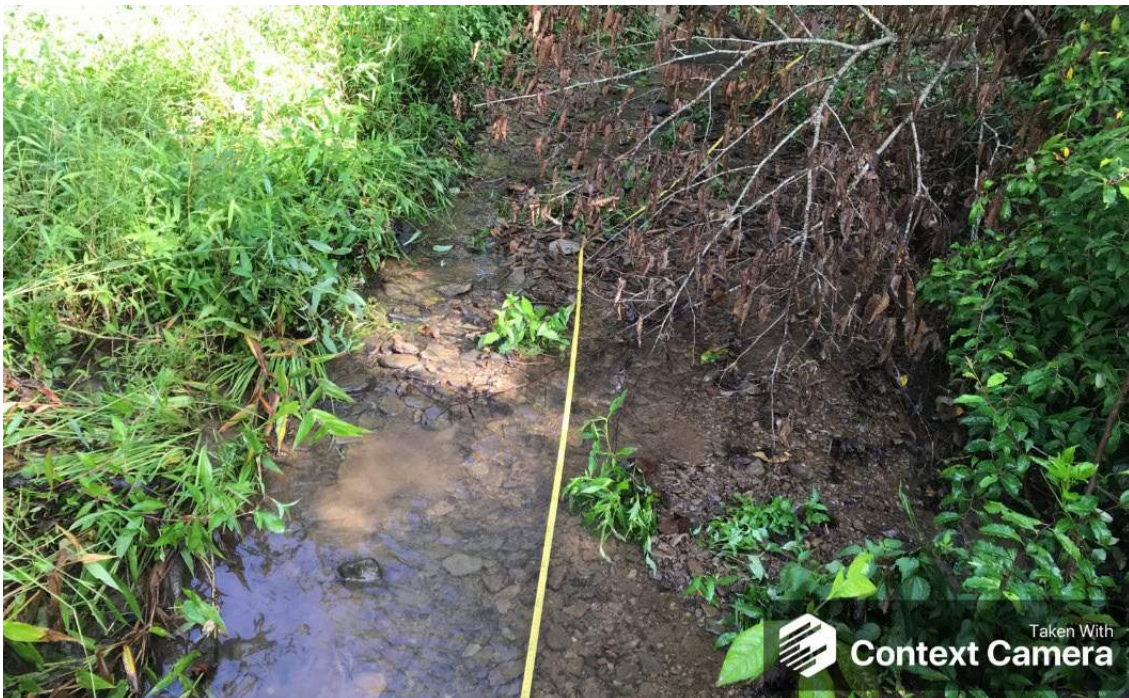
Photo Type: Riffle US View
Location, Orientation, Photographer Initials: Upstream at ROW looking downstream, HK, DH
Lat: 38.90393 Long: -80.563537

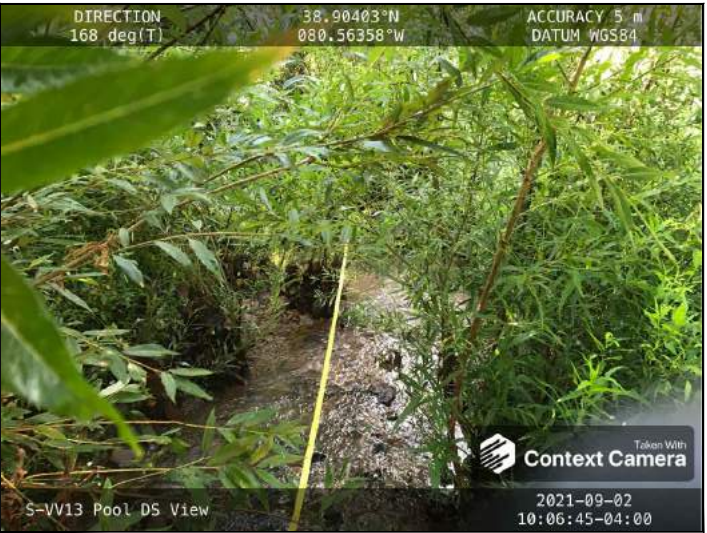
PHOTO TAKEN LOOKING DOWNSTREAM
FROM UPSTREAM IMPACT LIMITS

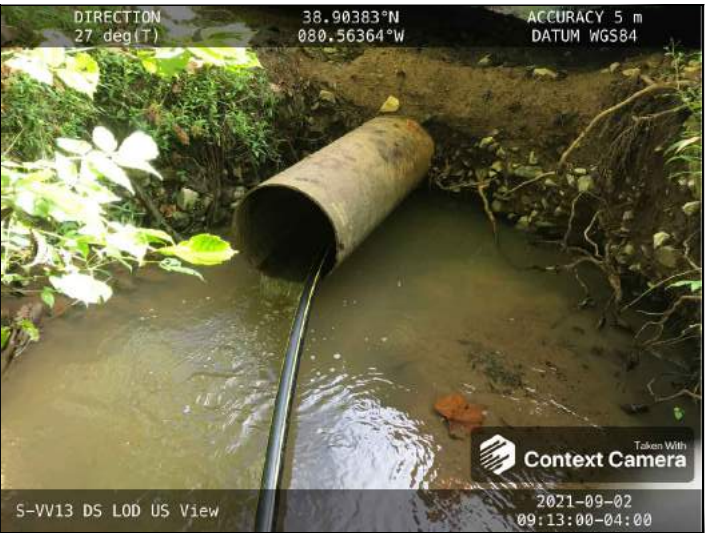
PHOTO TAKEN LOOKING UPSTREAM FROM
DOWNSTREAM IMPACT LIMITS
