Baseline Assessment – Stream Attributes

Reach S-VV13b (Temporary Access Road) Perennial Spread B Lewis County, West Virginia

Client
PROFILE AND CROSS-SECTIONS
BASELINE SURVEY
CROSSING S-VV13B -
SECOND BIG RUN (MP 61.30)
LEWIS COUNTY, WV

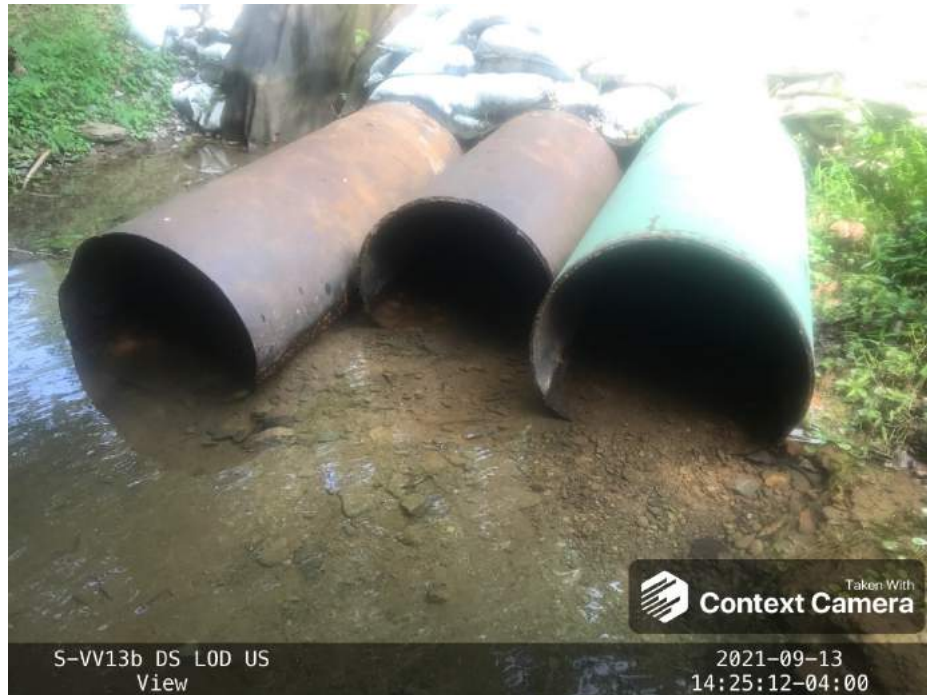
Photo Type: DS, US View

Location, Orientation, Photographer Initials: Downstream Edge of ROW, Upstream View, MAG/DPF
Lat: 38.898431 Long: -80.56825

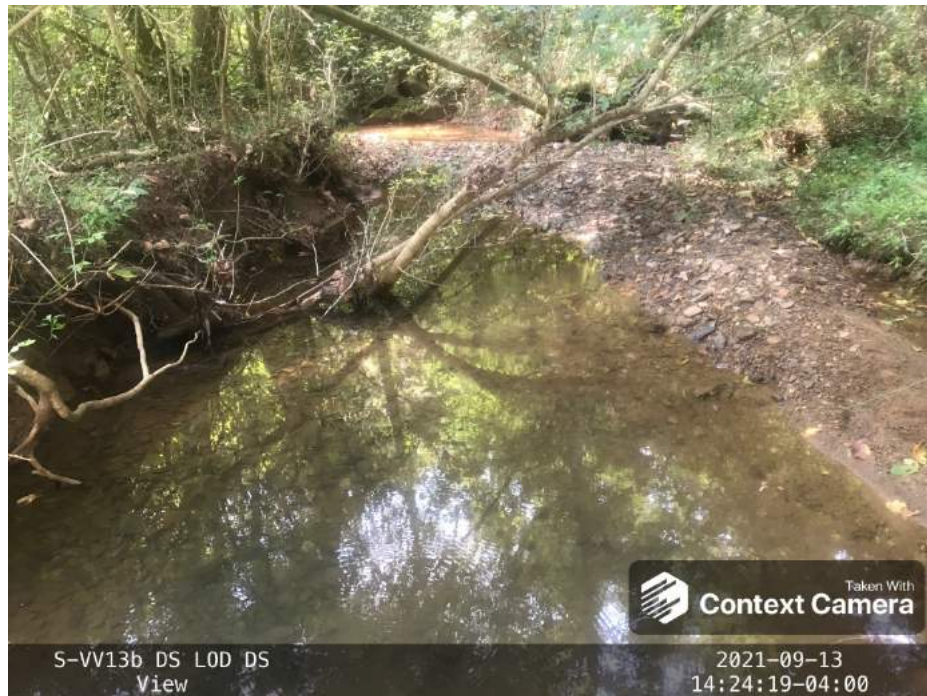
Photo Type: DS, DS View

Location, Orientation, Photographer Initials: Downstream Edge of ROW, Downstream View, MAG/DPF
Lat: 38.898431 Long: -80.56825

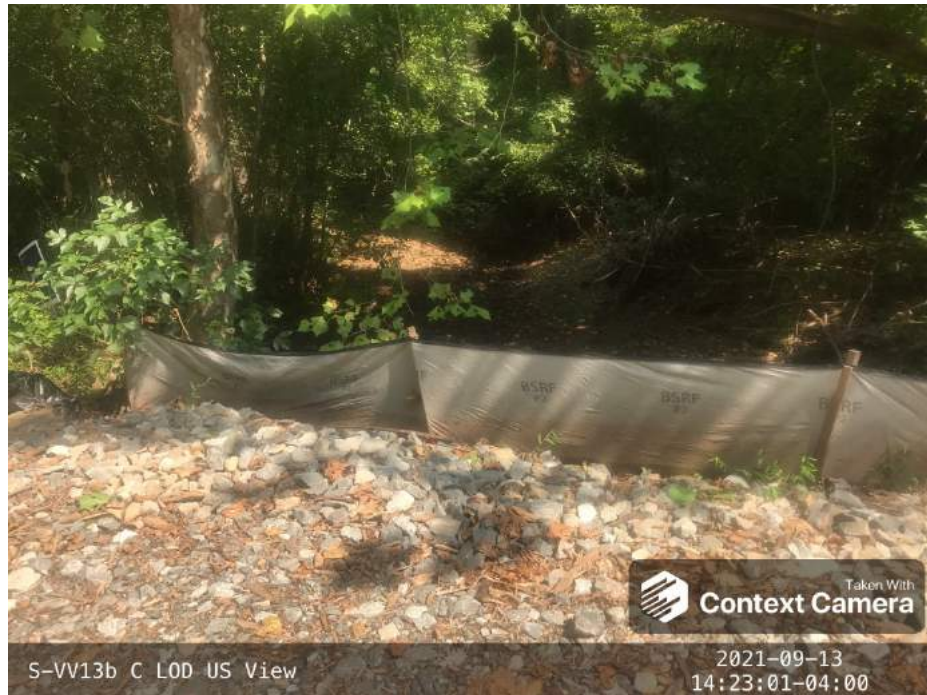
Photo Type: US View at Center
Location, Orientation, Photographer Initials: Center ROW, Upstream View, MAG/DPF
Lat: 38.898431 Long: -80.56825

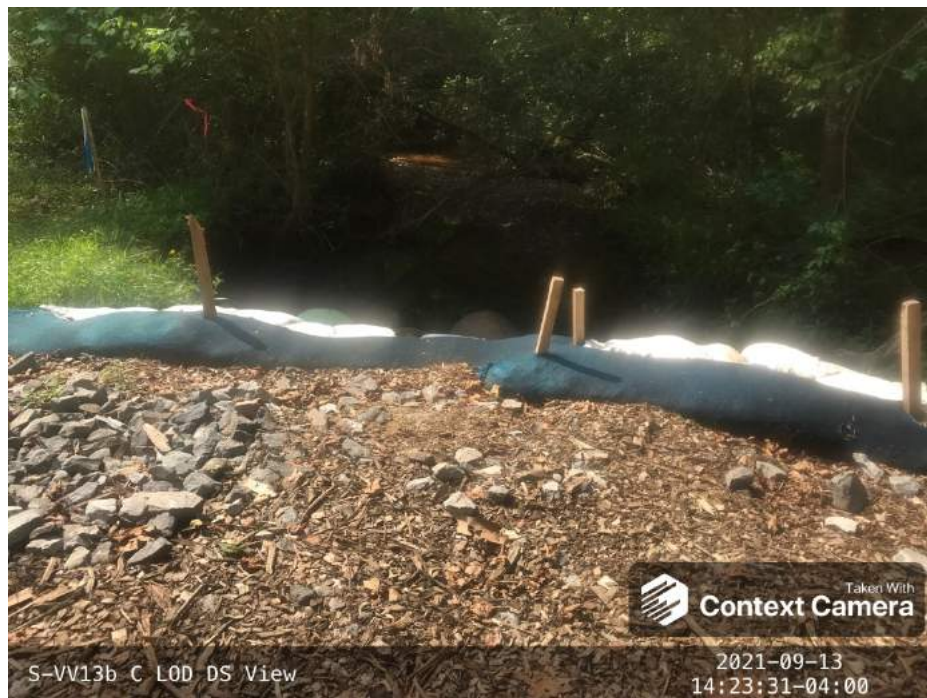
Photo Type: DS View at Center
Location, Orientation, Photographer Initials: ROW Center, Downstream View, MAG/DPF
Lat: 38.898431 Long: -80.56825

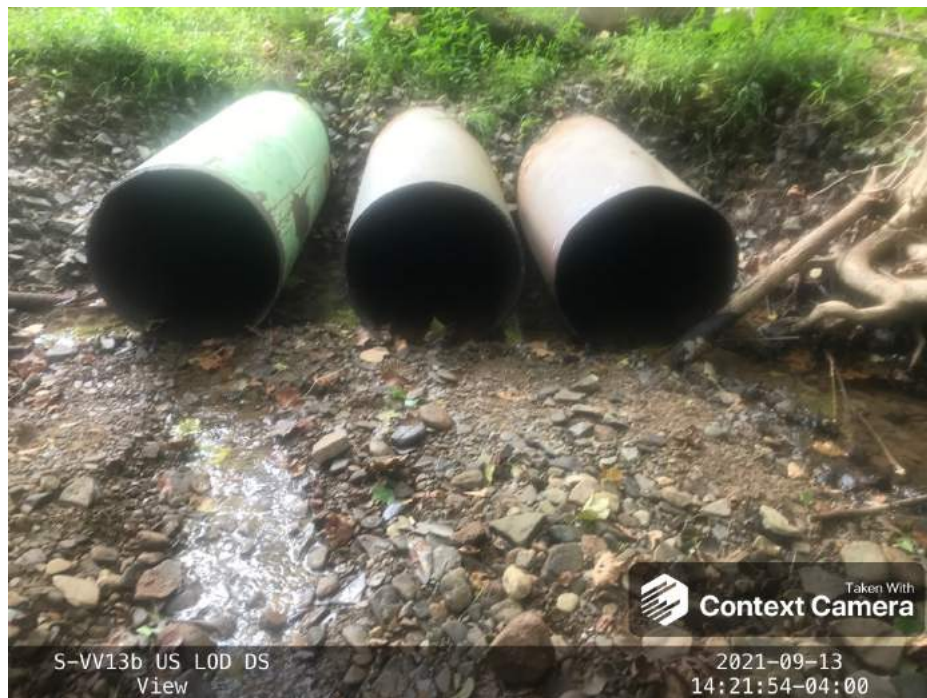
Photo Type: US, DS View

Location, Orientation, Photographer Initials: Upstream Edge of ROW, Downstream View, MAG/DPF
Lat: 38.898431 Long: -80.56825

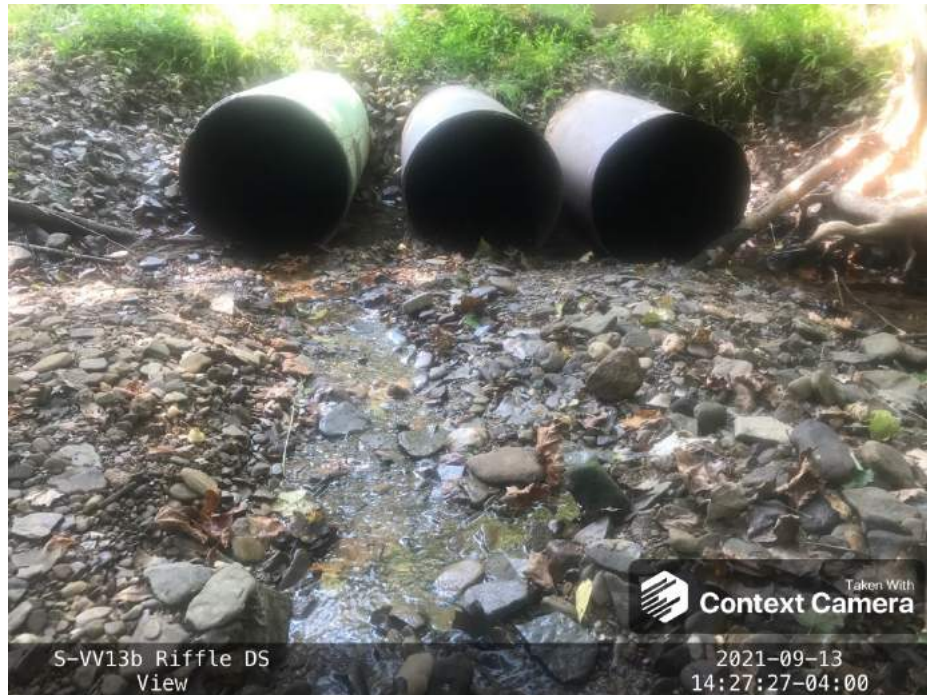
Photo Type: Riffle, DS View
Location, Orientation, Photographer Initials: Upstream of Riffle, Downstream View, MAG/DPF
Lat: 38.898431 Long: -80.56825

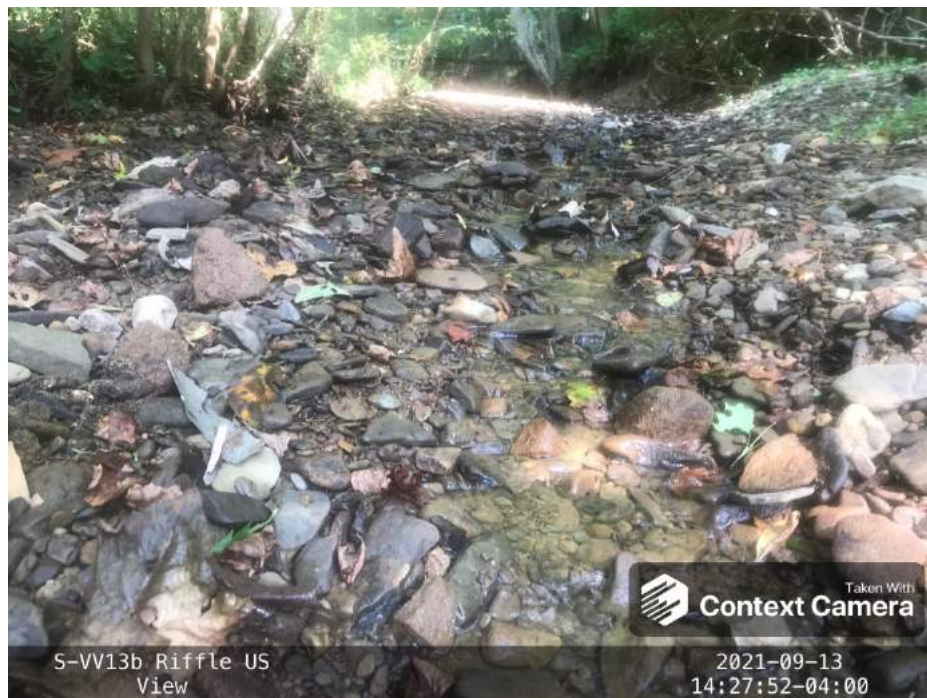
Photo Type: Riffle, US View
Location, Orientation, Photographer Initials: Downstream of Riffle, Upstream View, MAG/DPF
Lat: 38.898431 Long: -80.56825

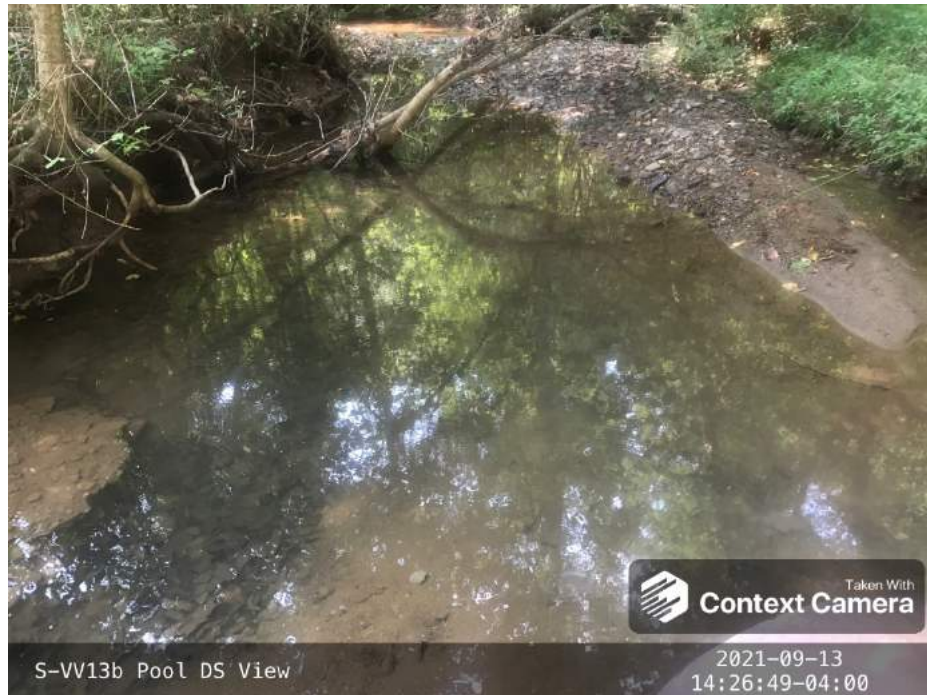
Photo Type: Pool, DS View

Location, Orientation, Photographer Initials: Upstream of Pool, Downstream View, MAG/DPF
Lat: 38.898431 Long: -80.56825

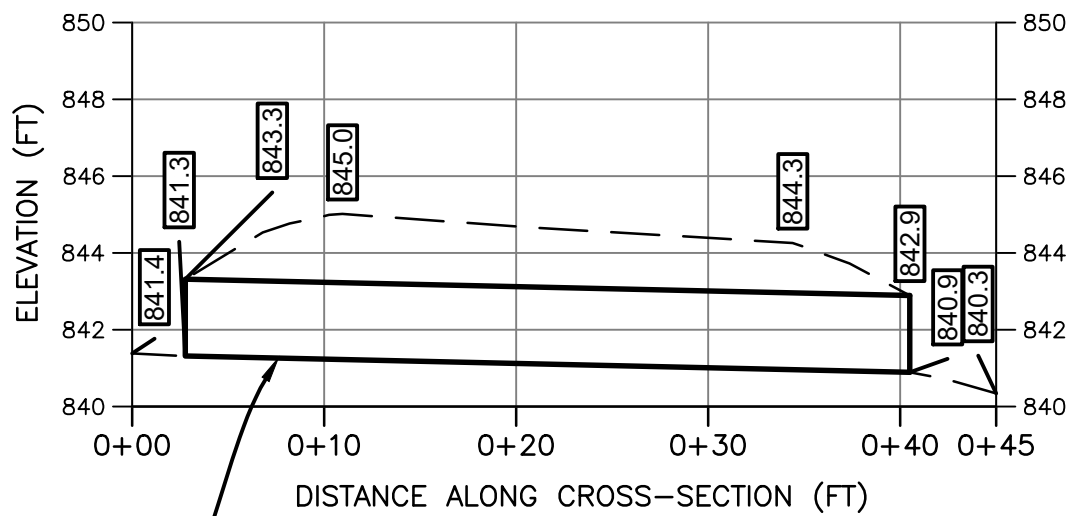
S-VV13B BASELINE THALWEG PROFILE

EXISTING CULVERT

PROFILE
SCALE: H: 1"=10'
V: 1"=5'

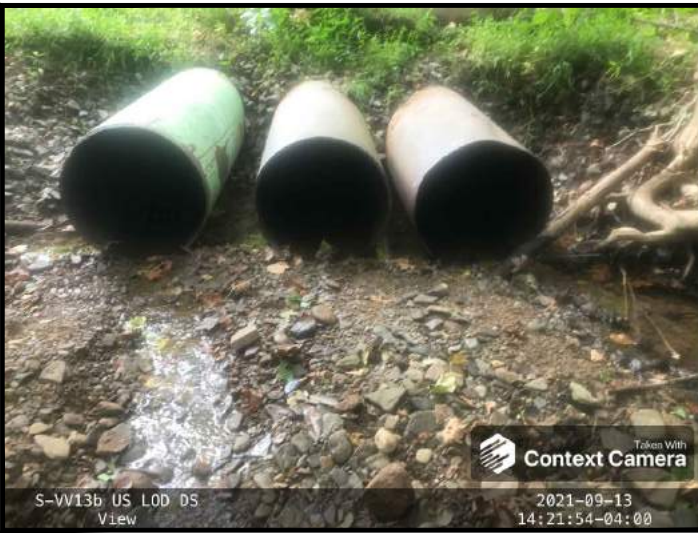
PHOTO TAKEN LOOKING DOWNSTREAM
FROM UPSTREAM IMPACT LIMITS

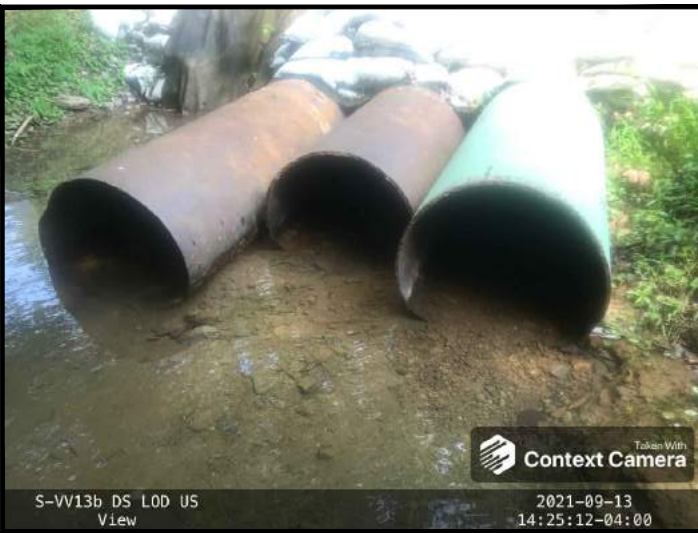
PHOTO TAKEN LOOKING UPSTREAM FROM
DOWNSTREAM IMPACT LIMITS
